CULTURAL HERITAGE APPRAISAL

WOODHEAD TUNNELS

SURFACE STRUCTURES

NAA 13/66
May 2013

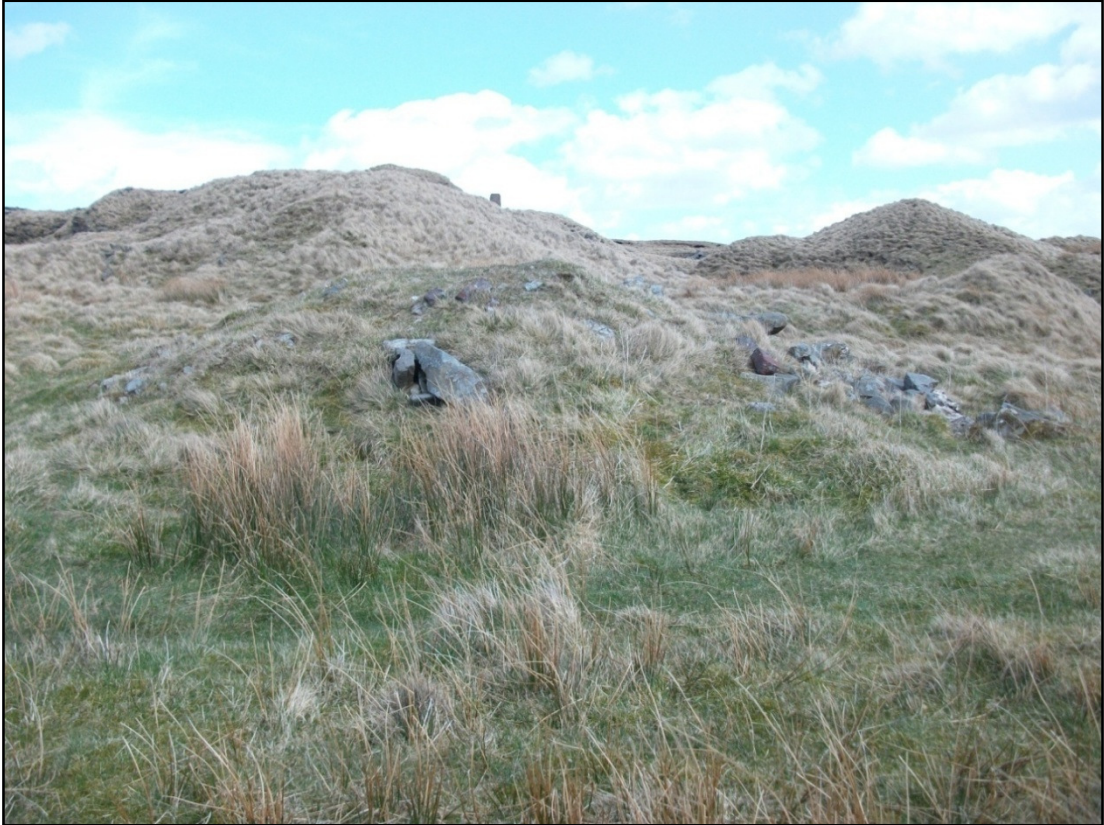
- 3.6 The remains of Construction Shaft 1 are located within a disused quarry, c. 1060m to the north-east of the western tunnel portal, and the shaft is relatively difficult to identify on the basis of its surviving structure alone.

Plate 1 The remains of Construction Shaft 1 from the west

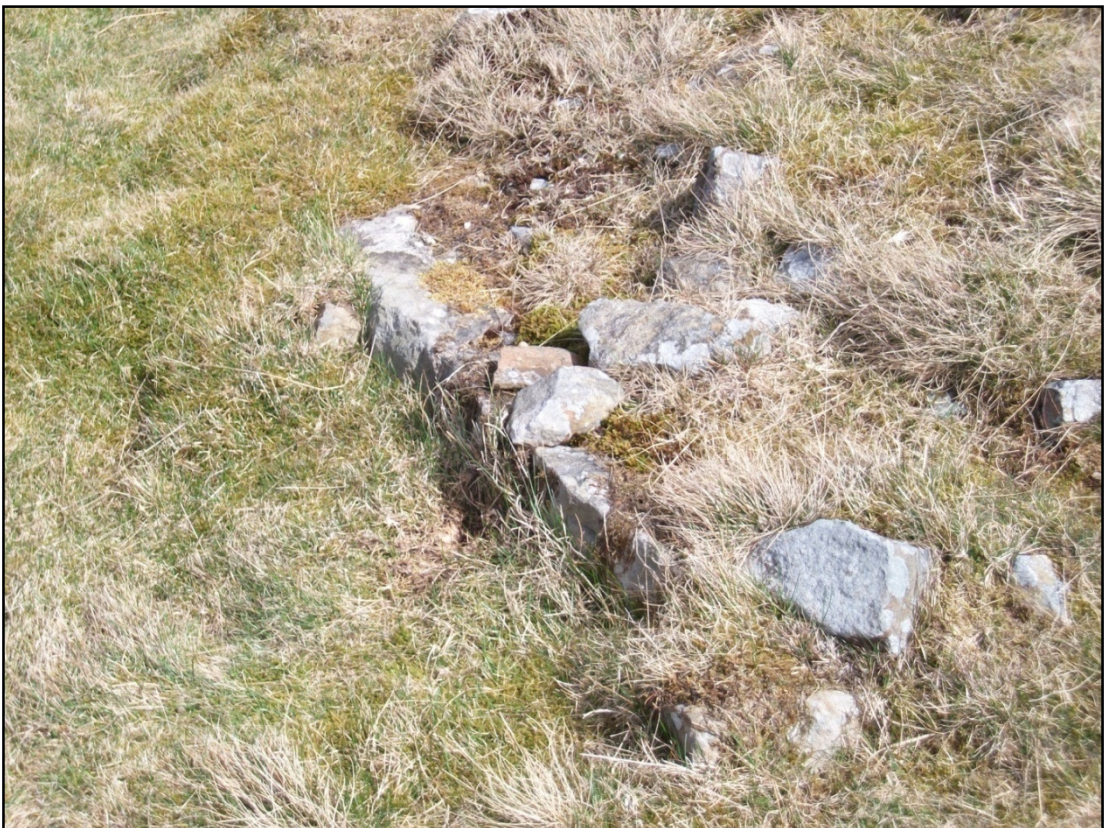
Plate 2 Fugitive remains of the lip of Construction Shaft 1

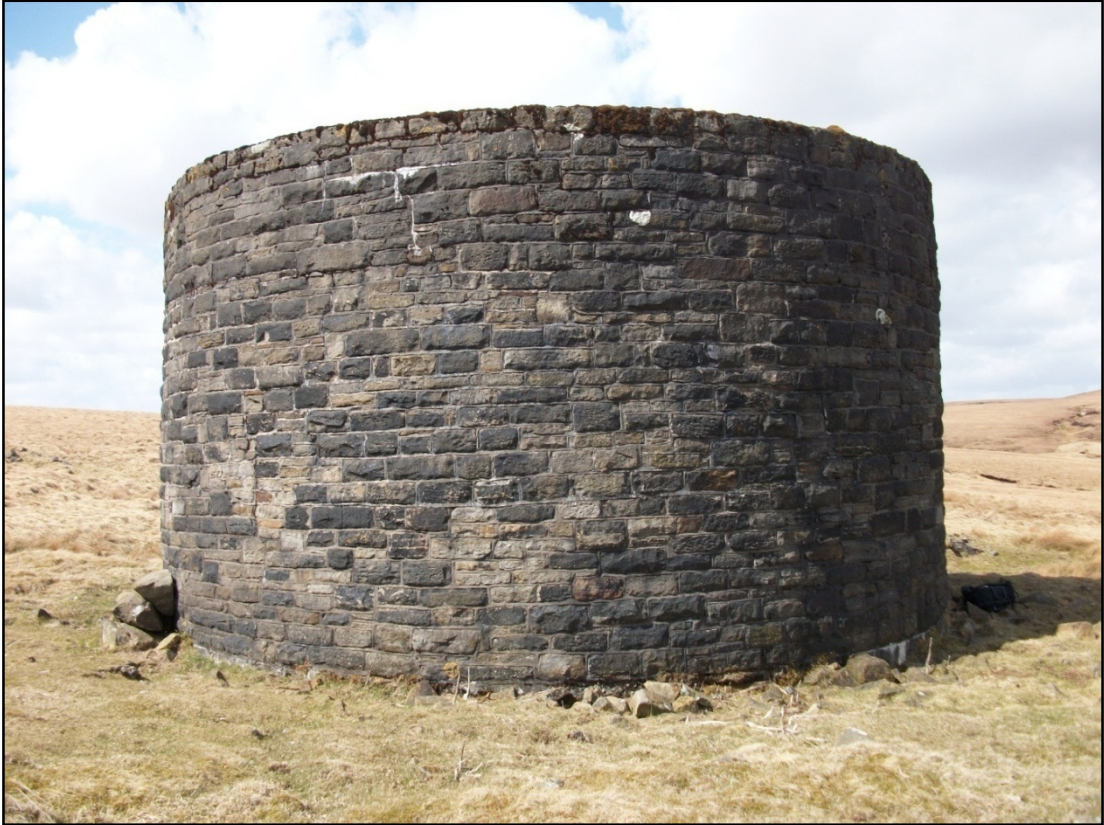
- 3.13 The air-shaft tower was constructed of cement-mortared, coursed gritstone blocks of various shapes and sizes and sits upon a concrete ring-beam which is eroding, predominantly on its western side. As a consequence of this erosion, the masonry of the structure has cracked in several places, and in at least one case, the crack extends through the blocks of the masonry rather than through the bonding. Some baulks of timber have also been incorporated into the structure at low level, these now being in poor condition.

Plate 3 Ventilation tower, Construction Shaft 2 from the south-east

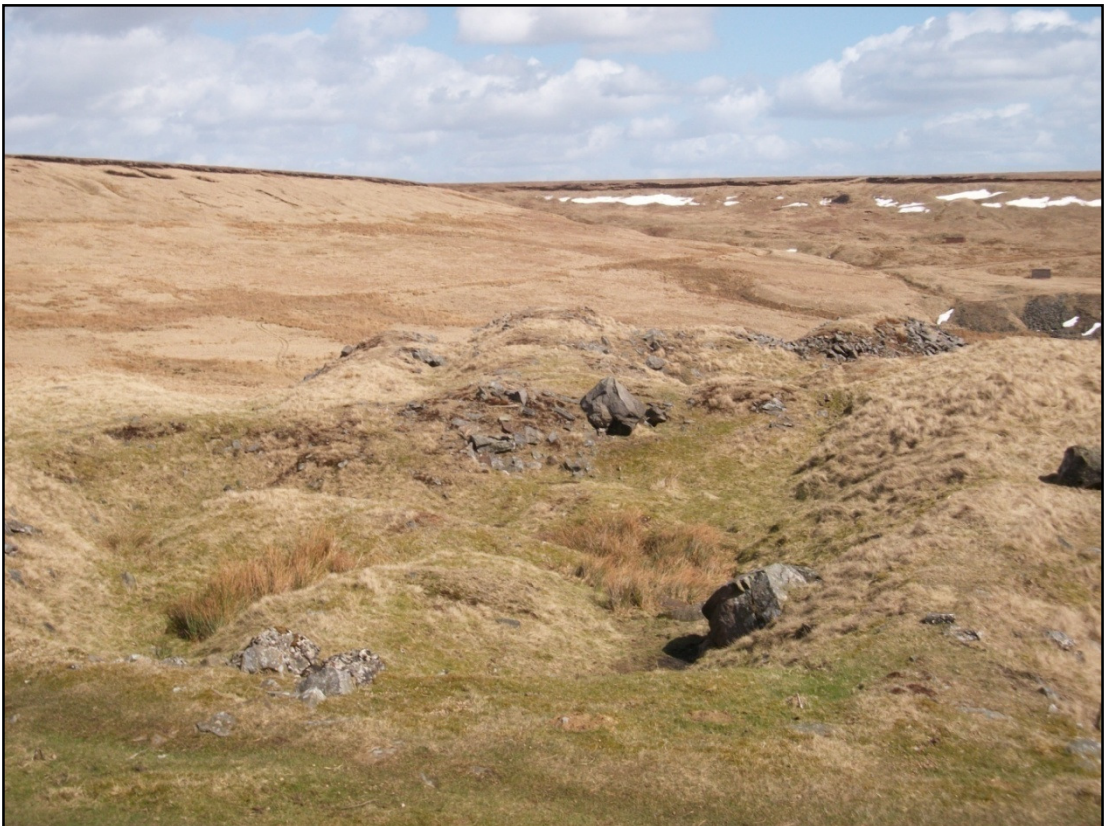
- 3.14 The tower sits amidst a complex of spoil-heaps, predominantly situated to the south and east of the tower, which undoubtedly contain the remains of ancillary structures such as the engine house which are difficult to definitively identify on the surface.

Plate 4 Spoil heaps and possible structural remains associated with Construction Shaft 2

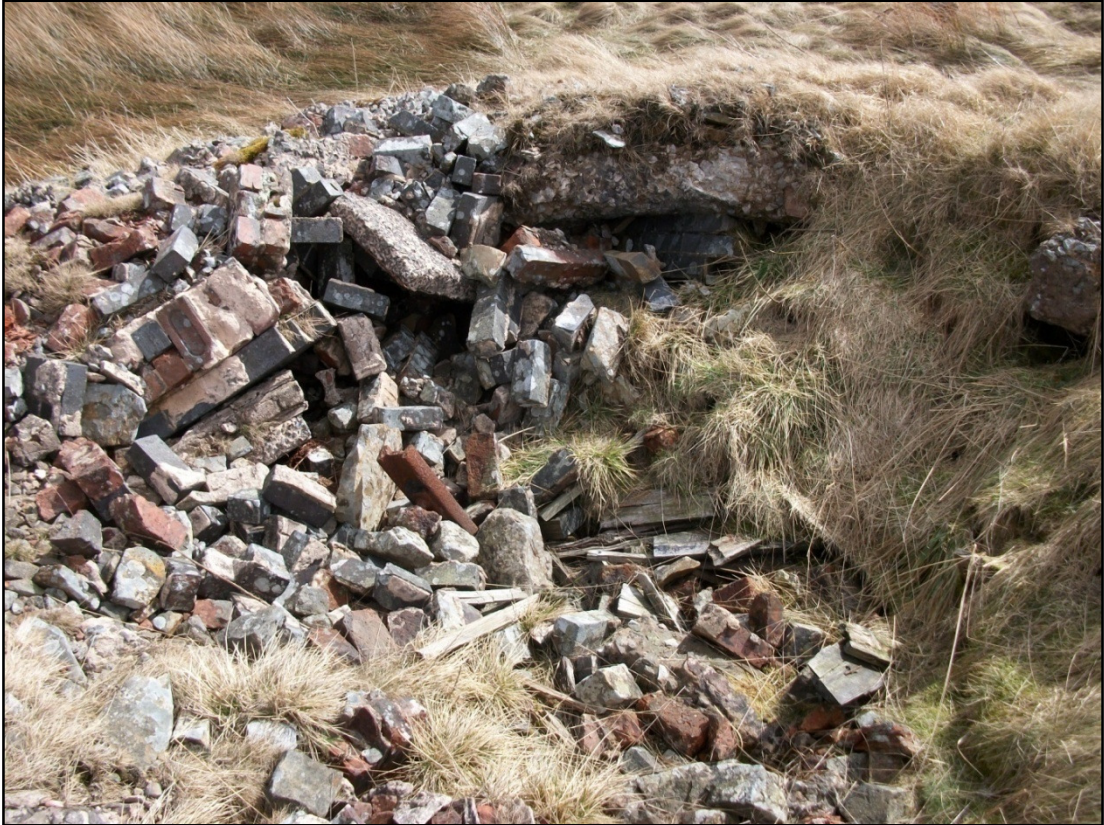
- 3.18 The mound sits within a patch of waterlogged ground, in the vicinity of a former brook, to the west of a scarp that was once surmounted by Observatory 3. The shaft is surrounded by a number of reworked and ill-defined earthwork features, some of which are likely to be of natural origin. There are no obvious indications of former ancillary structures, or former spoil heaps, these probably having been cleared during construction works associated with the later rail tunnel.

Plate 5 Unconsolidated backfill in Construction Shaft 3

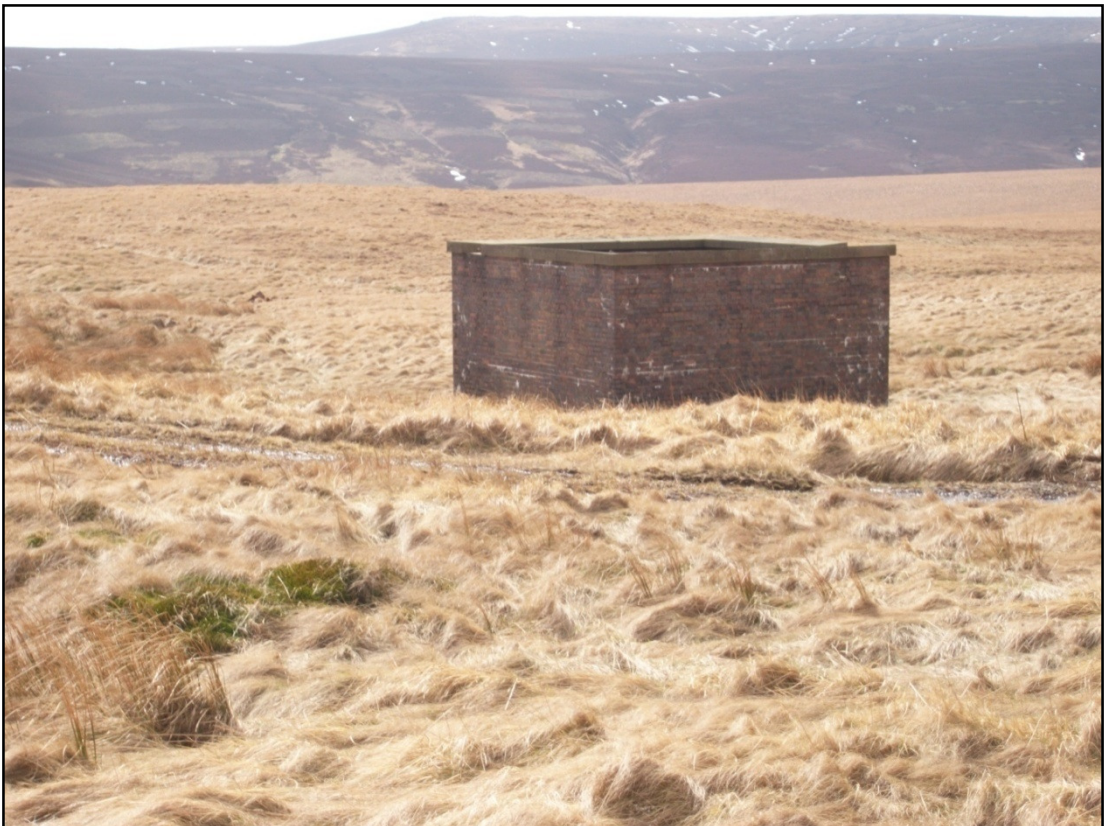
- 3.19 The sole construction shaft for the 1950s railway is located off the line of the 19th-century works, approximately 55m to the south, and its surface remains are represented by a single, square, brick ventilation tower constructed in English Garden Wall bond.

Plate 6 Ventilation tower on site of 1950s Construction Shaft, from the north.

- 3.20 The structure is approximately 6m square, its walls being capped with sandstone ashlar coping stones, one having been displaced. The spoil heap for this tunnel is vast in comparison to the dendritic spoil-heaps of the 1800s and comprises a well defined and deliberately shaped, level, platform of debris measuring some 240m north-west to south-east by 120m north-east to south-west. It would seem likely that the majority of the spoil from the earlier phase of construction, and the remains of any associated buildings, have been ‘tidied up’ and incorporated into this later heap.

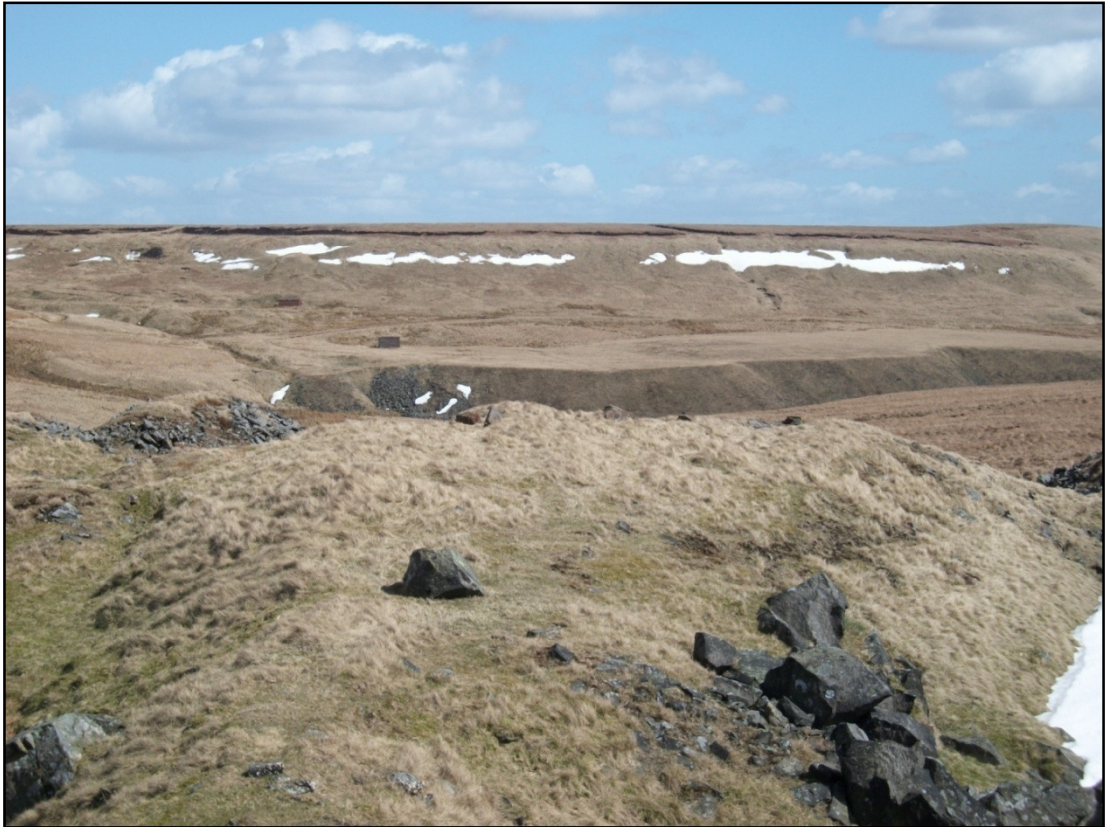
Plate 7 View of 1950s spoil heap from 1840s spoil heap at Construction Shaft 2, from west

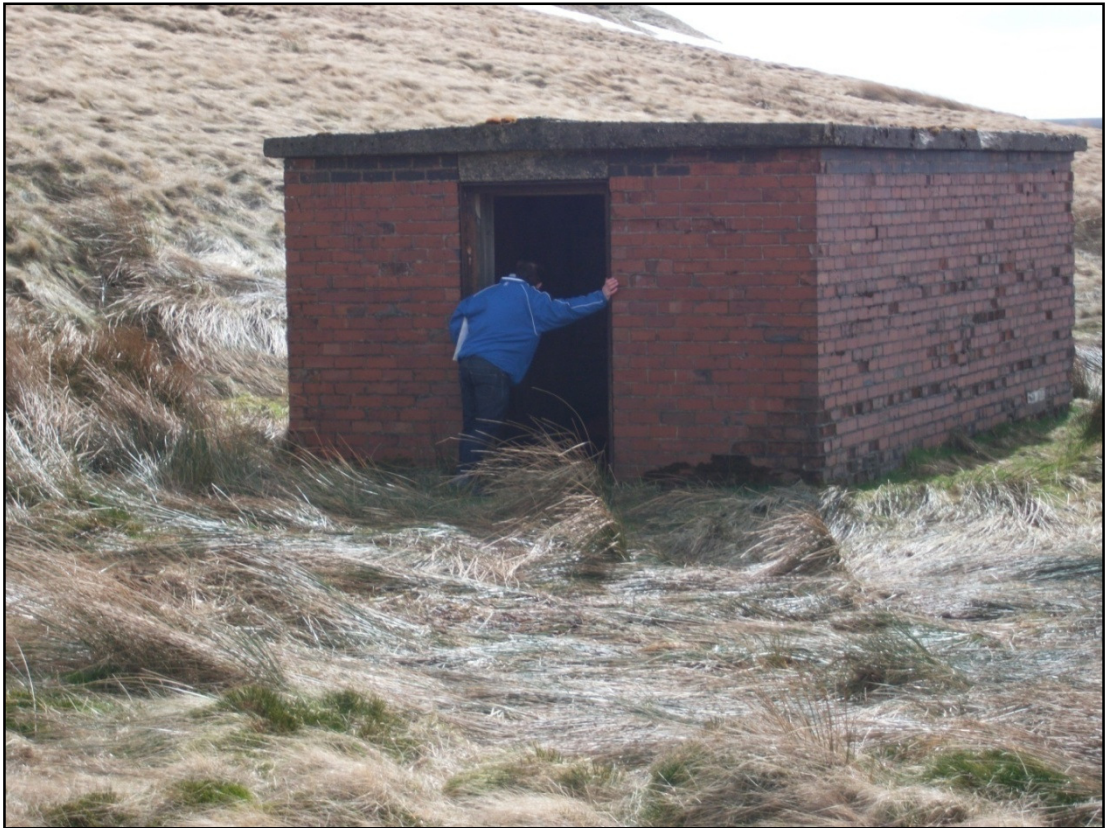
- 3.21 A single bicameral flat-roofed brick-built structure, which almost certainly relates to the 1950s tunnel, survives about 95m to the north-east of the later shaft, its function being unclear.
- 3.22 Access to the 1950s works was by a trackway leading south-eastwards to Goddard Lane. There is a further track leading eastwards, up the scarp towards Construction Shaft 4, it would seem unlikely that this was the principal route used for coaling or otherwise supplying shaft 3 as a consequence of the slope involved. As noted above, there is no easy means of access from shaft 2 in the west, and a former supply route leading from Goddard Lane in the 1840s would seem probable.

Plate 8 1950s ancillary building from north-west

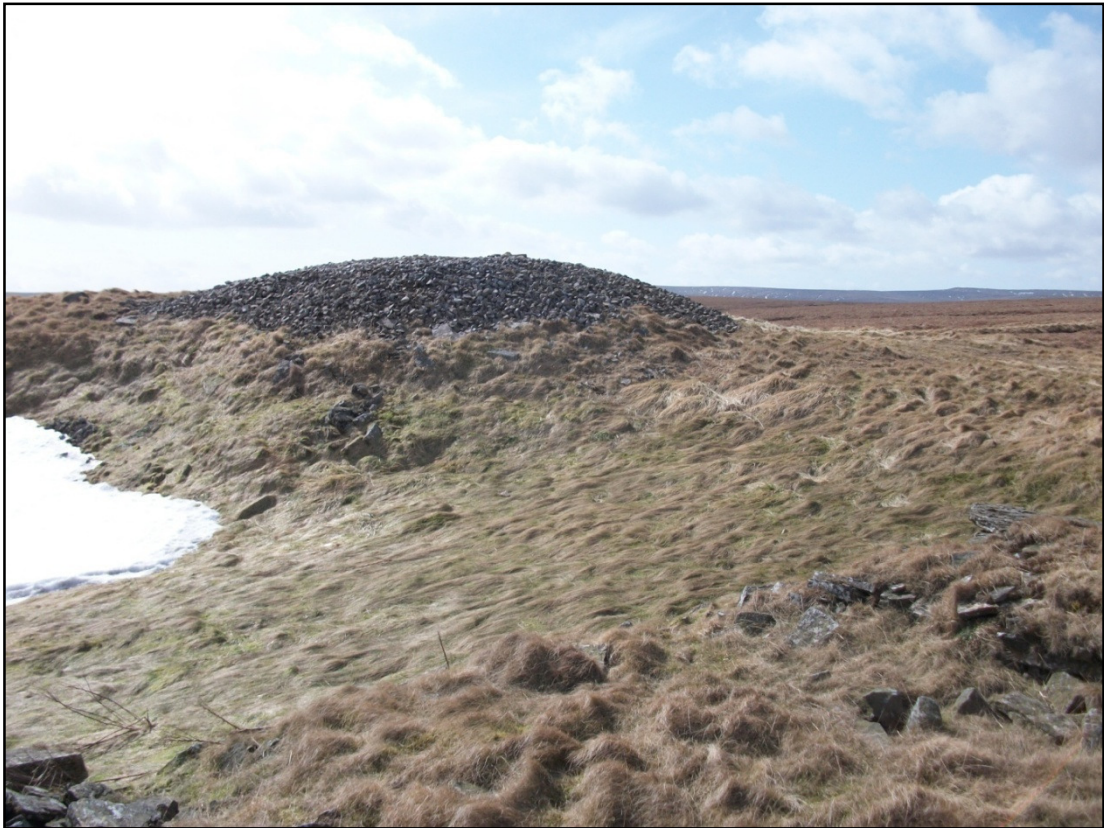
- 3.24 Construction Shaft 4 was located some 648m to the east of shaft 3 on gently eastward sloping ground. The remains of the shaft are represented by a tidy sub-circular cairn of sandstone rubble bounded to the south-east by a well preserved complex of dendritic spoils-mounds.

Plate 9 Cairn sealing Construction Shaft 4 from north

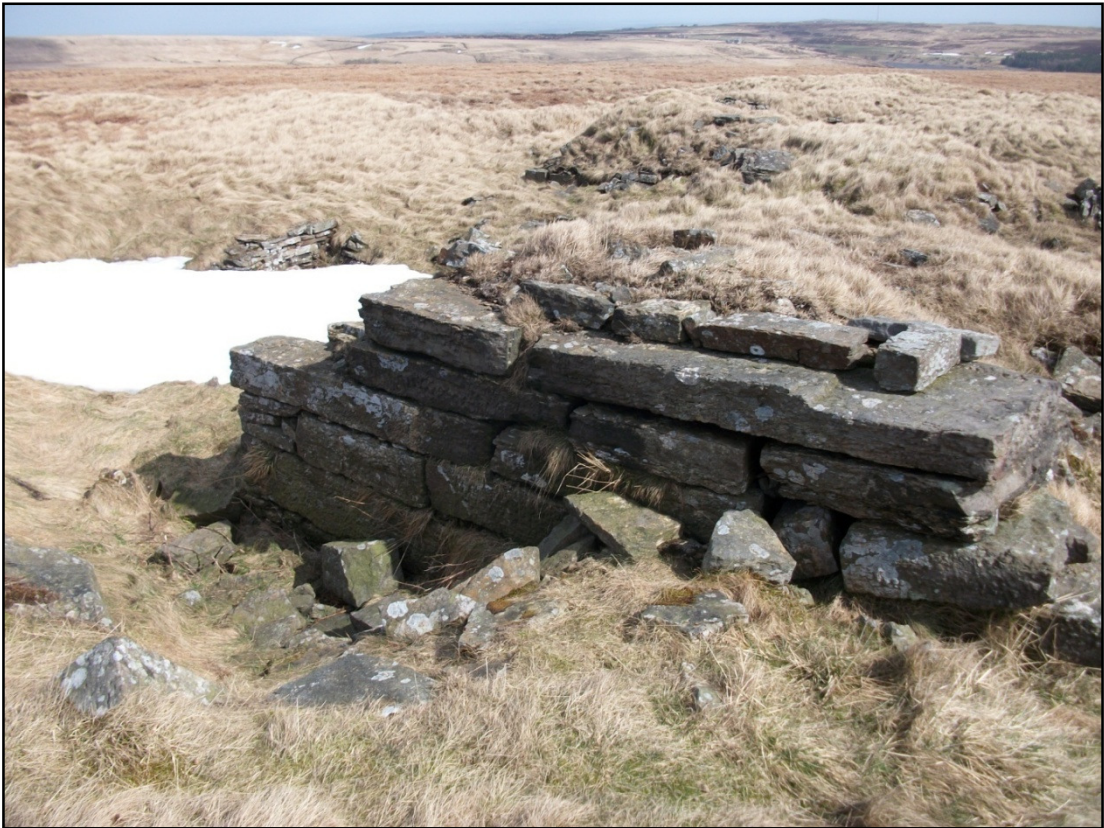
- 3.25 The foundations of a number of stone-built ancillary buildings survive to the north of the shaft, and a number of architectural fragments are scattered around the complex, including a substantial sandstone bearing-block (without its bearing) from a former machine.
- 3.26 Access to the shaft seems to have been by a track leading from Construction Shaft 5, to the east, and this track extended westwards to Observatory 3 situated on the crest of a scarp between shafts 4 and 3, whereupon it descended the scarp to shaft 3. A second track now loops southwards over somewhat boggy ground to intersect Goddard Lane, although it is uncertain if this track was part of the original communications network or represents a later feature.

Plate 10 Remains of ancillary building to the north of Construction Shaft 4

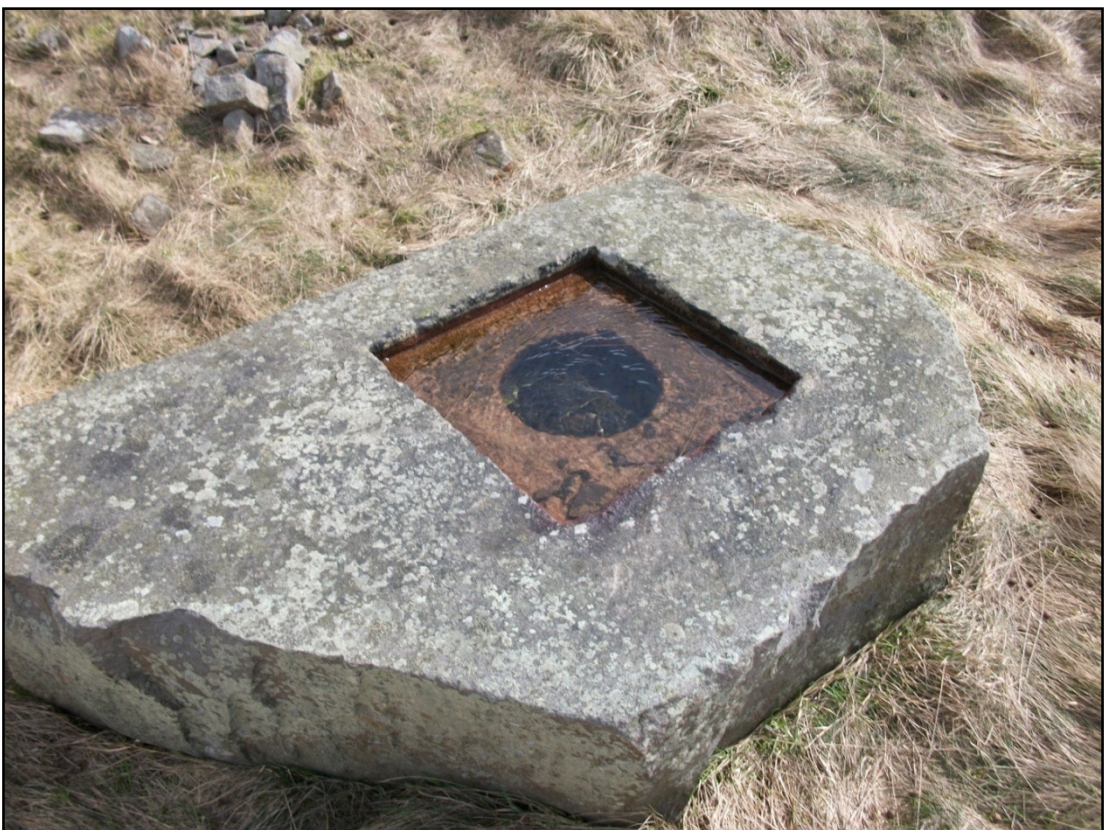
Plate 11 Former bearing-block adjacent to Construction Shaft 4

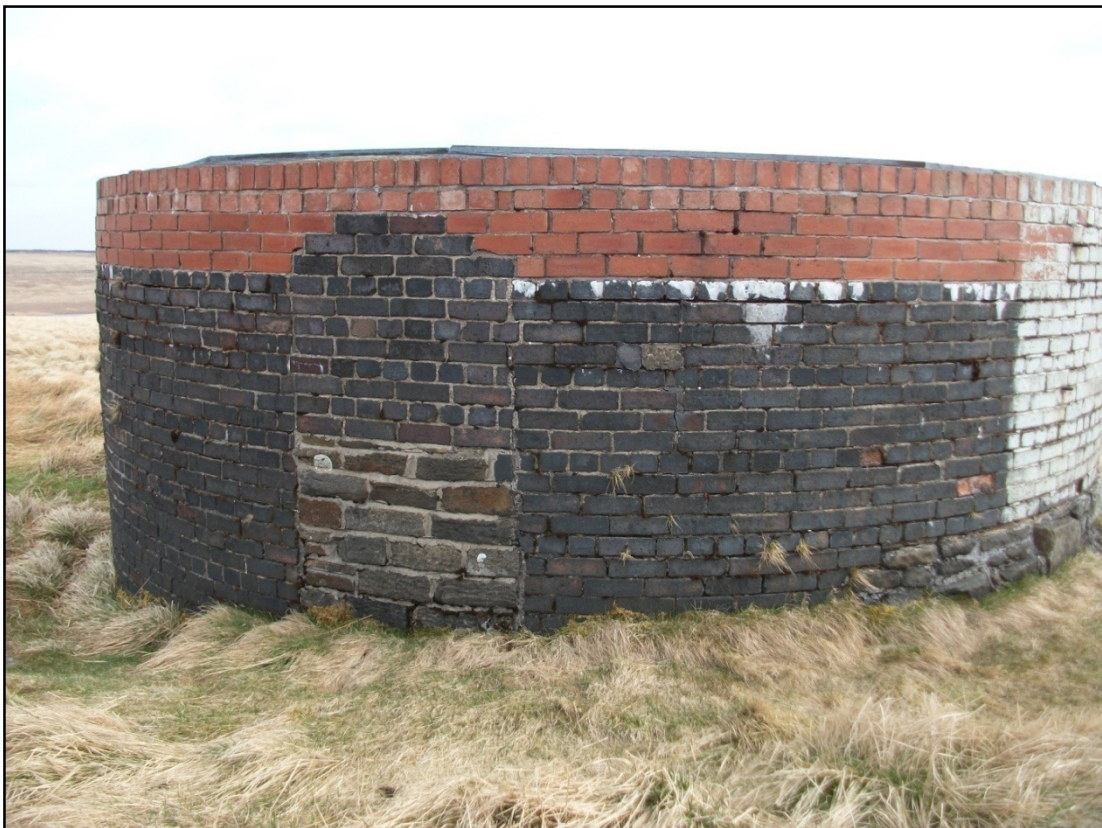
- 3.28 Construction Shaft 5 was the easternmost of the original shafts required by the 1840s engineering scheme. The position of the shaft is marked by a short ventilation tower, c.2m in height, constructed of brickwork surmounting the remains of an earlier sandstone-built structure which only survives to a maximum of four courses in height, for part of the circumference of the structure. The fabric brick tower, built in English Garden Wall bond, preserves evidence of a former doorway, now blocked, and the uppermost five courses are recent replacements of the original engineering brick.

Plate 12 Blocked doorway in ventilation tower, Construction Shaft 5

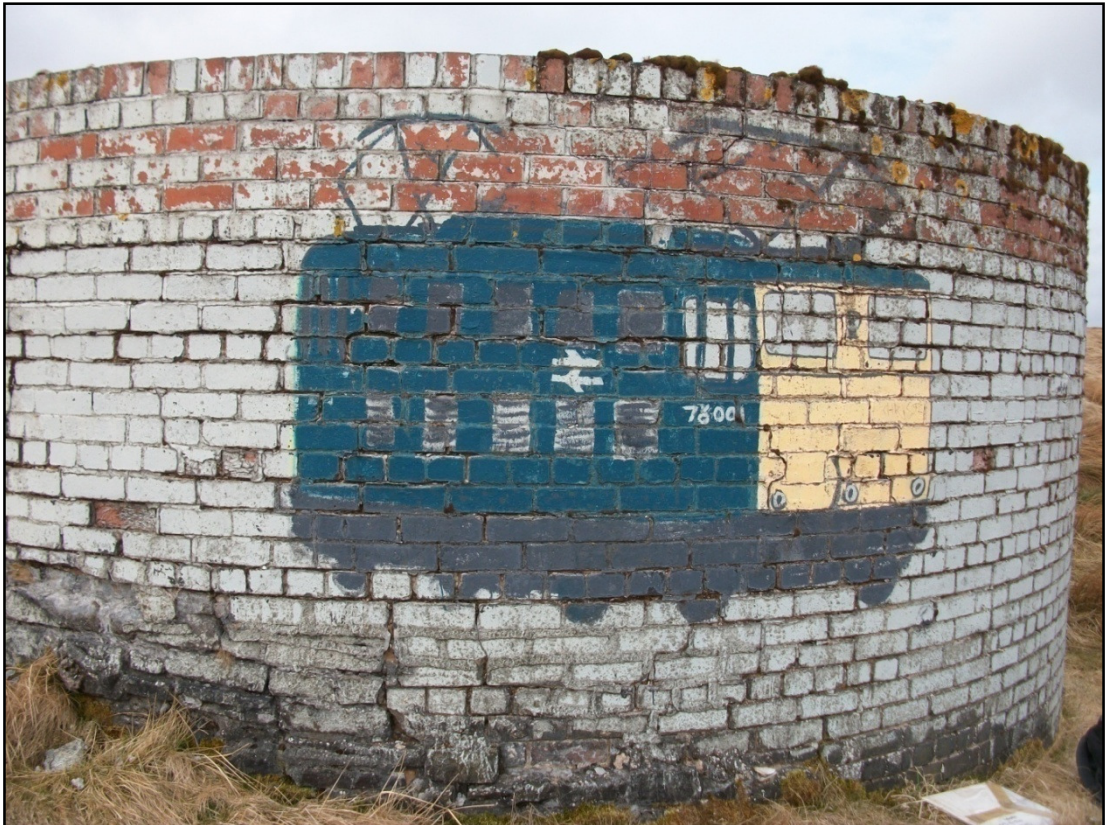
- 3.29 The southern half of the tower has been painted white and bears a mural depicting an electric locomotive in British Rail electric blue livery. This is possibly a crude depiction of a Bo-Bo Class EM1 (also known as Class 76, predominantly used for freight) locomotive, or a Co-Co Class EM2 (alternatively Class 77, predominantly used for passengers) locomotive, it being difficult to distinguish just how many wheels are depicted in the mural. Both classes were

Plate 13 Mural on ventilation tower, Construction Shaft 5

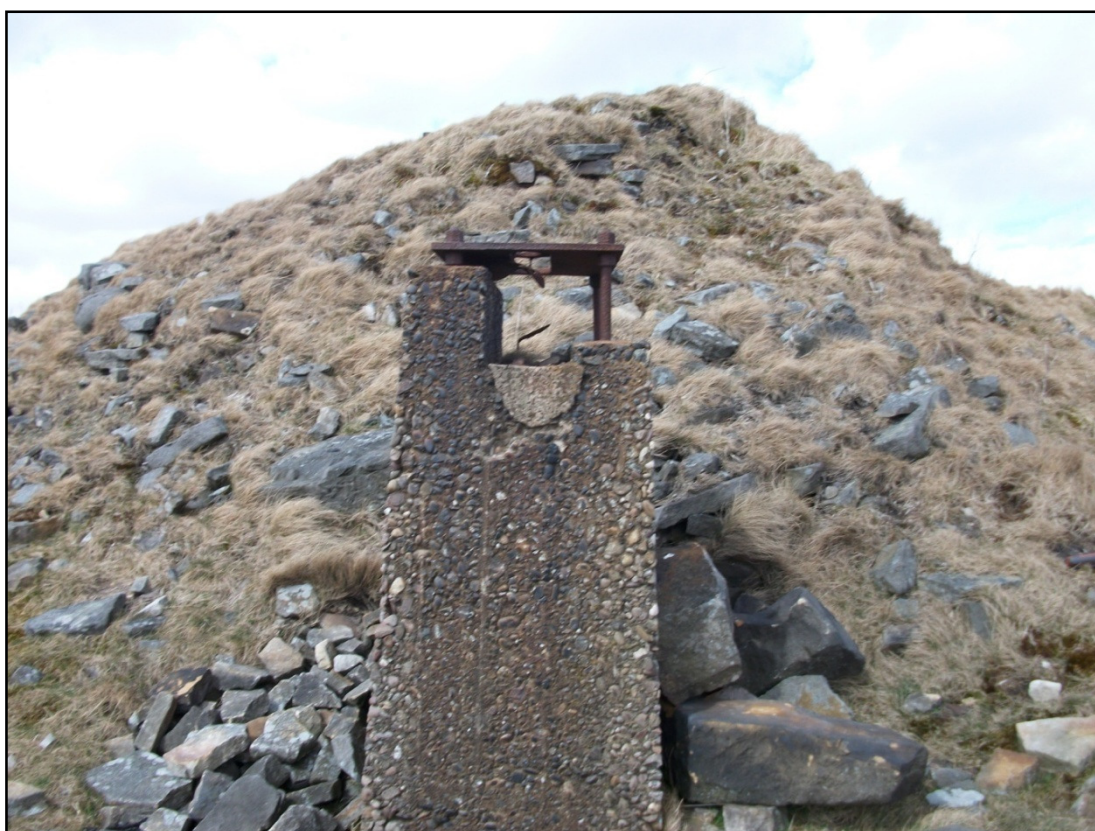
- 3.39 As with Construction Shaft 1, the remains of Observatory 2 are located within the former Greystone Edge Quarries, and are similarly difficult to identify by their structural remains alone, although once located, it comprises the most obvious example of this class of structure. The tower now consists of a heap of sandstone rubble, in excess of 2m high, surmounting a promontory which juts into the void of the quarry. This perhaps suggests that it was still extant while the quarry was active. The observatory could have been accessed and serviced in the same manner as Construction Shaft 1 which was in the same vicinity.

Plate 14 The remains of Observatory 2 behind a later concrete pillar, from south

- 3.40 The remains of the tower lie immediately adjacent to a concrete pillar, one of several encountered during the course of the fieldwork, which are discussed below.

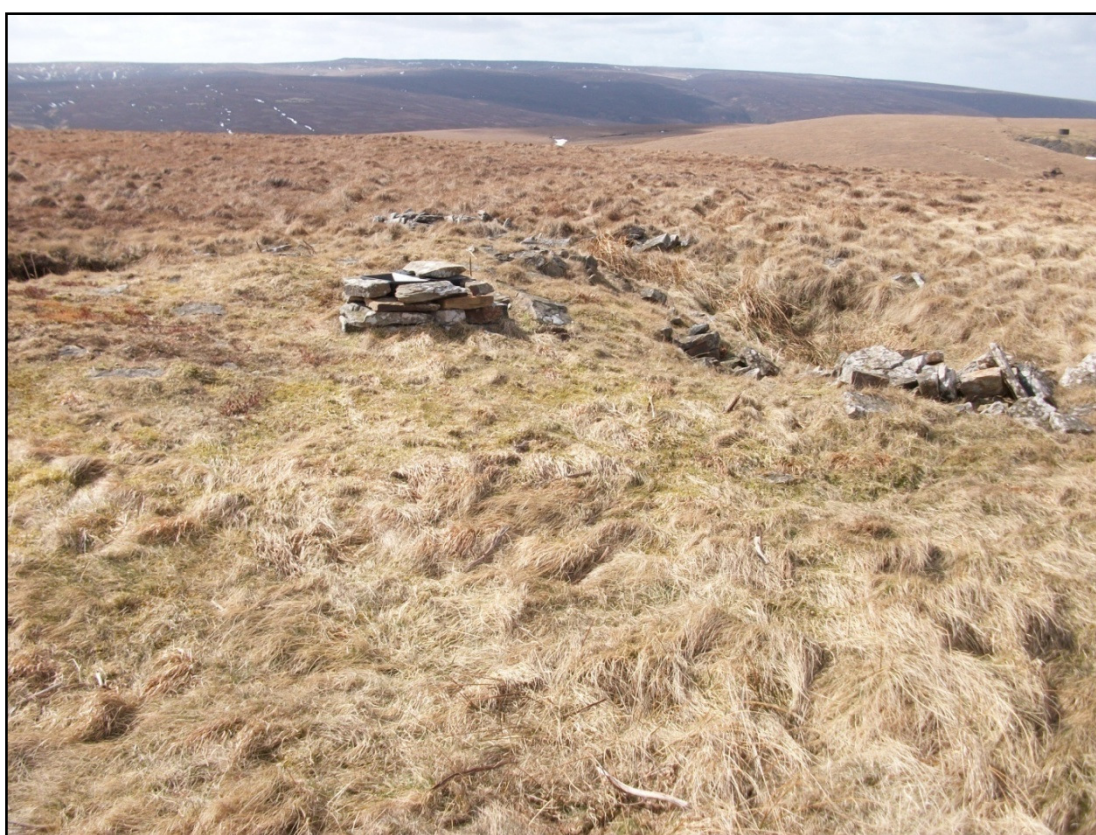
- 3.41 Observatory 3 was situated at the top of a scarp leading downwards to Construction Shaft 3 some 230m to the west. The remains of the tower are now represented by a barely perceptible circular, grassy, mound of containing some large sandstone fragments. The mound is surrounded by a circular ditch and has a small flat cairn built upon its top which presently appears to be being used for some other form of moorland survey.

Plate 15 The remains of Observatory 3

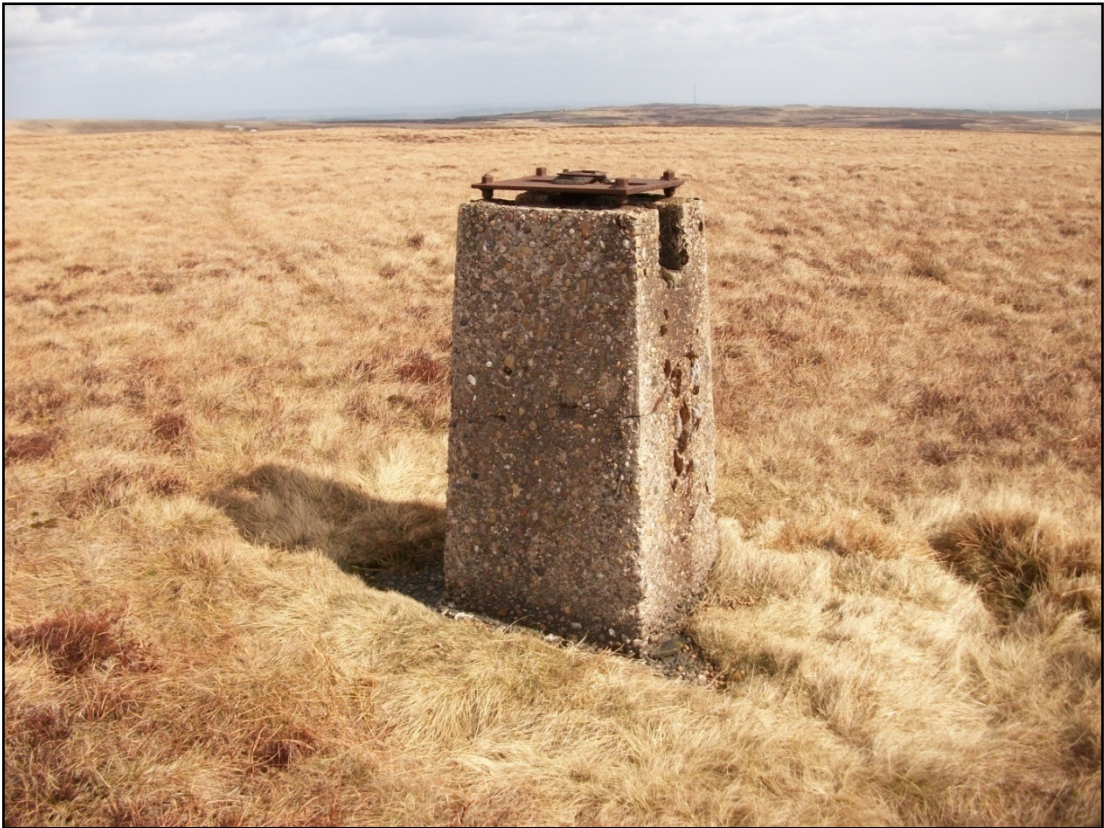
- 3.46 However they were all surmounted by an iron fitting, which survived differentially between each example, and were constructed from a coarse, pebbly, concrete mixture akin to the 'economy' concrete employed in various Defence of Britain structures during the Second World War.

- 3.47 The pillars were constructed upon rectangular concrete plinths made of the same material, but were not always centrally placed upon these plinths suggesting that the approximate route of the pillars was established first, the positions of the pillars being set-out more accurately by detailed survey. The pillars were not spaced equidistantly, but were generally intervisible with the exception of where the line of sight passed through the superstructure of shaft 2. The westernmost pillar, which appears to have been built upon peat, is now displaced and in poor condition.

Plate 16 Concrete pillar in open ground between Construction Shaft 4 and Observatory 3

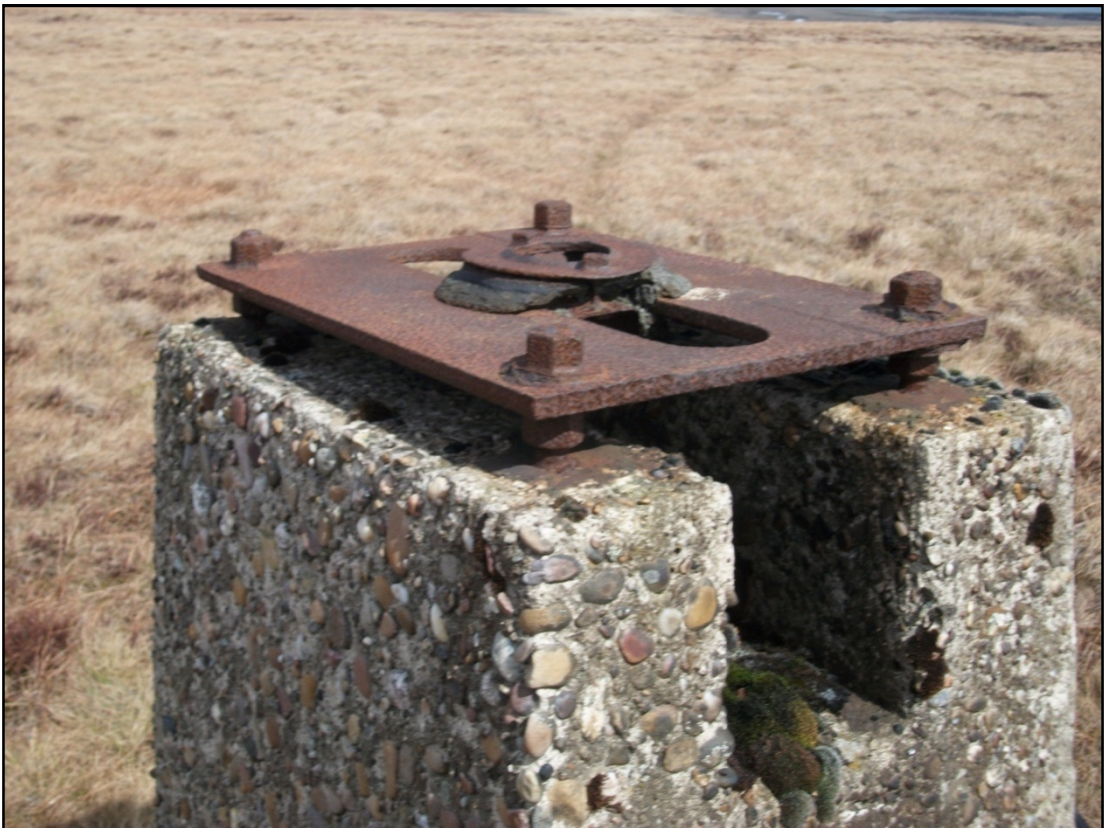
Plate 17 Detail of top of pillar

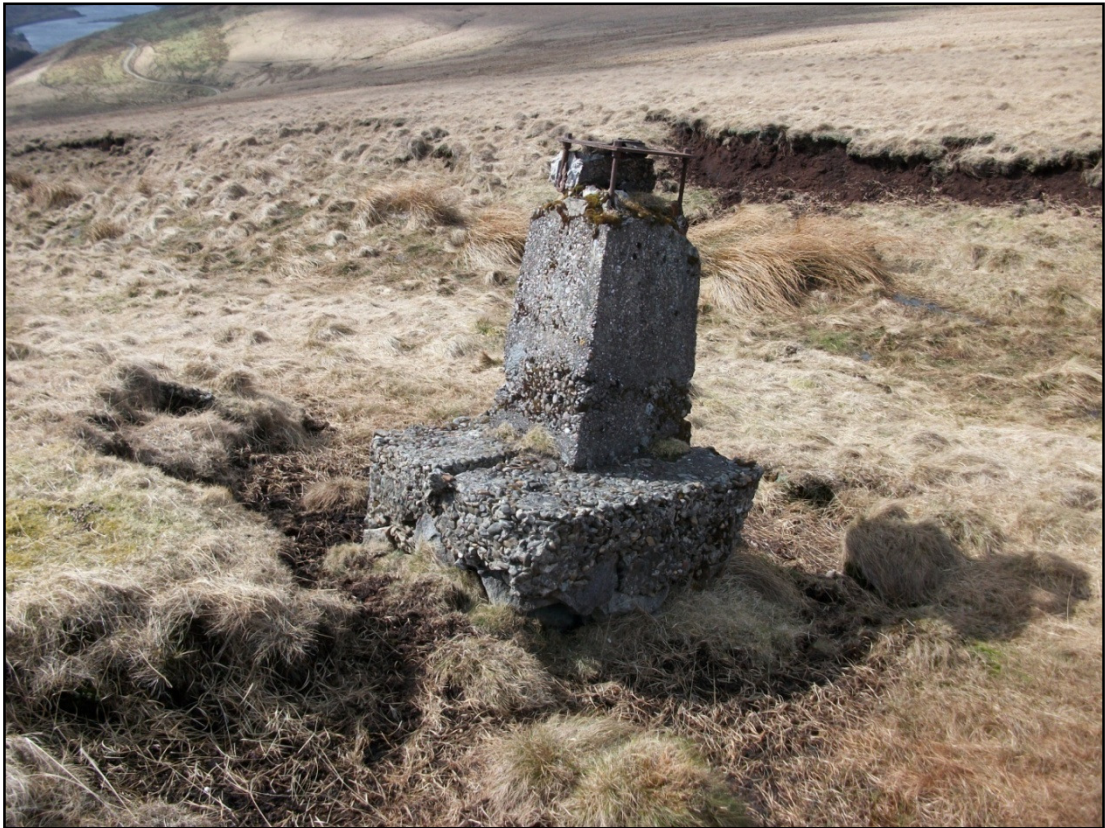
Plate 18 Pillar between Construction Shaft 1 and Observatory 1
