SILVERBAND MINESHOP,
CUMBRIA

STATEMENT OF SIGNIFICANCE

Natural England

Project No.: 1514

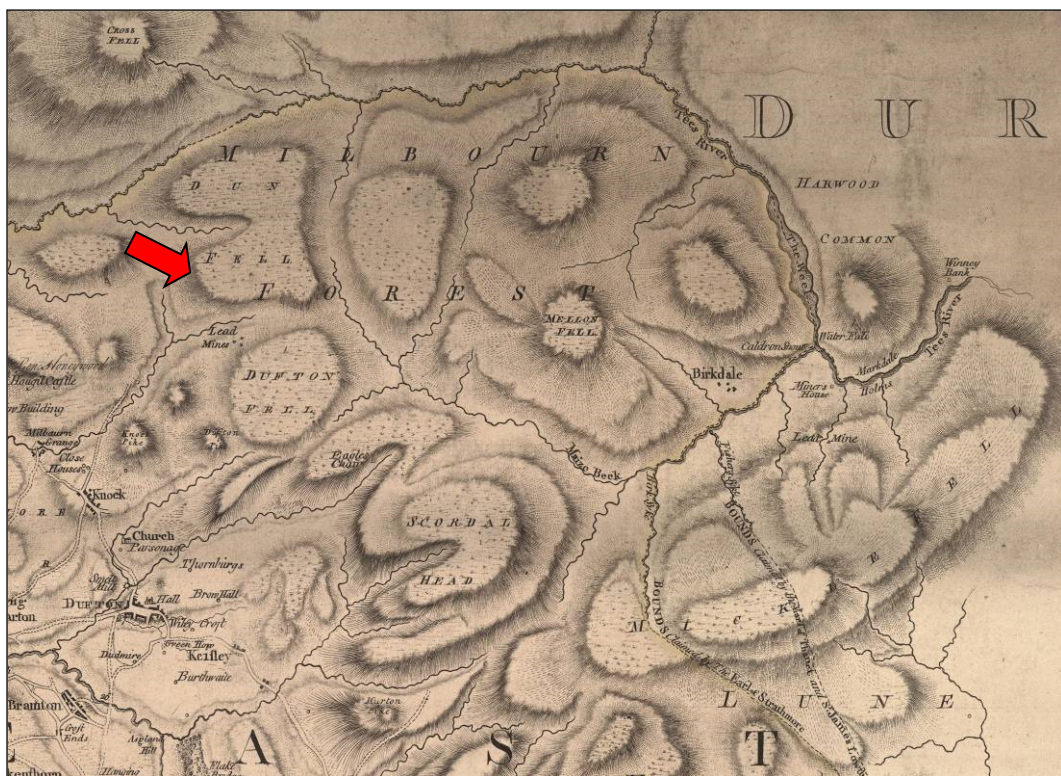
Plate 4: detail of Jeffery's map of Westmorland, 1770; note references to lead mines west of Dufton Fell and at Birkdale, but none in position of the study area.

Jeffery's Map of Westmorland, surveyed in 1768 and published in 1770, shows the area but does not indicate any lead mines, despite showing these on other parts of the map, where both *'lead mines'* and *'miner's houses'* are depicted (see Plate 4). The mines were presumably not significantly developed at this time to be included.

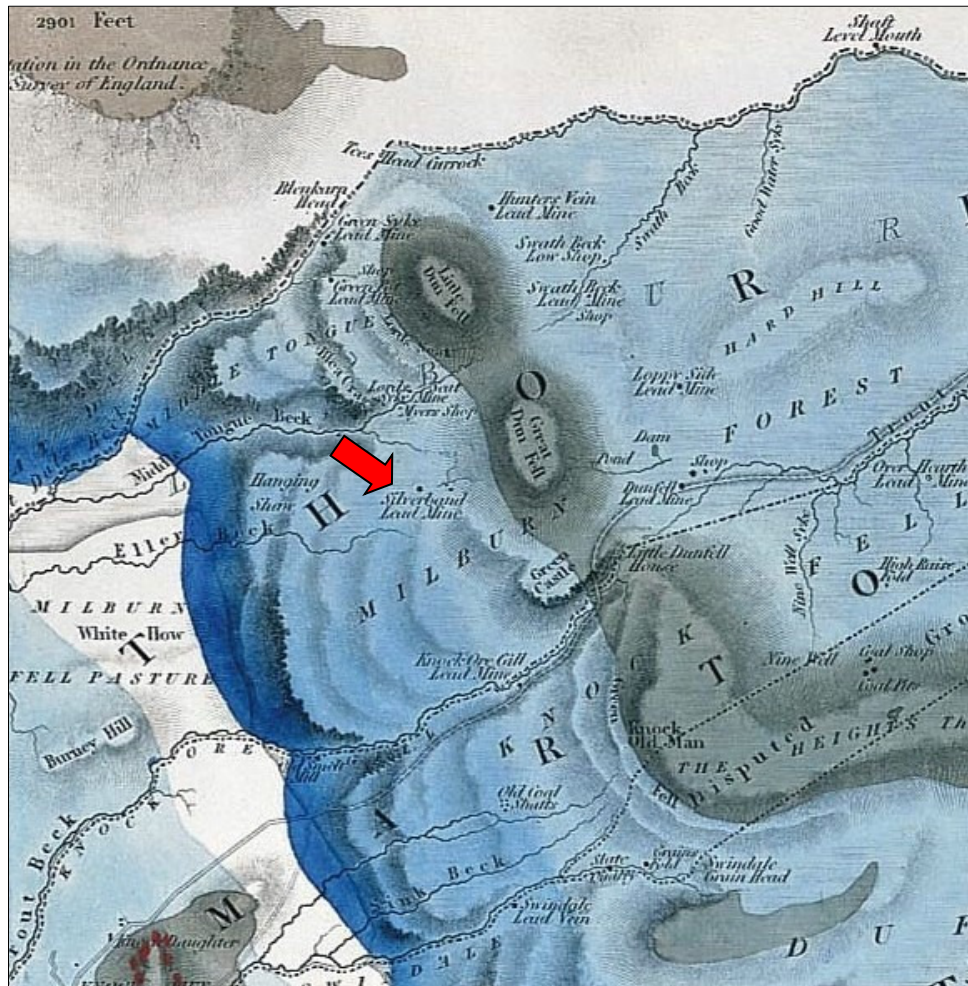
Plate 5: T. Hodgson's plan of Westmorland, 1823 (detail); Silverband Lead Mine named.

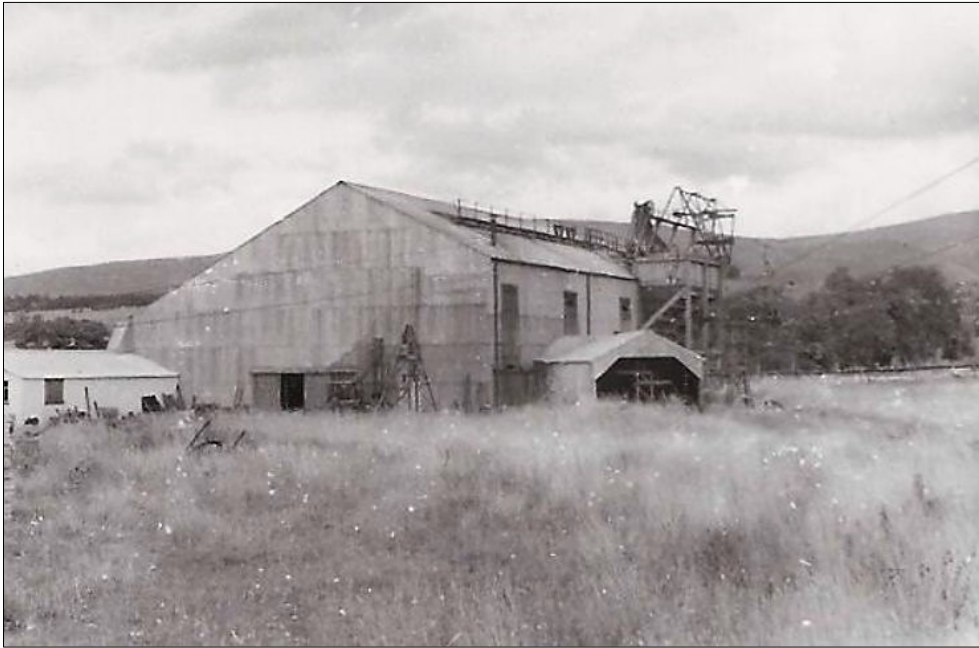
Plate 7: the mill at Millburn Grange, 1949 (© Fred Raynes)³

were recorded at the mine (40 below ground, 25 above²). An aerial ropeway was constructed 3.5 miles (5.6km) long, to transport the crude ore from the mine to a mill at Millburn Grange (Plate 7), where a further ropeway took it on to Long Marton railway station (Dunham 1990, 111); it was said that the miners travelled to the mine on the upturned buckets. Mining ceased because drainage problems made extraction uneconomic and cheaper ore was available in Eyam, Derbyshire. The ropeway and mill were dismantled (supposedly taken to Aviemore ski resort in Scotland – Smith and Murphy 2011, 64).

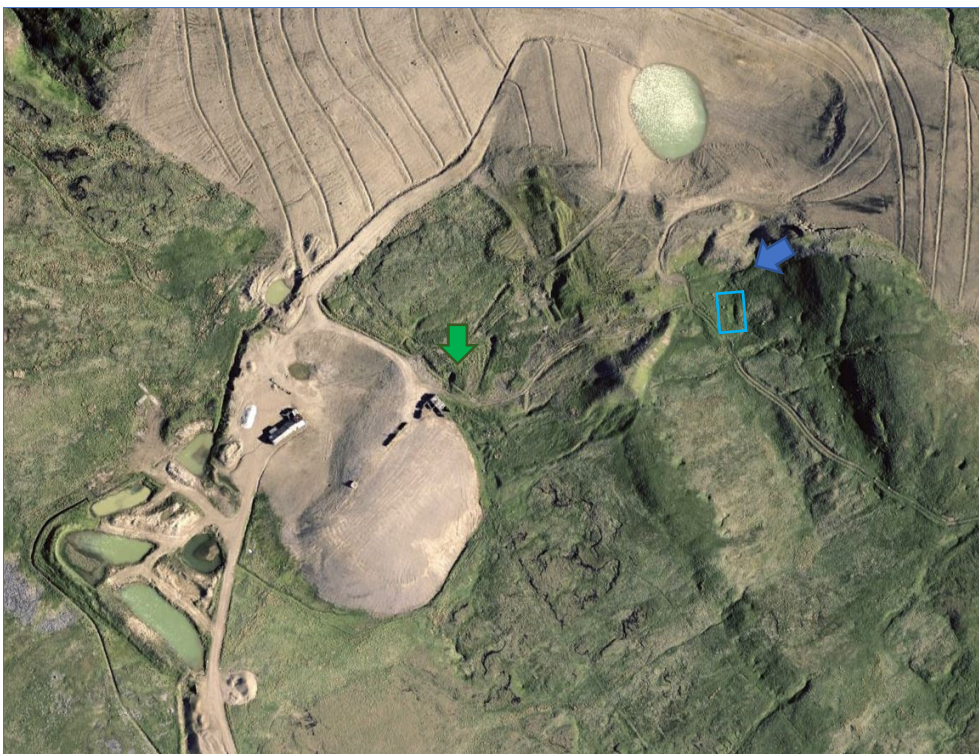
Plate 12: Google Earth, 2019; High Level (Blue Arrow) and Low Level (Green Arrow) shown, with High Level shop (pale blue box). The Silver Hush is entirely destroyed by Waitings opencast works.

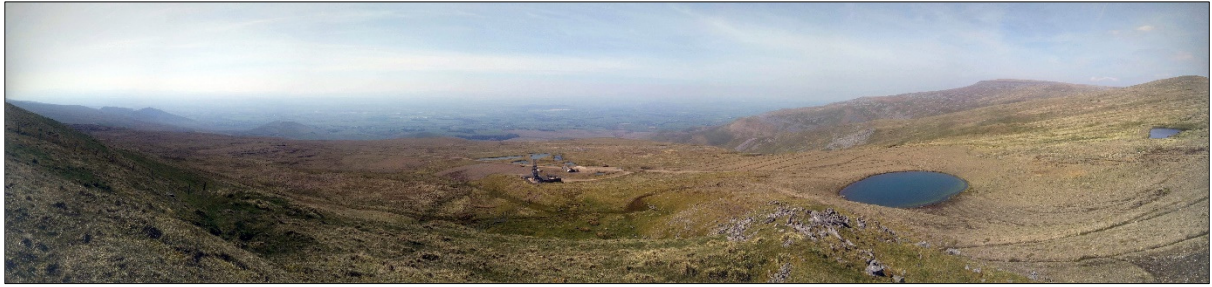
Plate 13: panorama of main mine workings; the Silver Band mine shop is to the centre of the photograph, with Rowpott's Vein hush dam to the extreme right. The land in-between has been scoured out by open cast barytes operations, with the big pond (centre-right) a product of these.

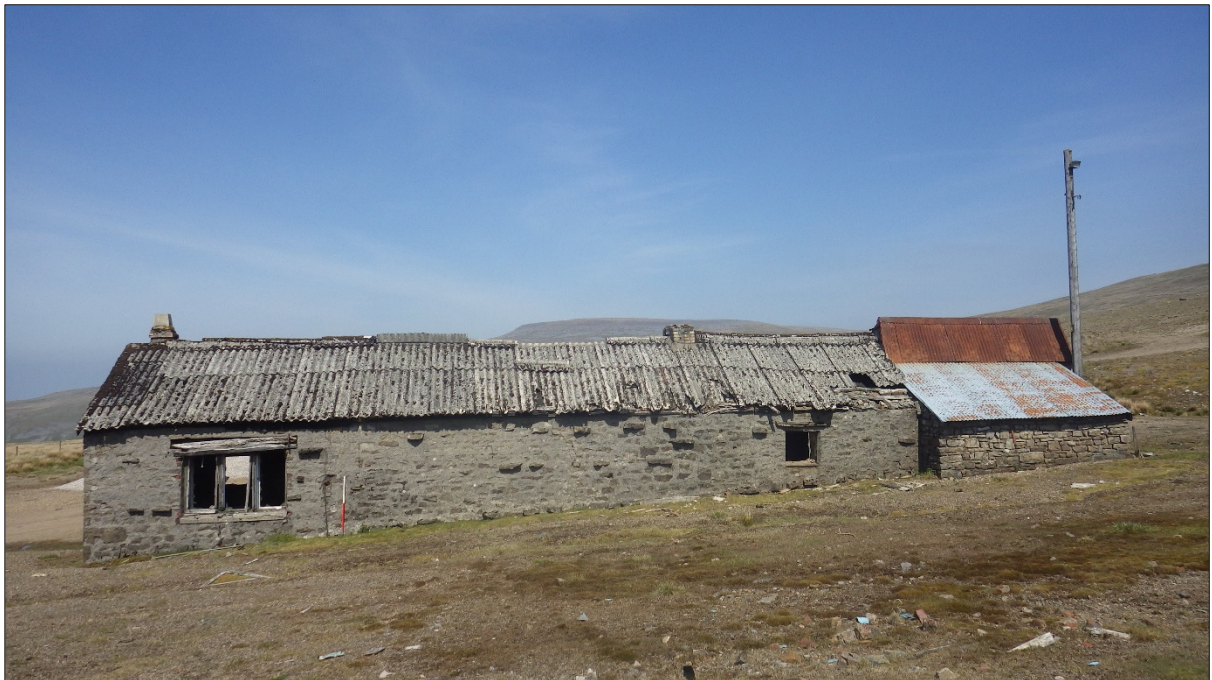
Plate 14: The mine shop, facing west; the building shows multiple phases of construction

The building is oriented roughly north-east to south-west, and measures 20.5m in length by 5.5m in width (though much wider with its western lean-to additions). The building has clearly been extended several times; the main body of the building appears to be a long structure, 11.70m in length, with a brick fireplace at each end; this probably ties up with the building depicted on the 1957 Ordnance Survey mapping. The interior is better described by Countryside Consultants (this report), but broadly speaking the building divides in thirds, with the southern third comprising a well-lit office, accessed by a door on the west side and with two broad windows, and remaining two thirds comprising a long room, much more poorly lit, with smaller windows along its western side, but blind on its eastern side. This latter room would have served as the miner's quarters, but probably not in the traditional sense, and perhaps little more than a cloakroom and mess room. A door in the north wall leads into an extension, 3.75m in length, comprising a single room with small window on the east side, which may have served as a store. A series of additional extensions abut this, with a wider building abutting the north side and measuring 6.3m by 4.5m (again further stores). There are very modern lean-tos on the north-west side: a modern lobby to the main office door, containing toilets, built in brick and measuring 4.45m by 2.25m; and a partially open extension to the stores, measuring 5.55m by 3.40m. The interior contains evidence for its former use in the form of shelving, coat-hooks, and workbenches, and timber floor boards survive in the main room.

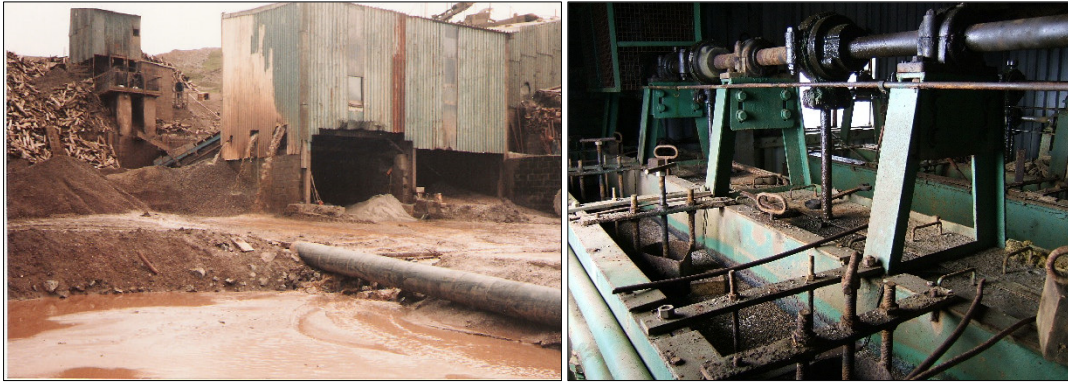
North of the mine shop was the gravity-fed barytes mill, built by H. Taylor in 1974 and now entirely dismantled. This lay against the west side of the large spoil-heap, all of which was material which had derived from Silver Band Low Level, or which had been added from open-cast and reprocessing works elsewhere on the site. Interestingly the 20th-century mill occupies roughly the same position as the early 19th-century crushing mill, which is shown on the First Edition Ordnance Survey mapping (Plate 8). Material from reprocessing was loaded into the mill from the elevated position on the spoil heap, where it was crushed and separated, with separated materials collected at the bottom near the mine shop. Photographs prior to its dismantling show the jiggers for separating the material in position, and an example of this machinery survives standing on the west side of the site, and west of the mine shop, in good (though deteriorating) condition.

Plate 15: Taylor's gravity mill (© Malcolm Street 1985)⁵, with in situ plant before it was demolished (© CJ Philip 2015)⁶

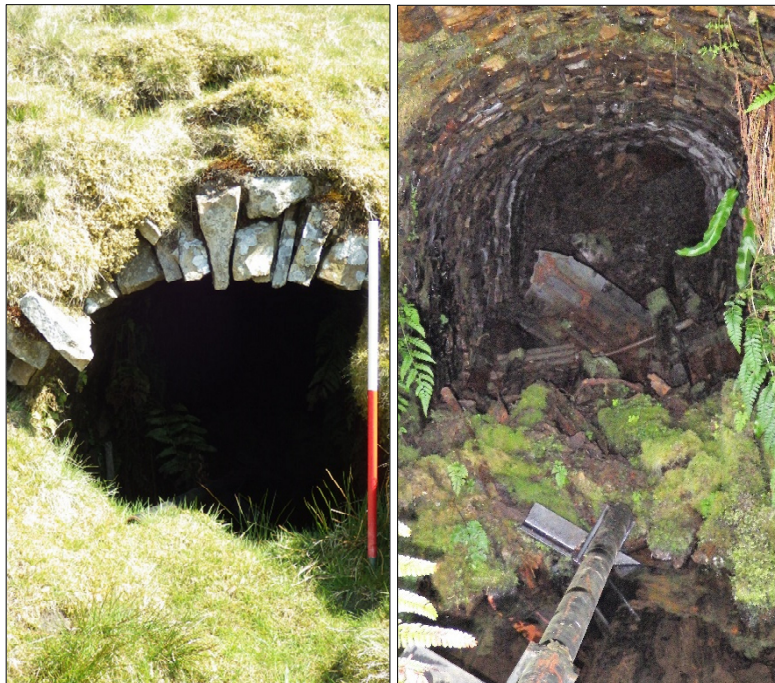
Plate 16: The Low Level, facing north-east; the picture on the right shows the blockage

Silver Band Low Level, also referred to as Locomotive Level (NY 7031 3176, 697m AOD) was driven by the London Lead Company in the early part of the 19th century and was reopened to become the main working level for Laporte's barytes business. The large spoil heap to the south was levelled and used by Waitings (and earlier companies) to load material into the barytes mill below. The arched portal of the level survives well, and there remains a continuous flow of water from the interior suggesting the level is still draining the mines, though the level is blocked by a

collapse c10m into the interior. There is also a small collapse at the entrance, which partially blocks it.

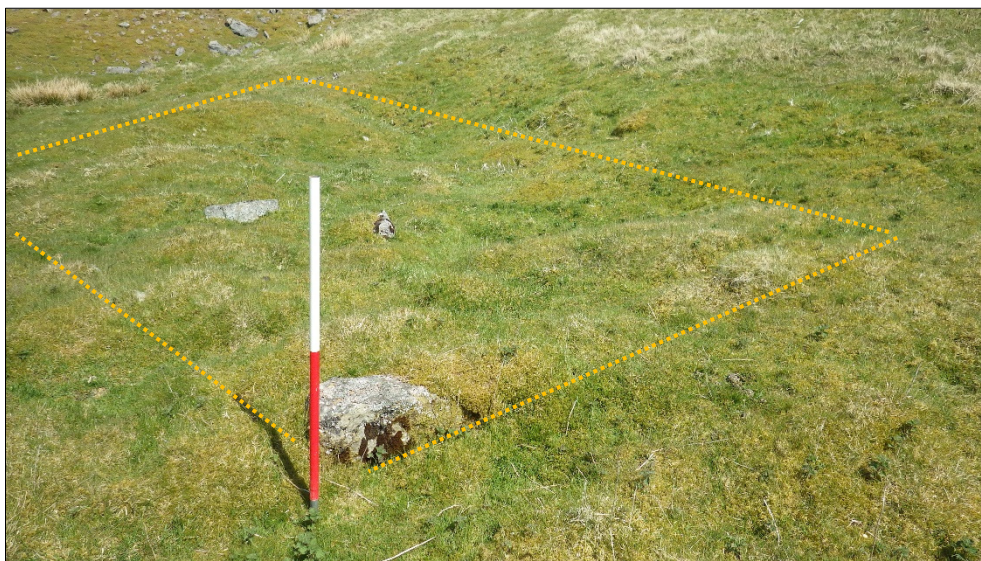
Silver Band High Level (NY 7048 3183, 727m AOD) lies 150m to the east of the Low Level, and was driven by the London Lead Company at broadly the same time as the Low Level; there may have been a further redundant level to the north, which is described as 'run' on the LLC surveys; this may have been the level mentioned on Joseph Salkeld lease of 1793. The High Level appears on First Edition Ordnance Survey mapping of 1861, which clearly depicts the mine shop just south of the entrance, the LLC describing it as a shop and stable on their plans (Plate 6). The level is hard to find as it appears to have collapsed at the portal entrance and been entirely grassed over; its approximate position can be gauged by following the earthworks of drains and waggonways which lead towards the hillside from the finger dumps, which still survive in good condition. The mine shop lies a short way to the south of the level, and is visible as little more than an earthwork, though the south-western corner of the building is just visible (Plate 16).

Plate 17: The High Level mine shop, facing north; the ranging pole marks the south-west corner.

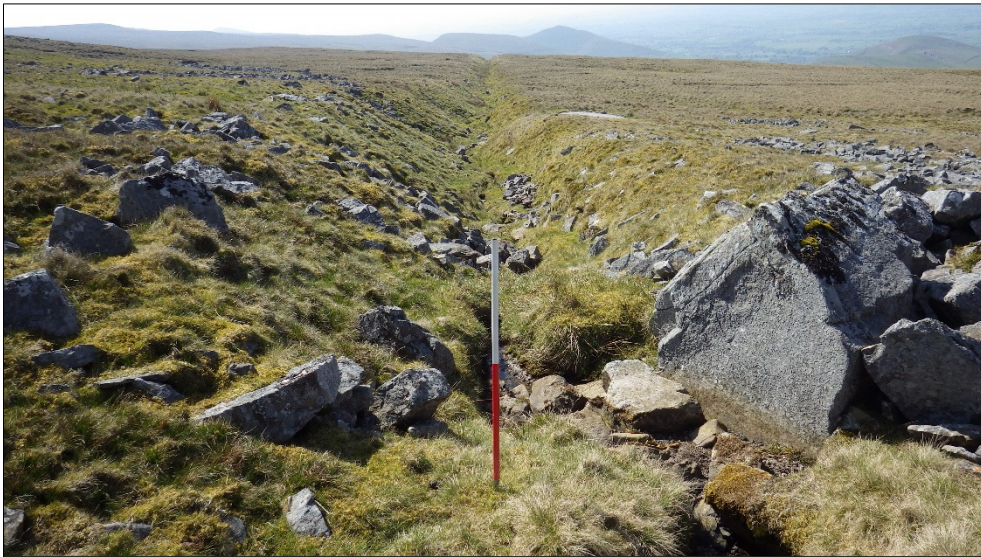
There are numerous hushes in the vicinity of the study area, but none of these lie particularly close to the site itself. Perhaps the best surviving is Knock Ore Gill North (Plate 18), the north-south aligned very straight hush, depicted on Plate 2, and said by Welch (1974, 18) to have been carried out by the LLC in the 18th century. There is evidence of ore dressing along the south side (two separate small dressing floors were noted during the visit, which only examined its northern end), and at least one circular ore bin, completely choked up with deads but still discernible. Smith and Murphy (2011, 57) correctly indicate that the settling ponds just south-west of the

Plate 18: Knock Ore Gill North hush, facing south; the pale scar to the right of the hush in the centre of the photo is a dressing floor.

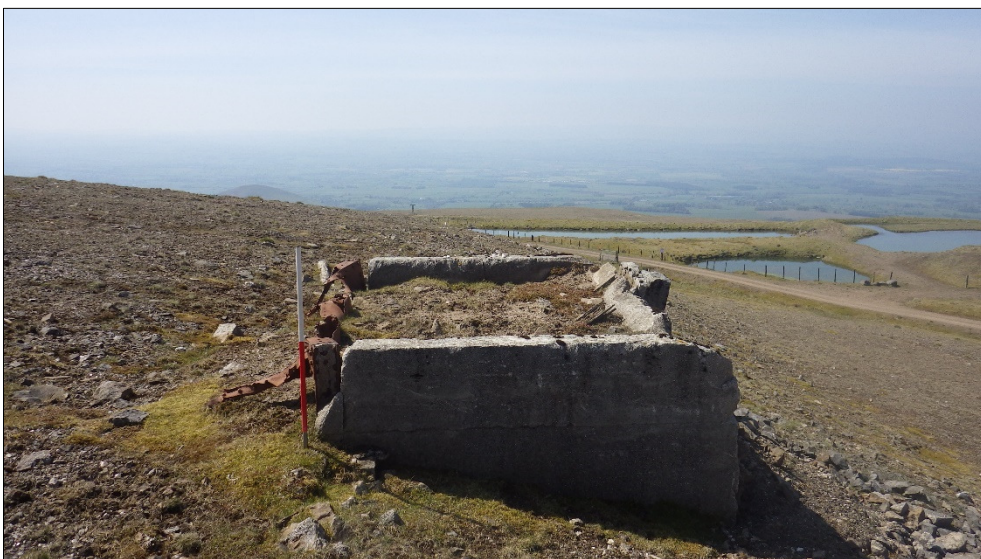
Plate 19: base of aerial ropeway pylon, with standing example in far distance.

The 1940s aerial ropeway survives well and is in fact the only element associated with the mine which is designated as a Scheduled Monument (Historic England 1021009). The designation includes the 17 surviving iron pylons extending over 1.75km, and a brake house at its midpoint, but does not extend up to the site itself, ending just short of the access track to the mine. The northern terminus of the ropeway, which is depicted on the Ordnance Survey mapping of 1957 (Plate 11) now only survives as some fragmentary walls, which include a brick fireplace which looks very similar to that in the mine shop. To the south, the concrete base of one of the pylons survives well (Plate 19). Contemporary photographs of the site in the late 1940s show an arrangement of low one-storey buildings in this location (Plate 20). The buildings are now dwarfed by a telecoms mast, with a modern breeze-block hut to the rear containing its power supply.

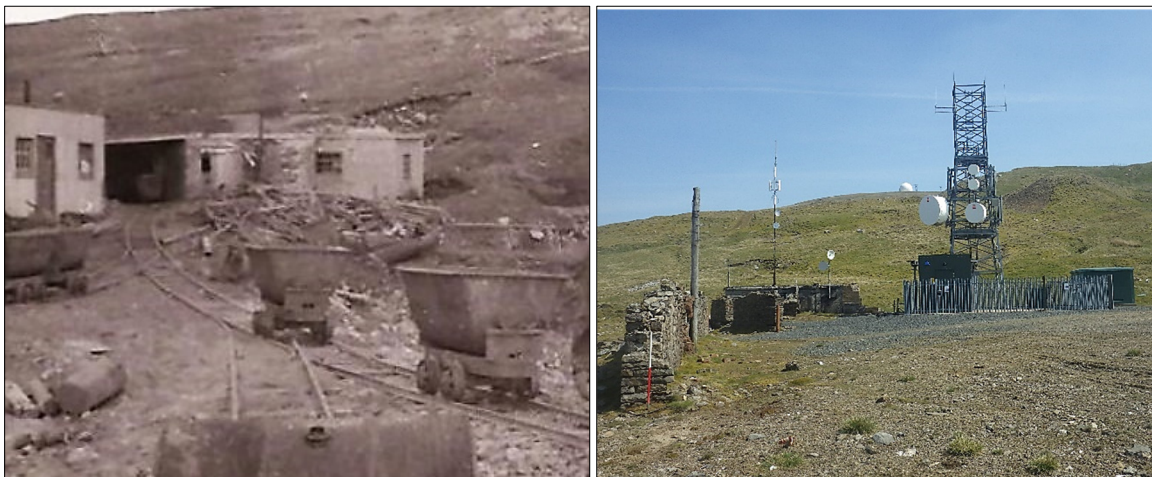
Plate 20: the terminus in 1949 (© Fred Raynes)⁷, and a similar view today
