**NORTHERN ARCHAEOLOGICAL ASSOCIATES LTD**  
**CLITHEROE STREET WATER MAIN, SKIPTON, NORTH YORKSHIRE**  
**Negative Watching Brief Report**

**Site name:** Clitheroe Street Water Main, Skipton                      **Grid reference:** SD 97867 51482

**NAA report number:** 19/102                      **Report date:** 18 October 2019

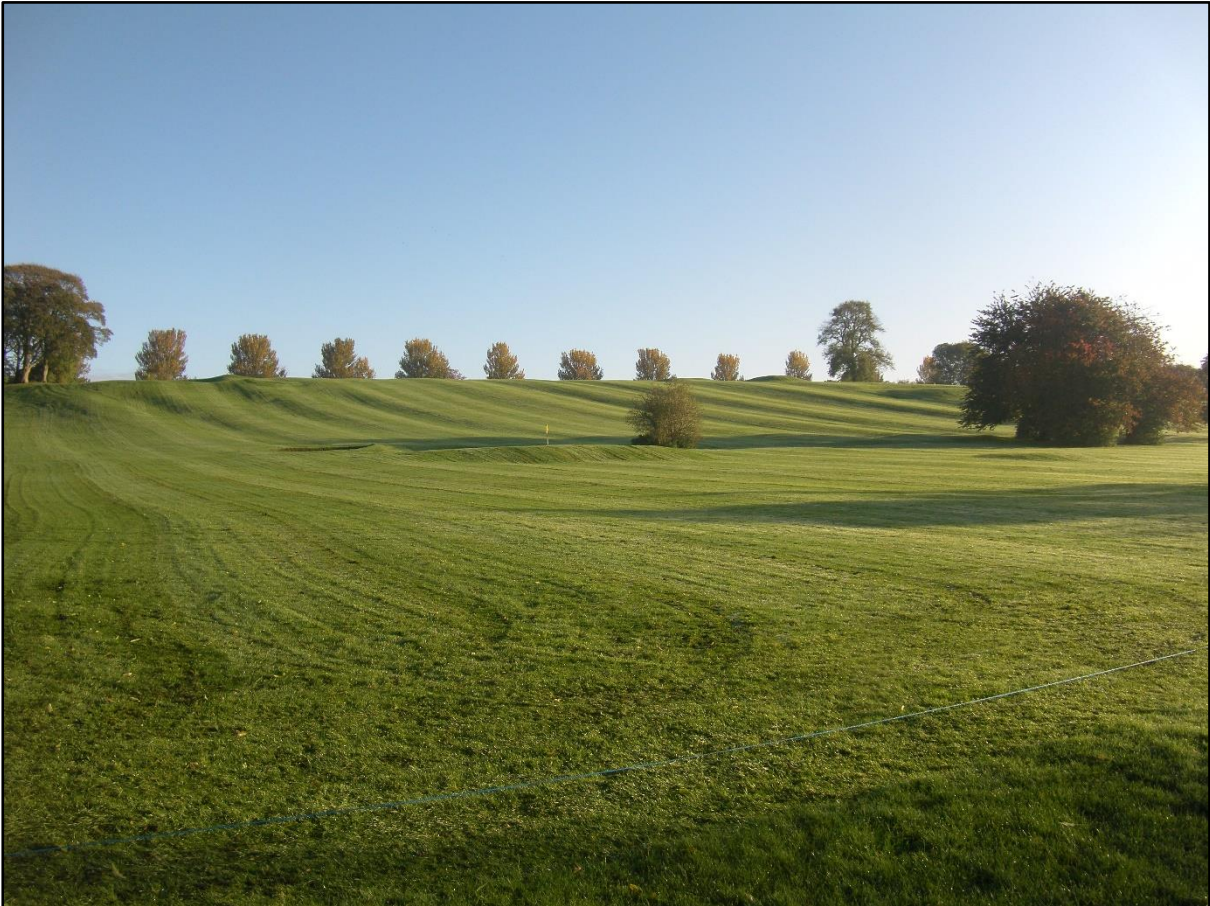
The area to the north of the Leeds and Liverpool Canal is currently in use as a local golf course within Aireville Park. Historic mapping prior to any large-scale 19th-century development shows the area to be primarily agricultural, comprising long, narrow strip-fields likely to be medieval in origin. Denuded earthworks relating to ridge and furrow can be seen running from north to south along the slope to the north of the reception pits and these have the potential to be medieval in date (Plate 1).

*Plate 1: Ridge and furrow to the north of the reception pits, looking north-west.*

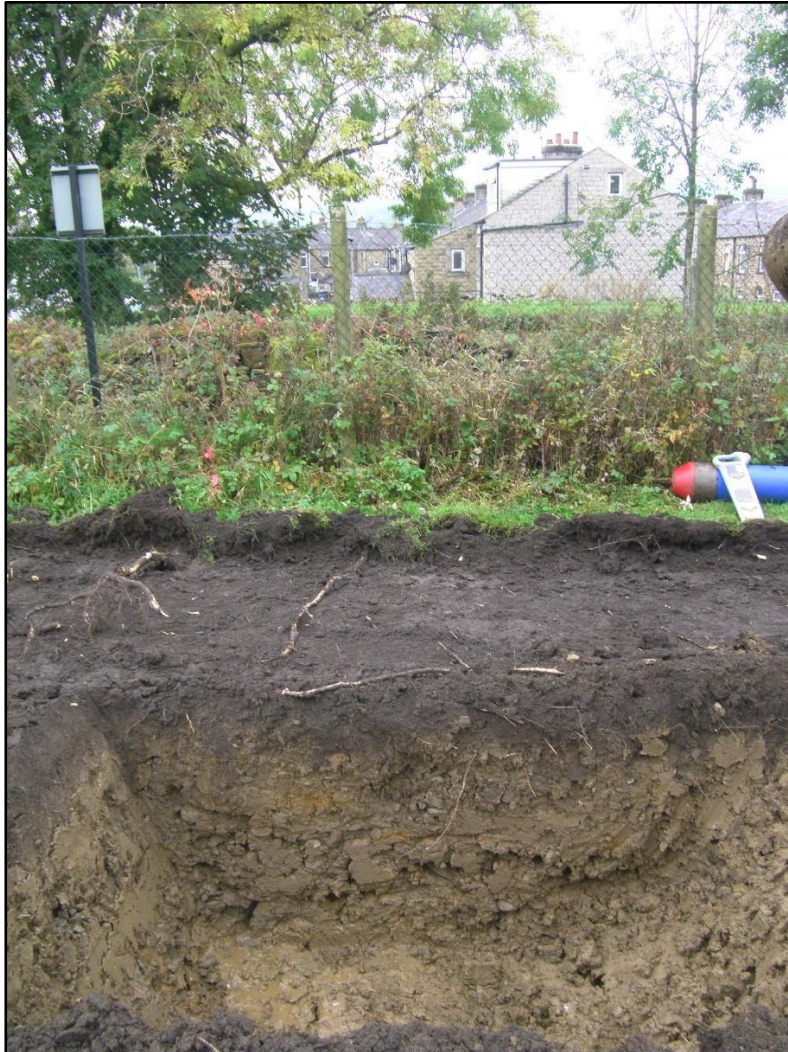
### **Reception Pit 1 (Plate 2)**

The first reception pit for the directional drilling was excavated by machine along the southern edge of the golf course, directly opposite the site compound located on Greenfield Street (Fig. 2). An area measuring 13.5m by 8.5m was stripped of topsoil to a depth of 0.3m, with a 1.1m deep L-shaped channel then dug into the natural clay geology to accommodate the water pipe. No archaeological features were recorded. Deposits comprised a 0.5m thick layer of black topsoil overlying a 0.1m thick mid-yellowish brown silty clay subsoil. The subsoil layer had accumulated directly above the natural stony clay. The only finds comprised several sherds of

transfer-printed 19th to 20th-century pottery from the topsoil which were not retained. The deposits within Reception Pit 1 probably relate to landscaping activity associated with the golf course.

*Plate 2: Reception Pit 1 showing accumulation of topsoil and subsoil. Looking south across the Leeds and Liverpool Canal towards the launch pit on Greenfield Street.*

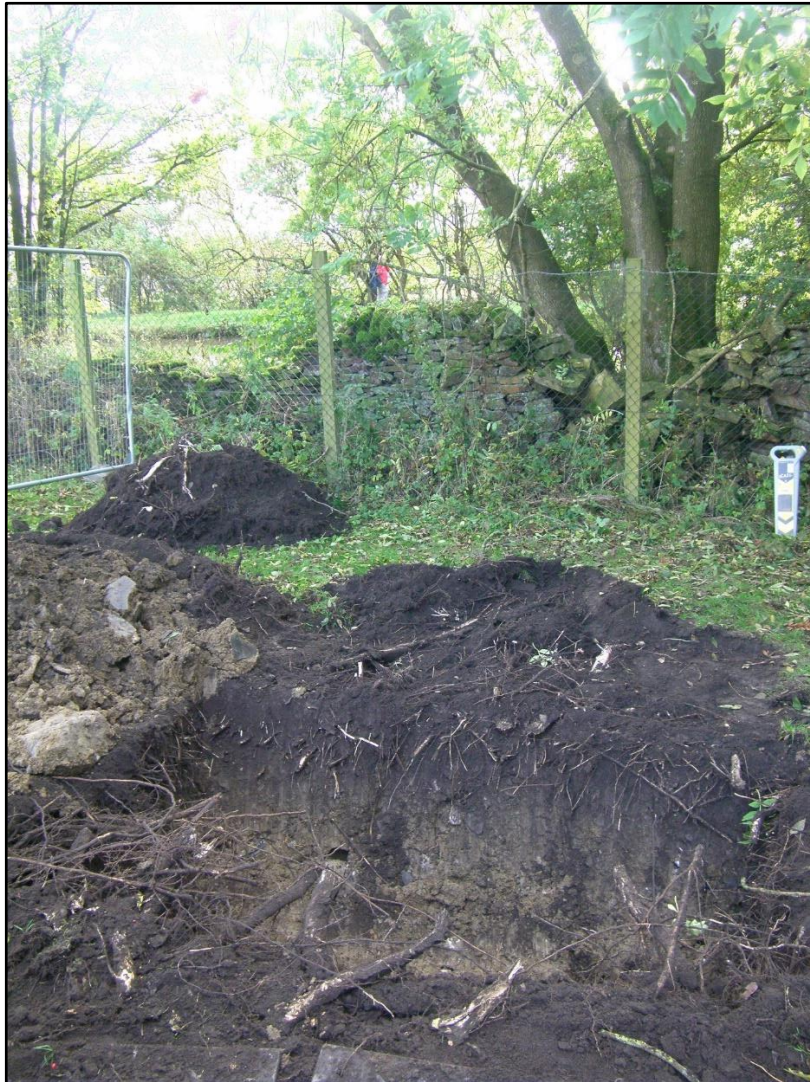
### **Reception Pit 2 (Plate 3)**

The second reception pit was situated approximately 100m to the west of the first, directly in front of the drystone wall defining the southern edge of the golf course. The pit measured 2.2m by 1.5m and was excavated to a depth of 1m. As with the first reception pit, no archaeological features were encountered and deposits comprised a 0.36m thick layer of topsoil and 0.1m of mid-yellowish brown silty clay subsoil, heavily disturbed by rooting, which had accumulated over the natural stony clay.

There was no evidence for ridge and furrow in this area, suggesting that the area around the current works had been heavily disturbed by post-medieval activity, relating either to the construction of the Leeds and Liverpool Canal or to the landscaping of the present golf course. No further archaeological work is therefore deemed necessary along this edge of the canal.

*Plate 3: Reception Pit 2 showing accumulation of topsoil and subsoil and substantial root disturbance. Looking south-east towards the Leeds and Liverpool Canal.*

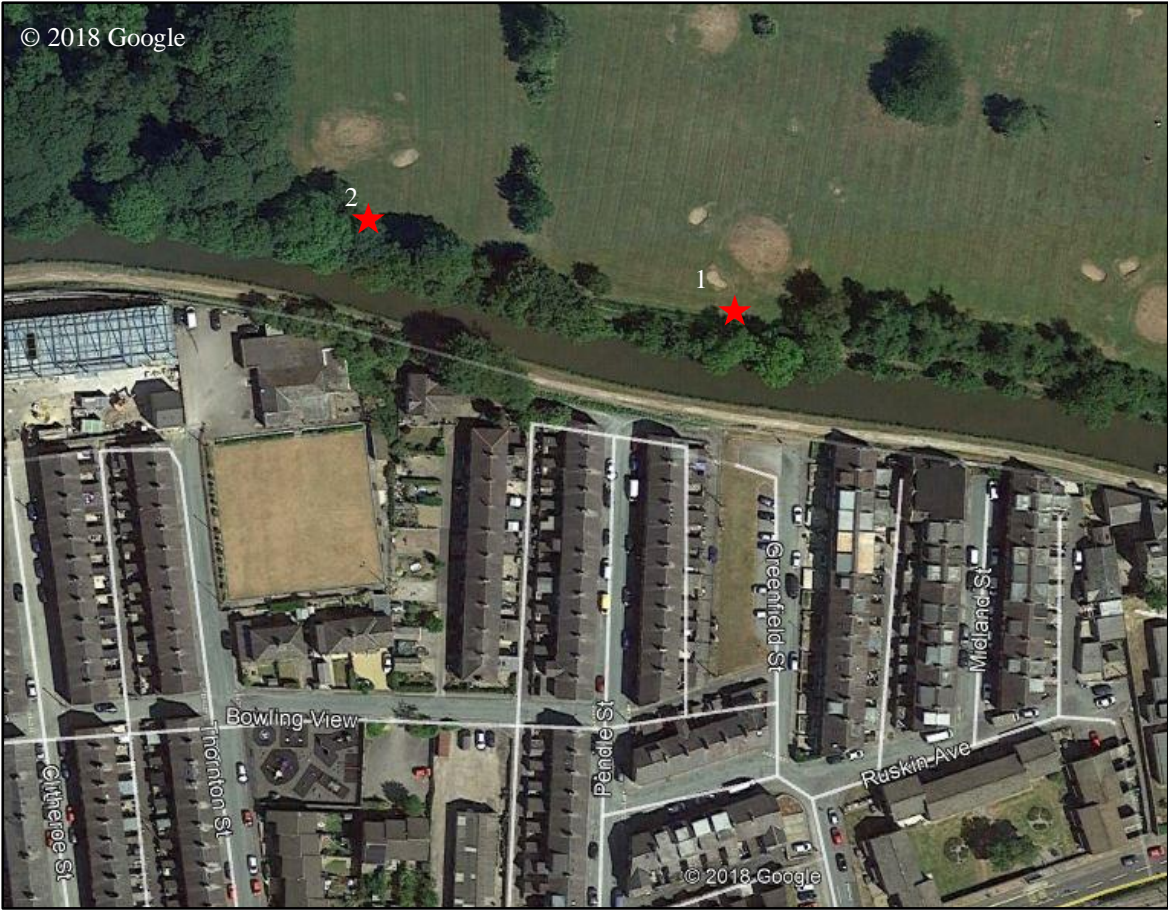
*Figure 2*

*Clitheroe Street Sipton: pit locations*
