NORTHERN ARCHAEOLOGICAL ASSOCIATES LTD
A69 WEST DENTON BARRIERS, NEWCASTLE UPON TYNE
Negative Watching Brief Report

Site name: A69 West Denton Barriers **Grid reference:** NGR - NZ 2188 6678
Borough: Newcastle upon Tyne **District:** Tyne and Wear
Administrative authority: Newcastle City Council **Development:** Road barrier replacement
Client: Road link (A69) limited **Contractor:** Protek Fencing Ltd
Site supervisor: Eddie Dougherty **Project manager:** Oliver Cooper
Fieldwork Date(s): 07-05-2019 to 08-05-2019
NAA project number: 1494 **Site code:** WDB19
NAA report number: 19-65 **Report date:** 12 June 2019

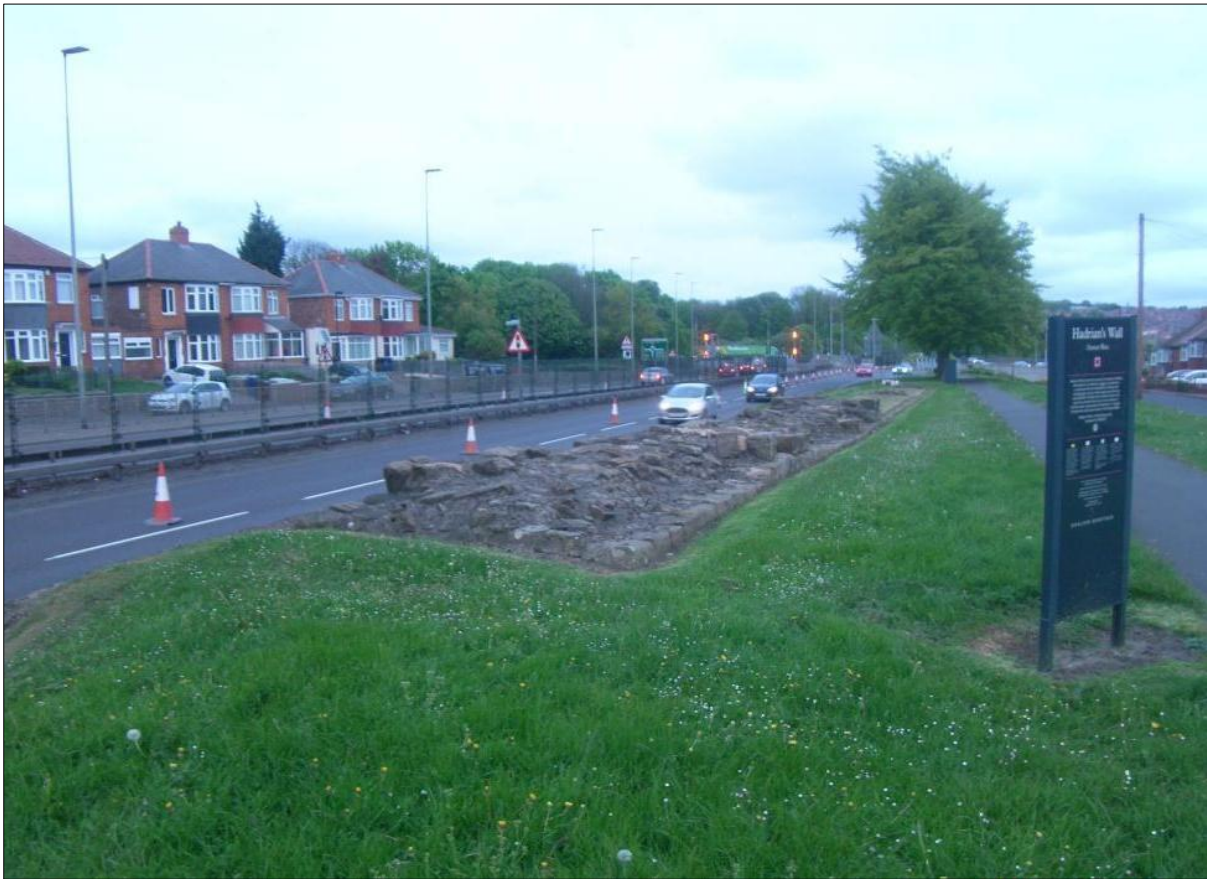
Plate 1. East-facing view across west-bound A69 towards central barriers; a section of Hadrian's Wall has been consolidated on the south side of the road

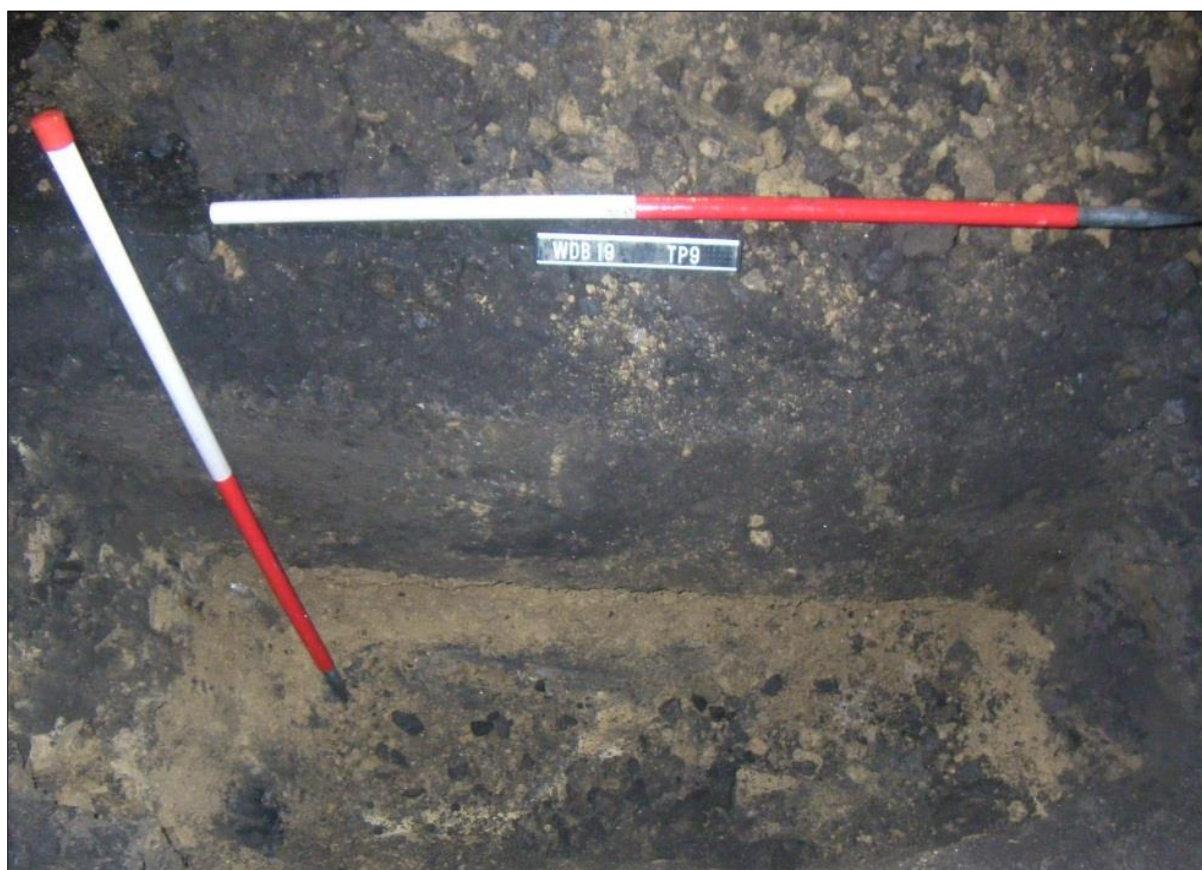
Natural horizons were not reached in any of the trial holes, and only modern deposits were observed. These included yellow dolomite, compacted mid-to-dark brown clays and grey sub-base for the road. Plate 2 illustrates a typical trial hole, and a summary of the deposits encountered in each trial hole is provided in Table 1. Given the absence of archaeological features, and the similarity between deposits encountered, the precise locations of each hole is not illustrated here.

Plate 2. Typical trial hole profile showing crushed dolomite layer overlain by redeposited clay and grey road sub-base

No archaeological deposits, features or artefacts were exposed within the trial holes, and it is likely that there is at least 1m of made ground across the entire width of the road corridor in this area, so only excavations exceeding this depth will be have any potential to encounter archaeological deposits or features.
