NORTHERN ARCHAEOLOGICAL ASSOCIATES  
*BOWES ROAD, STARTFORTH, BARNARD CASTLE*

Negative Watching Brief Report

**Site name:** Bowes Road, Barnard Castle    **Grid reference:** NZ 045 163

**Development:** Service trenches

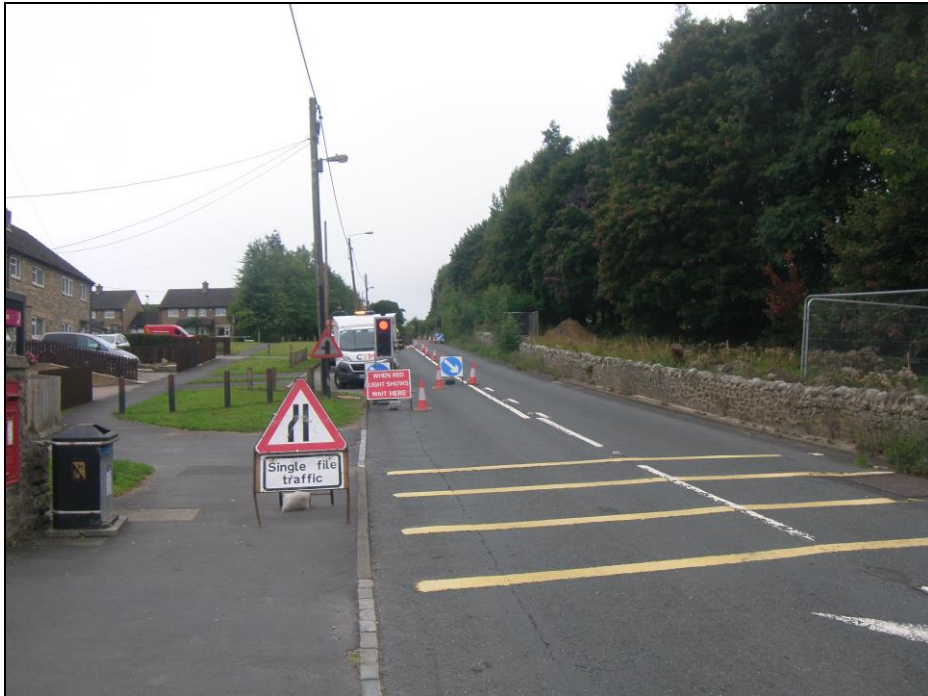
*Plate 1: Overview of road crossing Trench 1 looking south-westwards, towards Corn Close.*

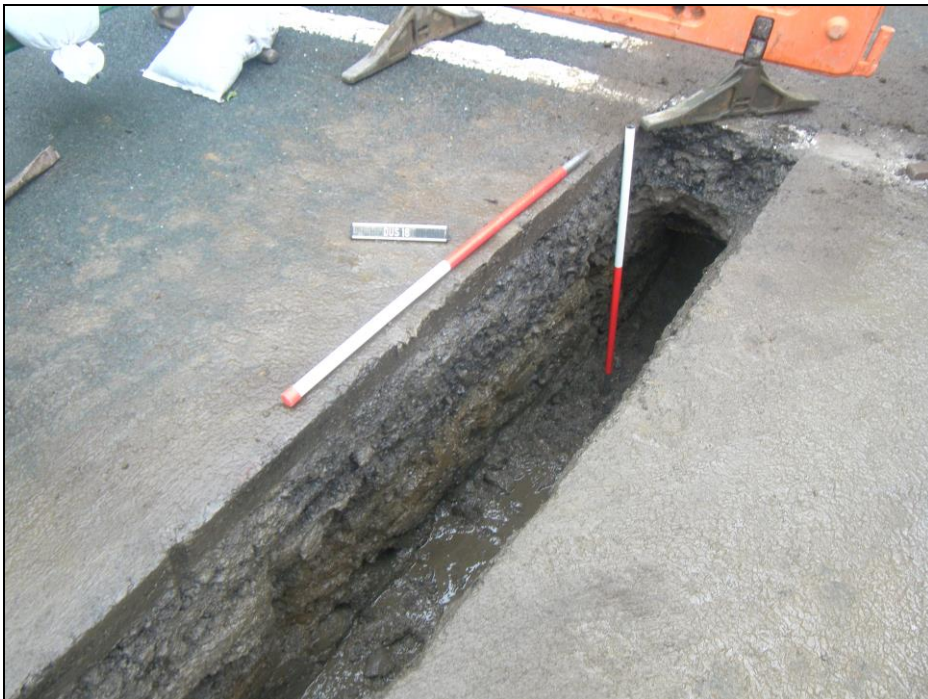
Within Trench 1, natural subsoil was encountered at various depths ranging from 0.4m to 0.8m below present ground level. The increase in depth was recorded in a north-westerly direction along the line of both segments of the trench towards the modern boundary wall. This material consisted of a range of deposits from firm brown clay and stony outcrops to compact sandy gravels. These materials were in turn overlain by a consistently thin layer of discoloured gravel, and a thick deposit of limestone chippings representing the foundation/ bedding for the bitumen road surface of the present road (Plate 2). In the north-western end of the trench these deposits were cut by a narrow, deep foundation cut for the modern, pin kerbing and its concrete footing. The south-eastern end of this trench was also badly disturbed by two inter-cutting service trenches, one containing a modern plastic gas pipe, the other a metal water pipe. These were in turn protected by their respective concrete capping. Set within the concrete capping of the southern of these was the present-day pin kerbing.

*Plate 2: North facing section of road crossing Trench 1, across the south-west bound carriageway of Bowes Road (A67).*

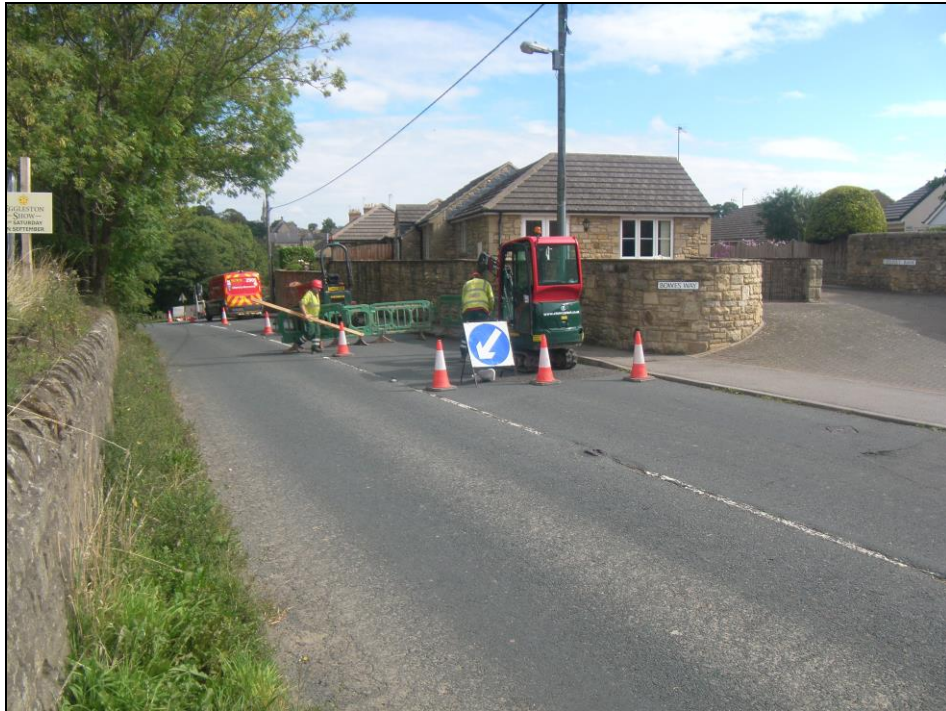
Trench 3 also cut across the line of Bowes Road and was positioned 5m east of the entrance to Bowes Way (Plate 3). The trench measured 9.2m x 0.6m to a maximum depth of 0.8m and ran in a north-west to south-east direction. The road crossing extended from the roadside kerbing of the south-west bound carriageway to the previously mentioned boundary wall.

*Plate 3. Location of Trench 3, looking north-eastwards towards Barnard Castle.*

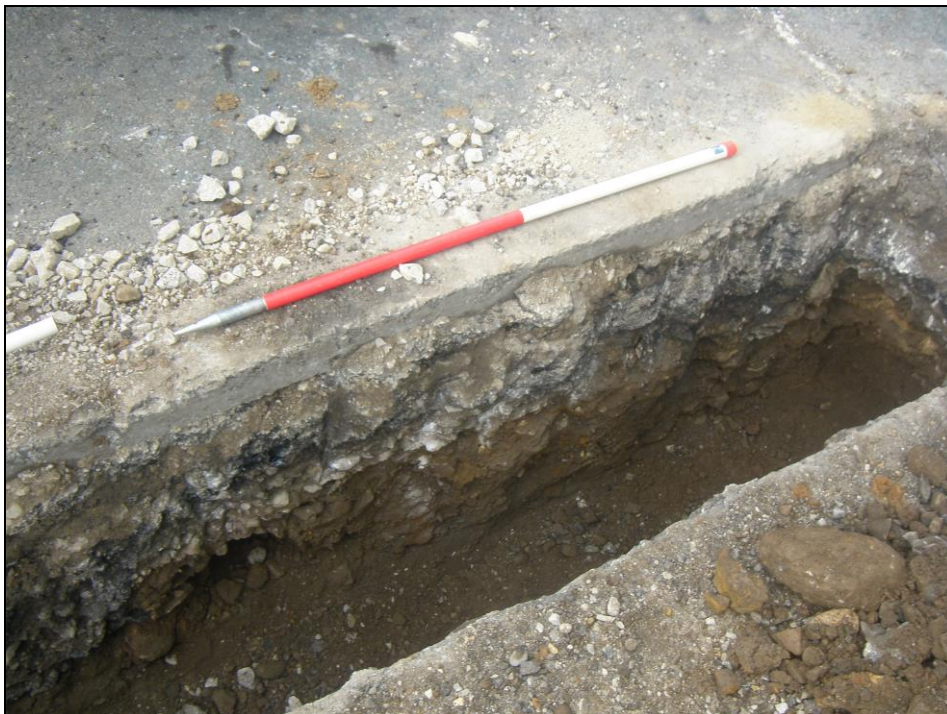
Natural subsoil in Trench 3 was encountered at a depth of 0.6m below present ground level. This was overlain by redeposited materials of identical consistency and thickness to that found in Trench 1 (Plate 4), and again these were cut through by three service trenches, although only one of these had also been identified in Trench 1. The service trenches were located at both ends of Trench 3. In the north-western section were two services; a narrow channel containing a fibre optic cable, and a wide cut situated under the roadside pin kerbing that contained a modern ceramic drain pipe. In the south-eastern part of the road crossing was a narrow cut which may have contained either of the existing water or gas supplies. These service trenches were subsequently sealed by the modern road materials.

*Plate 4. East facing section of Trench 3, cut through the south-west bound carriageway of Bowes Road (A67).*
