NORTHERN ARCHAEOLOGICAL ASSOCIATES

Barrasford Quarry, Hexham, Northumberland

NEGATIVE WATCHING BRIEF REPORT

Site name: Barrasford Quarry

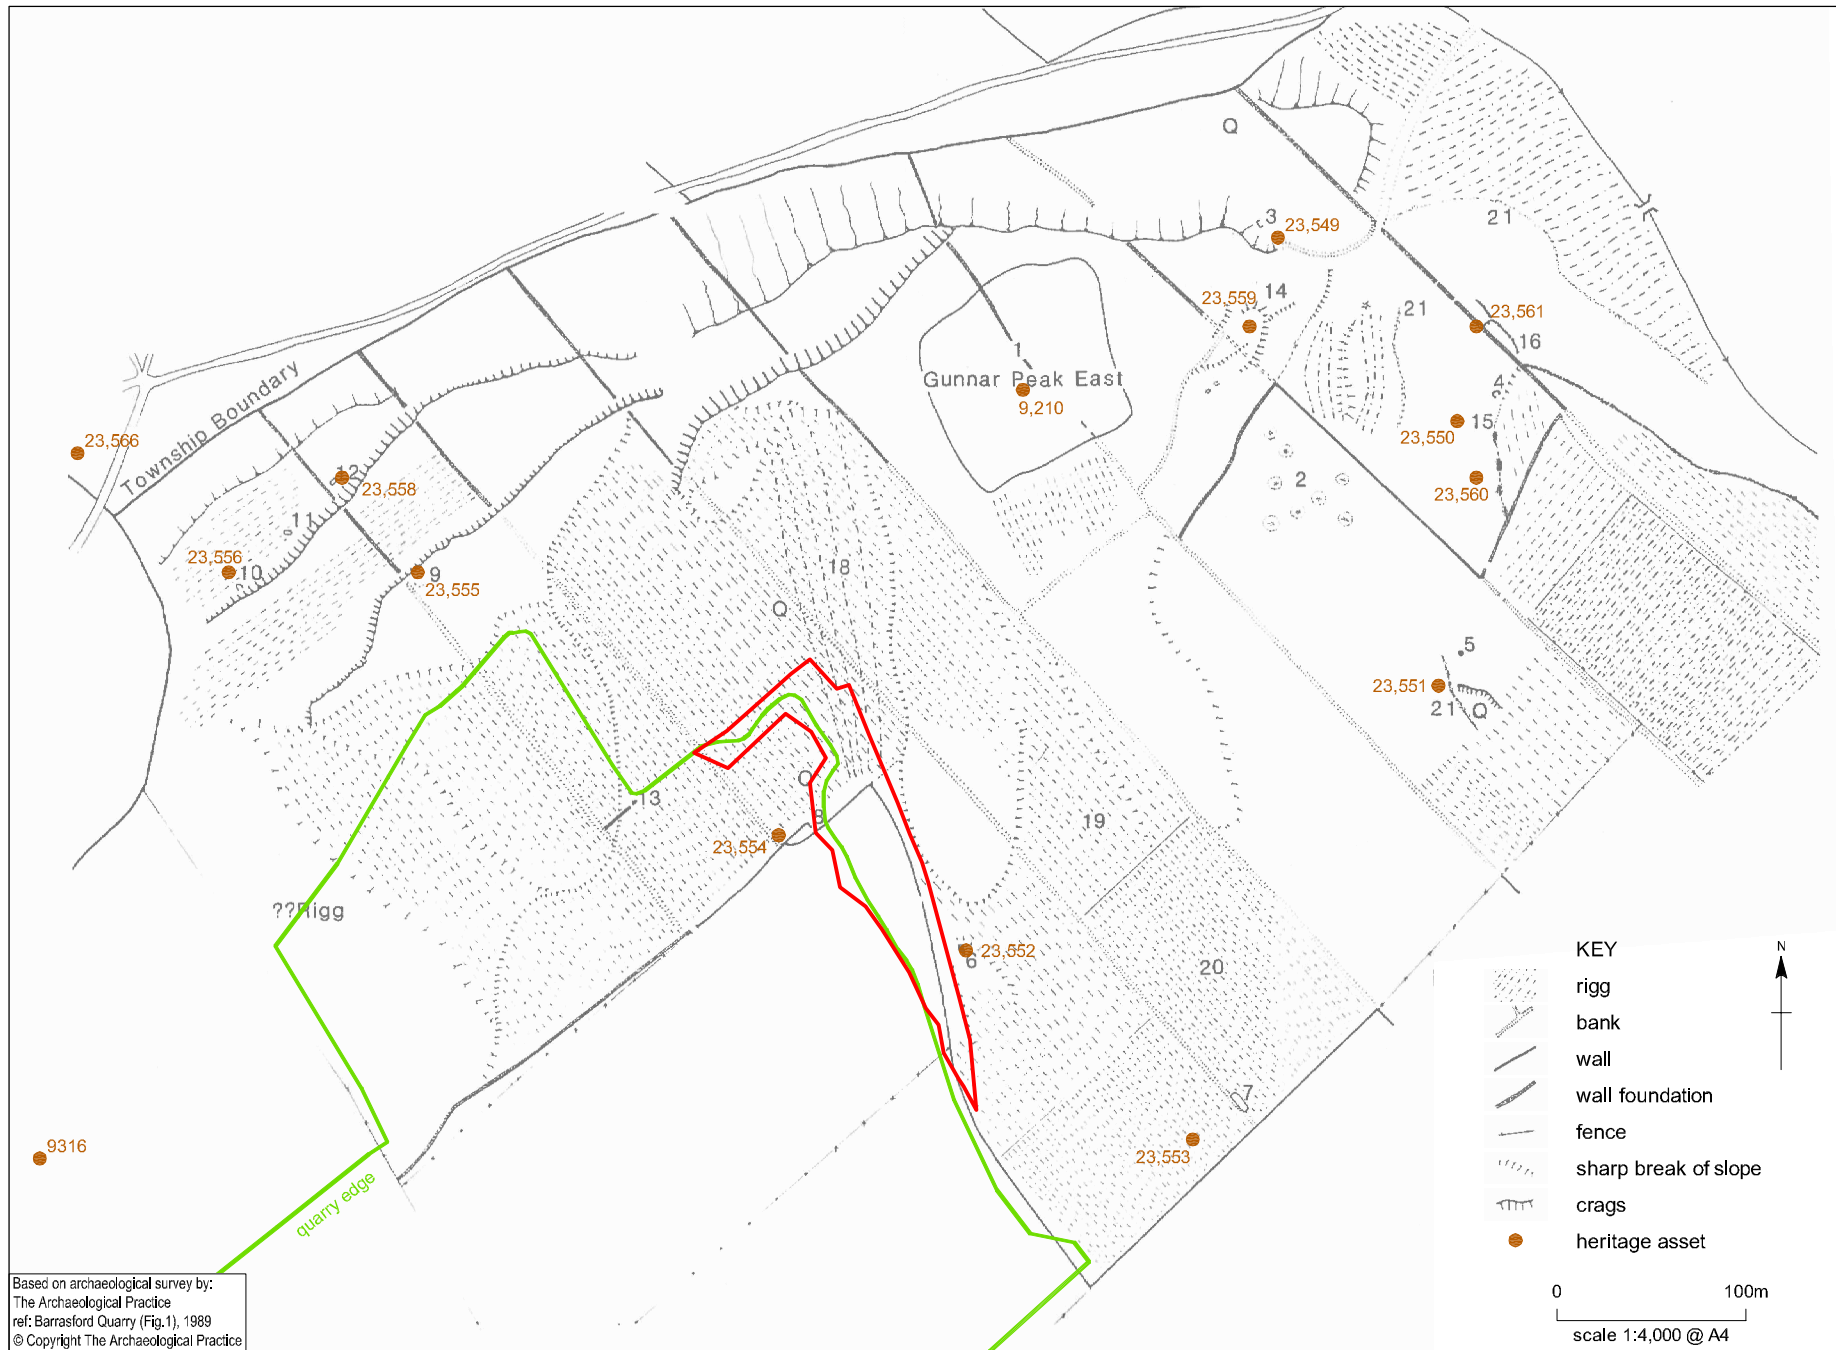
Figure 2

The site works comprised the stripping of topsoil and subsoil within an area measuring approximately 170m by 35m (Fig. 2). The removal of overburden (topsoil and subsoil) was undertaken using a mechanical excavator fitted with a toothless bucket. All soil removal was carried out under archaeological supervision.

Barrasford Quarry: landscape features and proposed extraction area

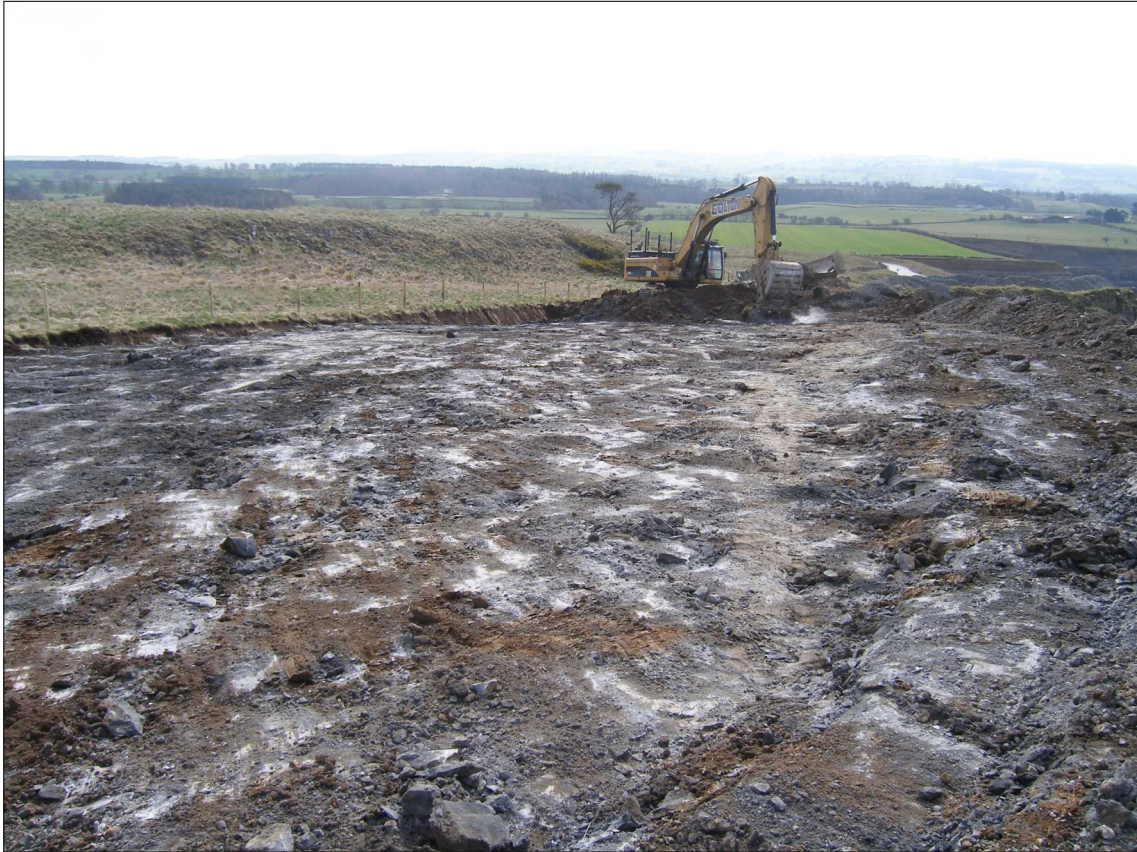
Plate 1

Natural bedrock was encountered immediately beneath the turf in the northern and western parts of the site (Plate 1). To the east the turf overlay topsoil and subsoil that increased in depth to approximately 1m. Below this was boulder clay and sand/gravels within a channel cut into the bedrock (Plate 2).

*Barrasford Quarry: bedrock below shallow topsoil
at north western half of site*

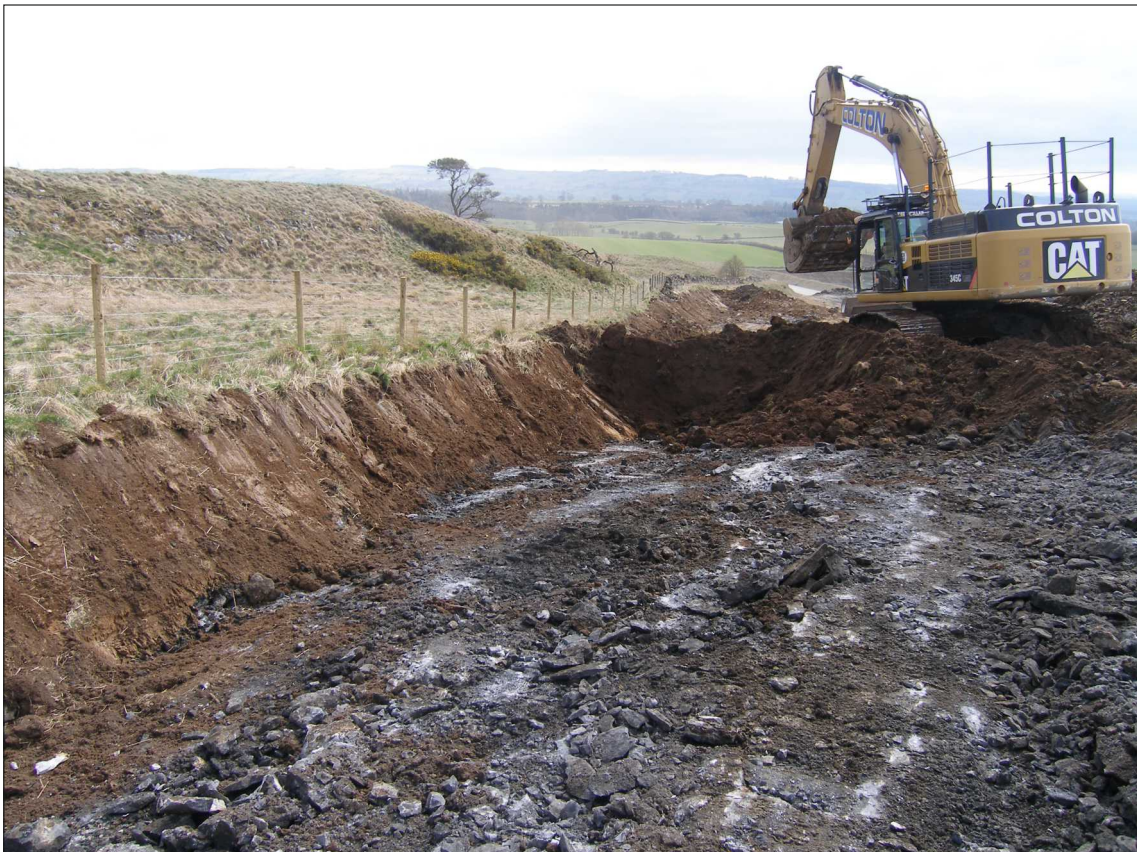
Plate 2

Barrasford Quarry: deeper overlying soils to the south and east
