## ARCHAEOLOGICAL MONITORING REPORT

SHOP BRIDGE, BROUGHTON  
MILLS, CUMBRIA

prepared for  
Metcalf Civil Engineering

NAA 21/78  
October 2021

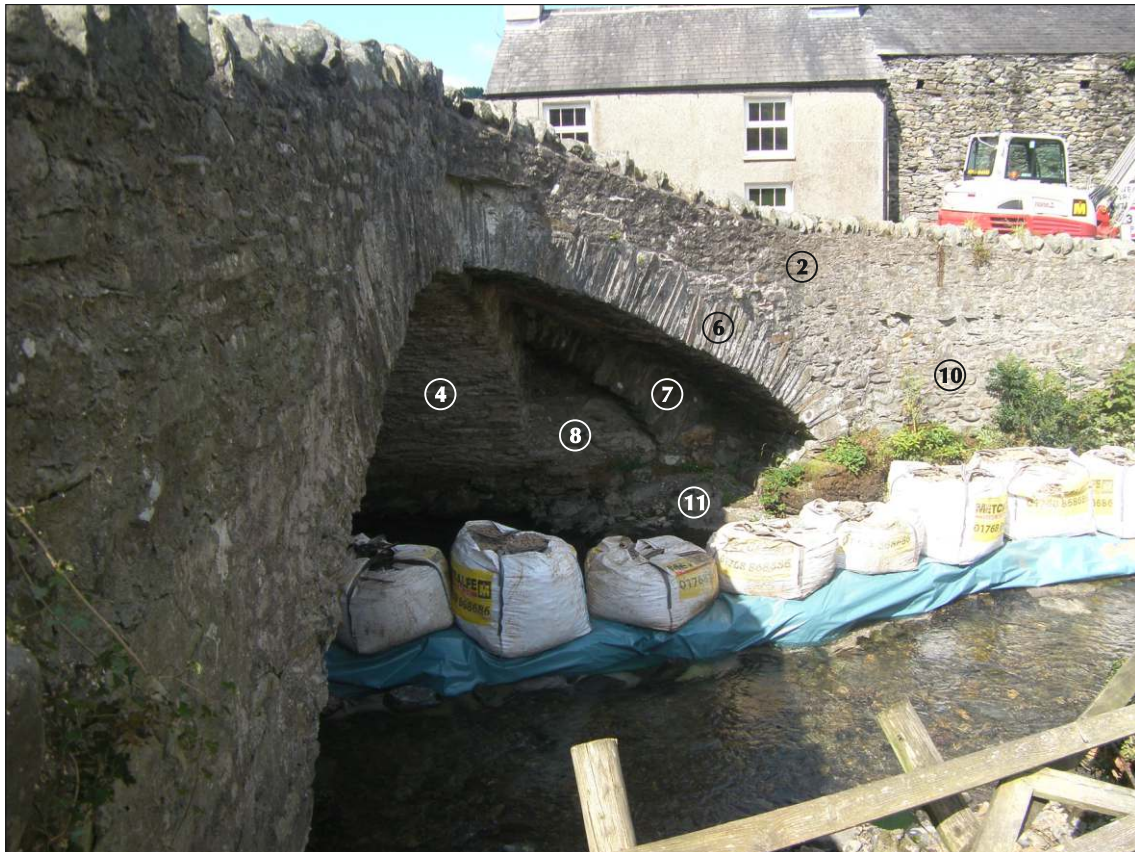
Plate 1

*Shop Bridge, Broughton Mills: phased components located on the east side of the north end of the bridge*

- 6.1 Archaeological monitoring at Shop Bridge has recorded four distinct phases of modification (Phase 1–4) at the east side of the north end of the bridge. The main phased components of the bridge include the original arch (**4**; Plate 2), an infill-arch (**7**) and a back wall (**8**), a half-arch (**6**) and later retaining wall (**10**) (Plate 1). An unphased stage of modification to the bridge included the construction of an arch extension (**5**; Plate 2) on the west side of the bridge and associated infilling of the widened deck (**1**; not illustrated). Some elements of the bridge's structure could not be accurately recorded due to unsafe conditions during some stages of demolition work.

- 6.7 Phase 3 represents the construction of the half-arch (6), the existing retaining wall (10) and an abutment (11; Plate 1). The half-arch (6) was approximately 6m long by up to 0.7m high. It was constructed from roughly hewn slate blocks measuring 0.7m by 0.5m by 0.1m and was bonded by mortar that had become friable due to water damage. The half-arch (6) had become flattened and was in danger of failure, hence the requirement for remedial structural work.
- 6.8 The retaining wall (10) was irregularly coursed with slate blocks and river cobbles that were up to 0.5m by 0.3m by 0.2m. It was bonded by friable mortar. The interface between the coursing of the retaining wall (10), and that of the overlying Phase 4 parapet/boundary wall (2) indicated that wall 2 had been constructed later (as visible on Plate 1).

- 6.13 The latest phase of construction was that of the eastern parapet wall (2), which continued to the north-east as a boundary wall and defined the road from the river (Plate 1). Construction of the existing parapet/boundary wall (2) had occurred later than that of the half-arch (6). The parapet/boundary wall was up to 1m high by 0.3m wide. It was constructed using irregularly coursed, roughly squared slate blocks and river cobbles that were up to 0.5m by 0.3m by 0.2m and mortar bonded. The eastern parapet wall (2) was removed to the level of the arch during remedial works (Plate 4).

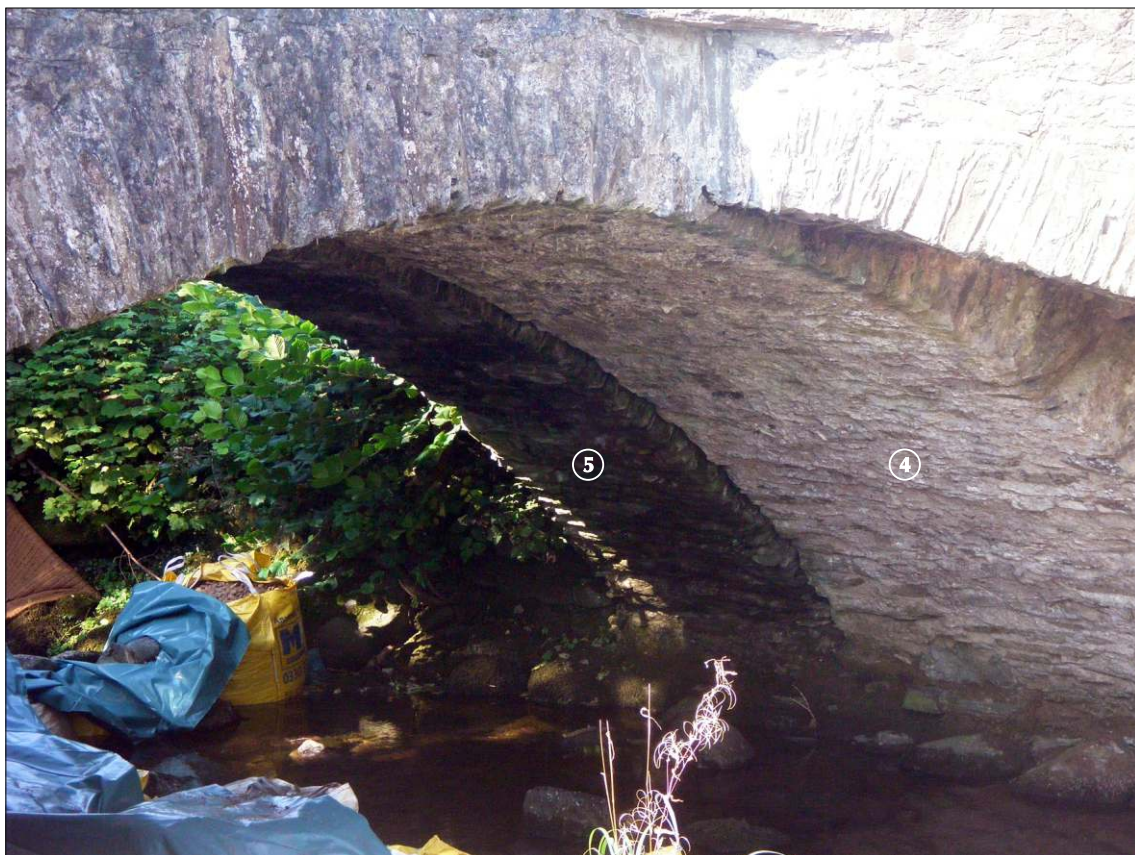
Plate 2

*Shop Bridge, Broughton Mills: the original arch (4) and arch extension (5)*

- 6.2 The original arch (**4**; Plate 2) of Shop Bridge was approximately 18m long and 3m wide. It was aligned north-west to south-east and crossed the River Lickle almost perpendicularly. The bridge was constructed from large slate blocks that were up to 0.5m by 0.3m by 0.2m in size, with smaller slate voussoirs up to 0.3m by 0.2m by 0.2m in size forming the arch. The outer stonework of the original arch (**4**) had been recently repointed, particularly on the underside of the arch (Plate 2).

- 6.10 The west side of Shop Bridge had been widened through construction of an arch extension (5; Plate 2). The extension was approximately 1.1m wide and was not keyed into the original arch (4). A gap of 0.1m was present between the arches and Arch 5 sat slightly lower than the original arch (4). The arch extension was constructed from roughly hewn slate blocks that were up to 0.5m by 0.3m by 0.2m in size.

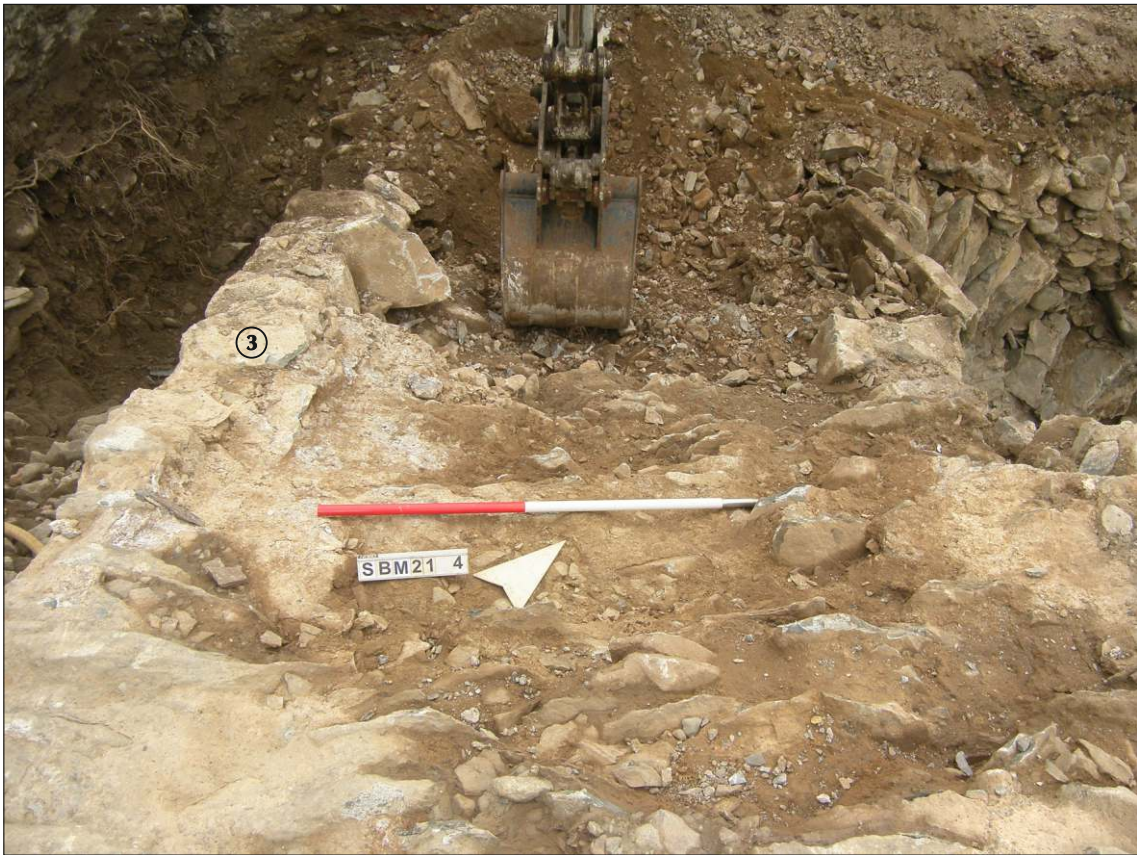
*Shop Bridge, Broughton Mills: original western spandrel / parapet wall (3) buried below deck fill and road surfaces* Plate 3

- 6.3 At its north end, the deck of the bridge descended from its apex sharply and was flanked by low parapet/spandrel walls that had been constructed during Phase 4 (see below). However, removal of the road surfaces and deck fill (**1**) exposed the footing of the original western parapet wall (**3**) that once lined the west side of the original arch (Plate 3). Footing **3** comprised irregularly coursed slate blocks that were up to 0.5m by 0.3m by 0.2m. Its presence beneath the road surface confirmed the original arch was the earliest recognisable iteration of Shop Bridge.

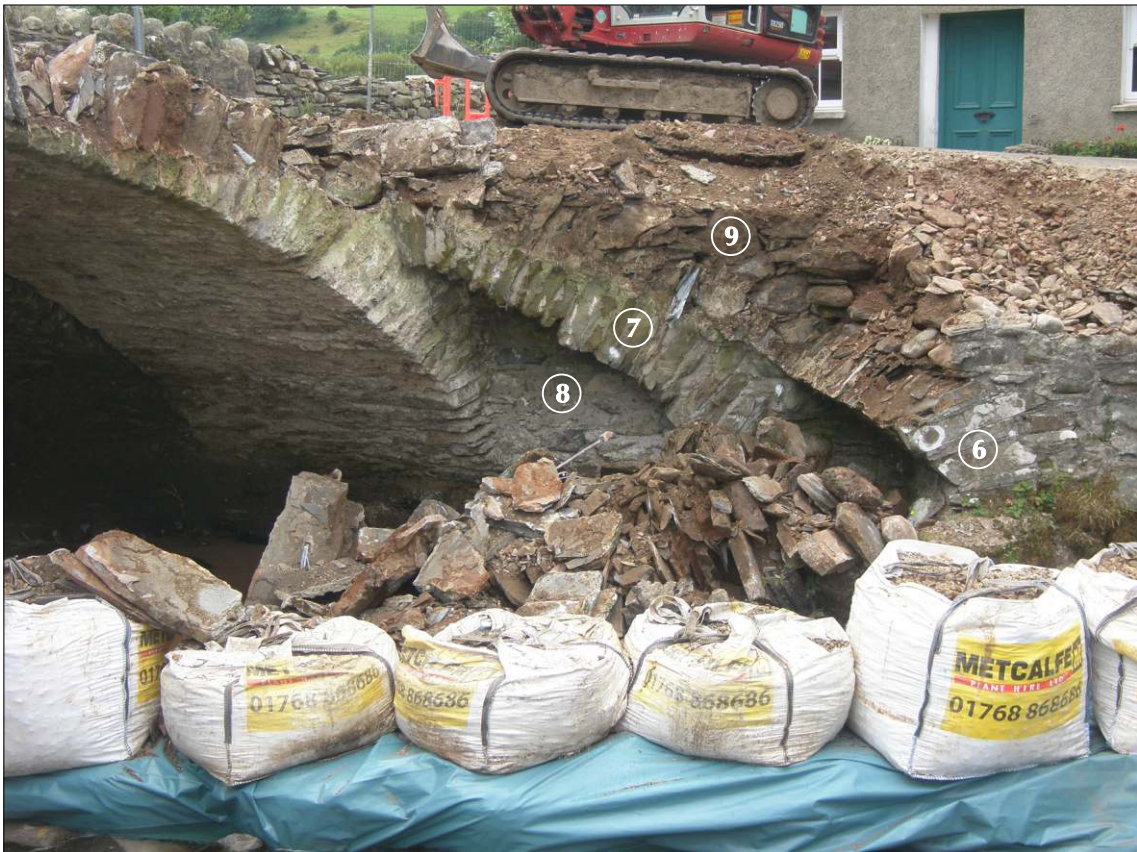
*Shop Bridge, Broughton Mills: infill-arch (7), back wall (8), and hidden retaining wall (9) following removal of half-arch (6)* Plate 4

- 6.4 Phase 2 included the construction of the infill-arch (7), in conjunction with a retaining wall (8 and 9; Plate 4). The infill-arch (7) was approximately 5m long and was constructed from roughly hewn slate blocks that were up to 0.7m by 0.5m by 0.1m in size. The arch was bonded by friable mortar that had become degraded by water damage.

- 6.5 The Phase 2 retaining wall comprised the back wall (8) and another hidden wall (9; Plate 4). The retaining walls served to support the road, which was raised above the level of the river, and mitigated its undermining by river erosion. Wall 9 had been sealed behind the latest Phase 3 retaining wall (10; Plate 1). Both elements (8 and 9) of the Phase 2 retaining wall were irregularly coursed using river cobbles, which were approximately 0.5m–0.7m by 0.3m by 0.1m in size. The back wall (8) was bonded using strong mortar, suggesting recent repointing.

- 6.6 The infill-arch (7) was keyed into, and took support from, the back wall (8) and the buried wall (9), demonstrating the features were constructed at the same time (Plate 4). The presence of a continuation of the back wall (9) behind the Phase 3 retaining wall (10) indicates that the Phase 3 half-arch (6) was a later addition. This suggests the bridge was in use for a time with only the infill-arch acting to support an initial stage of widening of the north end of the bridge.

- 6.9 An abutment (11) had been constructed at the base of the half-arch (6) to protect it from river erosion. Removal of this feature exposed a continuation of the Phase 2 back wall (8) to the level of the river (Plate 4).

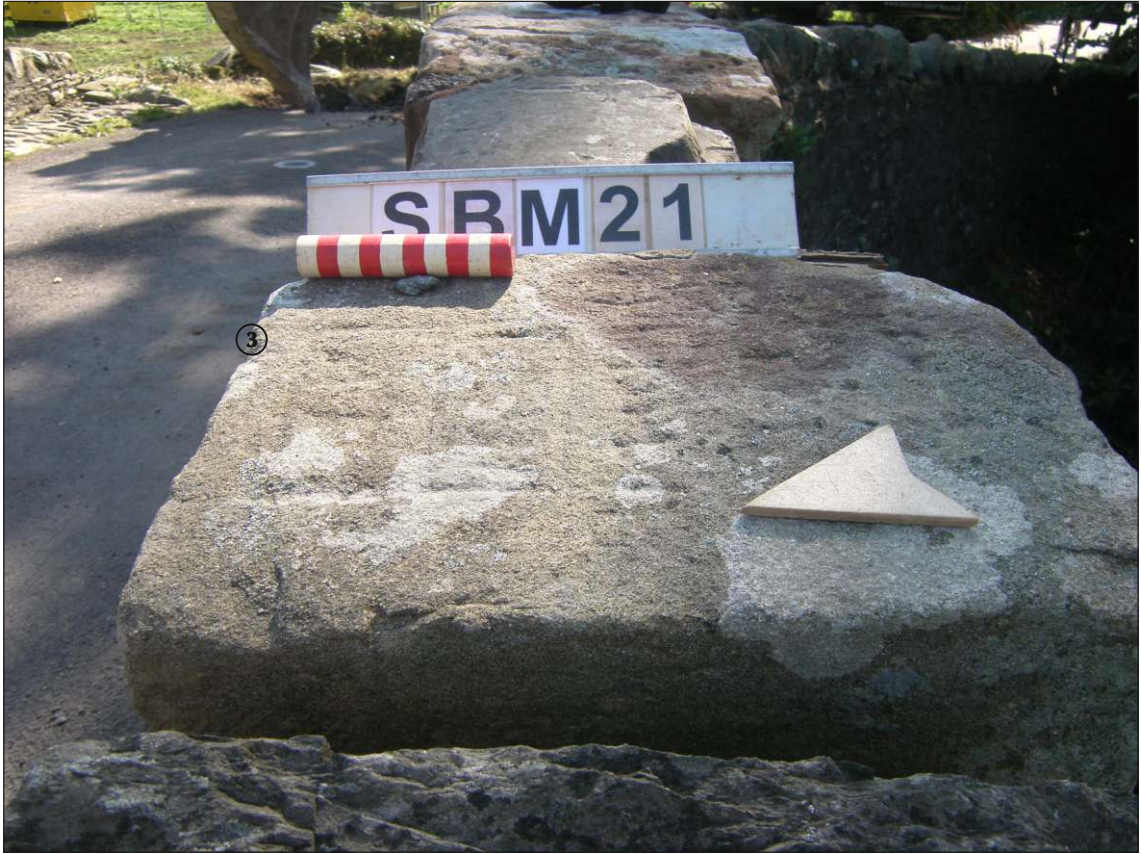
*Plate 5*

*Shop Bridge, Broughton Mills: carved stone present upon  
western parapet wall*

- 6.14 The opposing, western parapet wall of the bridge was of similar construction to the eastern (2) and was most likely constructed at the same time. It included the name-stone of the bridge, and a heavily weathered carved stone. The carved stone contained the remains of a motif in the shape of a shield with underlying text (Plate 5). The text was

illegible. The western parapet wall was not disturbed during the works and the name-stone and carved stone remain in situ.
