ARCHAEOLOGICAL SURVEY AND  
MONITORING REPORT

CRACOE TO RYLSTONE PIPELINE  
SCHEME, CRAVEN  
NORTH YORKSHIRE

NAA 21/73

September 2021

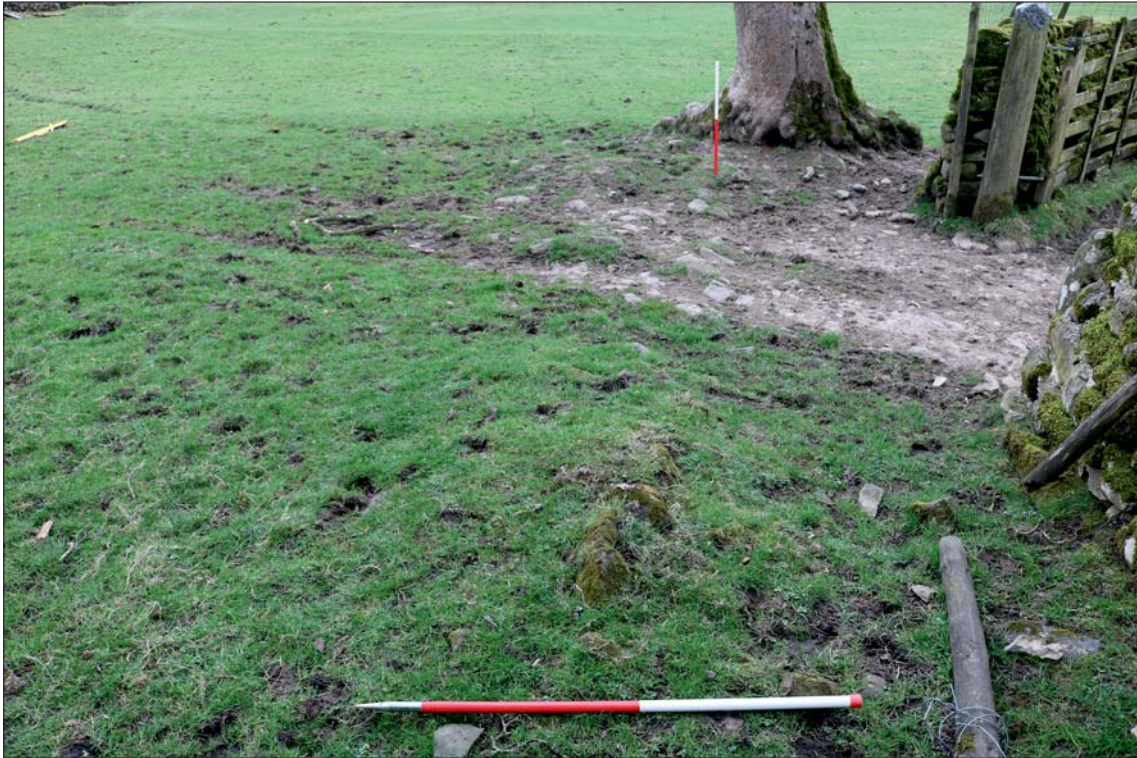
*Plate 1*

- 6.3 The remains of a dry-stone wall (1) were present at the eastern end of the investigation area. The wall had suffered considerable damage caused by the movement of modern farm vehicles. It survived as a slight earthwork up to 1.7m wide (Plate 1). The wall was located to the south of an existing gate and extended from the eastern field boundary westwards for c.11m. It was most likely of post-medieval origin.

*Cracoe to Rylstone Pipeline Scheme: remains of dry-stone wall 1, looking west*

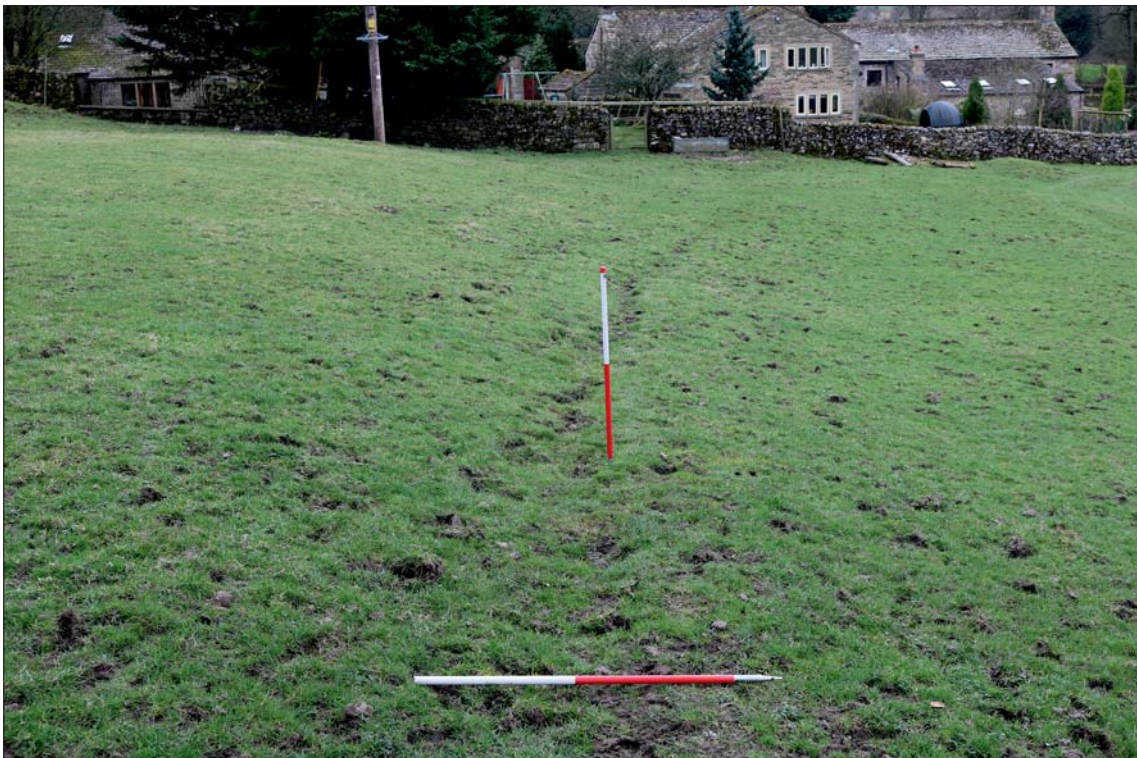
*Plate 2*

- 6.4 A shallow trackway (2) was located to the south of wall 1. The trackway ran north-northeast to south-southwest and crossed a natural terrace (26; Plate 2). The trackway was c.20m long and extended diagonally southwards down the terrace slope. It had a low bank along the western edge. A lower terrace (25) was located c.20m to the west of terrace 26, which was aligned parallel.

*Cracoe to Rylstone Pipeline Scheme: shallow trackway 2, looking south-south-west*

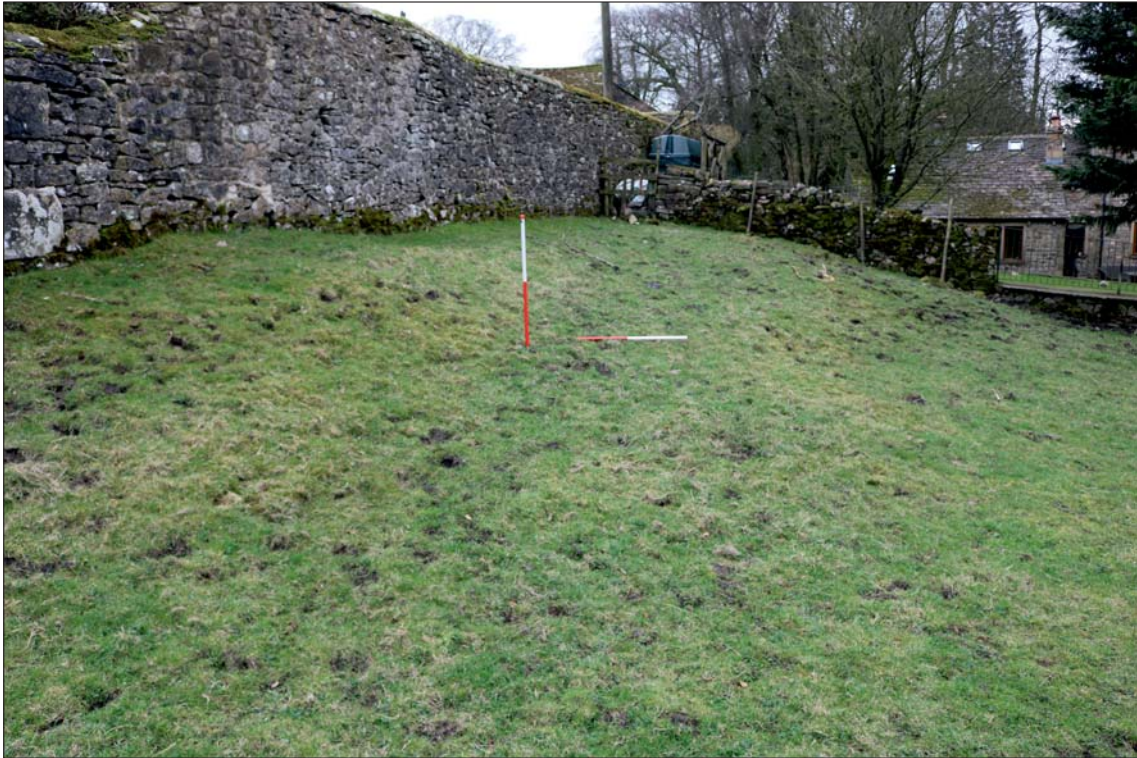
Plate 3

- 6.5 A shallow trackway (3) was located at the south-east corner of the survey area. The trackway was c.10m long and 1.5m wide and was aligned broadly north to south. It traversed an uphill slope, which may have represented the edge of another terrace above terrace 26 (Plate 3).

*Cracoe to Rylstone Pipeline Scheme: trackway 3 running south and up slope of terrace*

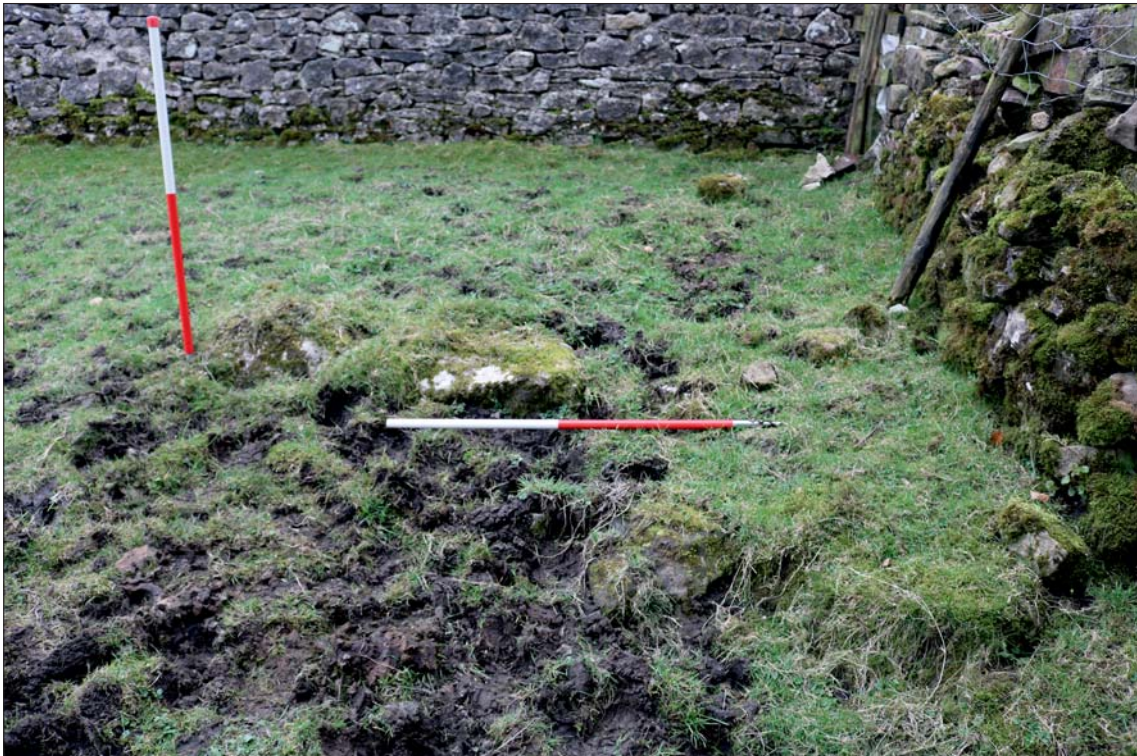
Plate 4

- 6.6 A single course of large stones in the south-eastern corner of the survey area may represent the upper course of a revetment wall (4; Plate 4). The visible remains of the wall were 0.4m wide. They extended northwards from the southern field boundary for c.2m.

*Cracoe to Rylstone Pipeline Scheme: possible revetment wall 4, looking east*

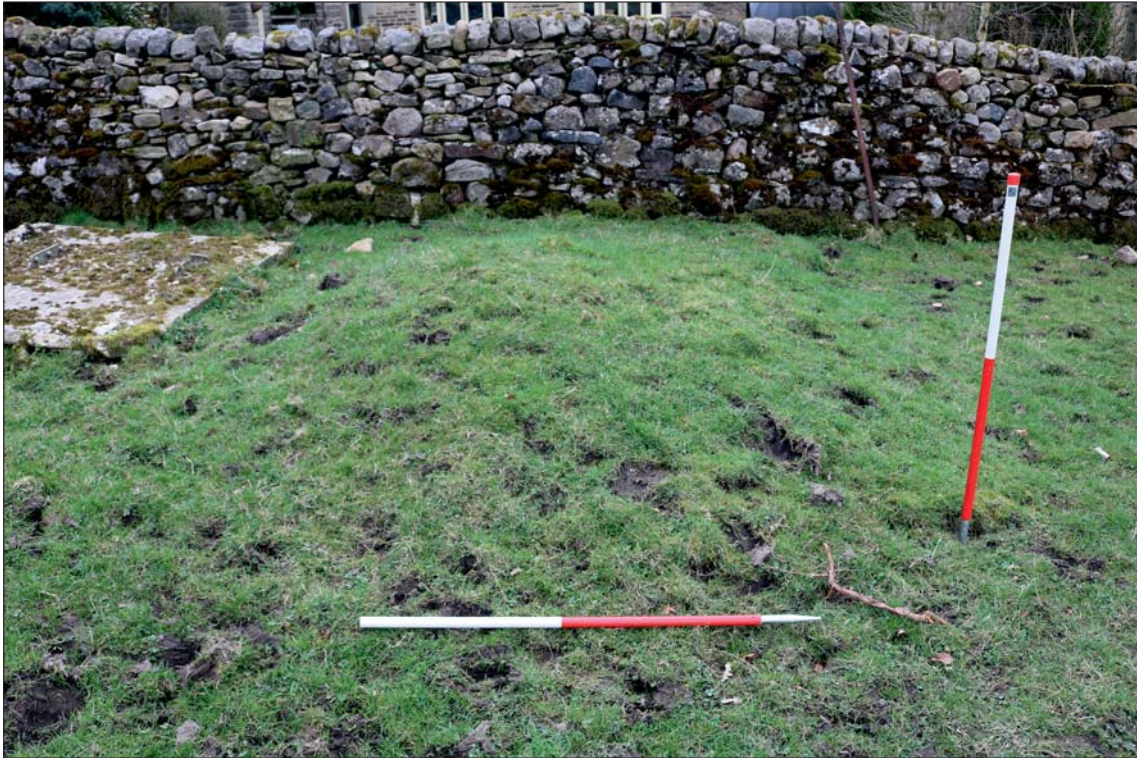
*Plate 5*

- 6.7 A discrete mound (5) was located 35m to the west of the possible revetment wall (4), which was situated adjacent to the southern field boundary wall. The mound was 3m in diameter and c.0.6m high. It could conceivably represent a heavily vegetated cairn. However, a large subsurface structure with concrete lid was located c.3m to the east of the mound, and it seems most likely that it represented upcast from the installation of this feature.

*Cracoe to Rylstone Pipeline Scheme: mound 5, looking south.  
Concrete lid visible to the left of the frame*

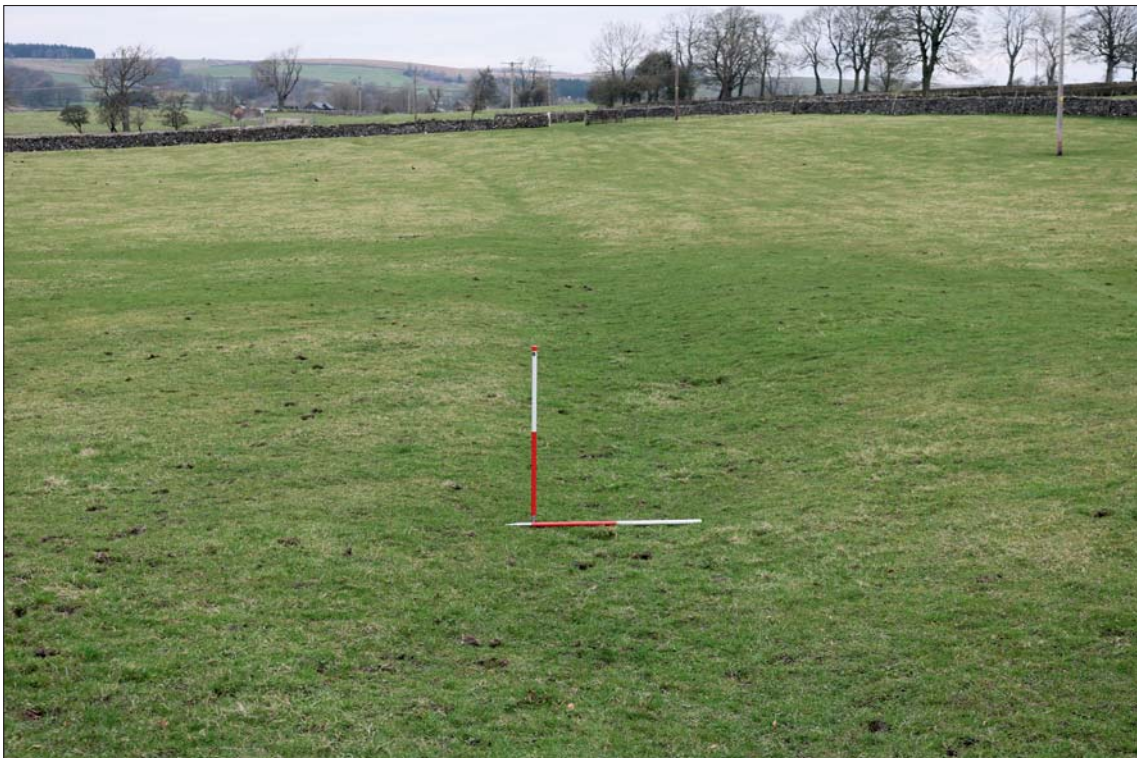
*Plate 6*

*Cracoe to Rylstone Pipeline Scheme: hollow way 6, looking north*

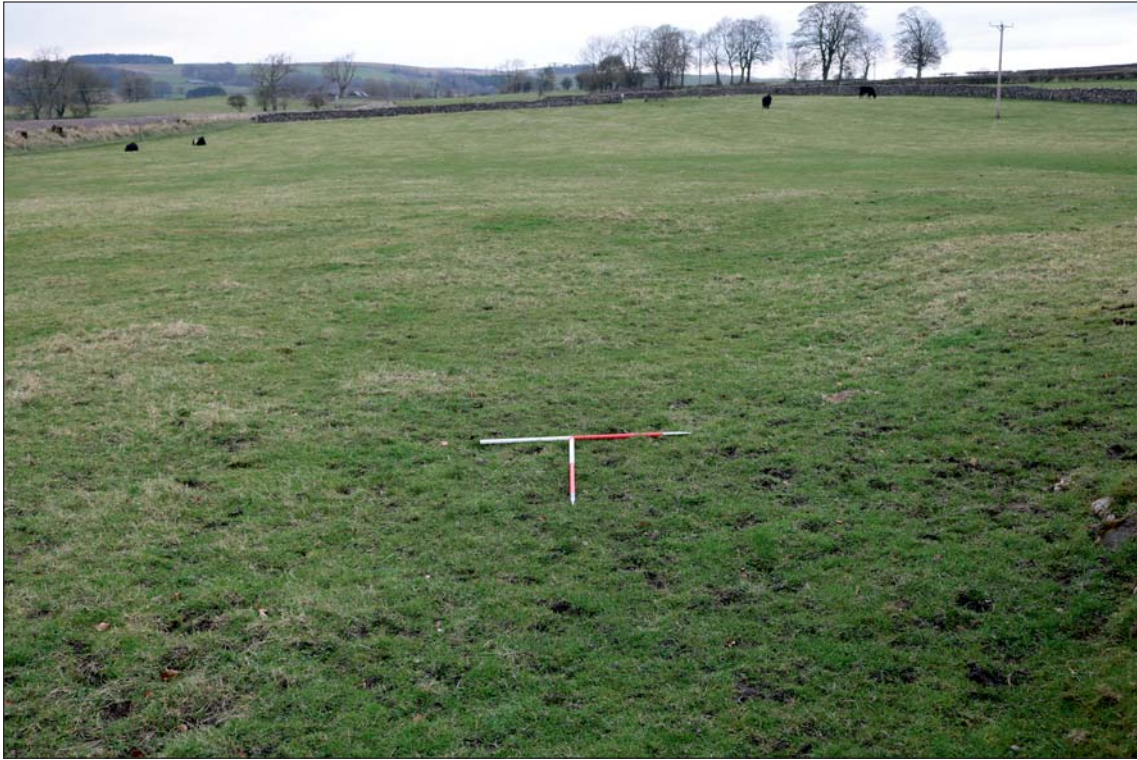
*Plate 7*

- 6.13 Enclosure 14 was 27m by 7m in size. It was delineated from enclosure 15 by another possible bank (24) and may have had an entrance to the north. Enclosure 15 was 10m by 13m in area, and it may have represented a platform or terrace that was raised slightly above enclosure 14. Both enclosures 14 and 15 were defined to the north by a low bank (16), which suggested they also represent the rear of settlement plots.

*Cracoe to Rylstone Pipeline Scheme: Field 14, looking north.  
Platform 15 to the right*

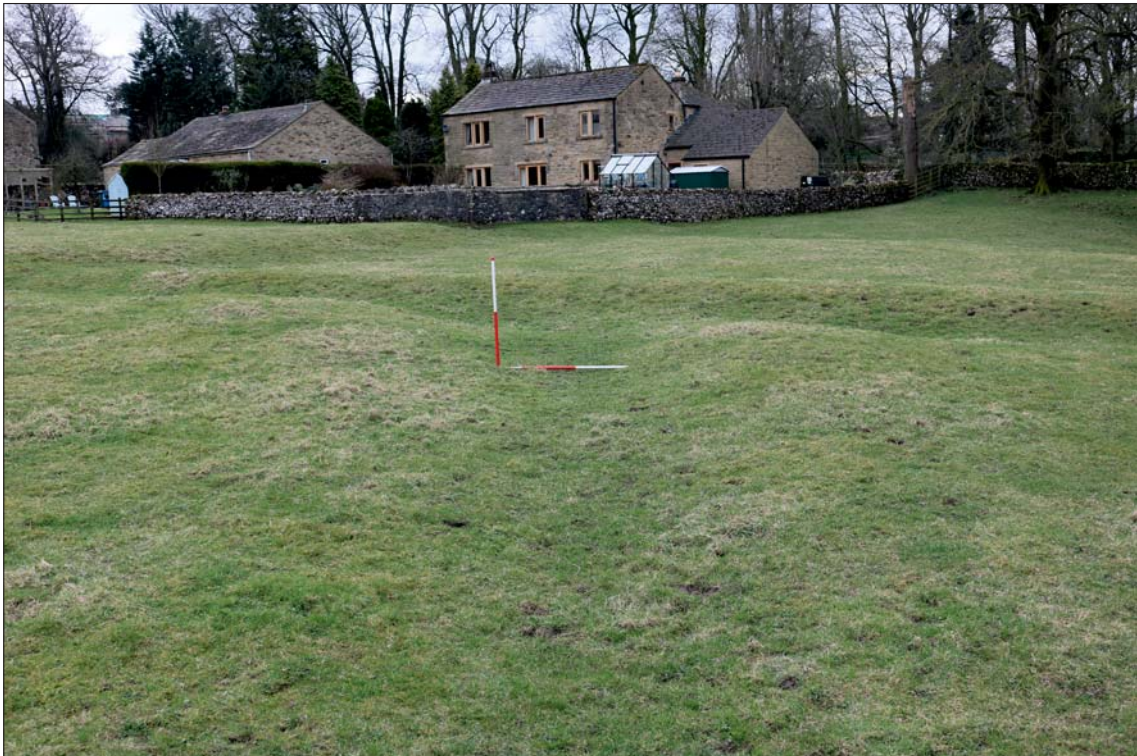
*Plate 8*

hollow way (8), which intersected with hollow way 7 at its south end. Hollow way 8 was 3m wide by 22m long and was aligned north-northwest to south-southeast. It was flanked by low banks. A second, parallel hollow way (6) was located 70m to the east, which defined the western side of another field of upstanding ridge and furrow. Hollow way 6 was 3.5–4m wide and was c.140m long. It became imperceptible at its south end, which was most likely due to erosion of the earthwork by modern farm activities. Hollow ways 8 and 6 presumably served to define the extent of fields, whilst providing access to more distant farmland.

*Cracoe to Rylstone Pipeline Scheme: hollow way 8,  
looking south to hollow way 7. Enclosures 9 and 10  
visible in the background*

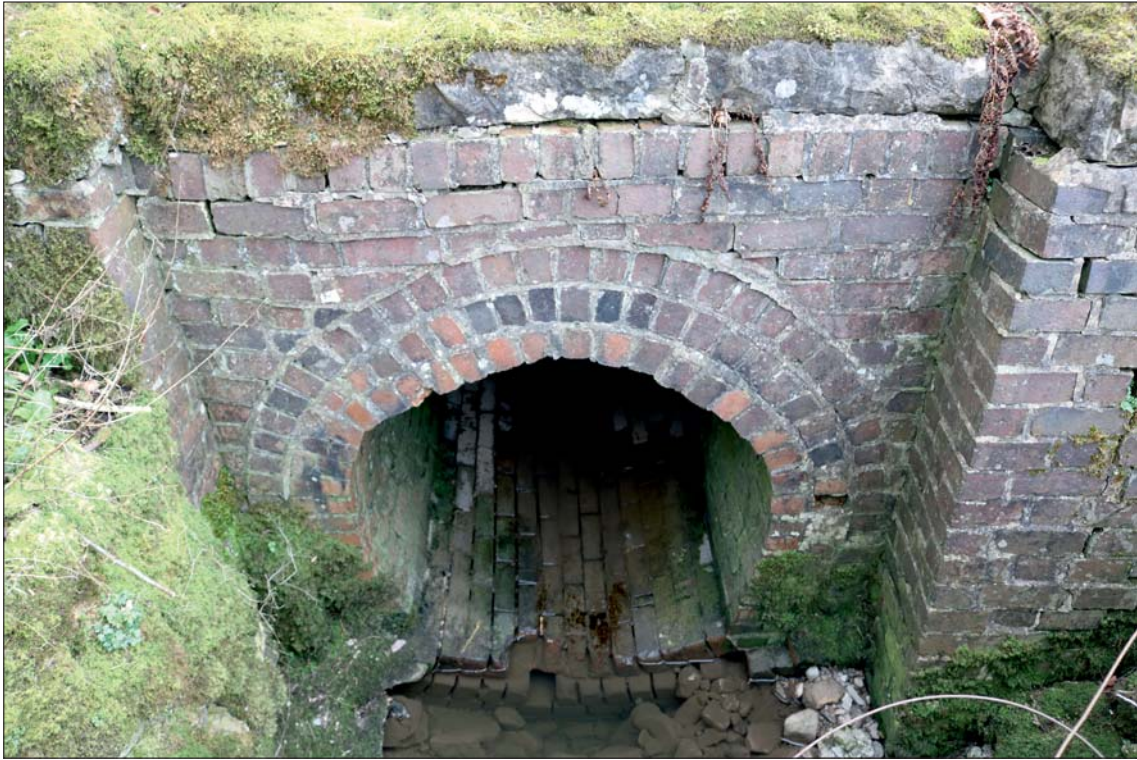
*Plate 9*

- 6.15 The remains of ridge and furrow cultivation across the northern part of the survey area was aligned north-northwest to south-southeast. The ridge centre points were spaced between 7m and 10m apart.
- 6.16 The entrance to a brick-lined culvert (22) was recorded just beyond the edge of the survey area to the south-west. The culvert ran beneath the survey area with a north-west to south-east alignment. Construction of the culvert was probably undertaken in conjunction with construction of the railway line, which defined the western site boundary.

*Cracoe to Rylstone Pipeline Scheme: western entrance  
to culvert 22*

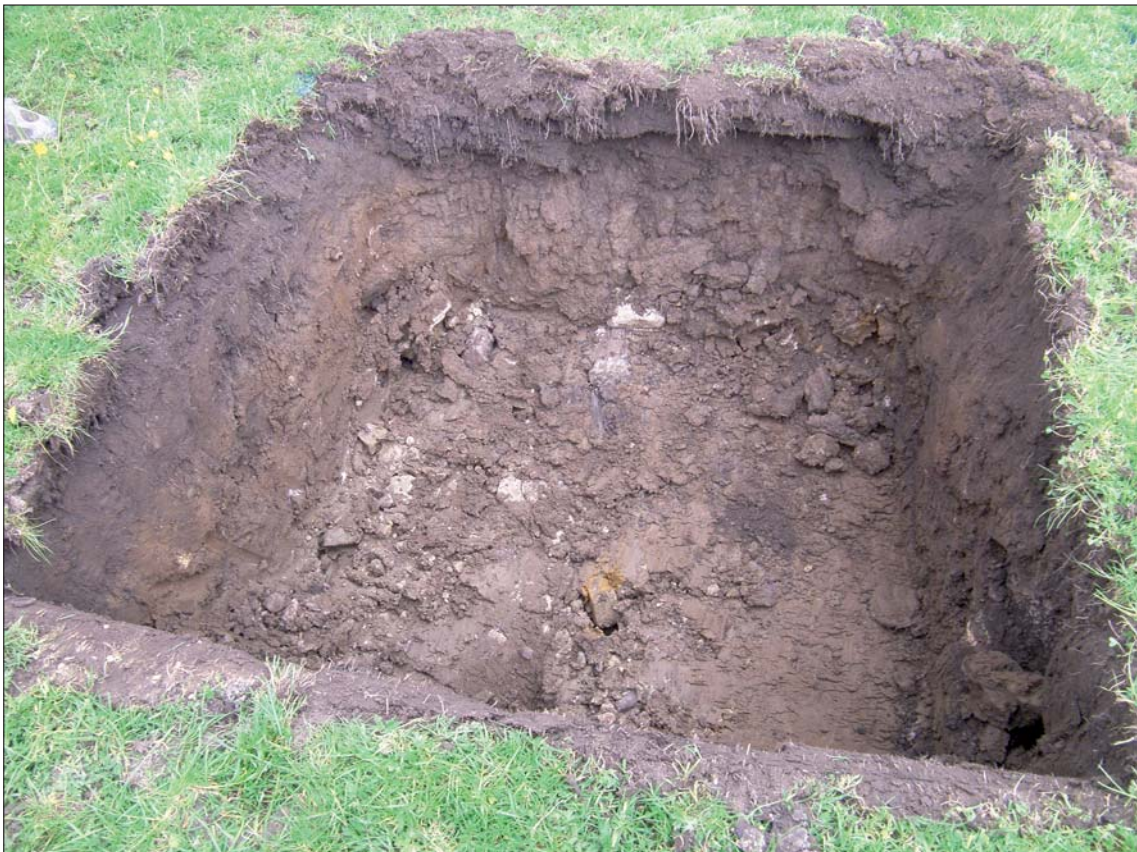
*Plate 10*

6.18 No archaeological features, deposits or finds were recognisable in any of the limited areas of excavation, other than the presence of a subsoil within each of the trenches. The natural boulder clay was exposed in each trench, which was sealed by a light brown silt subsoil that ranged from 0.1m–0.4m thick (Plate 10). This deposit had probably accumulated during medieval and post-medieval ploughing of the fields and enclosures recorded by the earthwork survey, and probably represented the fill of plough furrows. However, no artefactual material was recovered to indicate a date for this activity. The subsoil was sealed by up to 0.3m of dark brown topsoil.

*Cracoe to Rylstone Pipeline Scheme: the Launch Pit, excavated  
to the upper level of the natural boulder clay*
