THE CURTAIN RISES
THE MAUSOLEUM

ARCHAEOLOGICAL
INVESTIGATIONS

NATIONAL TRUST
SEATON DELAVAL HALL
NORTHUMBERLAND

NAA 21/90
October 2021

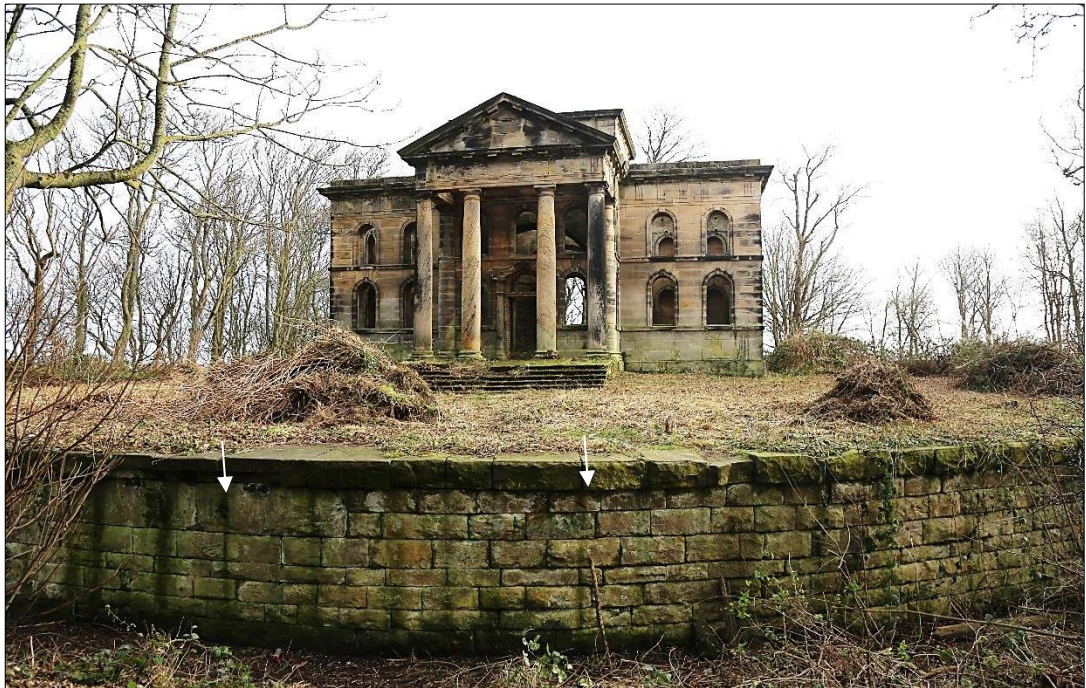
Plate 1: view across the ha-ha, showing the west-facing elevation and portico, with drawbridge masonry in foreground (between two white arrows).

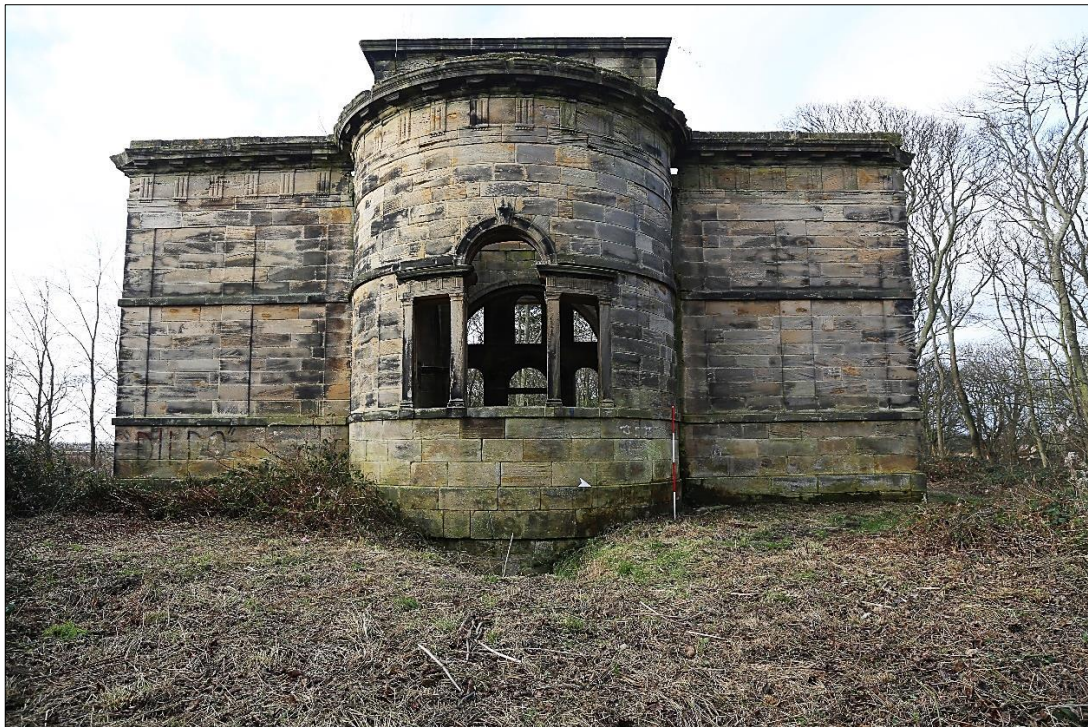
Plate 2: east-facing elevation with apse and vault entrance at ground level.

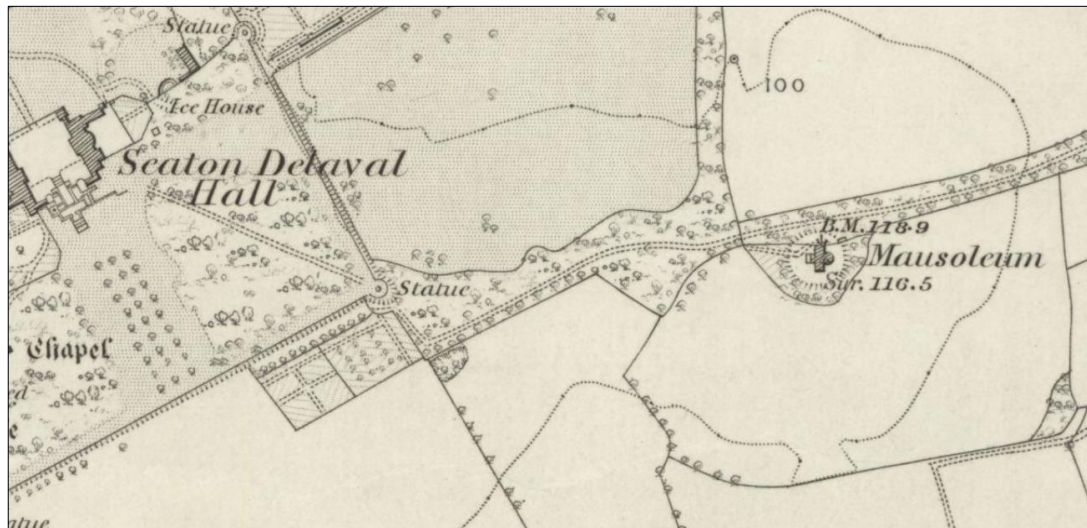
Figure 4: extract from First Edition six-inch OS map, published in 1865, showing the former entrance.

- 3.12 By the mid-19th century, the estate had passed to Jacob Astley (1797–1859), the 16th Baron Hastings. The First Edition six-inch Ordnance Survey (OS) map (Fig. 4), published in 1865, shows the building little changed, although the belt of woodland associated with the Sea Walk has filled out considerably and trees are shown surrounding the circular enclosure, potentially obscuring views towards the Mausoleum. The access track and drawbridge across the ha-ha are also depicted for the first time.

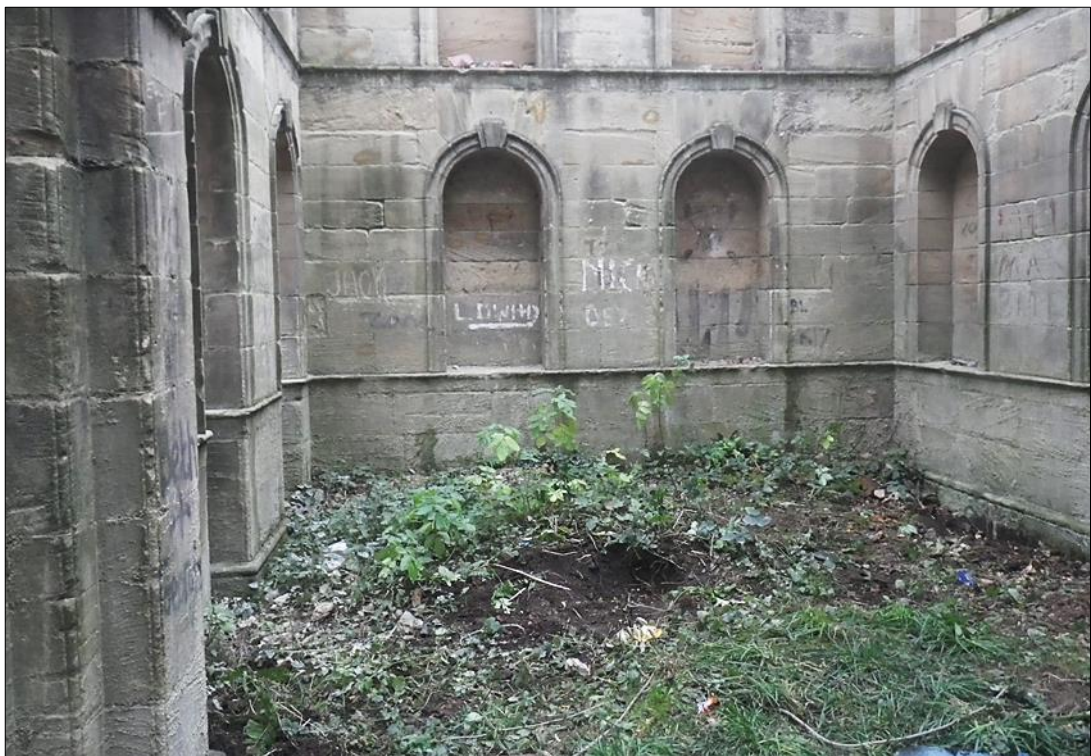
- 8.5 At the commencement of the work, the interior of the building was overgrown with vegetation, including several young trees (Plate 3). One of these had been cut down to ground level on at least two occasions in the past, making its removal problematic. Clearance of the undergrowth uncovered a considerable quantity of brick rubble (Plate 4) within a matrix of cream-coloured crushed mortar and render (2000), mixed with decades of leaf mould and decayed vegetation

Plate 3: interior during initial clearance, facing north.

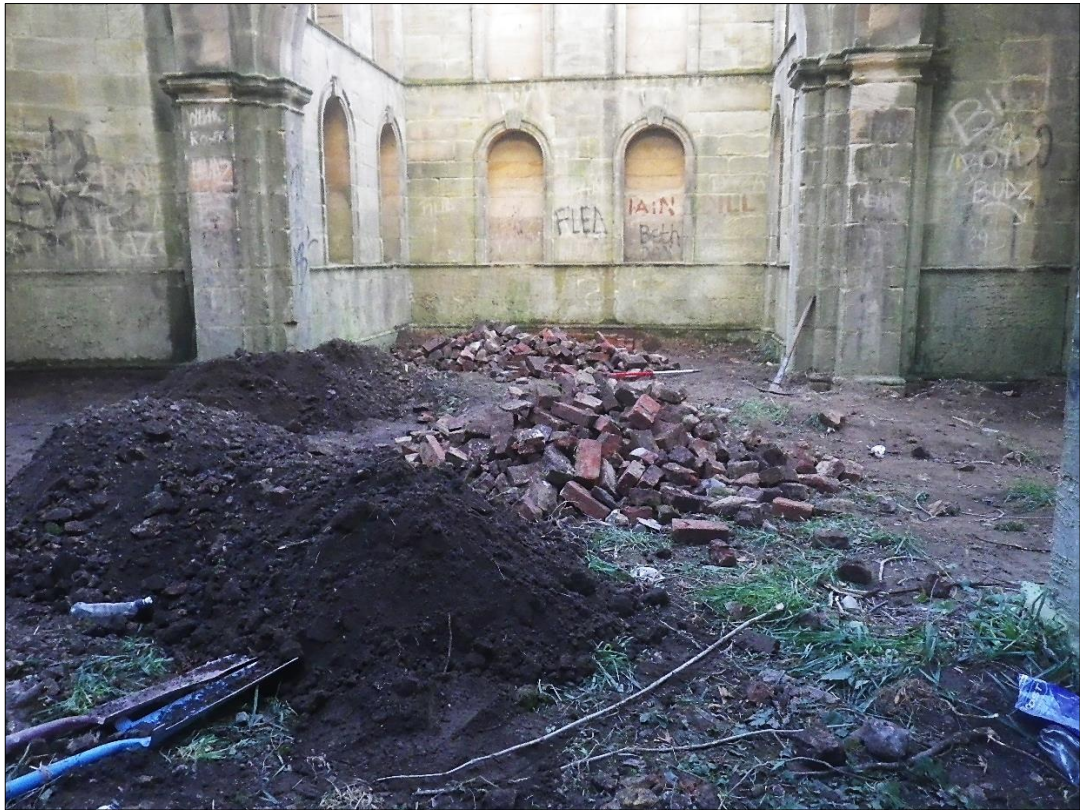
- 8.6 The bricks presumably came from the demolition of the 19th-century partition walls. The bricks were of two slightly different sizes, one measuring 0.23m by 0.12m by 0.08m and the other 0.24m by 0.115 by 0.07m. Both were unfrosted and made of a similar orange/red fabric, with a blue-grey interior when broken. Some bricks included a thin accretion of cream/white mortar.

Plate 4: separation of brick rubble and topsoil 2000, facing south.

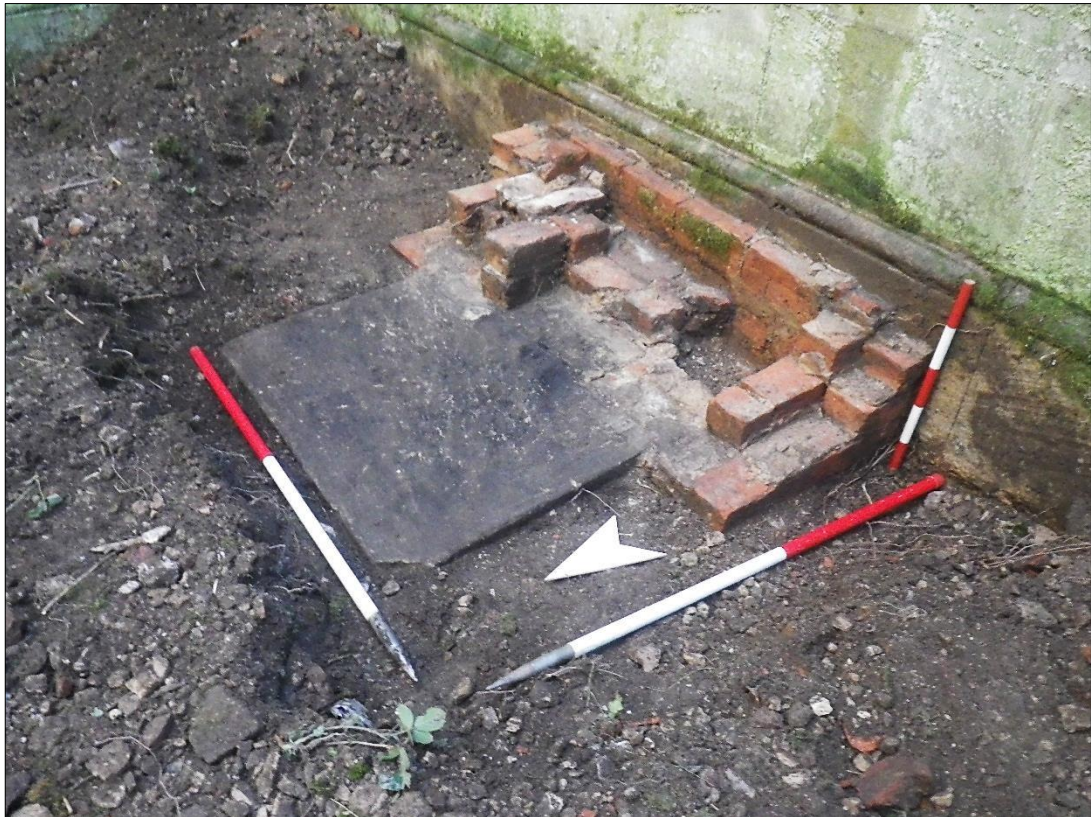
- 8.8 Fireplace 2001 was situated against the base of the south wall of the building. A single course of bricks lined the face of the wall behind the main body of the fireplace (Plate 5). The remains of the brickwork measured 1.42m by 0.56m, with 0.32m visible above the original floor level. The height of the former floor surface was evident from the location of the hearthstone. This measured 0.93m by 0.66m and was 0.12m thick. The bricks used in the construction of the fireplace were the same as those found in 2000.

- 8.10 The inner face of the south wall showed traces of the former fireplace, revealing that the body of the fireplace was 0.84m wide and 1.20m tall, with walls 0.16m thick. No evidence of a brick chimney (or other type of flue) was visible above the internal string course at window level.

Plate 5: fireplace 2001, showing marks on the wall above associated with the fireplace, the level of the hearthstone but the absence of surviving original floor.

- 8.11 Clearance of a small area around the hearthstone revealed no traces of the original floor surface. Documentary evidence suggests this was probably flagged with stone, which had been removed at some stage in the past as part of the abandonment or demolition of the interior. The hearthstone may have been left because, as an integral part of the fireplace, it would have been difficult to remove without a great deal of work.

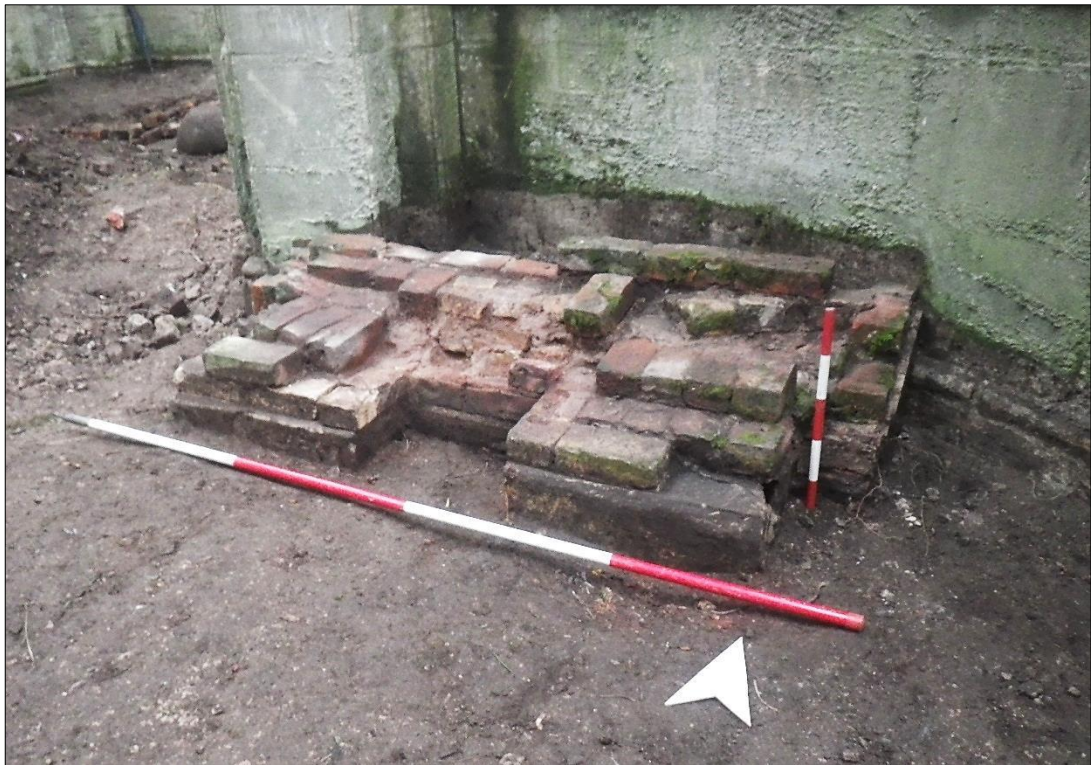
- 8.12 Fireplace 2002 was situated in the central nave, built up against the north side of the apse. The surviving brickwork measured 1.07m by 0.68m and was visible to a height of c.0.45m above the required level of the groundworks. The original hearth/floor level was not exposed by the depth of excavation required in this area. The structure was of the same construction as 2001 and employed the same types of brick. It was built

perpendicular to the inner face of the archway, with the space between the curve of the apse and the back of the brickwork being infilled with soil and rubble (Plate 6).

Plate 6: fireplace 2002, with arch pier and north wall of the apse behind.

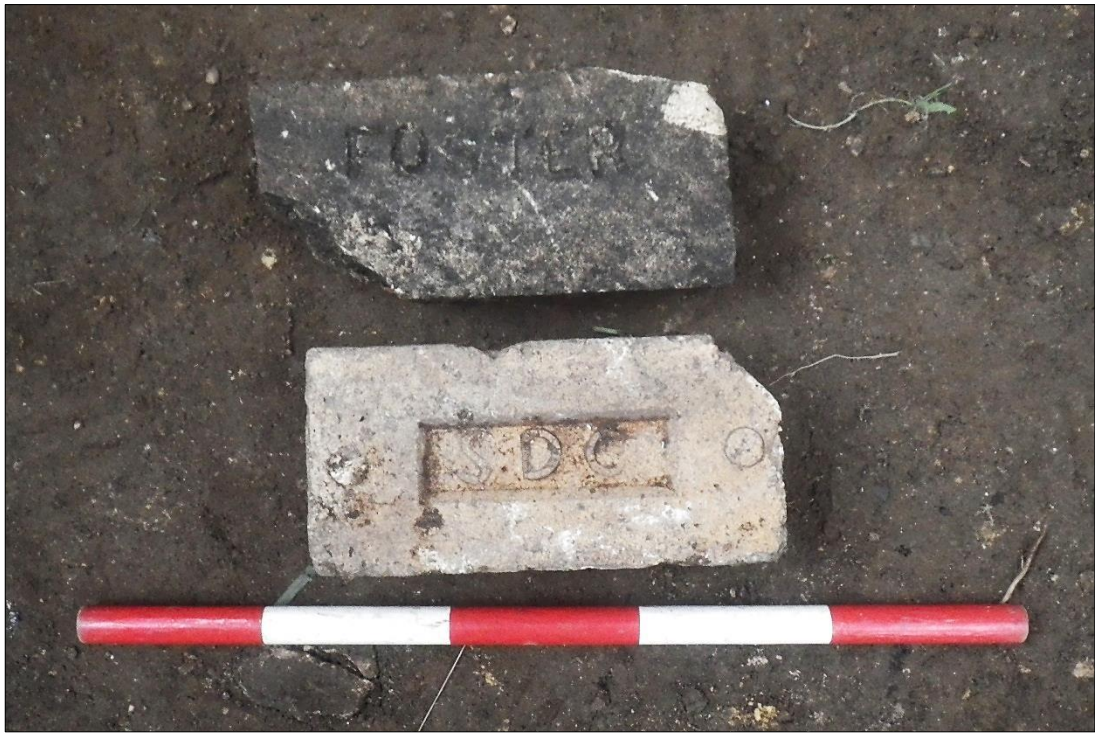
8.13 Two complete bricks were removed from the damaged upper portion of **2002** (Plate 7) and a corroded iron grill was recovered from the surrounding debris. These elements were recorded prior to reburial within the hearth of fireplace **2003** and are described below:

- **Brick 2009**
Soot-stained yellow/cream fabric measuring 0.23m by 0.11m by 0.06m with a stamp 'FOSTER' running slightly skew to the brick face.
- **Brick 2010**
Orange/cream, slightly glazed surface with a light cream fabric measuring 0.23m by 0.115m by 0.08m, with a sharply defined bevelled rectangular frog. The letters 'SDC' were pressed in relief in the frog and there were also discs in relief on the face on either side.
- **Fire-grill 2008**
Comprised three bars of wrought iron riveted to form a crude fire-grill, presumably associated with fireplace **2002**. Fire-grill **2008** was reburied within the fireplace **2003**.

Plate 7: firebricks 2009 and 2010 from fireplace 2002.

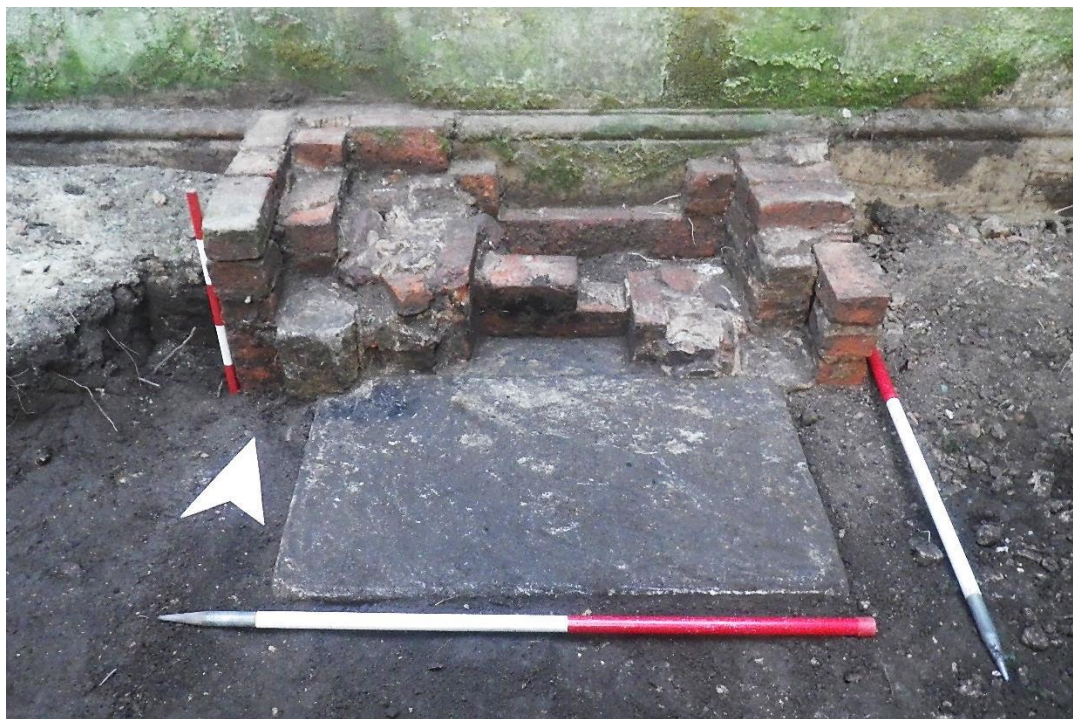
Plate 8: fireplace 2003.

- 8.14 Using the same brick type and construction method as the other fireplaces, **2003** was built against the north wall of the building and measured 1.40m by 0.60m (Plate 8). The cream/white mortared brickwork survived above the original ground level and sat above

a hearthstone that measured 1m by 0.60m by 0.08m. During excavation, part of a cast-iron fire-surround with a foliate design (2007) was found (Plate 9). It was recorded and reburied in the interior of the fireplace.

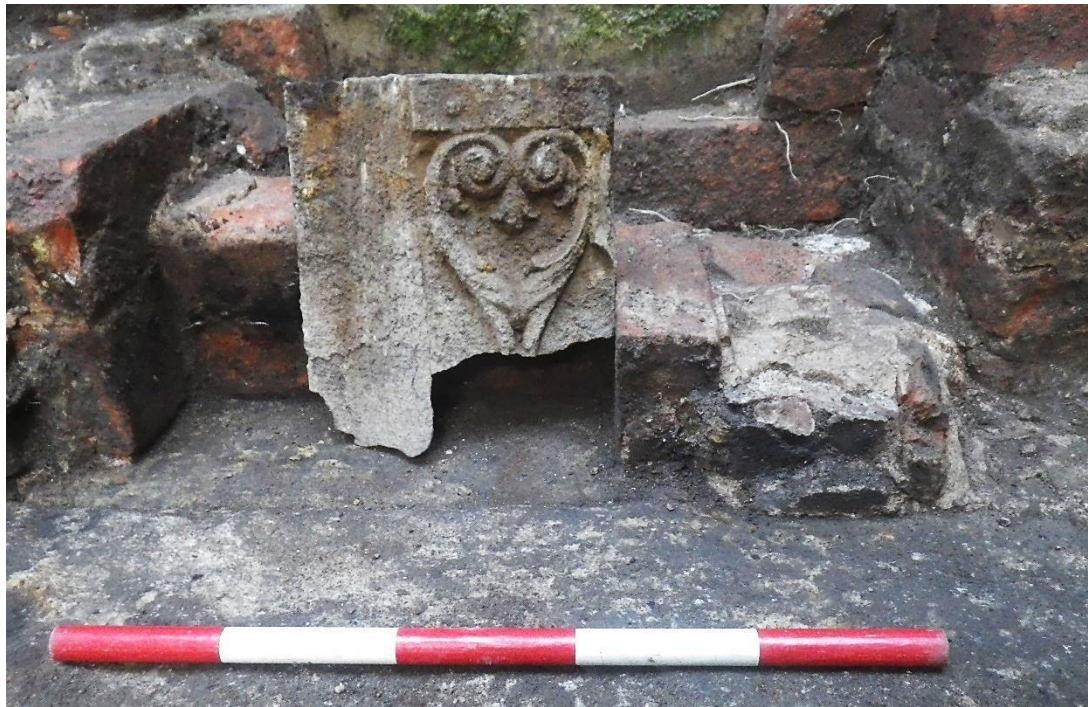
Plate 9: cast-iron fire surround 2007 from fireplace 2003.

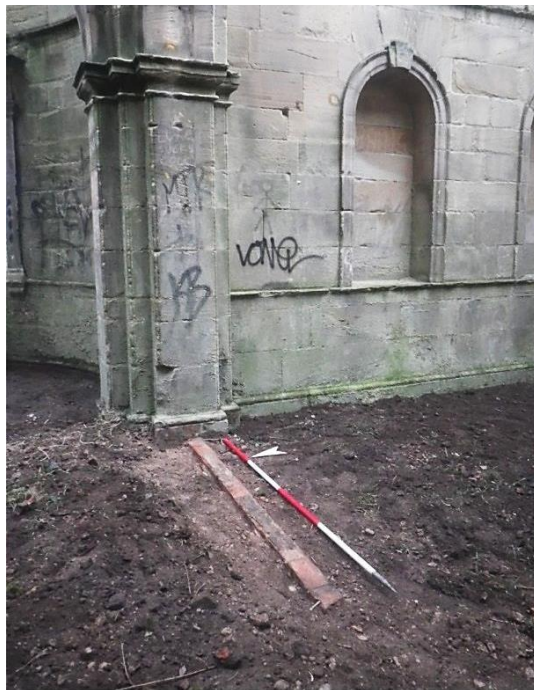
8.16 Traces of the wall were visible as staining on the arch reveal, and iron fittings in the stonework showed the wall had continued across the face of the masonry. The brickwork of the wall butted against the lower courses of the eastern arch pier and extended west for over 2m (Plate 10). The remains of a doorway were visible west of the dividing wall, close to the entrance and portico.

Plate 10: partition wall 2004.

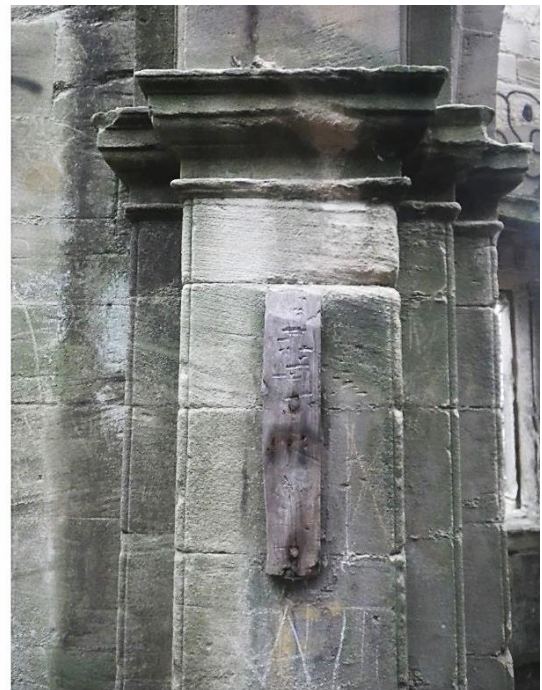
8.17 The iron ties noted in the masonry above wall 2004 were also visible on the north supporting arch of the dome. Within the arch, sections of timber planking were attached to the body of the masonry. These measured 0.50–0.60m by 0.16m by 0.015m. The

timber would have served to infill the gaps caused by the decorative moulding of the piers and curvature of the arch (Plate 11).

Plate 11: timber remains of wall 2006.

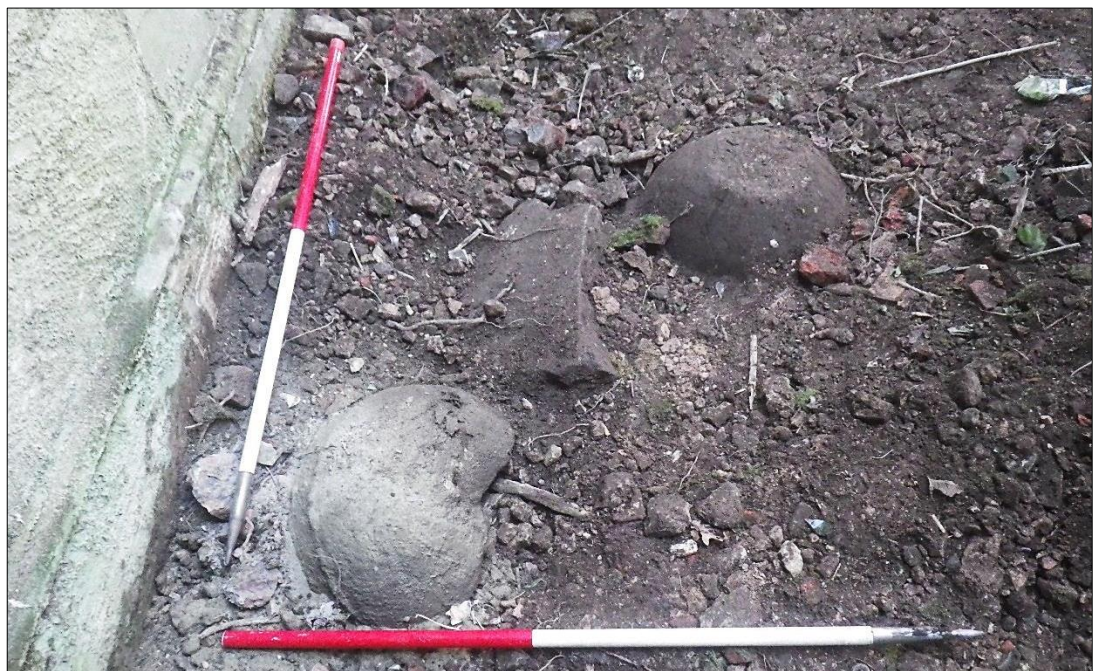
Plate 12: ball finial elements partially buried in the north-east corner of the interior.

- 8.18 The ground in the north-east of the Mausoleum was more disturbed than the rest of the interior. The removal of debris and fill in this area uncovered three elements of

decorative architecture partially buried in the corner of the building (Plate 12). These objects proved to be fragments of a ball finial and possibly the base of an urn. They were fully recorded prior to reburial within the hearth of fireplace **2003** (Plate 13).

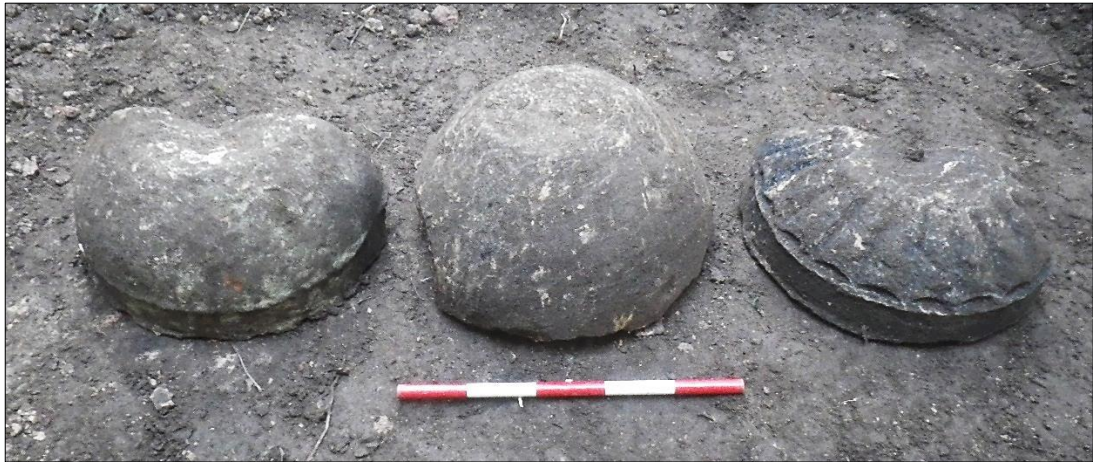
Plate 13: ball finial elements and the possible base of an urn.
