HISTORIC BUILDING RECORD

NATIONAL TRUST
SEATON DELAVAL HALL
NORTHUMBERLAND

NAA 20/30
March 2020

THE POTTING SHED, SEATON DELAVAL HALL, NORTHUMBERLAND: HISTORIC BUILDING RECORDING

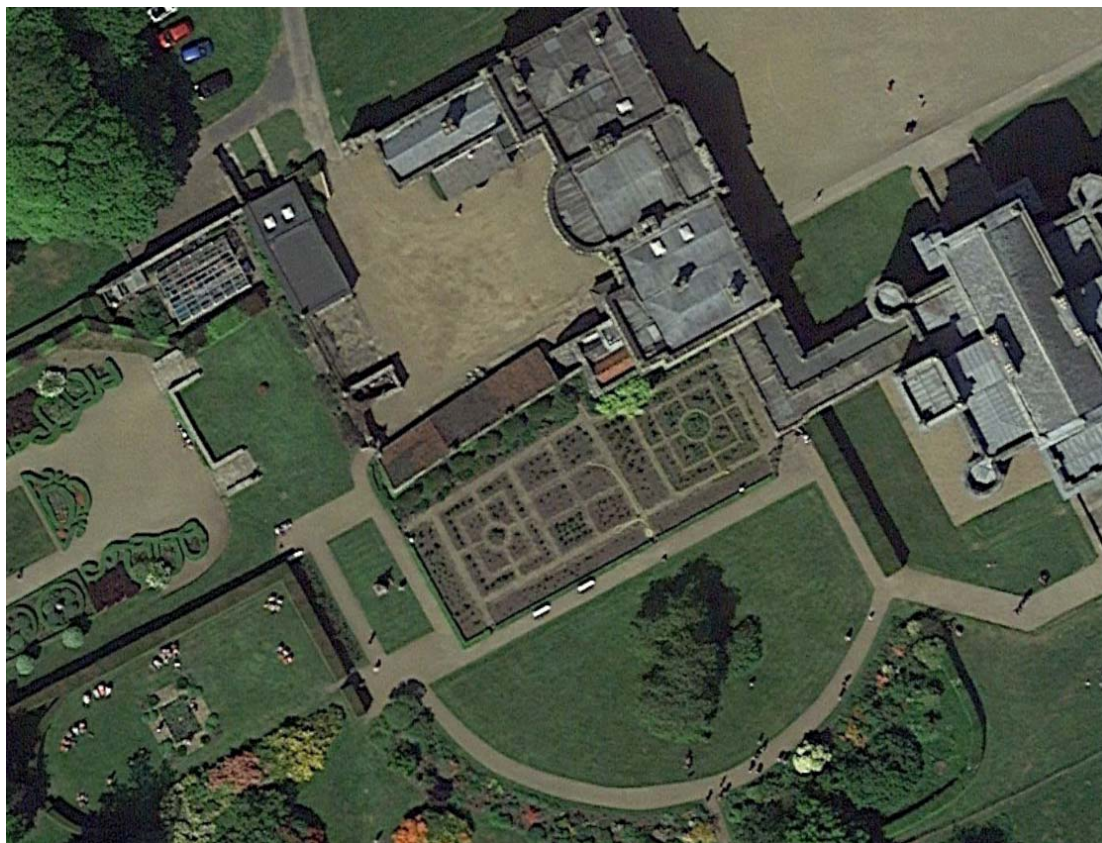
Figure 7: Aerial image of the west court as it appears today with the pantile roof of the Potting Shed clearly visible. Map data ©2018 Google

- 5.1 The building comprises a linear range measuring externally 21.2m long by 4.77m wide and divided internally into four rooms (Fig. 7). The range extends south-west from the south-west service block of the West Wing. It is currently one storey but originally incorporated a hayloft. It is built up against an earlier brick boundary wall and is covered by a steep mono-pitched pantile roof that rises toward the south.
- 5.2 The north (front), south and east gable walls are all c.0.5m thick and constructed of coursed rubble sandstone with some brick infill. Several pieces of stone may have been re-used. The south (rear) wall is of brick and pre-dates the main body of the building.

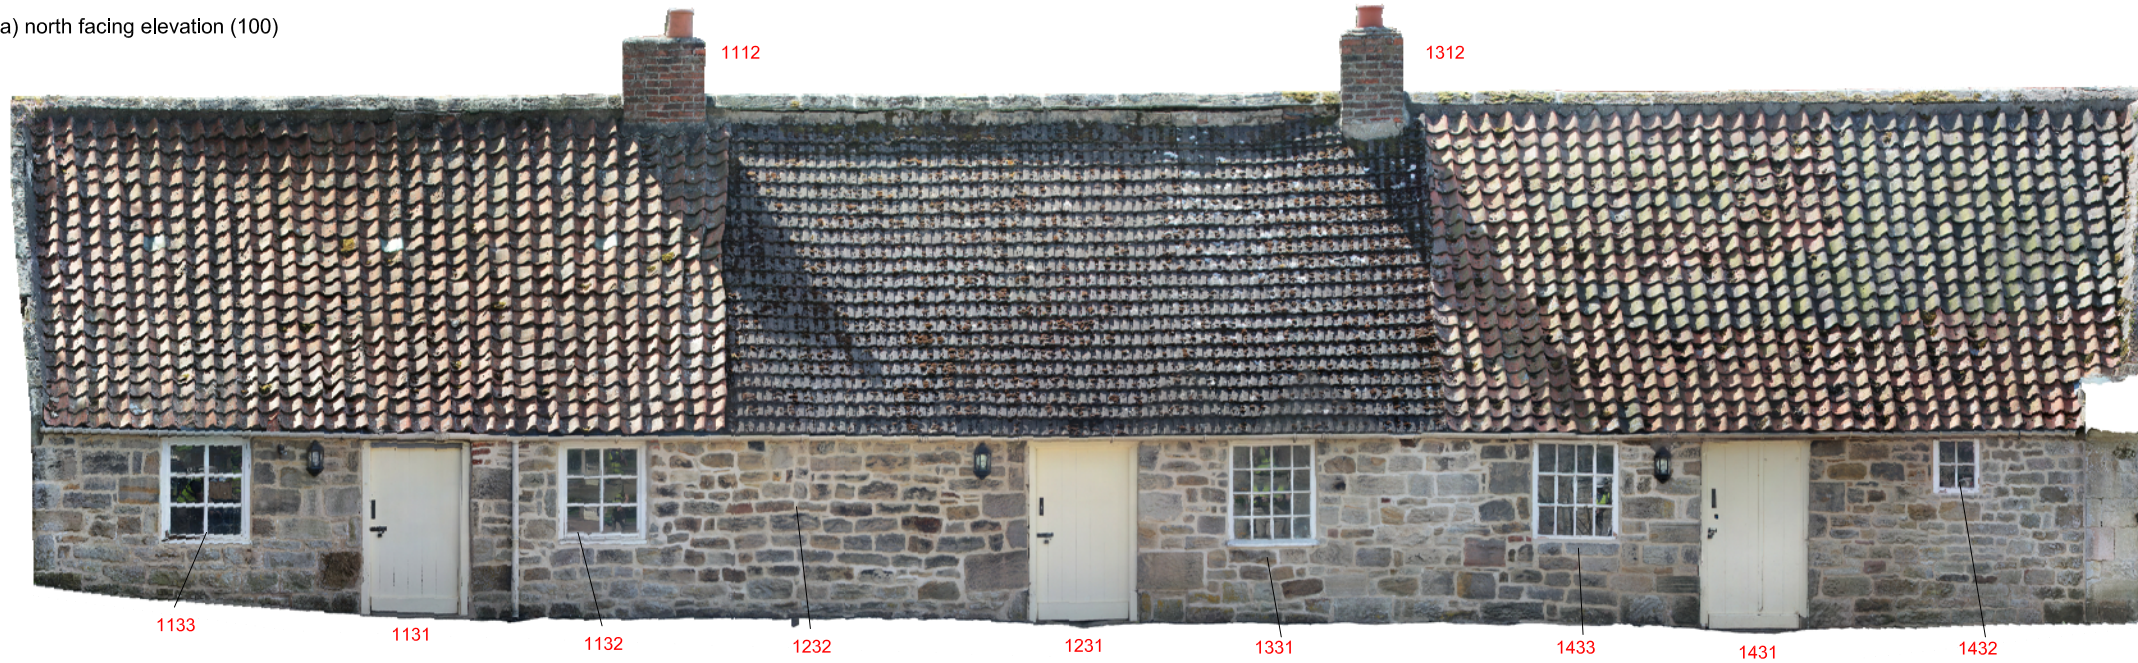
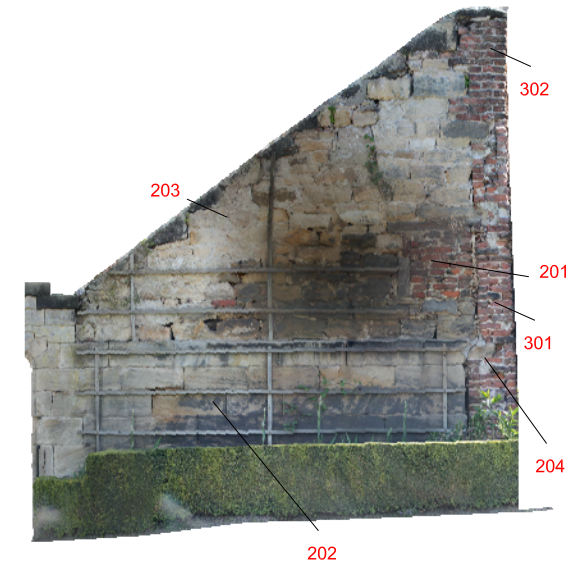
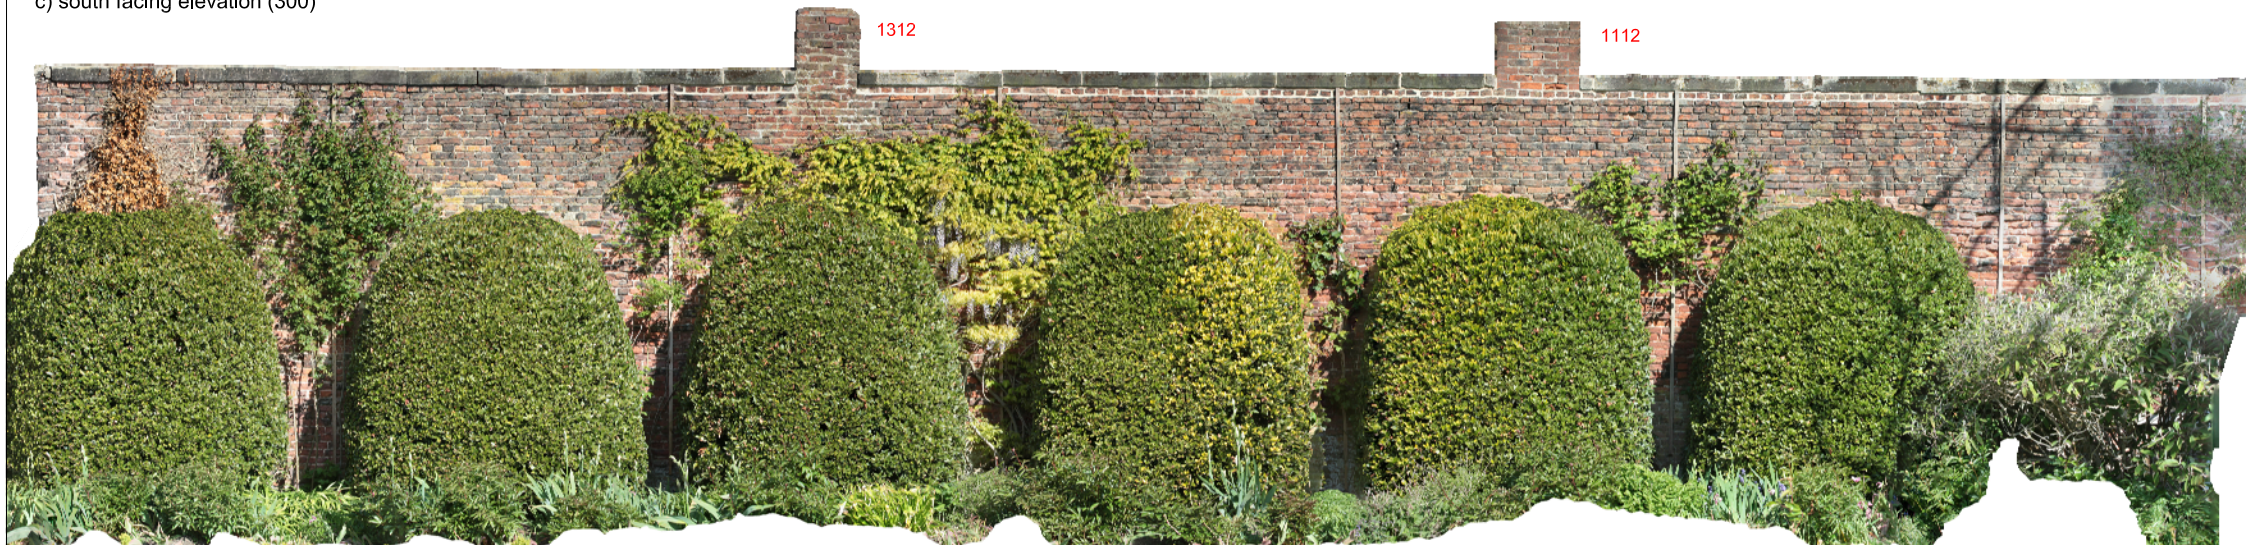
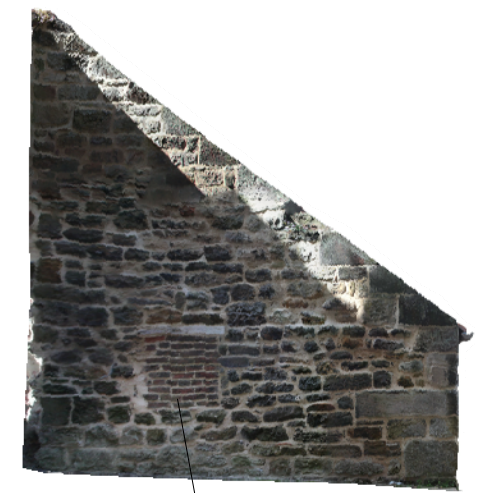
a) north facing elevation (100)

b) west facing elevation (300)

c) south facing elevation (300)

d) east facing elevation (400)

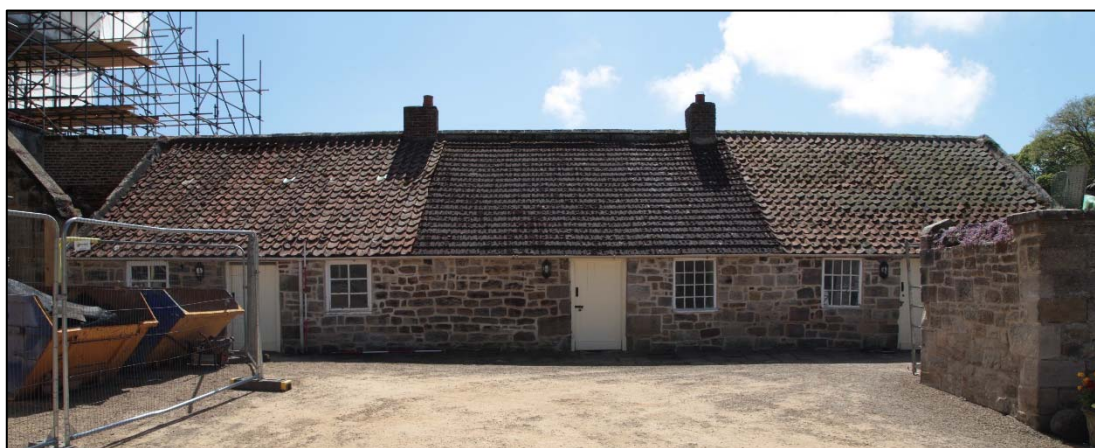
Plate 1: Front (north-facing) elevation of the Potting Shed looking south-east.

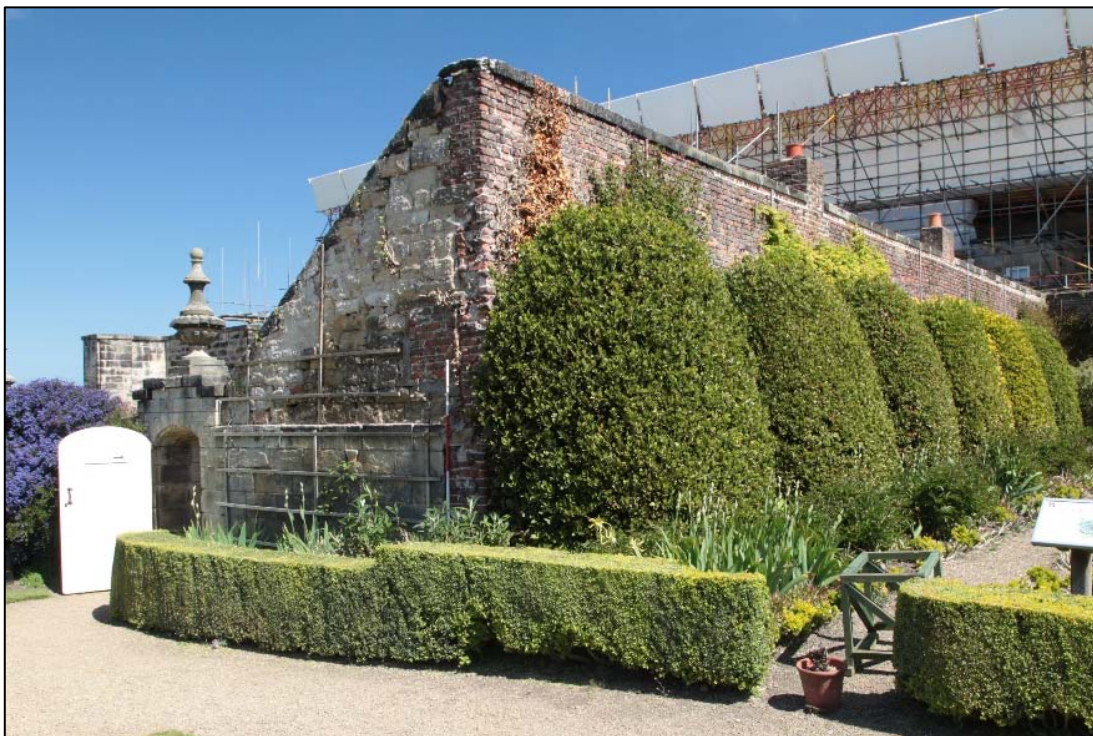
Plate 2: West- and south-facing elevations of the Potting Shed seen from the garden.

- 5.7 The west-facing elevation is the most interesting archaeologically with evidence of at least three phases of build (Plate 2). At the time of survey, a vine that usually covered the elevation had been stripped back to expose the wall and had caused some discolouration. The bottom part of the wall (202) is a continuation of the west boundary wall of the west court. This is built of close-jointed sandstone ashlar. Above is a section of coursed rubble-stone build (203) that extends up to the roofline and is contemporary with the main body of the building. Both of these phases are built up against the brick south wall (300), the line of which is clearly visible running the full height of the building. There is a single window or pitching hole (201) set halfway up on the south side of the elevation. This features a wooden lintel and has been in-filled with brick.

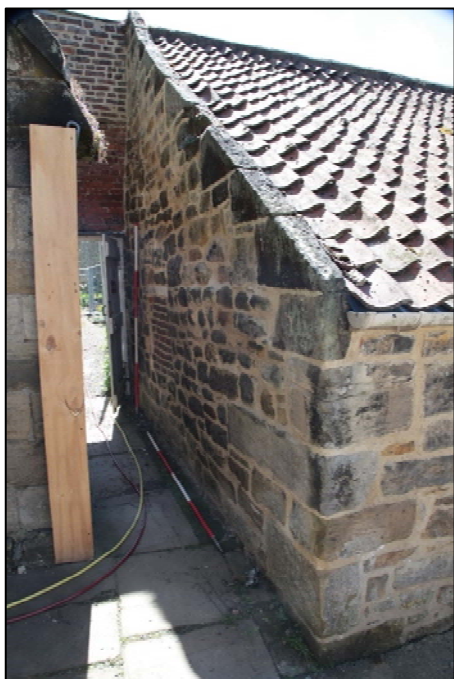
- 5.9 The lower section (301) extends to a height of c.4.25m above the current ground surface. It measures c.0.51m across at base and steps into a width of 0.37m at a height of 1.90m, resulting in an offset ledge on the north side only. This is capped with a curved coping stone that is clearly visible on the west elevation (204). The wider base provides

additional support for the free-standing wall and the offset also deflects away from the more vulnerable lower courses.

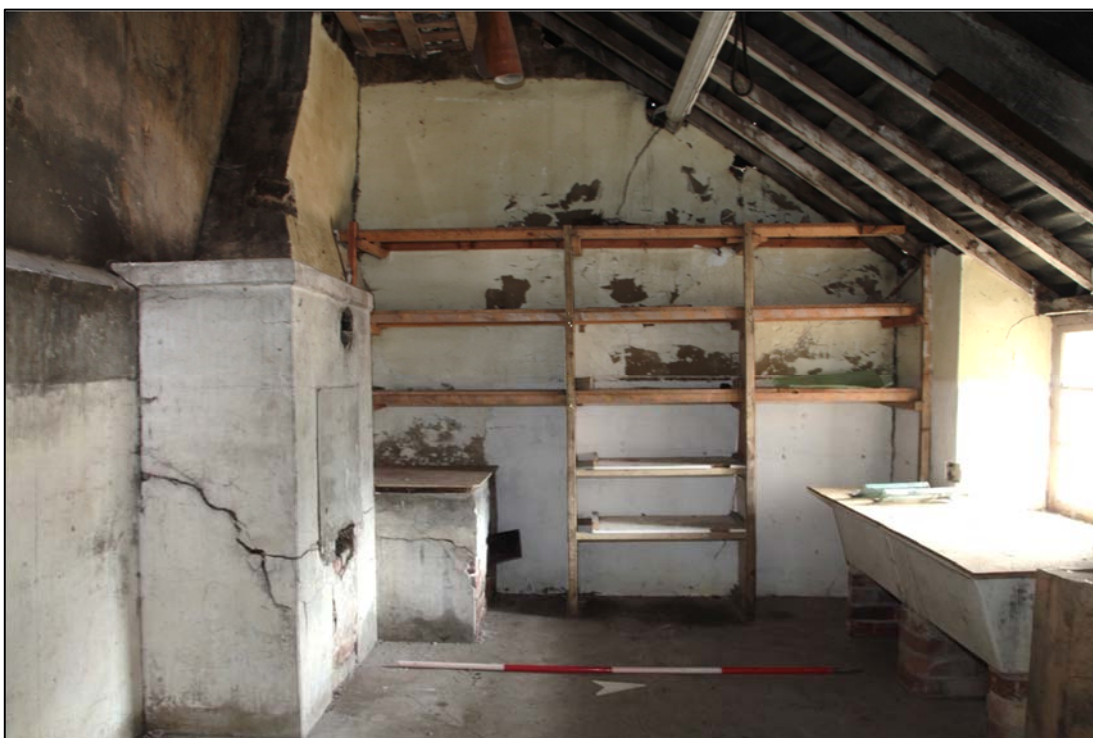
Plate 4: South-west 1120 wall of the east room.

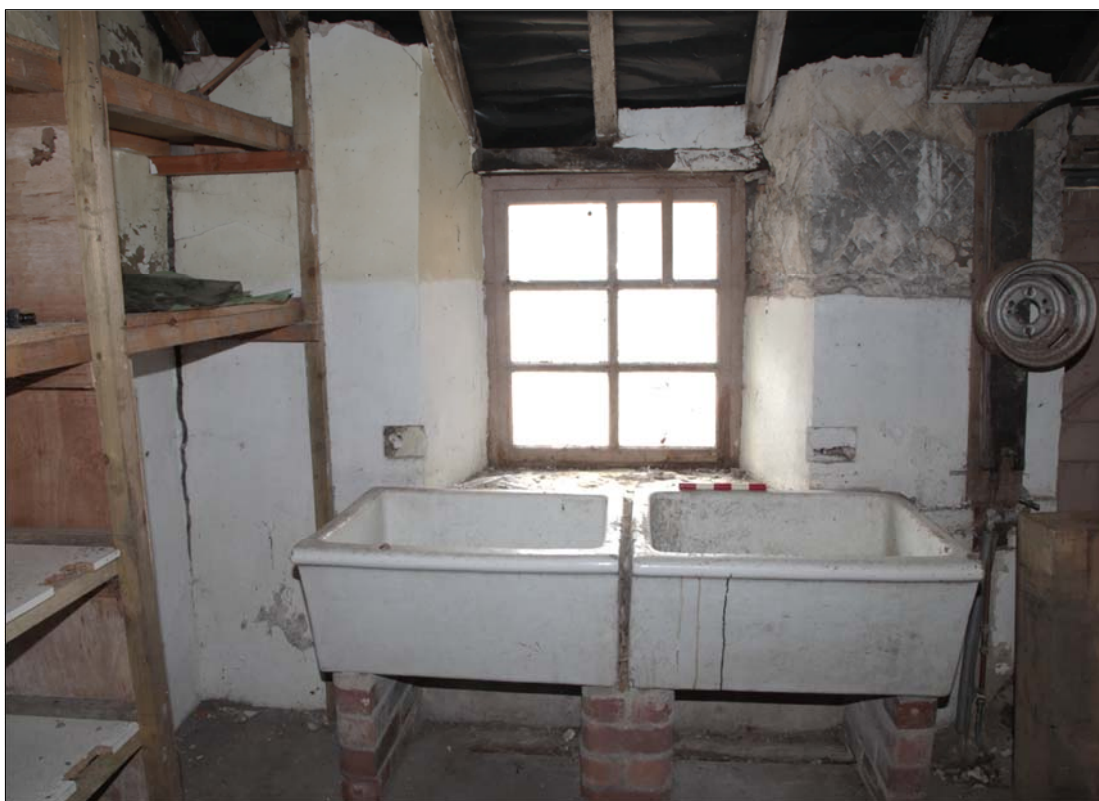
Plate 5: North wall (1130) of room (1100) showing the scullery sinks 1134 and window 1132.

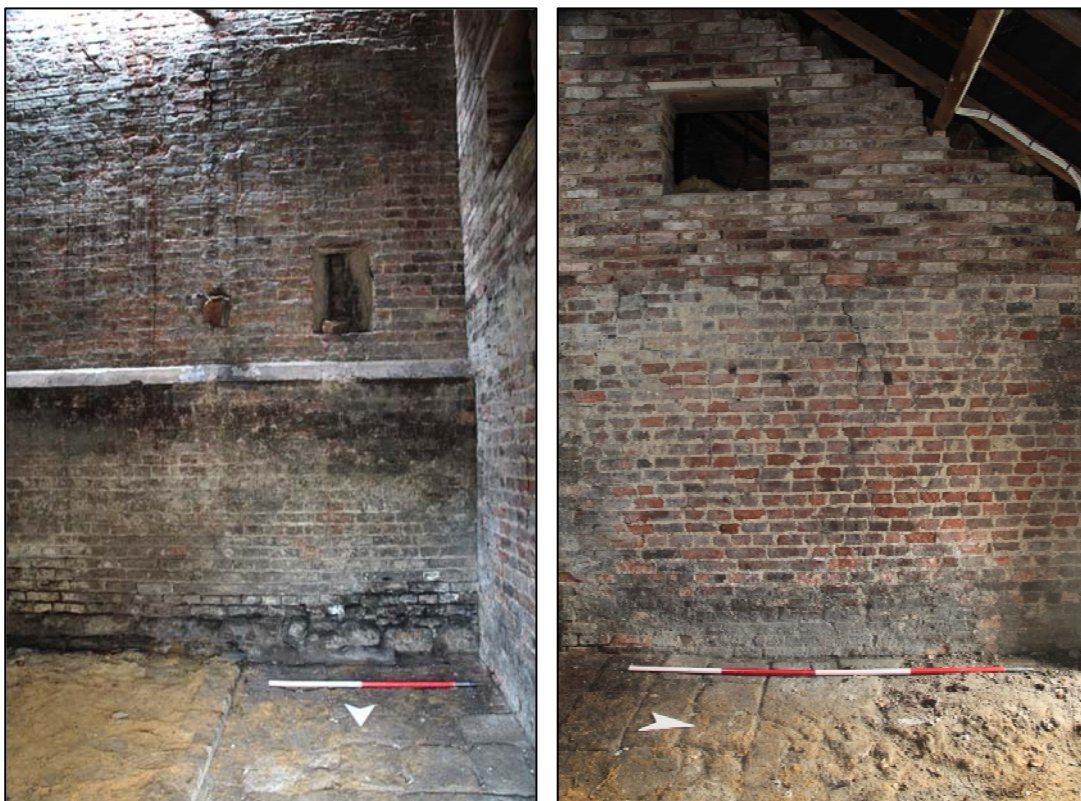
Plates 6 and 7: South wall of east-central room (left) showing the different floor surfaces and western ventilation slit (1213), and the western partition wall with first-floor opening (1221).

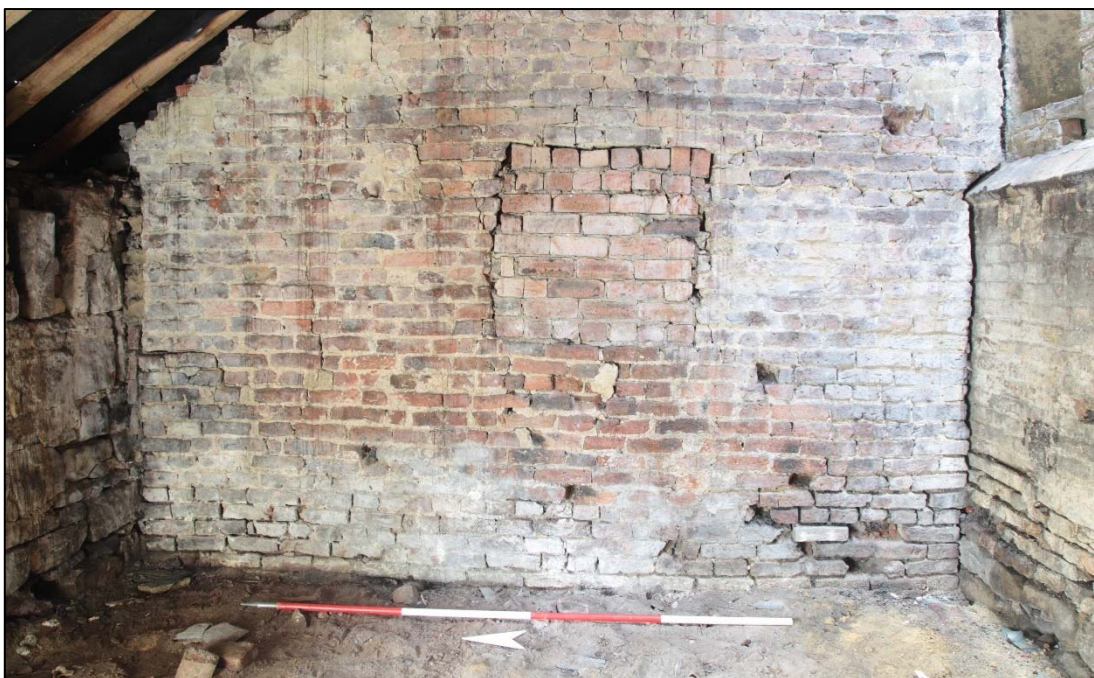
Plate 8: North-east elevation 1240 of the east-central room.

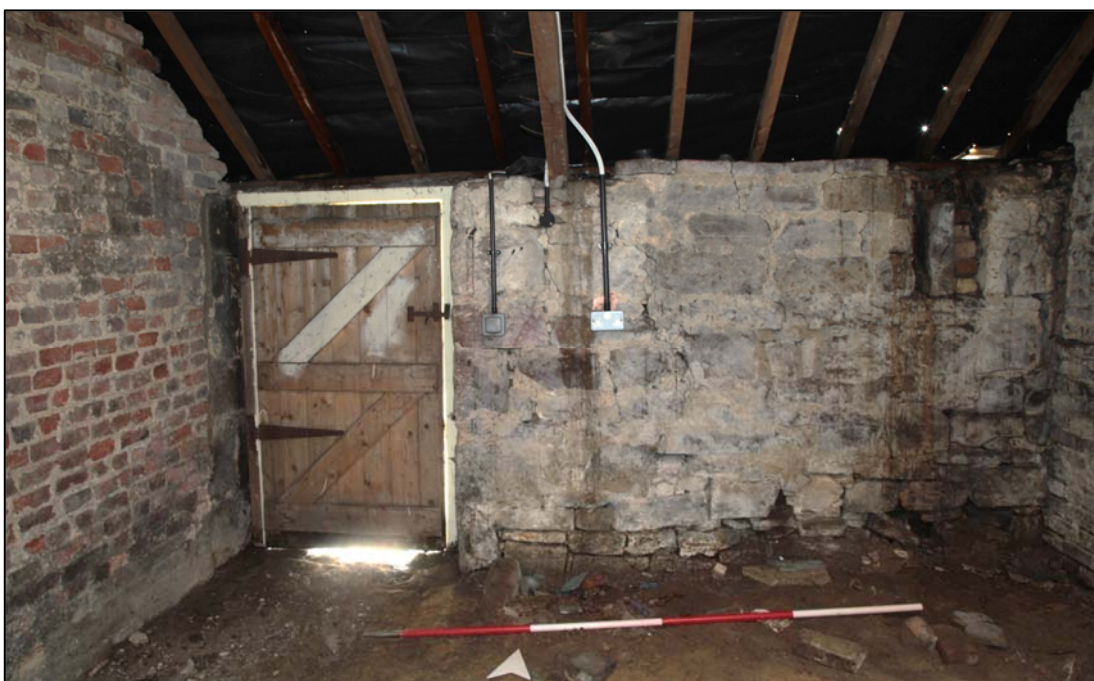
Plate 9: North wall (1230) of the east-central room with ventilation slot 1232 just visible on the right side of the image.

- 5.21 On the north wall (1230) is evidence of a third ventilation slot (1232), located to the east of door 1231. This has been loosely blocked with a combination of stone and brick (Plate 9).

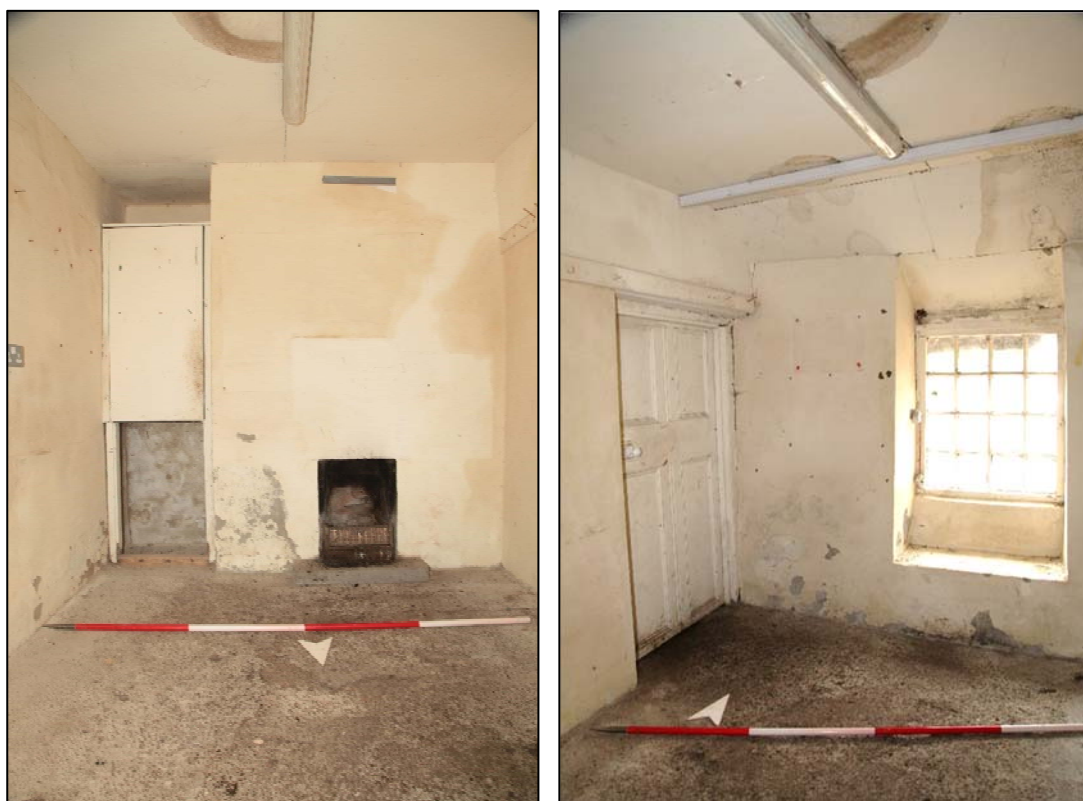
Plates 8 and 9: Rear wall (1310) of the west-central room (left) and west corner of the front wall (1330) of the west-central room (right).

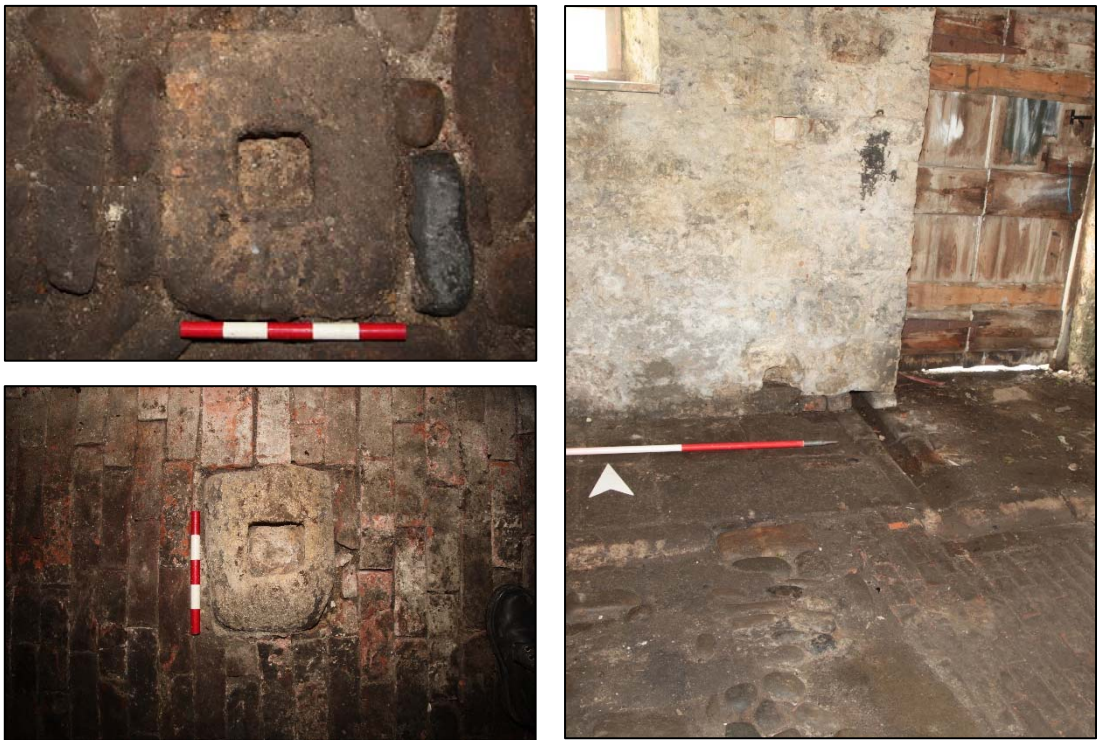
Plates 10-11: (upper left) post-base 1402 surrounded by cobbles; (lower left) post-base 1402 surrounded by brick; (left) the different floor surfaces visible on the north side of the room.

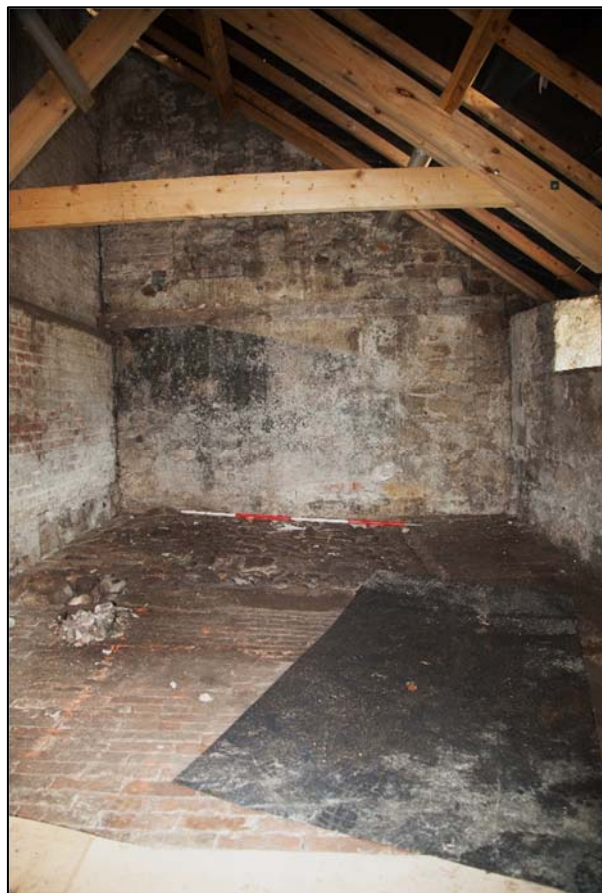
Plate 12: The south-east elevation. The blocked window is partially hidden by the truss.

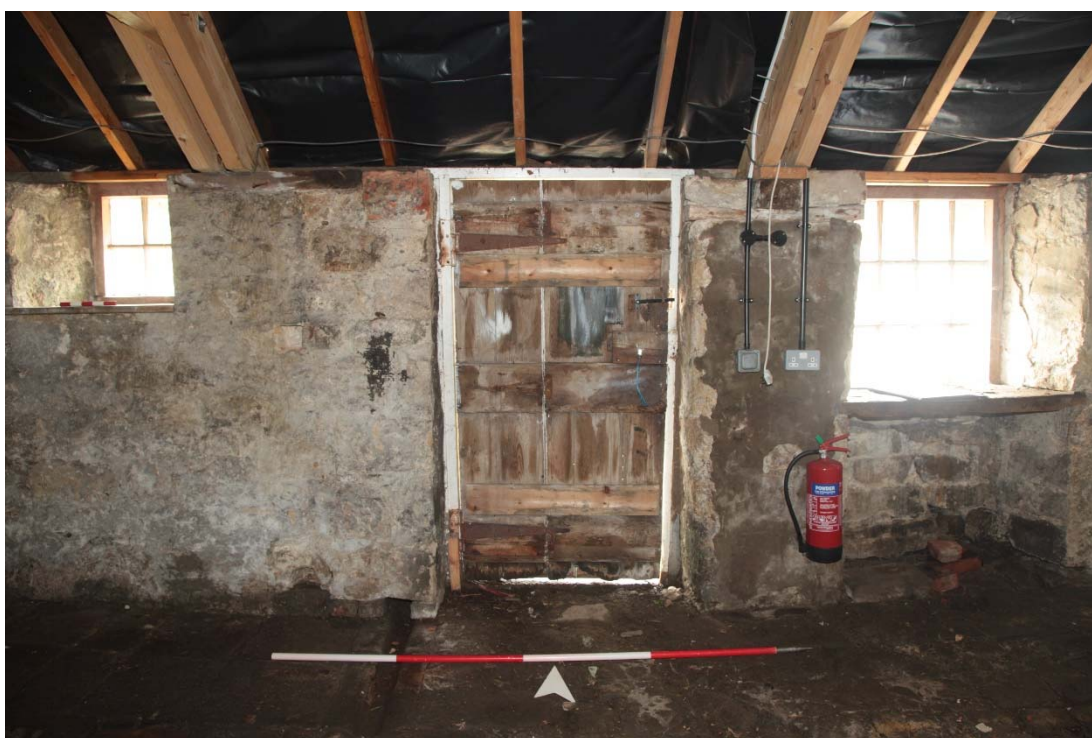
Plate 13: North-west wall 1430 of the west room.

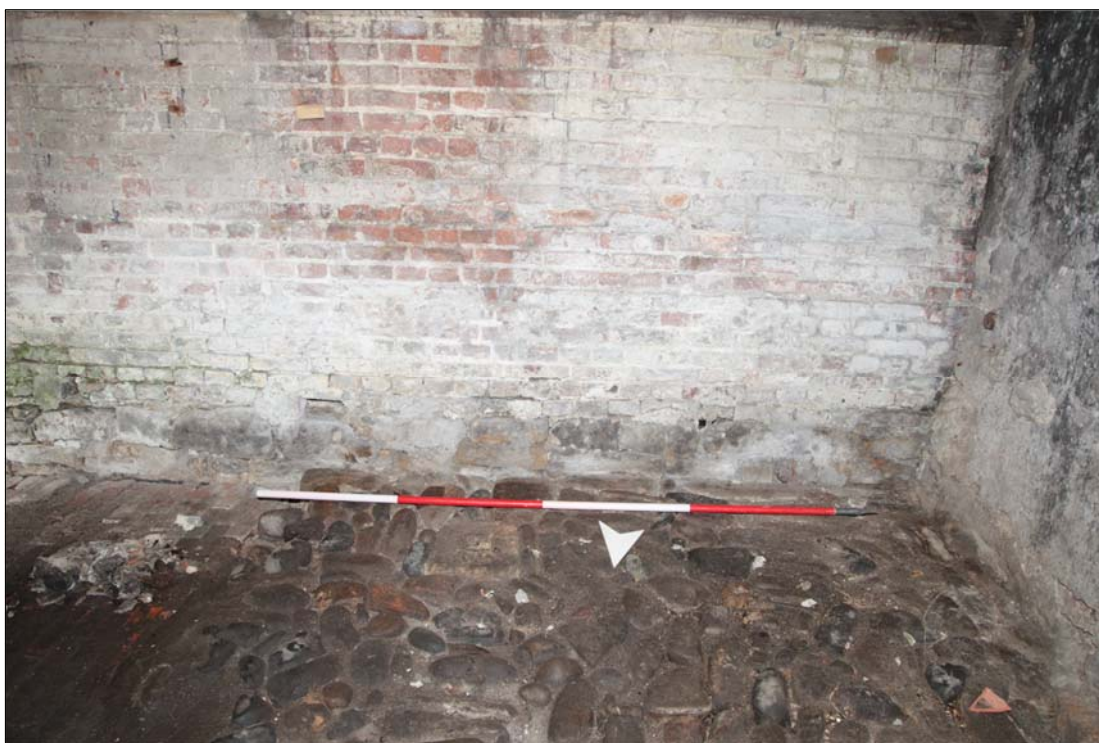
Plate 17: Foundation course (1413) of brick wall, visible in the south-west corner of 1400.

- 5.31 Similar to rooms 1100 and 1200 an offset ledge (1411) runs along the rear wall (1410). This features two notches, probably for stall divisions. The rear wall is of brick, but with stone footings (1413) visible along its length, extending to a height of c.0.4m. These were also recorded in room 1200 and are therefore likely to extend the full length of the building and are probably foundations for the brick wall. Set into the upper part of the west wall, near to the south-west corner, are several iron bolts (1421) of unknown function.

- 6.4 The oldest parts of the structure are the stone foundations (1413) observed beneath the south wall (300). These run along the whole of the south side of the building, although are exposed without render only in rooms 1200 and 1400. They are of rubble-stone construction and are likely footings for the brick structure above. This may date to the Tudor or Jacobean period, a time when brick was a costly and high-status building material in considerable demand. The stonework would have been a cheaper and more stable material for use in the foundations of the wall. The exposure of this course suggests that the internal floor levels of the building were considerably reduced when the Potting Shed was built, probably to provide for the addition of the hayloft.

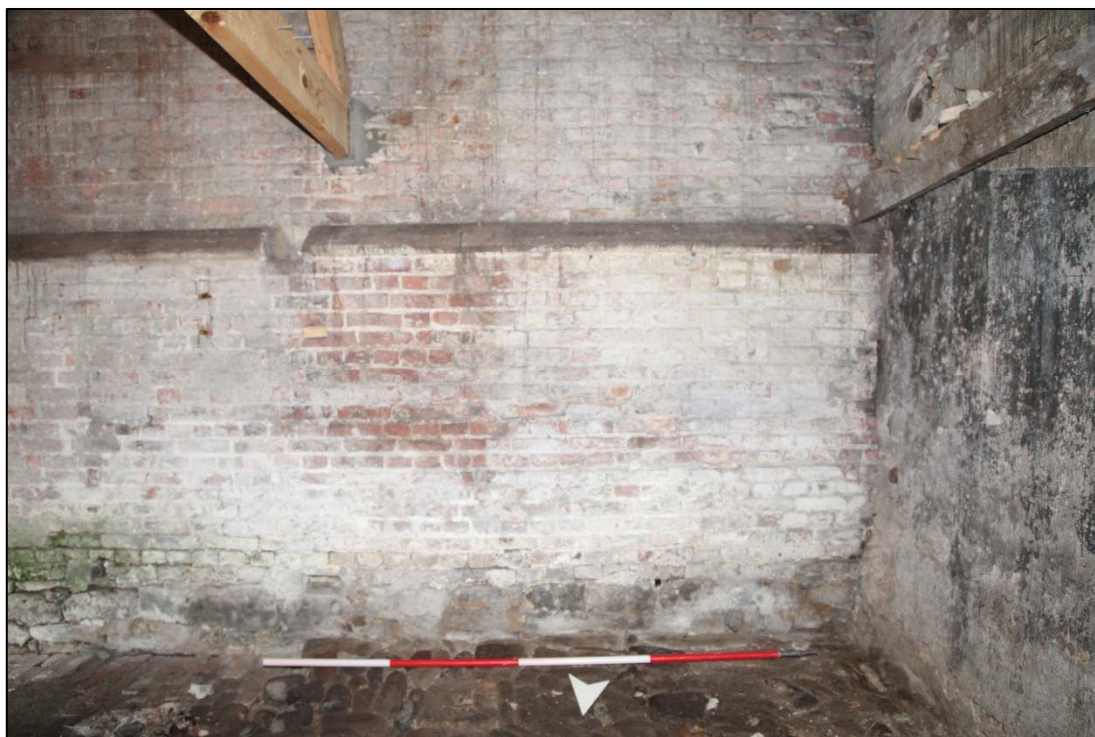
Plate 14: The rear wall of the Potting Shed (300) pre-dates the main building. Note the offset ledge that runs through the entire length of the structure.

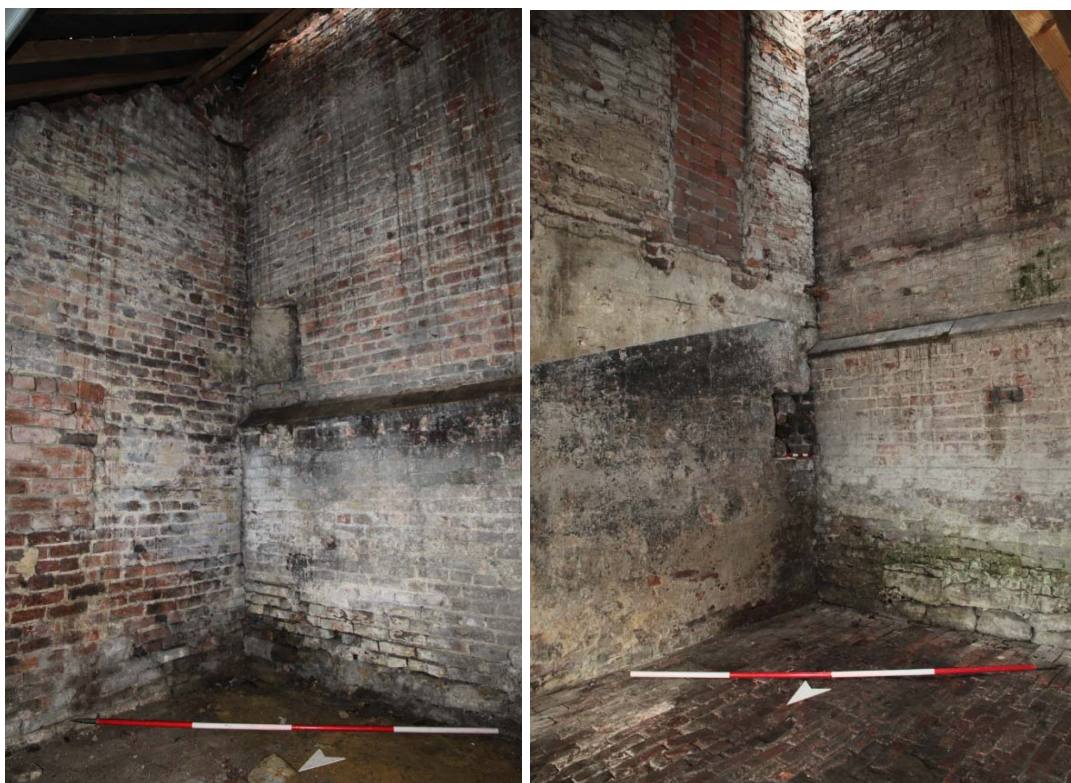
Plates 15: Later partition walls abutting rear brick boundary wall (300); (left) wall 1220 on the east side of room 1200, and (right) wall 1440 on the east side of room 1400.

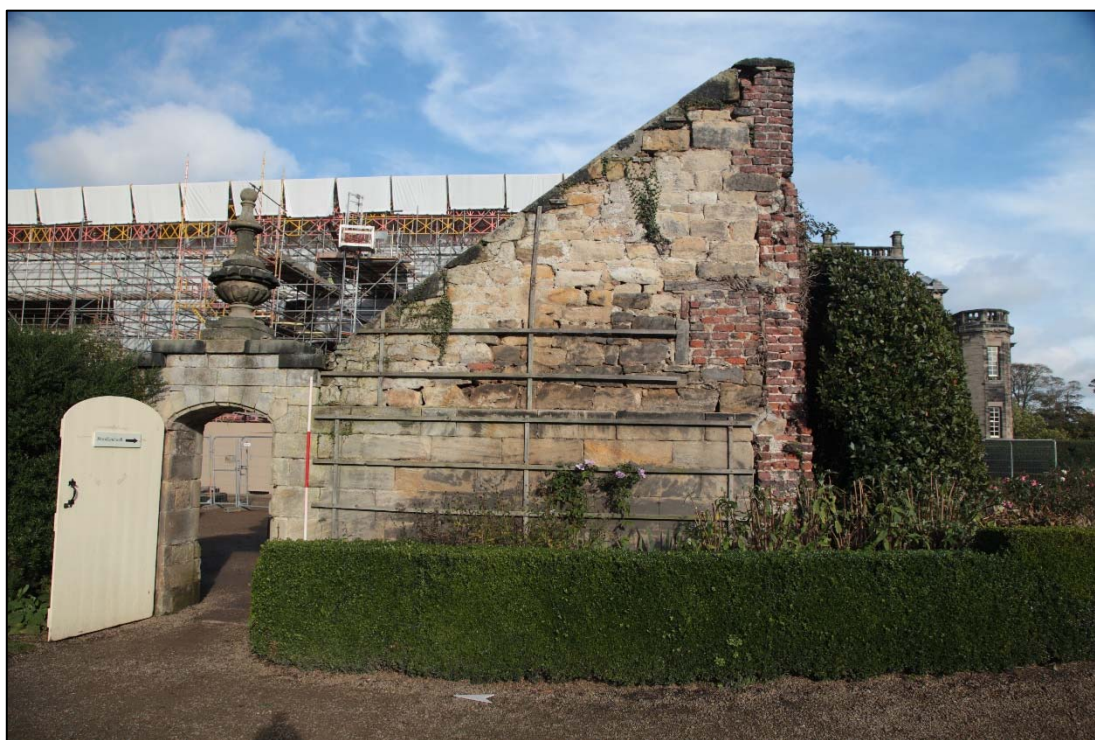
Plate 21: Clear evidence of stratigraphic phasing demonstrated in the west-facing elevation. The original redbrick garden wall (300) is abutted by the ashlar stone boundary wall (202) above which is the stonework (203) of the main structure.

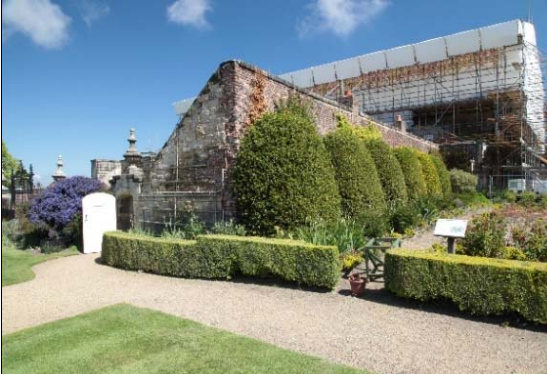
100	North-facing elevation	The front elevation of the building looks onto the west courtyard. The elevation is a single storey, with four windows and three doors. It is constructed of even coursed rubble-stone.	Mid-18th c.?	101 flag. paving 1112 E chimney 1133 E window 1131 E door 1132 CE window 1231 C door 1312 W chimney 1331 C window 1431 W door 1432 W window 1433 CW window	High – the north-facing elevation is the front of the building and, such as it is, the main public façade.

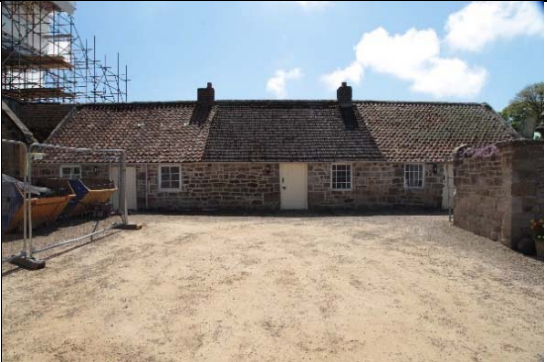
Name	Description	Phase	Related Features	Significance	Photo
101	Flagstone paving	Extends along the front of the building, measures c. 1.00m wide and is slightly concave to improve drainage.	Mid-18th c.?	100 N elevation	Moderate –historical and archaeological interest as part of the original fabric of the building.

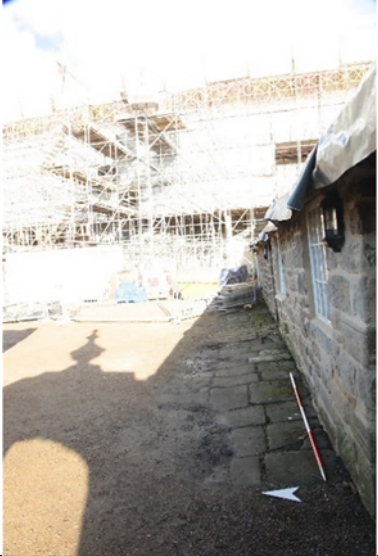
200	West-facing elevation	The west elevation faces onto the gardens. It is a mix of ashlar, rubble-stone, and brick construction. It incorporates evidence of two boundary walls and a blocked window or pitching hole.	E. to mid-18th c. with later modification	201 Blocked or pitching hole 202 Boundary wall 203 Upper section of stonework 300 S elevation 301 Later brickwork	High – this elevation has archaeological interest as it contains evidence of various phases of build. Very important in terms of understanding the sequence of development.

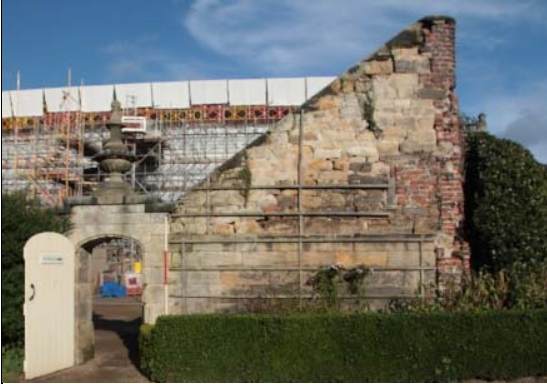
Name	Description	Phase	Related Features	Significance	Photo
201	Blocked window or pitching hole	Blocked window or pitching hole located above the ashlar boundary wall. Measures 0.72x0.63m. It is blocked with brick. Features a wooden lintel and surround.	Mid-18th – early 19th c.	200 W elevation 401 Blocked pitching hole	Moderate – archaeological interest in terms of the development of building.

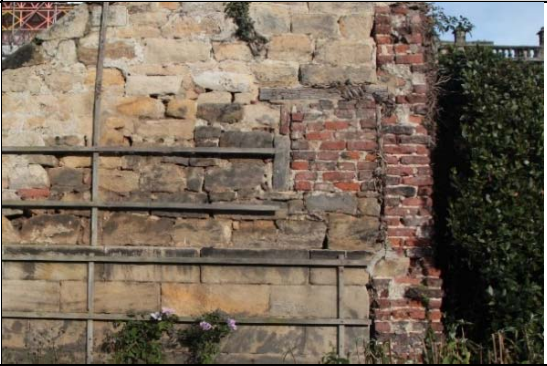
202	West court boundary wall	Sandstone ashlar boundary wall forming the lower section of the west-facing elevation. Abuts the rear brick wall of the building (300).	Early 18th c.	200 W elevation 300 S elevation	High – high archaeological interest providing the only clue as to the second phase of construction.	See 200
203	Upper section of stonework	Section of rubble-stone wall that sits above the earlier ashlar boundary wall (202) and forms the west gable of the building. Stonework is contemporary with the rest of the structure.	Mid-18th c.	100 N elevation 300 S elevation 400 E elevation 201 blocked opening	High – high archaeological interest as part of the main structure. Especially important as it established the sequence of build.	See 200

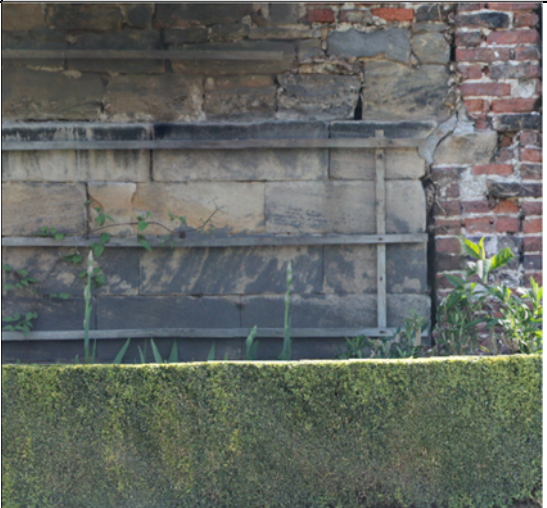
300	South-facing elevation	A brick boundary wall which now forms the north side of the rose garden. Extends the whole length of the building. Built in two stages.	c. late 16th/17th c. to mid-18th c	301 Lower section 302 Upper section 1111 Ledge 1112 Chimney 1211 Ledge 1212 E blocked vent 1213 W blocked vent 1312 Chimney 1411 Ledge	High – this structure has high archaeological and historical interest as one of the oldest structures in the Seaton Delaval complex, pre-dating the current hall.

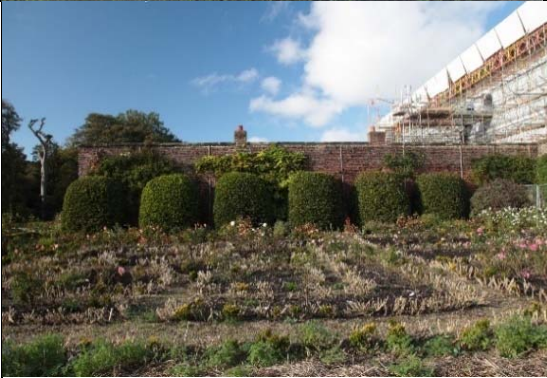
301	Lower section of brick wall	Stands 4.25m high and measure 0.51m wide at base, narrowing to 0.7m at 1.90m high. Built of handmade red brick set in English garden wall bond.	c. late 16th/17th	300 S elevation 302 Upper section 204 Offset ledge	As above	See 200

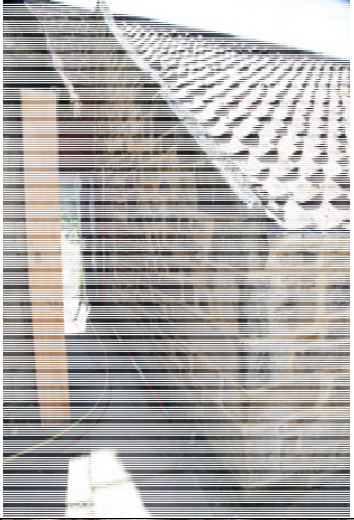
401	Blocked window or pitching hole	Measures c. 0.75x0.6m. With wooden lintel. Appears to be a later insert into the east-facing elevation.	Late 18th c to 19th c.	400 E elevation 201 Blocked window	Moderate – has some archaeological interest in terms of the sequence of development.

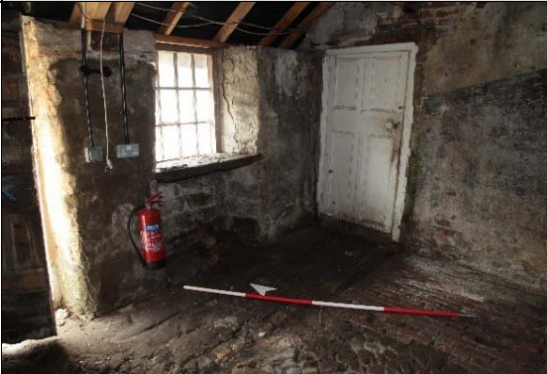
1100	East room	The east room is utilitarian in nature. It features a scullery sink along the north wall an incinerator, copper and shelving. The render-covered walls and concrete floor may obscure archaeological features.	Mid-18th – modern	1101 Roof 1102 Drain 1110 S wall 1120 W wall 1130 N wall 1140 E wall	Moderate – the archaeological interest in this room is minimised by the more recent additions and rendered walls.

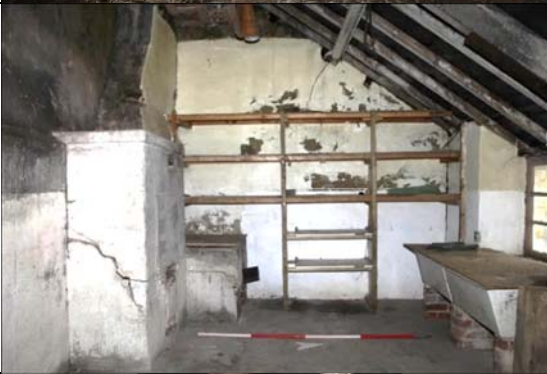
1101	Roof of east room	Though it appears to be a more modern roof, this roof structure is the only one that remained at the time of survey. Below the roof, along the rear wall was a low platform used for storage.	20th c.	1100 E room	Moderate-low – as the only remaining roof it has archaeological interest. Yet the structure is fairly modern and was put in place during a recent phase of modification.

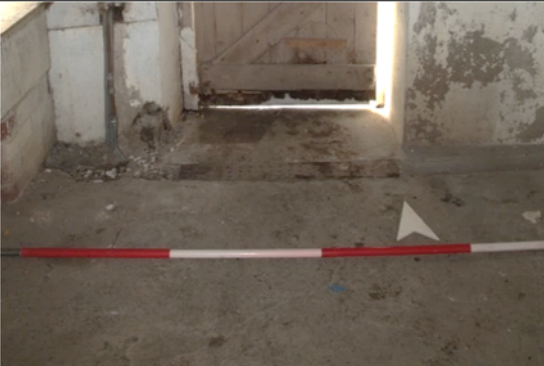
1110	South wall of east room	The south wall is brick but is rendered over, potentially obscuring some archaeological features. The ledge along the wall is associated with the historic boundary wall. An incinerator and chimney breast abut the wall.	16th/17th c. later mods.	1100 E room 1111 Ledge 1112 Chimney breast 1113 Incinerator 1210 CE room S wall 1310 CW room S wall 1410 W room S wall	High – this wall is one of the few historical structures that predates the Hall and therefore has high historical and archaeological interest.

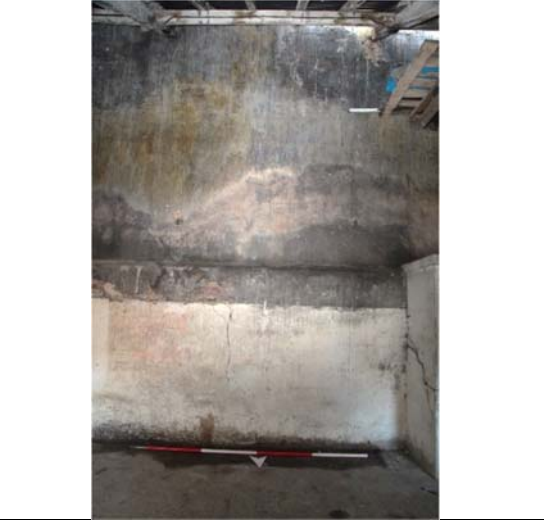
1111	Ledge	A plastered ledge appears along the full length of the building. It measures 0.15m wide and is located 1.7m from the current floor surface.	l.16th/17th c.	300 S elevation 1211 Ledge 1411 Ledge	High – the ledge forms part of the late 16th or 17th century boundary wall and as such is of considerable archaeological interest.	See above

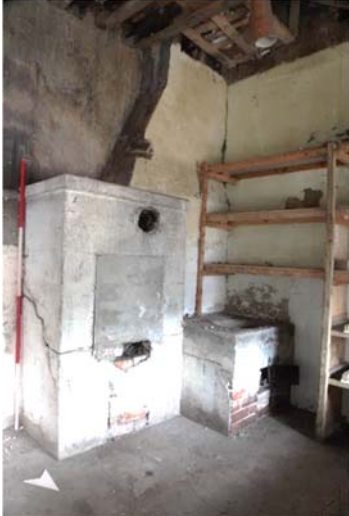
1113	Incinerator	The incinerator is 0.8m high, 0.6m wide and 1.26m long. It connects to the chimney behind it. It had a large central opening 0.6x0.75m that is now blocked. Below this, a stoke hole 0.3x0.5 is blocked with brick and stretches down to the floor. A round opening 0.2m in diameter is in the upper right corner, probably for a flue.	Modern	1110 S wall 1112 Chimney breast	Low – the addition of the incinerator provides some information as to the most recent use of the room.

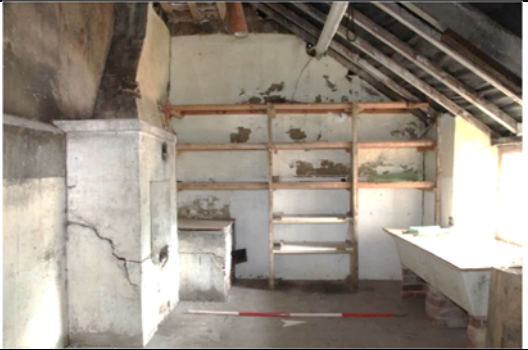
1121	Copper	Located in the south-west corner of the wall is a copper for boiling water or mash. Constructed of brick at base with stoke hole measuring 0.45x0.26m. The upper part is of concrete with a copper that is 0.44m in diameter and 0.32m in depth.	Late 19th – e 20th c	1120 W wall 1112 Chimney breast	Moderate – has some archaeological and historic interest in terms of the later function and use of the range.

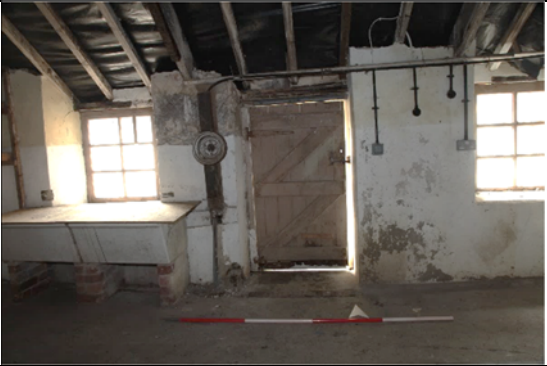
1131	East door	This large doorway is 1.06m wide and 2.06m high, the wall is 0.54m thick. The door frame has a wooden lintel and the door is a plank and batten design. Evidence above of the lowering of the wall plate.	Mid-18th – modern	1130 N wall 1231 C door 1431 W door	High-moderate archaeological interest.

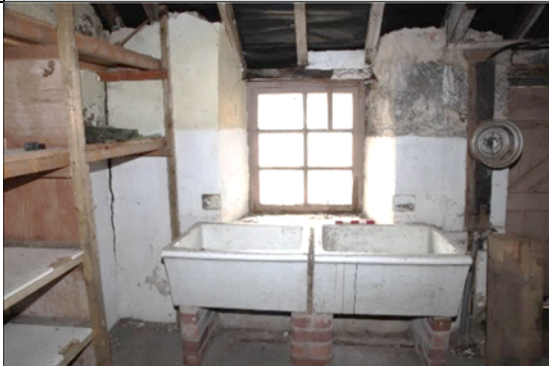
1133	East window	6-light Fixed-pane window. Measures 0.89m wide and 1.35m high. It has a splayed revealed.	Mid-18th – 19th c.	1130 N wall 1132 CE window	Moderate – This window is possibly part of the original structure of the building and therefore has marked archaeological and architectural interest.
