HISTORIC BUILDING RECORD

NATIONAL TRUST
SEATON DELAVAL HALL
NORTHUMBERLAND

NAA 20/30
March 2020

THE POTTING SHED, SEATON DELAVAL HALL, NORTHUMBERLAND: HISTORIC BUILDING RECORDING

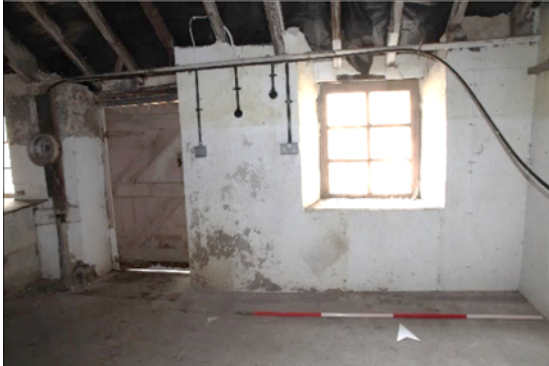
1134	Sinks	Two large scullery sinks are supported on three brick piers. The exterior two plinths are 0.11m and the central plinth is thicker at 0.23m and 0.35m high. Each sink is approximately 0.6mx0.6m and 0.3m deep.	Modern	1130 N Wall	Low-moderate – the addition of the sinks provide some information as to the most recent use of the room.

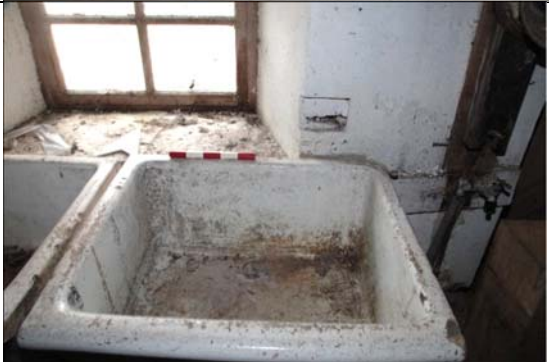
Name	Description	Phase	Related Features	Significance	Photo
1135	Notches	Two notches line the central-east window. The notches are 0.12x0.06m and 0.01m deep. It is uncertain what purpose they served, but they appear to have been filled in.	Late 19th – Modern	1130 N Wall 1132 CE window	Low – these notches contribute little to our understanding of the historical development of the building.	See above
1136	Planks and fittings	A plank of wood is mounted on the wall behind the sinks and connects to another that runs vertically along the door. This is a splashback for the sink and mounting for the taps	Modern	1130 N wall 1134 Sinks 1131 E door	Negligible – these fittings are not related to the archaeology or historical use of the building but simply reflect its current usage.	See 1133 and 1134
1140	North wall of east room	This wall has been plastered over, but likely holds evidence of the blocked pitching hole beneath the render. Three evenly spaced holes along the wall may be associated with the former hay loft.	Phase 3-5	1100 E room 401 Block forking hole	Low-moderate – this wall contributes little to our understanding of the historical development of the building.

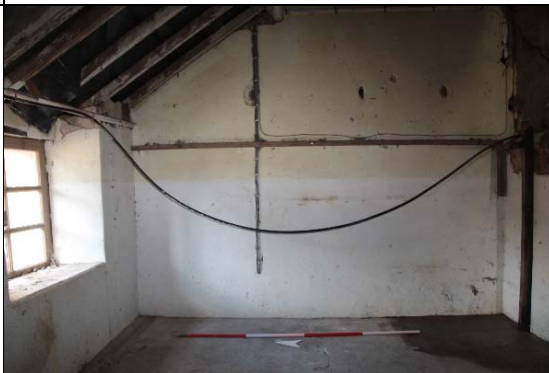
1141	Joist holes	These evenly spaced holes along the wall may indicate the presence of some sort of partition or floor, though the holes do not seem large enough to hold much weight.	Mid-18th – 19th c.	1100 E room 1422 Joist holes 1443 Joist holes	Moderate – these have a degree of archaeological interest in terms of understanding the layout of the original building	See above

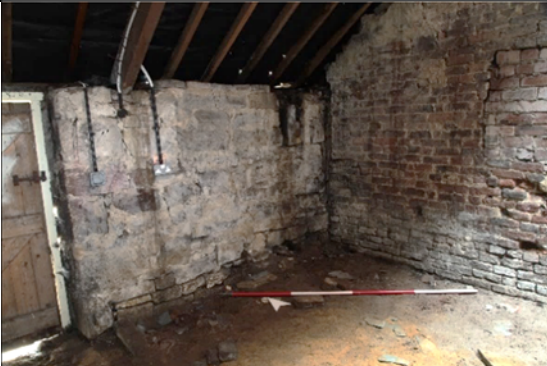
Name	Description	Phase	Related Features	Significance	Photo
1200	Central-east room	This room is poorly lit due to a lack of windows. The floor is divided, on side is beaten earth and on the other is a flag surface with drain.	Mid-18th – 19th c.	1201 Floor partition 1202 Flag. surface 1210 S wall 1220 W wall 1230 N wall 1240 E wall	High – this room has archaeological and historical interest in terms of the function and later development of the building.

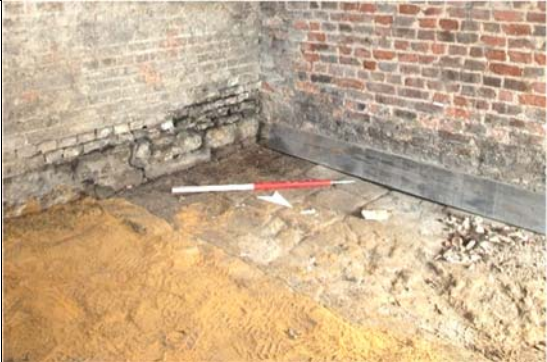
1201	Floor partition	This partition in the floor is formed by stones placed on their sides. These stones rise 0.08m above floor level create a partition 0.19m wide.	Mid-18th – 19th c.	1200 CE room 1202 Flag. surface	High – archaeological interest in terms of the layout and use of the building.

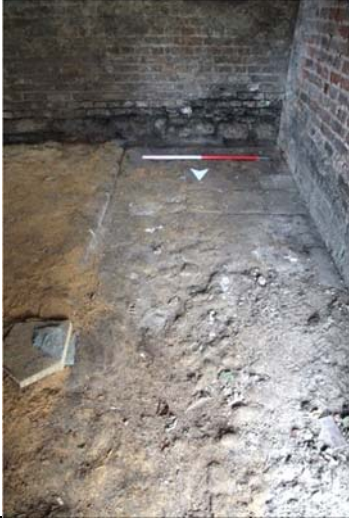
Name	Description	Phase	Related Features	Significance	Photo
1202	Flagstone surface	The western third of the room has a paved surface separated from the remainder of the floor by the floor partition (1201). This flagstone surface is 1.4m wide and has a slight dip running the length of the floor toward the door, creating a drain.	Mid-18th – 19th c.	1201 – Floor partition	High – archaeological interest in terms of the layout and use of the building.

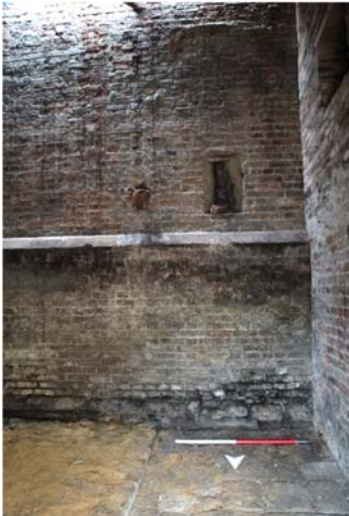
1210	South wall of east-central room	This wall is of brick with a ledge that runs across the whole length. It has two blocked ventilation slits inserted at a later phase. The brick wall lies above stone foundations. The wall is 4.52m tall, with the stone foundations rising 0.26m above the floor surface (see 1413).	16th/17th c. later mods.	1211 Ledge 1212 E vent 1213 W vent 1110 E room SE wall 1310 CW room SE wall 1410 W room SE wall 1413 foundation course	High – this wall is one of the few historical structures that predates the Hall and therefore has high historical and archaeological interest.

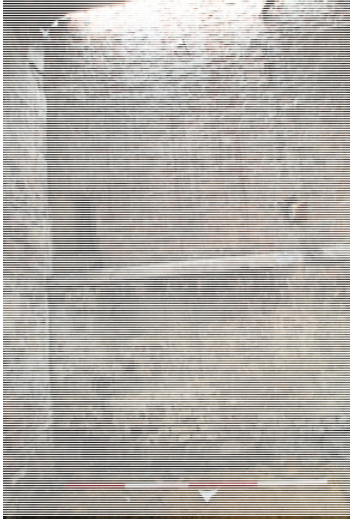
Name	Description	Phase	Related Features	Significance	Photo
1211	Ledge	Ledge with stone coping. It has a notch that has since been filled and may have originally held a manger support. The Ledge is 0.13m wide is located 1.70m above the floor surface.	16th/17th c. later mods.	1210 E wall 1111 Ledge 1411 Ledge	High – associated with the original boundary wall and therefore of high historical and archaeological interest.	See above
1212	East ventilation slit	Ventilation slit that has now been blocked with small bits of brick. It lies flush with the east corner of the room. It is splayed with an initial width of 0.45m and thinning to 0.14m. The vent has a height of 0.61m	Mid-18th c.	1210 S wall 1213 W vent 1232 Front vent. slit	High – archaeological interest in terms of the layout and use of the building.

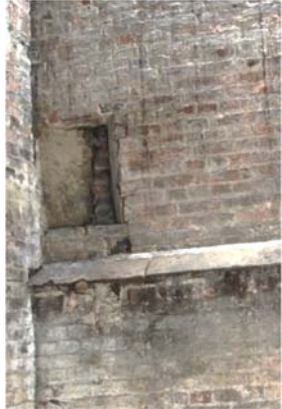
Name	Description	Phase	Related Features	Significance	Photo
1214	Timber or joist	The end of a timber sticking out of the wall above the ledge. Probably associated with a manager or hay rack structure or could relate to part of the roof structure. Projects out of the wall 0.23m and is 0.11x0.2m.	Mid-18th c.	1210 S wall 1422 Joist holes 1442 Joist holes	Moderate – archaeological interest may help understand the development of the building but function currently unclear.	See 1212
1215	Small hole	A small square hole of uncertain purpose lies just below the east ventilation slit and above the ledge. It is 0.15x0.11m with an unknown depth.	Uncertain	1210 S wall 1211 Ledge 1212 E vent	Moderate – archaeological interest may help understand the development of the building but function currently unclear.

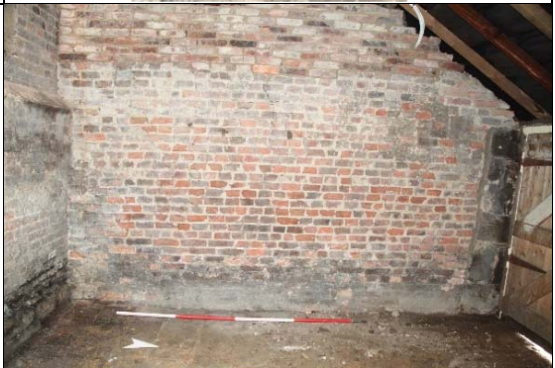
1220	South wall	Partition wall constructed in two phases. There is a small pitching hole in the upper level.	Mid-18th – 19th c	1221 pitching hole.	Moderate – this elevation has the potential to inform our archaeological understanding of the building's development.

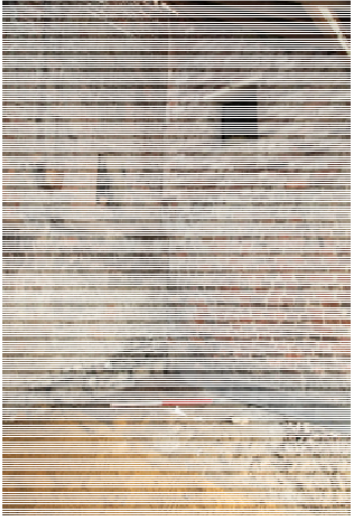
Name	Description	Phase	Related Features	Significance	Photo
1221	Pitching hole – hayloft access.	A small pitching hole is located 2.64m above the floor level. It is approximately 0.6x0.6m and has a wooden lintel.	Mid-18th – 19th c	1220 S wall 1300 CW Room	Moderate – the feature is of archaeological interest and provides a greater understanding of the development and use of the building.

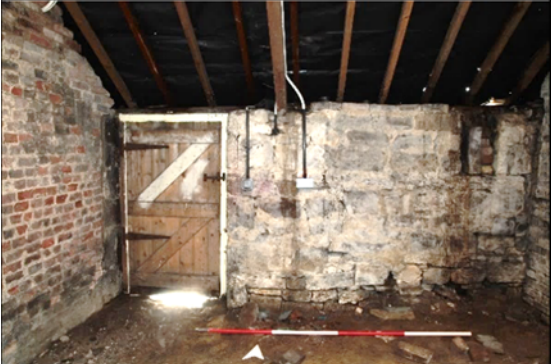
1230	North wall	Front wall of the room. Includes the main door and a small blocked ventilation slit. The wall appears to have been lowered to the level of the doorframe.	Mid-18th – Modern	1231 C door 1232 Front vent. slit	High – archaeological and architectural interest. Provides a greater understanding of the layout, development and use of the building. Also of some architectural value as part of the main façade of the building.

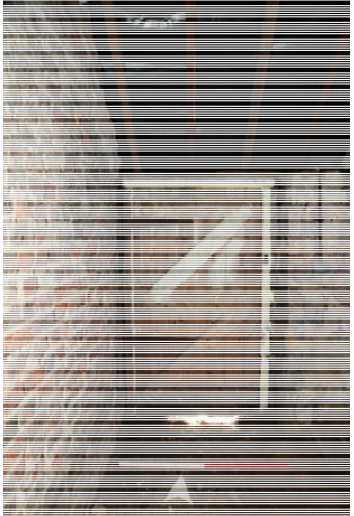
1232	Blocked ventilation slit.	Blocked ventilation slit on north wall. Measures 0.3m wide and 0.5m high.	Mid-18th c	1212 E vent. slit 1213 W vent. slit	High – archaeological interest in terms of the layout and use of the building.

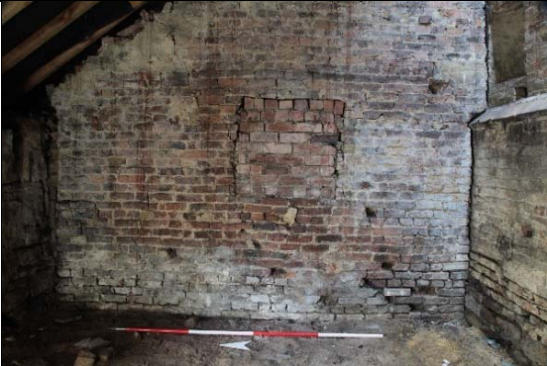
Name	Description	Phase	Related Features	Significance	Photo
1240	North wall	Brick partition wall with a large blocked opening and a metal peg in the upper south corner.	Mid-18th – modern	1241 Blocked hatch hole 1242 Metal bolt	High – high archaeological interest in terms of the original layout of the building and subsequent changes of use.

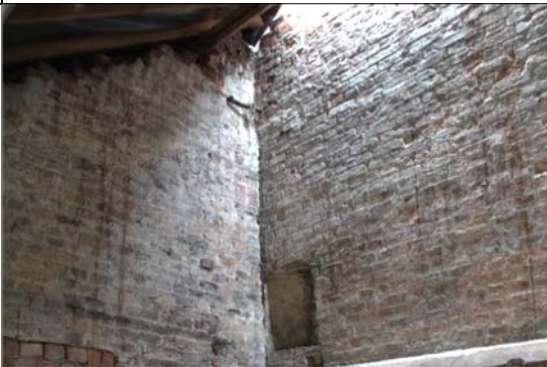
1241	Blocked hatch	Blocked hatch. Possibly a pitching hole but seems unlikely, Measures 0.83x0.85m and stands 1.06m above the floor level. Is a later insert,	La. 19th-early 20th c	1240 N wall	Moderate – degree of archaeological interest in terms of the later use of the building.	See above
1242	Metal bolts	Metal bolts stick out of the wall in the upper south corner. The use of is unknown.	Uncertain	1240 N wall	Low – these bolts contribute little to our understanding of the building. Significance may alter with more information.

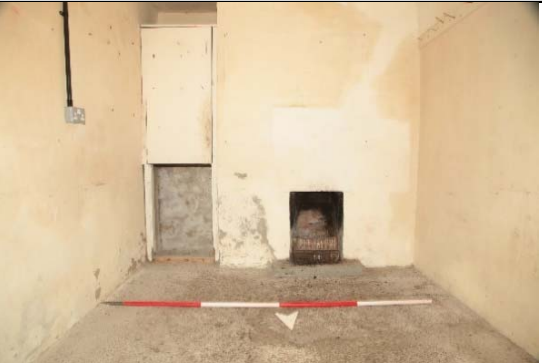
Name	Description	Phase	Related Features	Significance	Photo
1300	Central-west room	This room is smaller than the others and fully covered in modern plaster, obscuring any evidence. It has a fireplace, chimney breast, and large window. It is lower than the other rooms at 2.35m with a suspended ceiling.	19th c – modern	1310 S wall 1320 W wall 1330 N wall 1340 E wall	Moderate-high – has archaeological interest in terms of the later development of the building. Also of historic interest in the terms of domestic use.

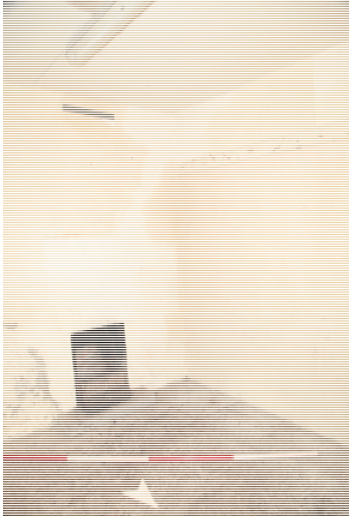
Name	Description	Phase	Related Features	Significance	Photo
1313	Fireplace	The fireplace is not ornate and is 0.2m deep and 0.5m high, running 0.45m across. In front is a small hearth, 0.8m high, 0.25m deep and 0.74m across.	Modern	1310 S wall 1312 W chimney breast	Low – recent introduction but may obscure and earlier hearth. Worth further investigation if removed.	See 1300
1314	Wooden tie	A single wooden tie lies across the chimney near the ceiling. Its use is unknown, and it measures c. 0.45m across.	Uncertain	1310 S wall 1312 W chimney breast	Negligible – the tie does little to contribute to our understanding of the building.

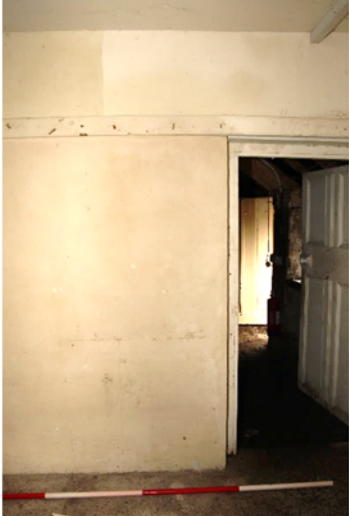
Name	Description	Phase	Related Features	Significance	Photo
1320	West wall	The west wall is plastered and contains the door leading into room 1400. A single board runs the whole length of the room at the height of the top of the door.	L 18th – 19th c?	1300 CW room 1321 Door 1322 Board	High – high archaeological interest in terms of the original layout of the building and subsequent changes of use.

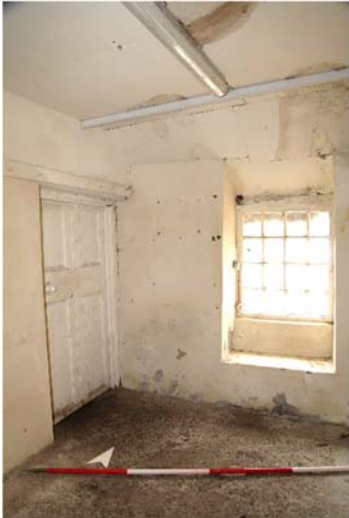
1321	Door	The door is 1.04m wide and opens into the west room. It lies flush with the north-west corner of the wall. The door is a four-panelled wooden door which is late 19th – early 20th c. in date	19th – modern	1320 W wall 1322 Board	Moderate – The door has some archaeological and historical interest as part of the changing use and layout of the Potting Shed. Also of some architectural value as part of the main façade of the building.

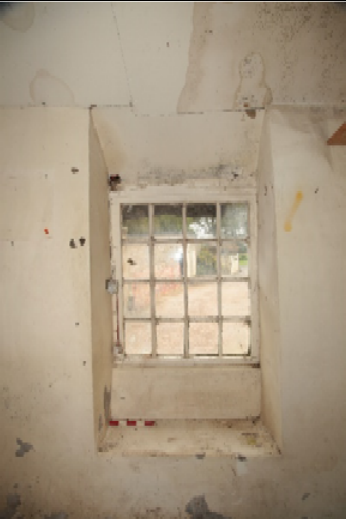
Name	Description	Phase	Related Features	Significance	Photo
1322	Board	A wooden board runs the whole length of the wall above the door. It is approximately 0.15m thick and has nails spaced evenly along it. Probably for hanging harnesses or drying herbs.	19th – modern	1320 W wall 1321 Door 1423 Board	Moderate – the board is of some archaeological interest in terms of the function of the room.	See 1320
1330	North wall	The north wall slopes slightly where it meets with the roof. It contains a single window	Mid-18th – modern	1300 CW room 1331 C window	High – archaeological and architectural interest. Provides a greater understanding of the layout, development and use of the building.	See 1321
1331	Central window	This window appears to have been shortened as the window aperture is longer than the window itself. It is a 16-light fixed pane window and measures 1.13m high (whereas the window aperture is 1.45m high). The window 0.86m wide. Unlike the other windows in the building it is not splayed. Line of the former room pitch visible above.	19th – modern	1330 N wall 1433 CW window	High – archaeological and architectural interest. A later insert, it provides a greater understanding the modification of the building in the 19th century to a new use.

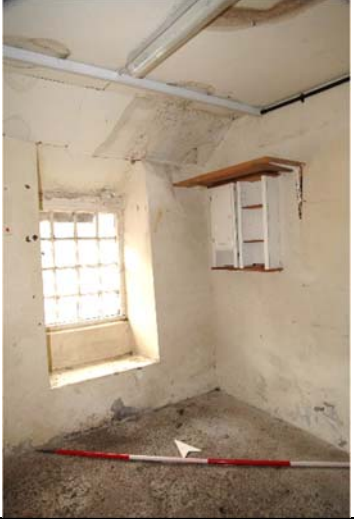
Name	Description	Phase	Related Features	Significance	Photo
1340	East wall	This wall is largely devoid of interest except for a shelf in the north-east corner.	Mid-18th – modern	1300 CW room 1341 Shelf	High – high archaeological interest in terms of the original layout of the building and subsequent changes of use.

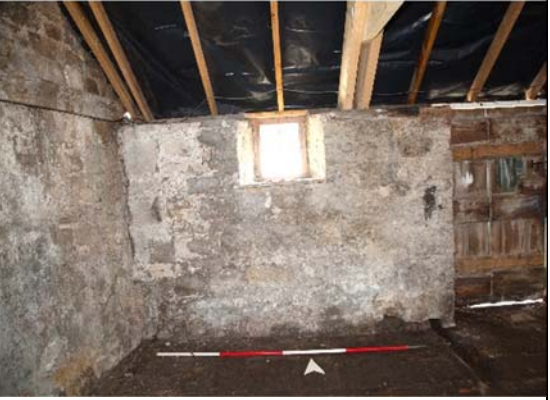
1341	Shelf	A small shelf that appears a to recent addition to the room lies in the north corner.	Modern	1340 E wall	Low – the shelf has little archaeological but some historical interest	See above
1400	West room	The west room is the largest of the four in the range and the best preserved. The floor is divided into three sections – one cobbled, one paved, and one brick. It is set with two post bases for a manger or feeder of some sort. It is divided by two drains. The walls show evidence of previous modification.	Mid-18th c – 19th	1401 E pillar base 1402 W pillar base 1403 Cobbles 1404 Flag. surface 1405 Brick floor 1406 Drain 1407 Drain below CW window 1410 S wall 1420 W wall 1430 N wall 1440 E wall	High – the room is of considerable archaeological and historical interest. One of the few areas where function is clear and seems to have remained relatively unaltered.

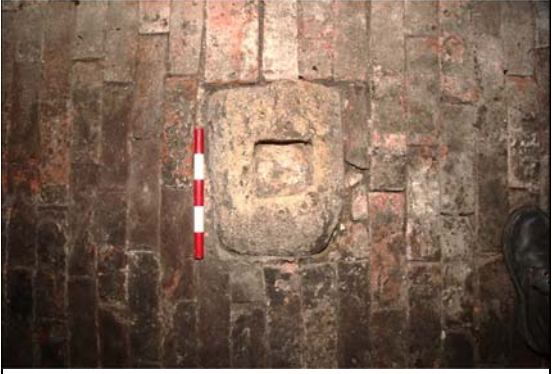
1402	West post base	This sub-rectangular post base is set in the cobbled floor, which is slightly elevated from the brick flooring. The post base, therefore does not rise from the ground as it does the east. It measures 0.34 x 0.25m and is located 0.35m from the S wall.	Mid-18th – 19th c. ?	1400 W room 1401 E post base 1403 Cobbles	High – as above.

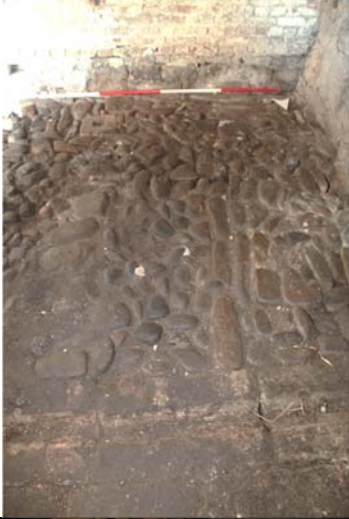
Name	Description	Phase	Related Features	Significance	Photo
1403	Cobbles	Cobble surface spanning forming the western third of the floor of the room. Area measures 2.58x2.43m and rises c.08m above the nearby brick and paved floors. To the north, the surface is bounded by a drain, but to the east, the surface is worn and the transition into the brick floor not as clear.	Mid-18th – 19th c. ?	1400 W room 1402 W post base 1404 Flag. surface 1405 Brick floor 1406 Drain	High – considerable archaeological as part of the original fabric of the structure. Important in terms of understanding the layout and use of the building

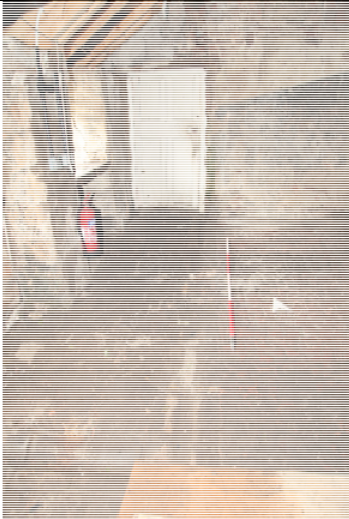
1404	Flagstone surface	Paved surface along the north wall. Divided from the brick and cobbled surface to the south by a drain (1406) that runs the length of the room. The flagstone floor is 0.96m wide and is truncated by a second north to south drain (1407).	Mid-18th – 19th c. ?	1400 W room 1403 Cobbles 1405 Brick floor 1406 Drain 1407 Drain beneath window	High – as above.

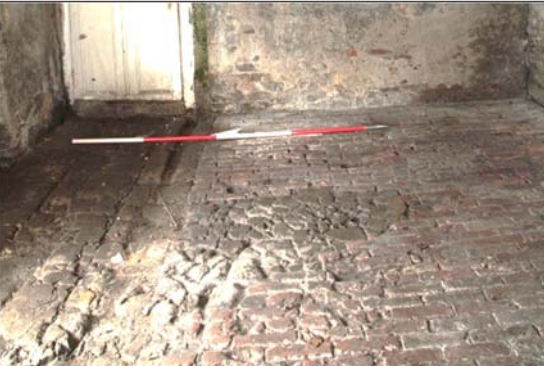
Name	Description	Phase	Related Features	Significance	Photo
1405	Brick Floor	The brick floor covers the remainder of the room between the cobbles and the flagstone surface, to the south-east of the drain. It surrounds the east post base. May overlie the cobbled surface	Mid-18th – 19th c. ?	1400 W room 1401 E post base 1403 Cobbles 1404 Flag. surface 1406 Drain	High – considerable archaeological as part of the original fabric of the structure. Important in terms of understanding the layout and use of the building

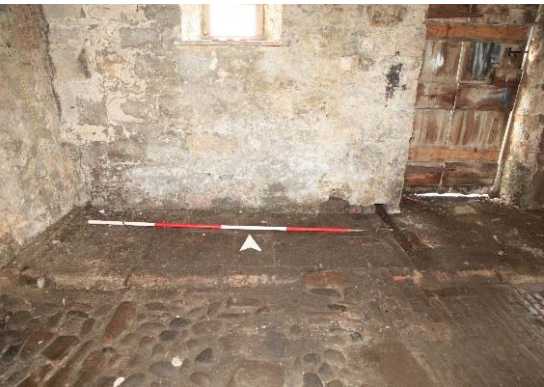
1406	Drain along floor	A drain that runs the length of the room, dividing the flagstone surface from the brick and cobbled floors. Adjoined by a second drain then extends toward the north wall which vent out into the west court. The drain is 0.12m wide and 0.06m deep. This is a later replacement of 1407.	19th c.	1400 W room 1430 N wall 1403 Cobbles 1404 Flag. surface 1405 Brick floor	High – as above.

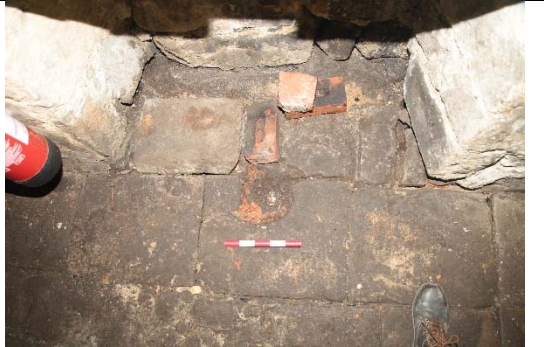
1407	Drain below window	A rounded hole in the pavement with some fragments of terracotta tile. Indicate the location of an earlier drain associated with the original door.	Mid-18th – 19th c. ?	1400 W room 1404 Flag. surface	Moderate – the drain has a degree of archaeological interest but is poorly preserved.

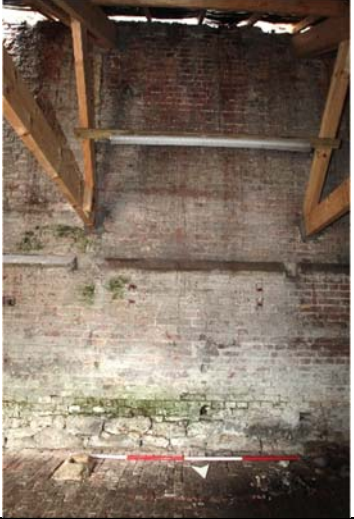
Name	Description	Phase	Related Features	Significance	Photo
1410	South wall	The southern boundary wall which pre-dates the main structure (see earlier descriptions). Some iron bolts or nails protruding in the upper south-west corner.	I. 16th/17th with later mods.	1400 W room 1411 Ledge 1412 Iron bolts 1110 E room S wall 1210 CE room S wall 1310 CW room S wall	High – this wall is one of the few historical structures that predate the Hall and therefore has high historical and archaeological interest.

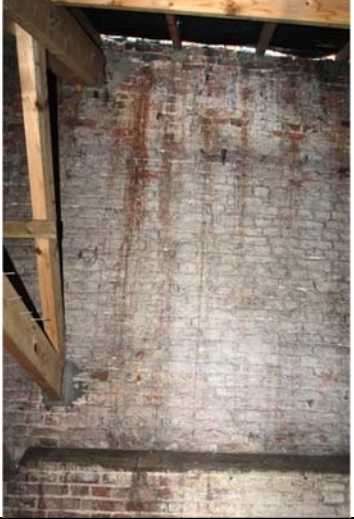
1413	Foundation course	Rubble stone course, extending 0.40m high, visible at the base of the south wall. Likely to be foundations for the south wall (300), although could potentially relate to an earlier structure.	Late 18th c – 19th c.?	301 lower section of south wall	High – considerable archaeological value as part of the fabric of the late 16th/17th century wall and has the potential to possibly relate to something earlier.

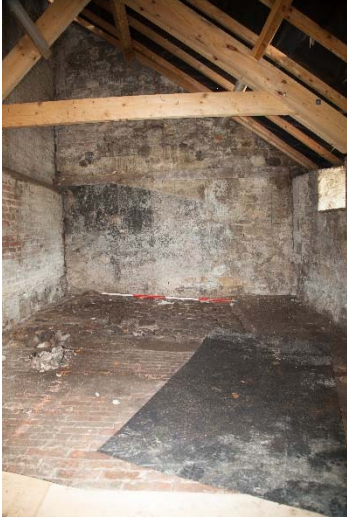
Name	Description	Phase	Related Features	Significance	Photo
1420	West wall	The west wall is partially rendered. This is panted with sloped panel indicting the length of the cattle stalls. There is a blocked window or pitching hole in the upper south corner; very close to the south wall. A wooden board spans the wall above which are three joist holes marking the height of the former hayloft. Lower section is built out against the east boundary wall of the west court.	E. 18th to mid-18th c with later mods.	1400 W room 201 Blocked window 1421 Joist holes 1422 Board	High – considerable archaeological value as part of the original fabric of the structure and important in terms of understanding the phases of construction.

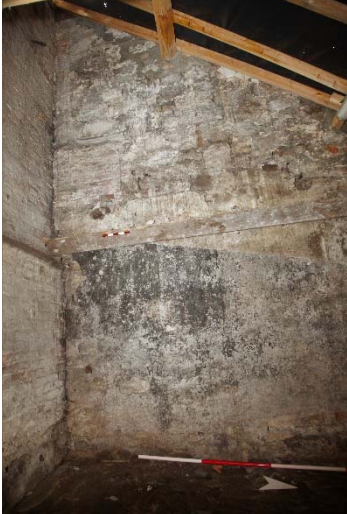
1421	Joist holes	Three joist holes in a line on the wall above 1420. Situated just below blocked window 201. Holes are approximately 0.08m wide and spaced 0.75m apart. Associated with former hayloft floor.	Mid-18th c.	1420 W wall 1443 E wall joist holes	High – considerable archaeological value as part of the fabric of the 18th century building and important in terms of understanding its layout and later development.

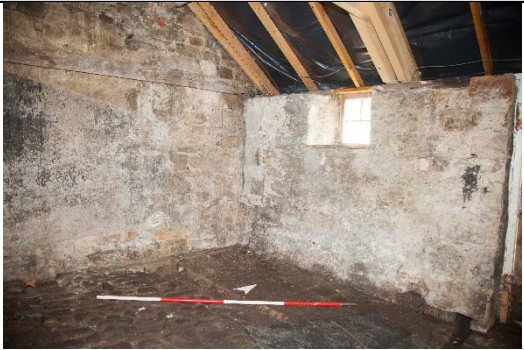
Name	Description	Phase	Related Features	Significance	Photo
1422	Beam	A single beam that crosses the wall. Below are three joist holes for supports running east to west. Beam has several nails along it.	Mid-18th – 19th c	1420 S wall	Moderate – of some archaeological significance as part of the hayloft floor but uncertain if original.

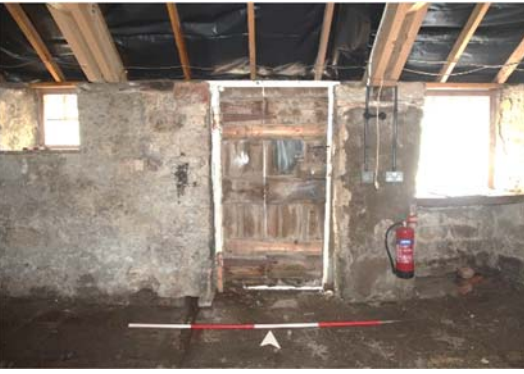
1430	North wall	The north wall marks the front of the room. It has a central door (a later insertion) flanked by two windows. The door into the room was originally further to the east (1433).	Mid-18th c. with later mods.	1431 Door 1432 W window 1433 CW window 1441 Niche	High – considerable archaeological value as part of the original fabric of the structure. Evidence of relocation of the door is important in terms of understanding later development and modification to layout. Also of some architectural value as part of the main façade of the building.

was originally slightly further east, in the location of window **1433**, which was added later when the door was blocked and moved to its present location (**1431**). The alternating stone jambs of the original door can be clearly seen on the exterior of the building. It is notable that there are no ventilation slits in room **1400**. There may have been some on the north wall, replaced by later windows, but this does not account for their absence on the south side of the room. One possible interpretation is that cattle were brought into this area on a temporary basis for milking and would have otherwise grazing nearby throughout the day. A later pitching or inspection hole (**201**) was added on the west side of the room.

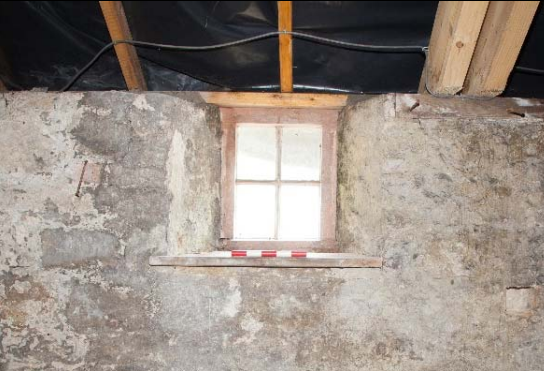
Name	Description	Phase	Related Features	Significance	Photo
1432	West window	The west window is the smallest extant window. It is composed of four lights with a wooden sill. The window measure 0.46m wide and is 0.62m high. The aperture is splayed.	Mid-18th c. ?	1430 N wall	High – archaeological and architectural interest as part of the original fabric of the building. Also of some architectural value as part of the main façade of the building.

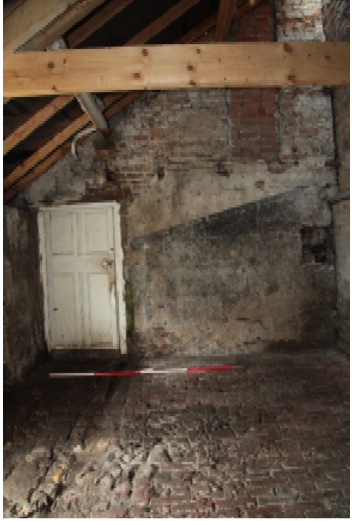
Name	Description	Phase	Related Features	Significance	Photo
1440	East wall	The east wall is partially rendered but some evidence of modification is still visible. An area of the render has been painted black, marking the length of the former cattle stalls. The door (1321) leading into the west-central room is on the north side. Five joist holes mark the height of the former hayloft and above this on the south side is an brick infilled vertical scar; probably a flue.	Late 18th c – 19th c.?	1400 W room 1321 Door to CW room 1441 Lamp niche 1442 Flue? 1443 Joist holes	High – has considerable archaeological significance in terms of understanding the later layout and modification of the building.

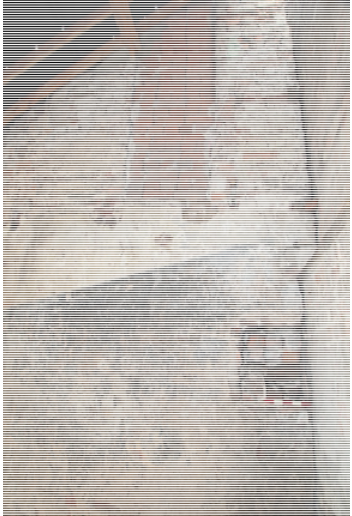
1441	Lamp niche	A small, partially blocked lamp niche in the south-east corner of the room. Measures 0.39x0.45m and is situated 1.03m above the floor surface.	19th c.	1440 E wall	Moderate – of some archaeological and historical interest in terms of the operation of the byre/milking shed.
