THE WEST WING SERVICE COURT,  
REPORT ON ARCHAEOLOGICAL  
MONITORING

SEATON DELAVAL HALL,  
NORTHUMBERLAND

prepared for  
The National Trust

NAA 20/105  
April 2021

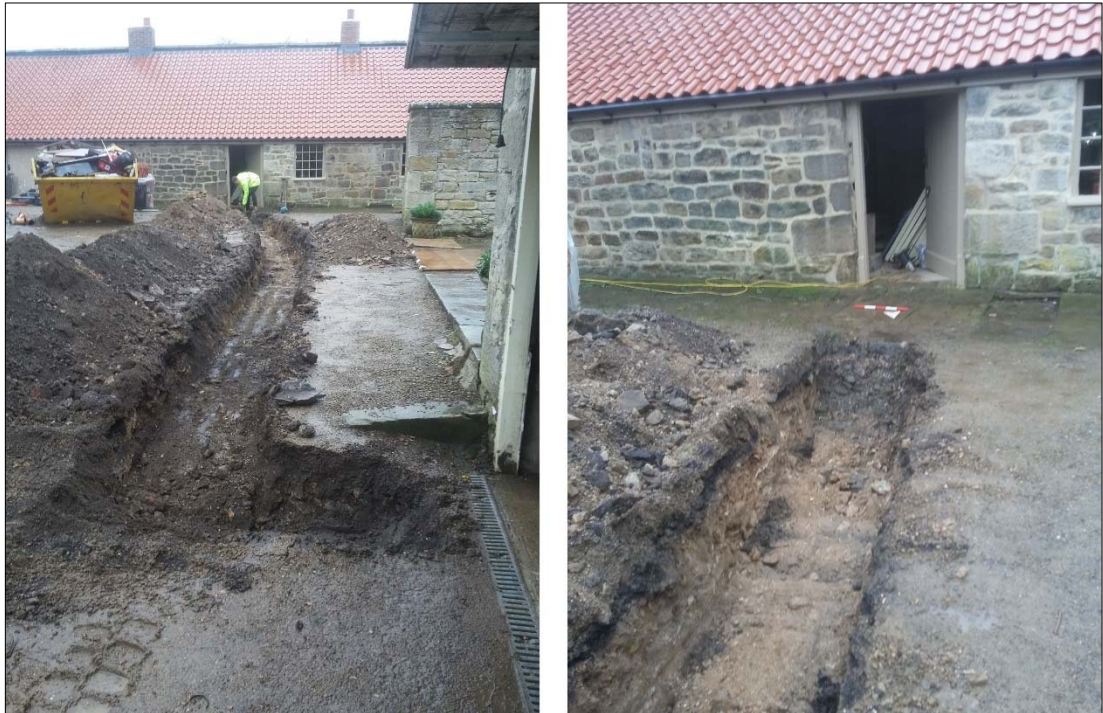
6.1 Natural sandstone bedrock (3001) was encountered in front of the potting shed at the southern end of the trench at 0.3–0.35m below ground level (bgl). It sloped down to the north, the upper surface recorded at a depth of 0.45m bgl at the northern end of the trench (Plates 1 and 2). A rough estimate, given the length of the trench, suggests an approximate gradient of 1 in 40.

*Plate 1 (left): service trench as excavated, with (deposit 3004 visible in its northern extent; Plate 2 (right): natural sandstone (3001) exposed at the southern end.*

8.2 The natural sandstone geology (3001) was shown to slope gently down from the south to the north on a gradient of approximately 1 in 40, with the rose garden wall located at the top of the rise. The wall is believed to date to the late 16th or 17th century,

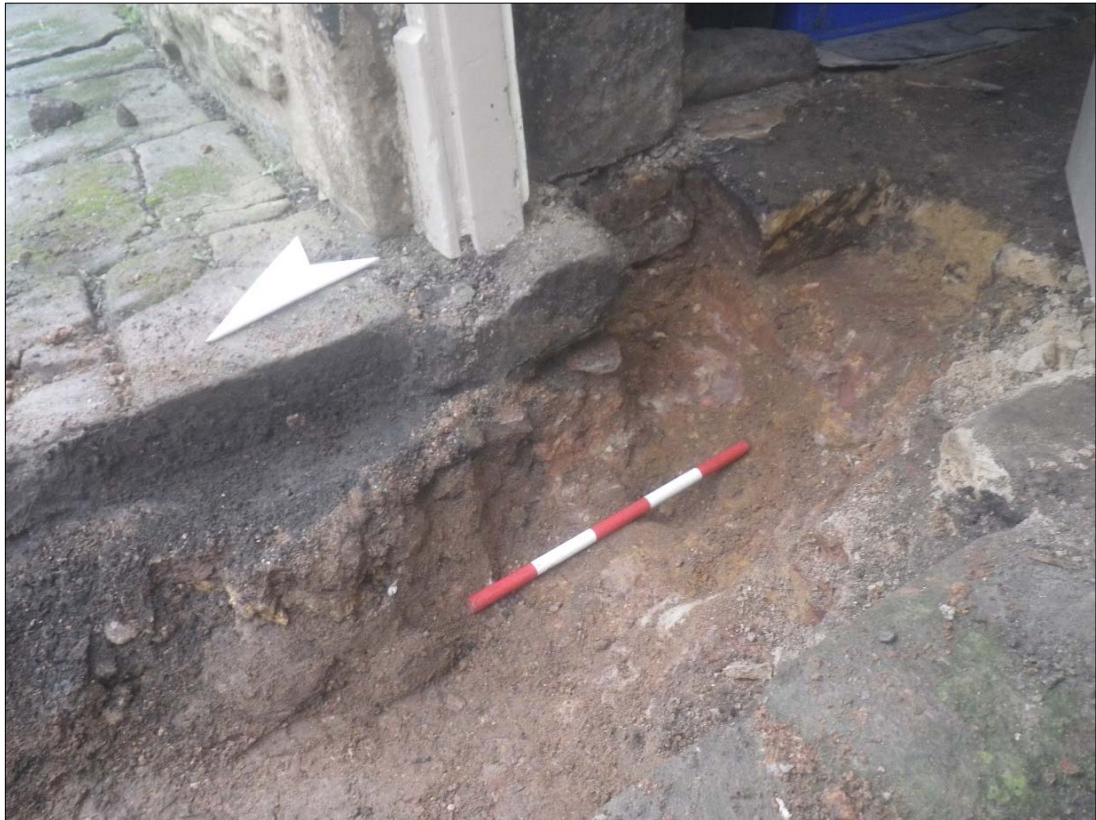
*Plate 3: potting shed wall and floor bedded onto clay layer 3003, with foundation cut 3008 on the left.*

- 6.6 The construction cut (3008) for the flag surface (3006) was dug vertically at the front of the potting shed, effectively destroying the physical relationship between clay deposit 3003 recorded within the building interior and deposit 3004 in the courtyard. The construction trench was c.0.35m deep and 1.6m wide. The mixed nature of the primary fill (3007) suggests the surface was the last of a series of historic interventions along the front of the building.

providing further evidence of the form pre-Vanbrugh landscape. The potting shed was later constructed against the north face of the garden wall. The foundations of the building and internal flagstone floor were bedded directly onto the levelled glacial clay (3003).

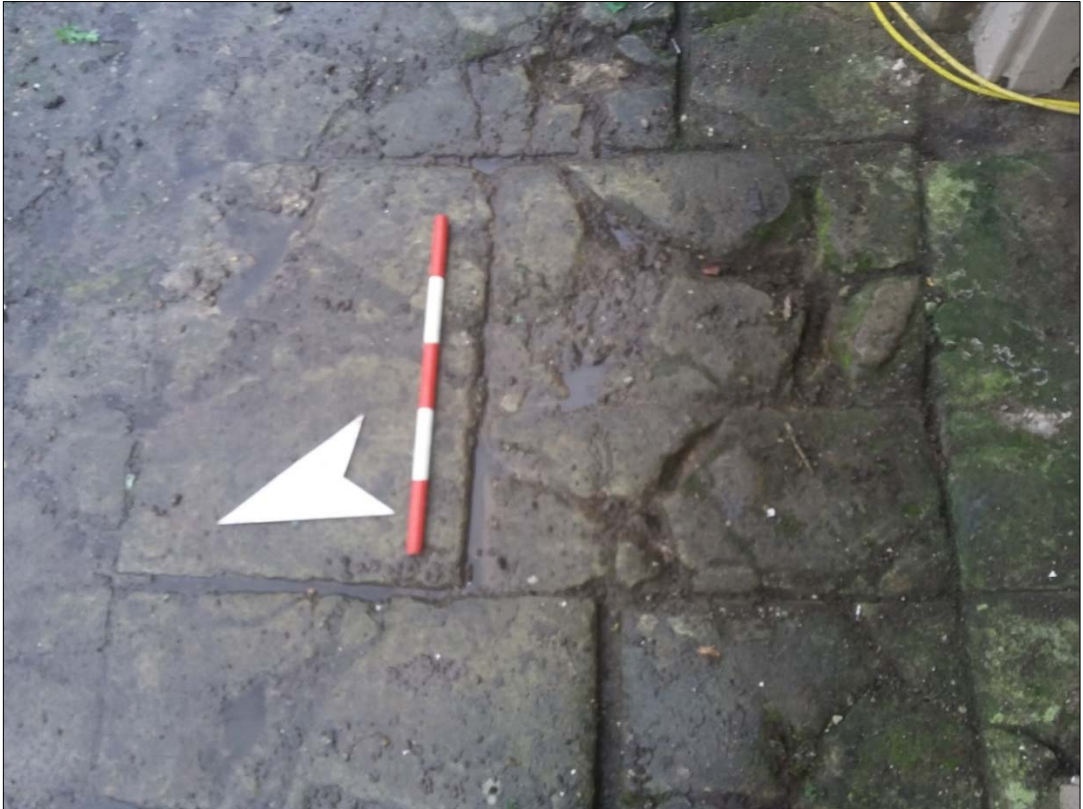
- 6.5 In front of the potting shed was a flagged surface (**3006**) which extend along the north elevation of the building. It was 1.5m in width and constructed of sandstone flags that measured 0.6m by 0.7m with an average thickness of 0.12m. This was bedded into a 0.2–0.25m-thick levelling layer (**3007**) of mixed mid-brown clay with some angular stones (averaging 0.15–0.25m in diameter) and frequent brick rubble. The brick

*Plate 4: pathway 3006 prior to hand excavation.*
