NORTHERN ARCHAEOLOGICAL ASSOCIATES LTD
FORGE FARM, RAVENSWORTH, NORTH YORKSHIRE
Negative Watching Brief Report

Site name: Forge Farm	Grid reference: NZ1399408044
Parish: Ravensworth	District: Richmondshire County: North Yorkshire
Administrative authority: RDC	Development: Residential
Client: Mallard Homes Ltd.	
Planning application reference: 16/00427/FULL	
Site supervisor: Therese Falk	Project manager: Oliver Cooper
Fieldwork Date(s): 26/02/20	NAA project number: 2040 Site code: RFF20
NAA report number: 20/22	Report date: 04/03/2020

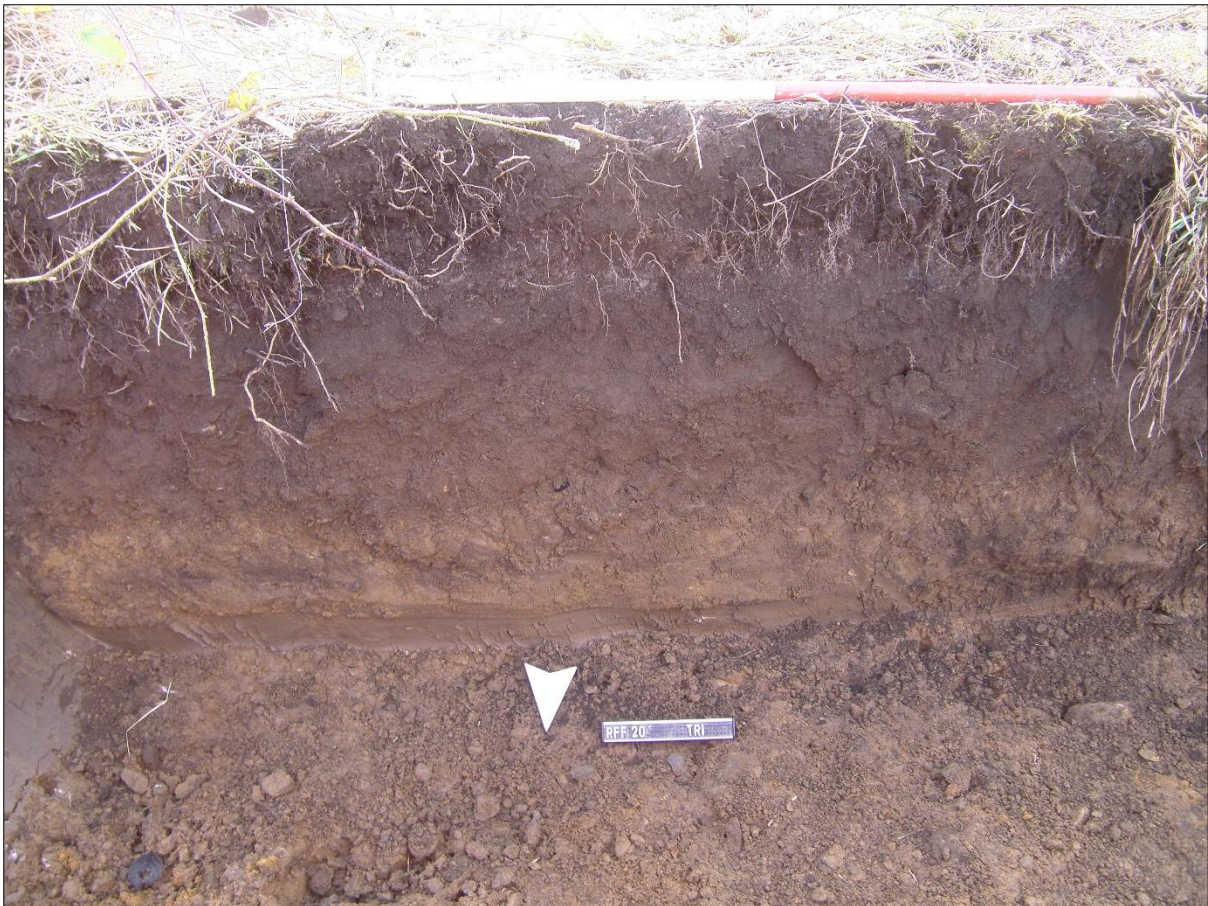
Trench 1 was excavated within the eastern part of the proposed development area. It was located 2m west of an extant garden wall and orientated east to west. The trench measured 5m by 2m and was excavated to a depth of 1m. An initial layer of 0.4m deep topsoil consisting of sandy silt was removed to expose a 0.35m deep sandy silt subsoil. Underlying the subsoil was a layer of colluvium (hill-wash), comprising clayey silt and measuring 0.25m in depth. Natural gravel was encountered at a depth of 1m. No archaeological features or finds were present.

Plate 1: north-facing section of Trench 1.

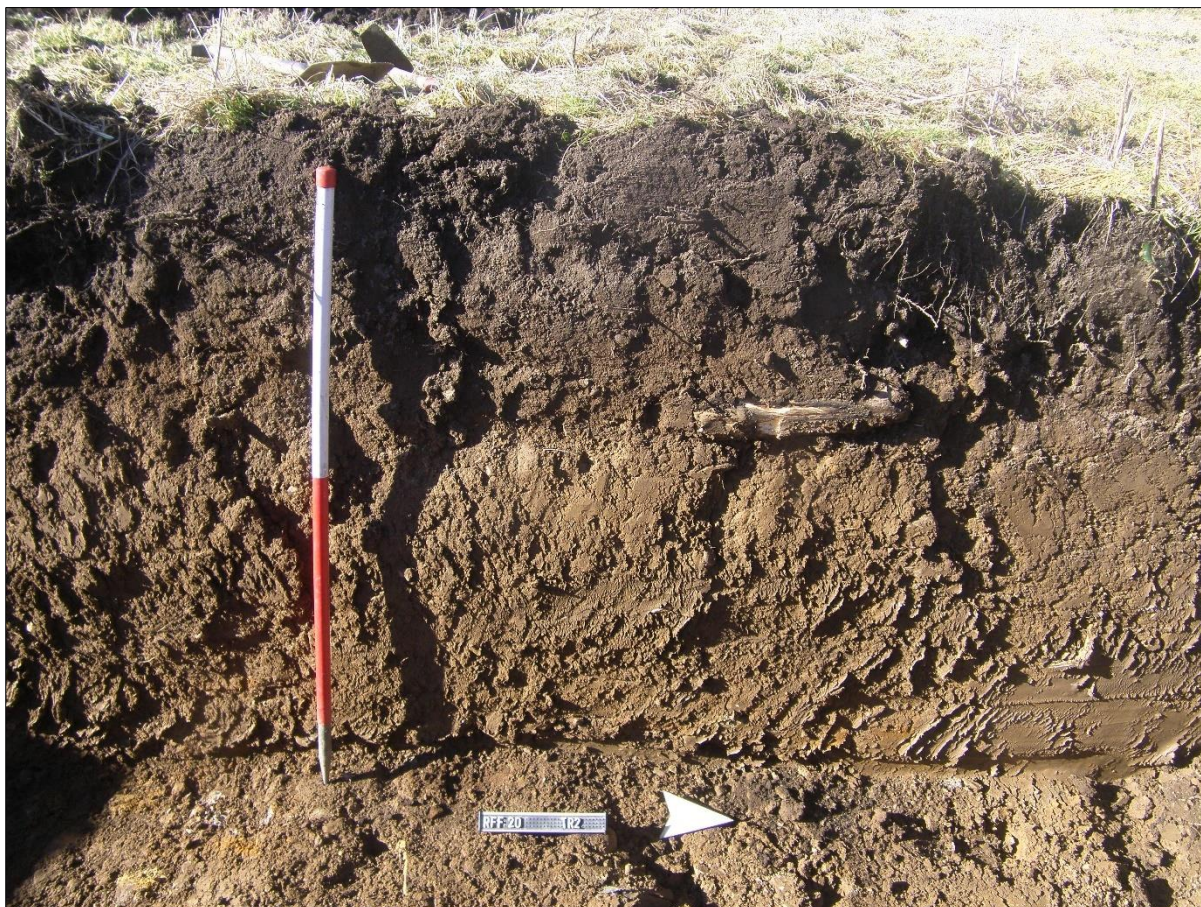
Trench 2 was excavated within the northern part of the proposed development area. It was located 6.5m south of an extant garden fence and orientated north to south. The trench measured 5m by 2m and was excavated to a depth of 1.2m. An initial layer of 0.2m deep topsoil consisting

of sandy silt was removed to expose a 0.3m deep sandy silt subsoil. Underlying the subsoil was a thick layer of colluvium, comprising clayey silt and measuring 0.7m in depth. Natural gravel was encountered at a depth of 1.2m. No archaeological features or finds were present.

Plate 2: east facing section of Trench 2.

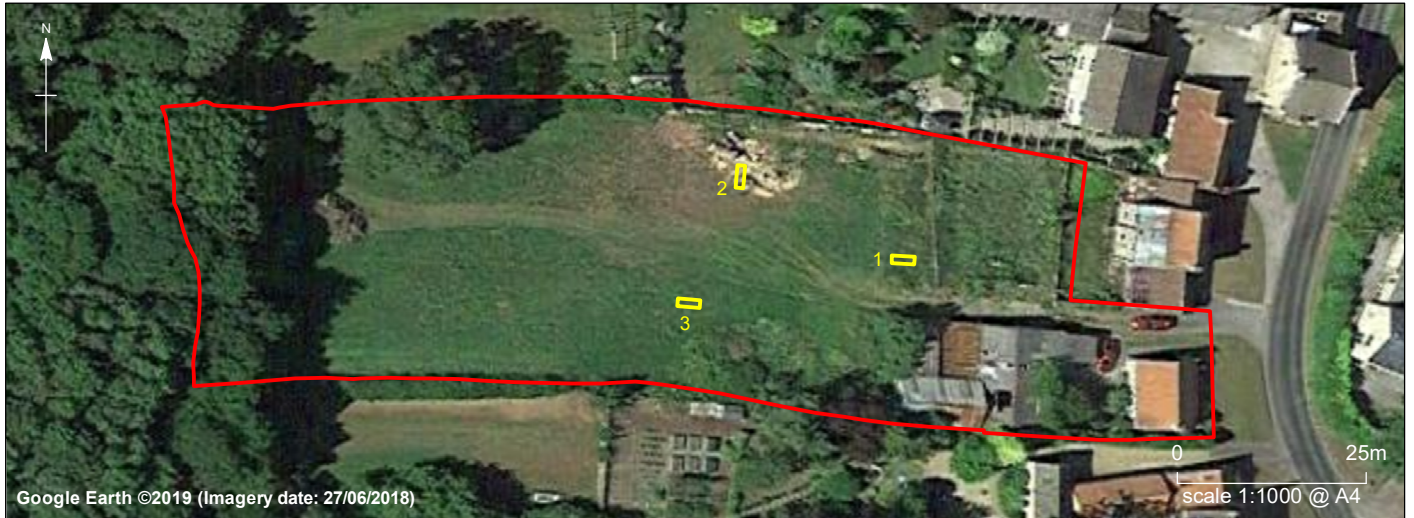
Figure 3

Trench locations are shown on Figure 3.

Forge Farm, Ravensworth: trial trench locations overlain on Google Earth imagery and proposed development plan
