NORTHERN ARCHAEOLOGICAL ASSOCIATES LTD FLATTS LANE, NORMANBY, REDCAR AND CLEVELAND

Additional monitoring

Site name: Flatts Lane Grid reference: NGR 454687 516753

NAA report number: 20-87 Report date: 02 October 2020

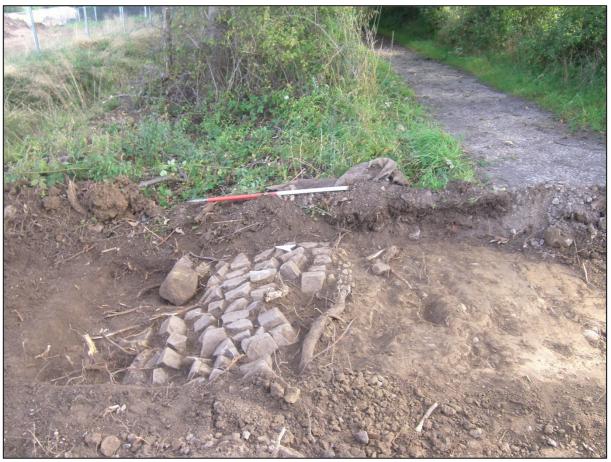
Plate 1: Slot across Flatts Lane looking west, showing stone trod and vestiges of the northern kerb.

The trackway was constructed of roughly squared limestone setts with the vestiges of a kerb of sandstone blocks along the northern edge (Plate 1) and survived up to 1m in width. The previously excavated slot to the east, showed that the trackway would have initially been flanked by a pair of sandstone kerbs (Plate 2), however this intervention showed greater disturbance because of rooting and the slumping of the stone surface into the later, northern hedgerow ditch. The initial excavation had also revealed an earlier ditched trackway, denoted by a 0.3m wide ditch running along the southern edge that had been truncated by the later cut for the stone track. This ditch was absent in the current trench; however, the southern edge of the trackway had been heavily disturbed, and it is possible that the ditch had been removed along with the southern kerb.

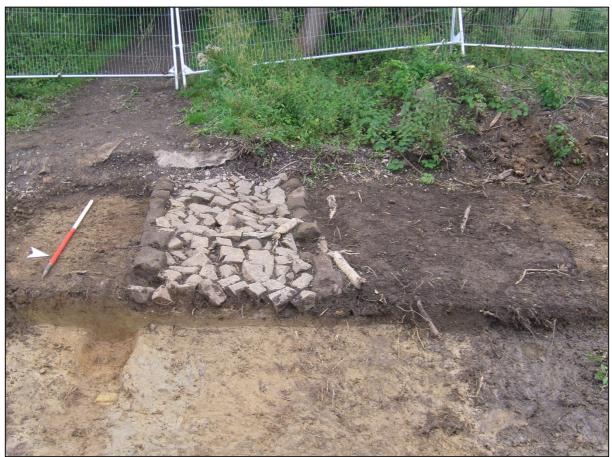
Plate 2: Original slot across Flatts Lane from the previous watching brief (NAA 2020, Plate 3) showing flanking sandstone kerbs and southern ditch.

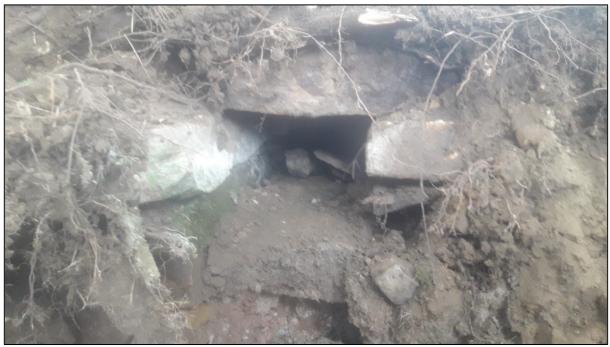
Plate 3: Heavily disturbed sandstone culvert.

To minimise any further disturbance to the historic trackway, the second drainage trench was installed within an existing culvert that had been dug through the line of Flatts Lane when the surrounding fields were farmland. Clearing of the vegetation and modern footpath gravel revealed a heavily disturbed sandstone culvert, likely installed in the 19th century (Plate 3). None of the original stone trackway survived in this trench. The remnants of the disturbed culvert were removed, and the existing trench was formalised for the installation of the modern drain.
