NORTHERN ARCHAEOLOGICAL ASSOCIATES

Askrigg to Bowbridge Hill

NEGATIVE WATCHING BRIEF REPORT

Development: Water Main Renewal

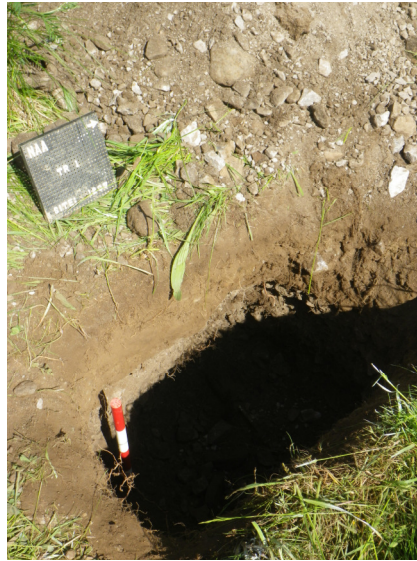
Plate 1: Inspection trench 1 looking Northwest

Inspection trench 1 was located in the verge to the north of the road running towards Askrigg. The trench measured 0.70m in length, 0.40m in width and had a maximum excavated depth of 0.70m, at which depth the water main was encountered.

A layer of mixed stones and dark brown silty loam soil, with an average thickness of 0.40m overlay the pipe and this was subsequently overlain by the current topsoil. This consisted of a mid to dark brown silty loam and had an average thickness of 0.30m.

No archaeological features were encountered within trench 1 (plate 1).

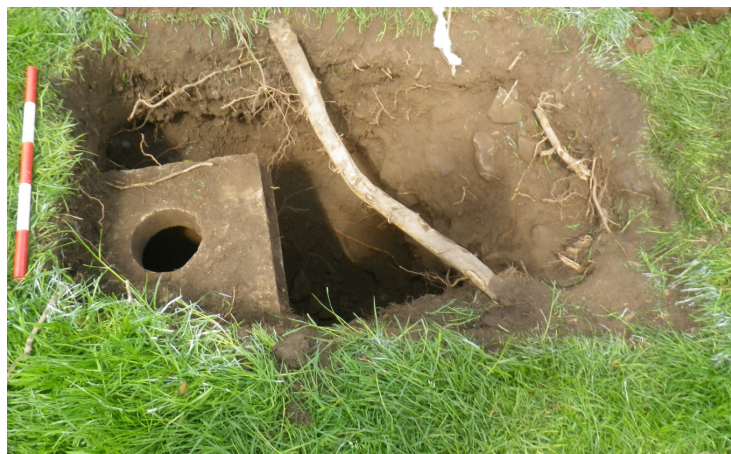
Plate 2: Inspection trench 2 looking Northwest

Inspection trench 2 was located in the corner of a field, just to the east of Skellgill Lane and to the south of Gill Gate Farm. The trench measured 1.10m in length, 0.60m in width and had a maximum excavated depth of 1.20m, at which depth the water main was encountered.

A layer of mixed stones and dark brown silty loam, with an average thickness of 0.90m overlay the pipe. This was subsequently overlain by the current topsoil. This consisted of a mid to dark brown silty loam and had an average thickness of 0.30m.

A concrete valve cover measuring 0.40m square with a depth of 1.20m was encountered directly under the topsoil and this related to the existing water main. No archaeological features were encountered within trench 2 (Plate 2).

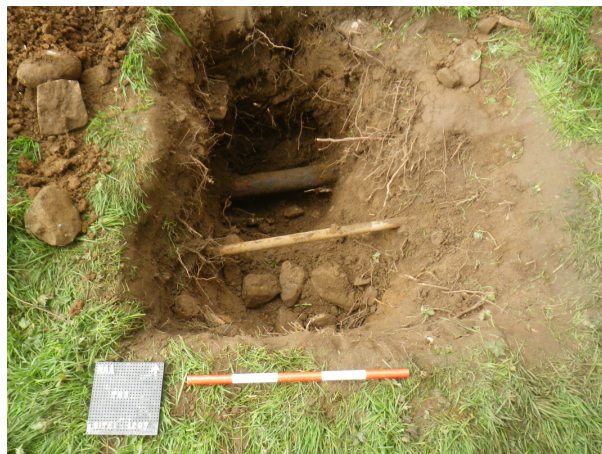
Plate 3: Inspection trench 3 looking North

Inspection trench 3 was located in a field 240m to the west of trench 2. The trench measured 1.10m in length, 1.10m in width and had a maximum excavated depth of 1.00m at which depth the water main was encountered.

A layer of mixed stones and dark brown silty loam, with an average thickness of 0.70m overlay the pipe. This was subsequently overlain by the current topsoil. This consisted of a mid to dark brown silty loam and had an average thickness of 0.30m.

No archaeological features were encountered within trench 3 (Plate 3).
