NORTHERN ARCHAEOLOGICAL ASSOCIATES LTD

The Manor, Bowes, County Durham

NEGATIVE WATCHING BRIEF REPORT

Site name: The Manor, Bowes.

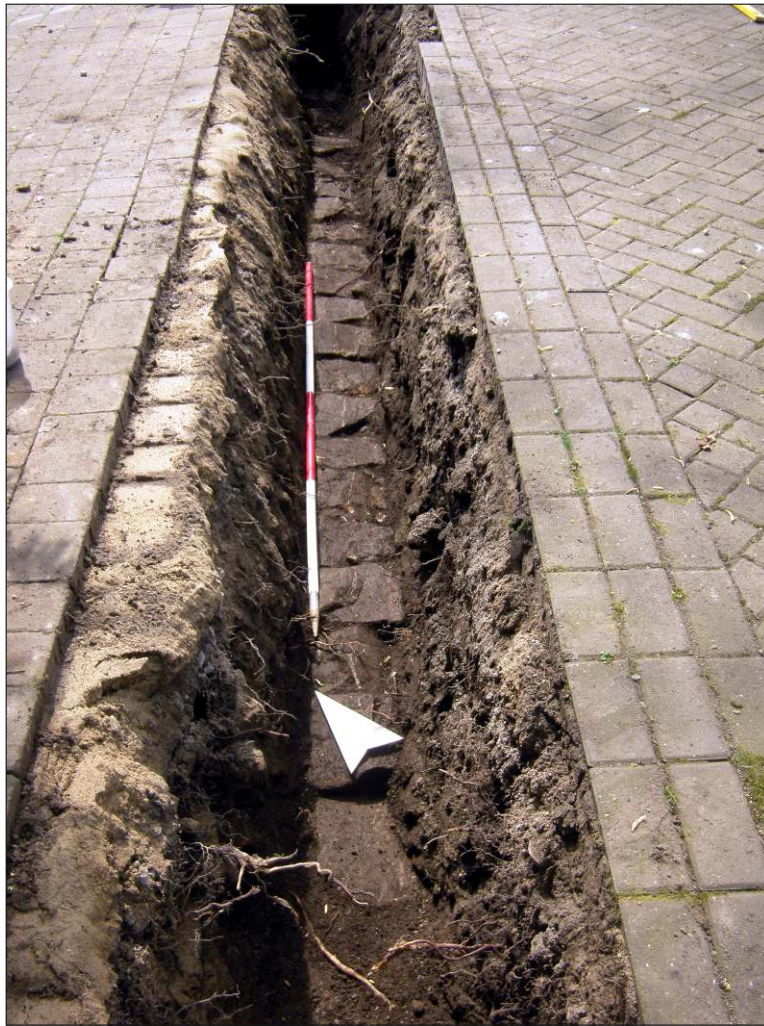
Plate 1

*The Manor, Bowes: stone surface in
base of pipe trench*

The trench within the area of modern block paving was cut entirely through a 0.45m deep deposit of dark grey soil, probably a deposit of reworked topsoil, which in turn was sealed by a 0.30m deep deposit of gravel acting as a sub-base for the present block paving. No finds, other than fragments of machine-made brick were encountered within the excavated soils, perhaps suggesting this deposit was a later import. Sealed directly below the reworked topsoil were the remains of a stone surface comprising unworn, squared, sandstone blocks, its upper surface being situated at approximately 0.75m BGL. The alignment of the stones comprising this surface was almost parallel to the individual blocks of the present driveway, so far as could be reasonably ascertained from the inspection of the base of a trench that was only 0.30m wide. The individual stones of the surface were not clay or mortar bonded, a deposit essentially similar to that which sealed them having worked its way between the joints of the individual blocks. As this surface was not to be disturbed by the development, it was cleaned, photographed and described but otherwise left undisturbed, thus effecting its preservation *in situ*. However, where individual stones had been accidentally disturbed during groundworks, they were found to be bedded on a mixed deposit of slightly gritty, clayey topsoil, with no further stonework beneath.

The service trench as excavated both within and outside of the curtilage of Bowes Manor did not identify any archaeological features or deposits that could be attributed to the Roman or medieval periods. The only surface that was identified was sealed by a recent deposit of what appears to have been imported topsoil, probably employed for ground-raising purposes. Given the lack of any intervening deposits attributable to the Roman, medieval or post-medieval periods between the stone surface and the topsoil,

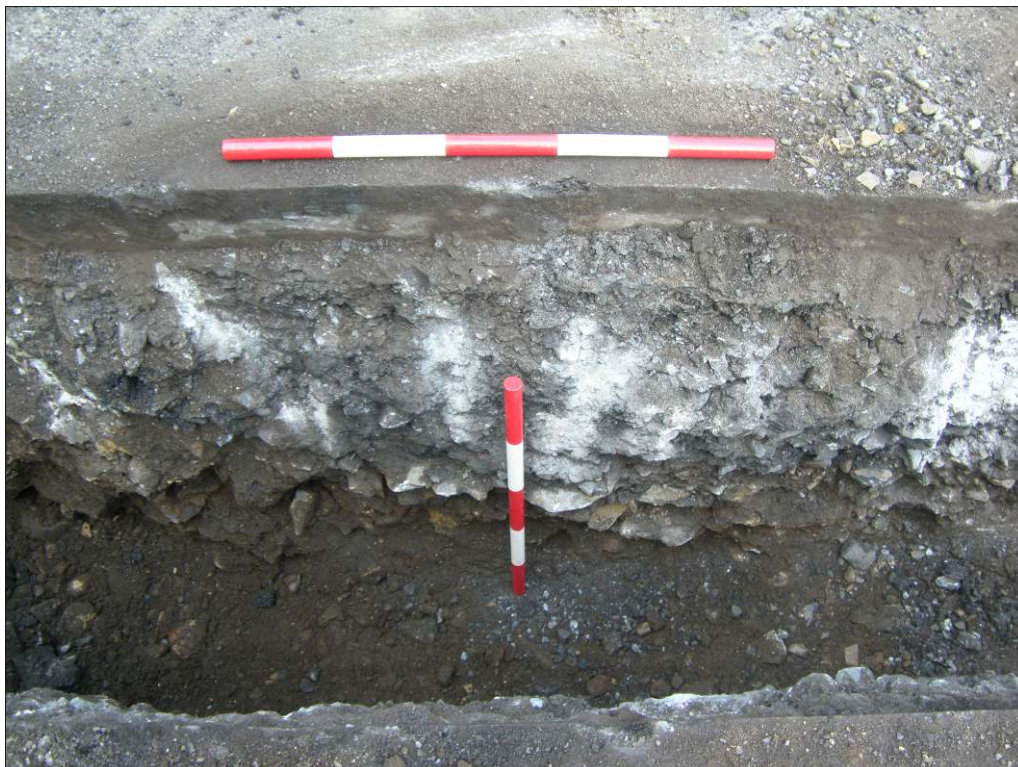
Plate 2

The Manor, Bowes: trench section through road

No features or deposits of archaeological interest were found during the watching brief undertaken on the groundworks within the pavement and carriageway to the north of The Manor. The pipe trench was not excavated to a depth where natural subsoil was encountered, all of the deposits cut by the trench comprised recently disturbed layers of modern material or roadway make-up deposits. No finds of any antiquity were revealed by these groundworks.
