Randy Mere to Ruswarp Water Main, North Yorkshire

NEGATIVE WATCHING BRIEF REPORT

Development: Water main inspection prior to replacement/repair

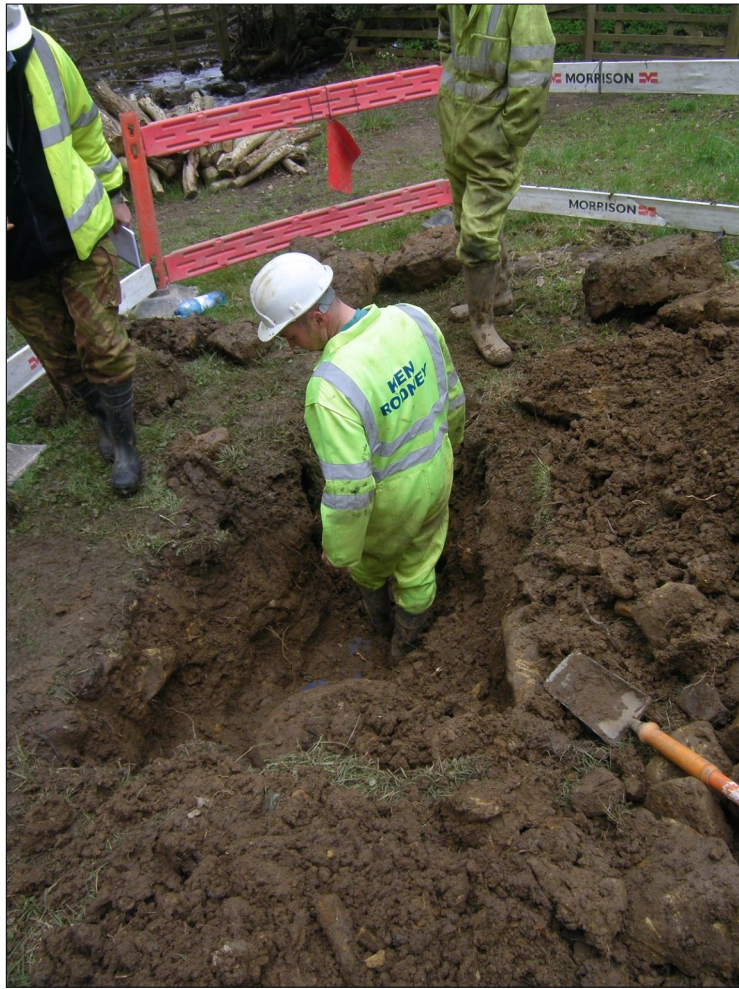
Plate 1

The inspection trench measured approximately 1.6m in length, 1m in width, and 0.65m in depth. It was excavated by hand (Plate 1).

*Randy Mere to Ruswarp Water Main:
hand-excavation of inspection trench*

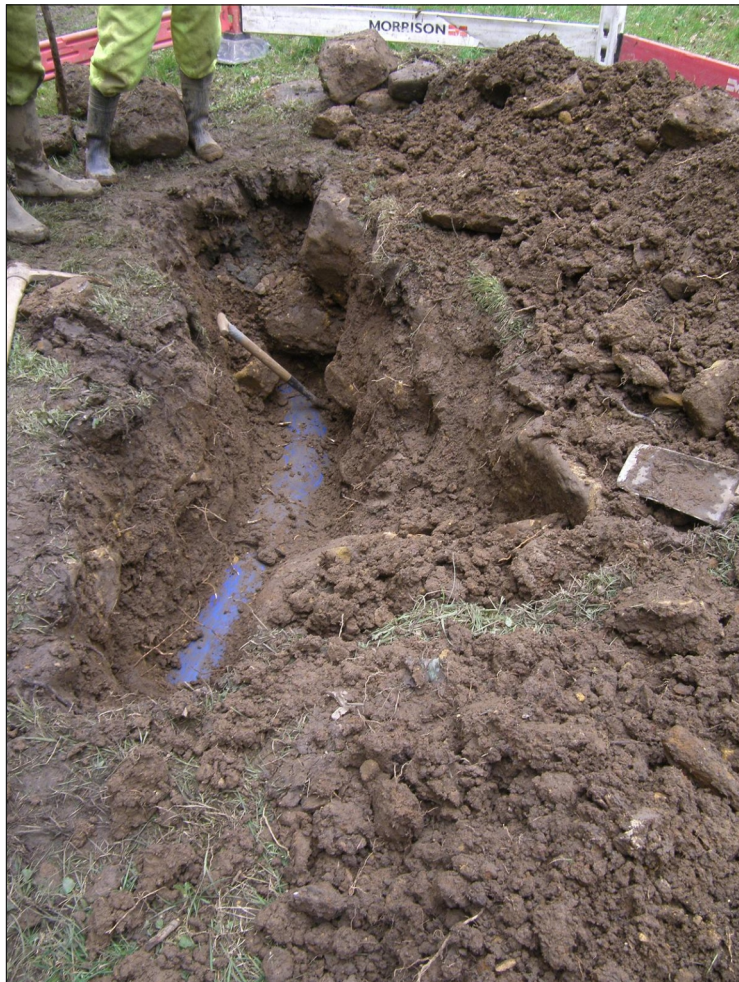
Plate 2

The natural subsoil was not exposed in the trench. The water main was sealed by up to 0.5m of mid-yellowish brown clayey silt with some large stony inclusions. This deposit was sealed in turn by the modern topsoil (Plate 2). No archaeological structures, artefacts or deposits were present within the trench.

*Randy Mere to Ruswarp Water Main:
inspection trench*

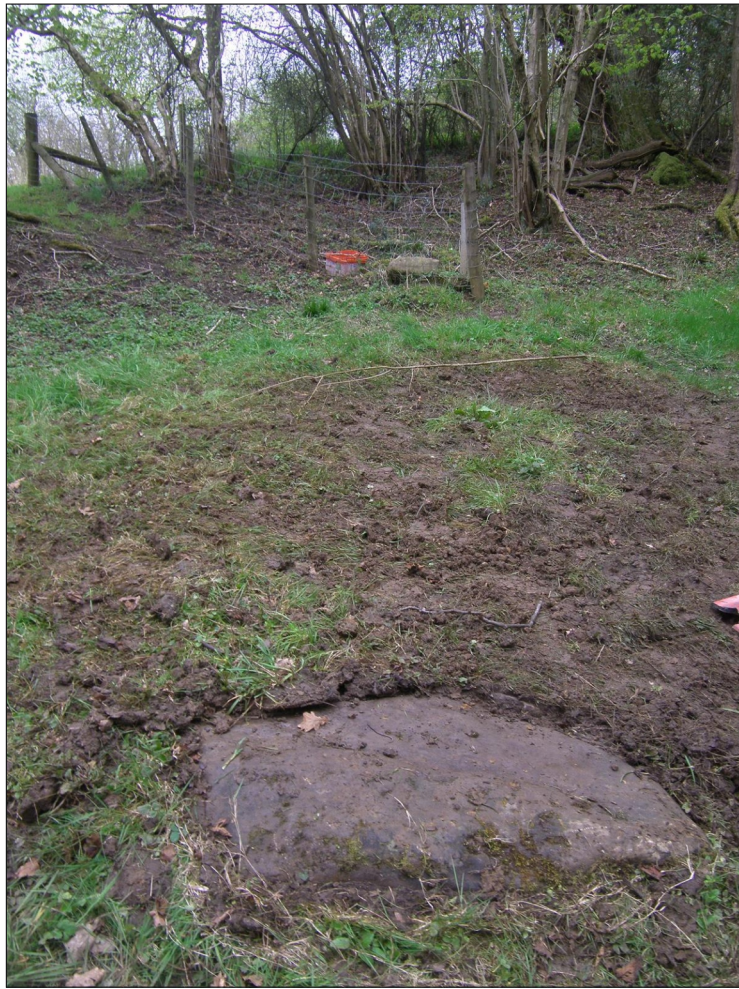
Plate 3

A stone slab lay immediately adjacent to the trench (Plate 3); this remained undisturbed. This stone slab may be associated with the pannier way, although its provenance remained uncertain.

There were no other *in situ* stone slabs visible in this area, although it is possible that they are now buried and survive beneath the topsoil. Some of the pannier way slabs may have been used to construct a footbridge which crosses the nearby Oakley Beck.

*Randy Mere to Ruswarp Water Main:
stone slab adjacent to inspection trench*

Given the possibility that the trod is now buried, it is recommended that archaeological monitoring is undertaken for any pipeline renewal off the line of the existing main.
