REPLACEMENT GAS MAIN

615 WEST ROAD

NEWCASTLE UPON TYNE

ARCHAEOLOGICAL MONITORING

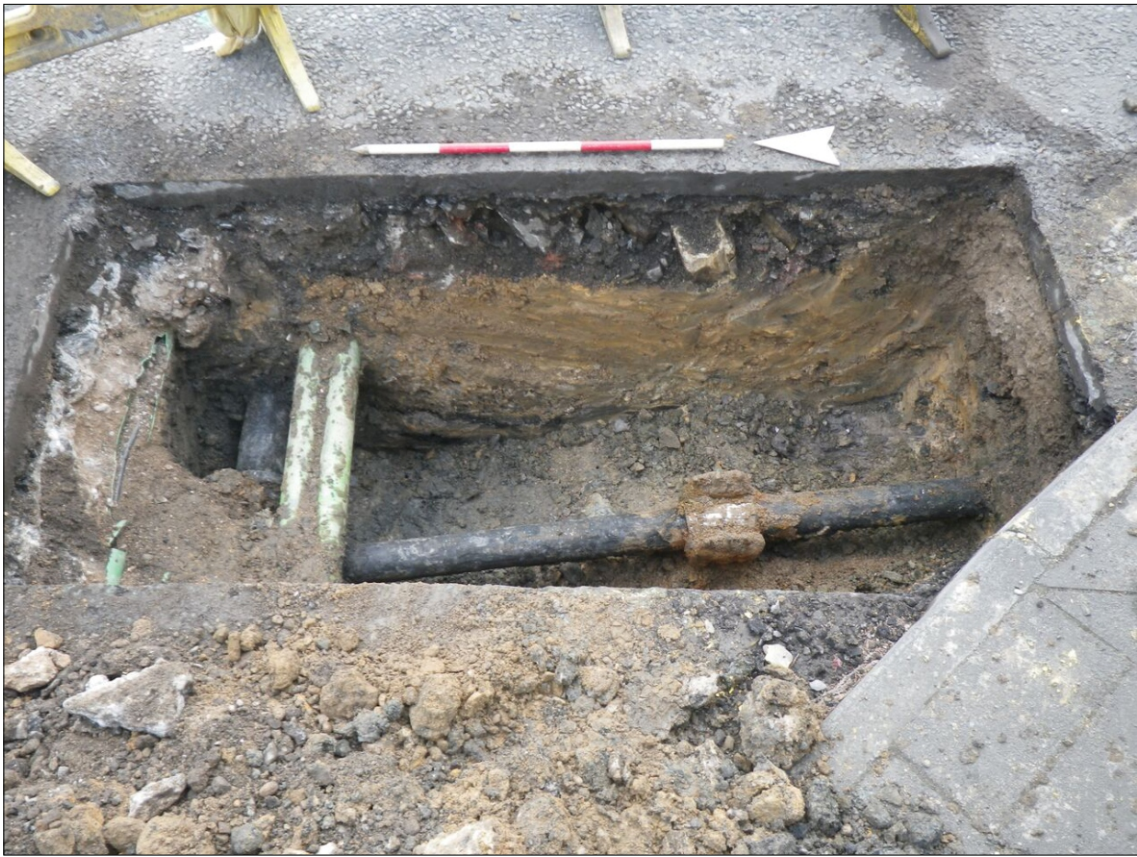
Plate 1

*615 West Road, Newcastle Upon Tyne: Trench 1,
natural clay and re-used sandstone*

- 6.1 Trench 1 was located on the western corner of the junction of West Road and Thorntree Drive, and measured 2.62m x 1.25m and up to 1.17m deep. There were no remains of archaeological significance, and the natural subsoil comprised a mid brown clean sandy, silty clay.
- 6.2 Overlying this was a deposit of random sandstone fragments, blending with the hard-core road bedding beneath the modern tarmac. The sandstone fragments varied in shape and size from small angular chips to medium-sized (c. 150mm) blocks. Two lenses of dark purple/ black silt were visible in the side of the trench and there were patches of a similar material at the base; these were considered to be natural.

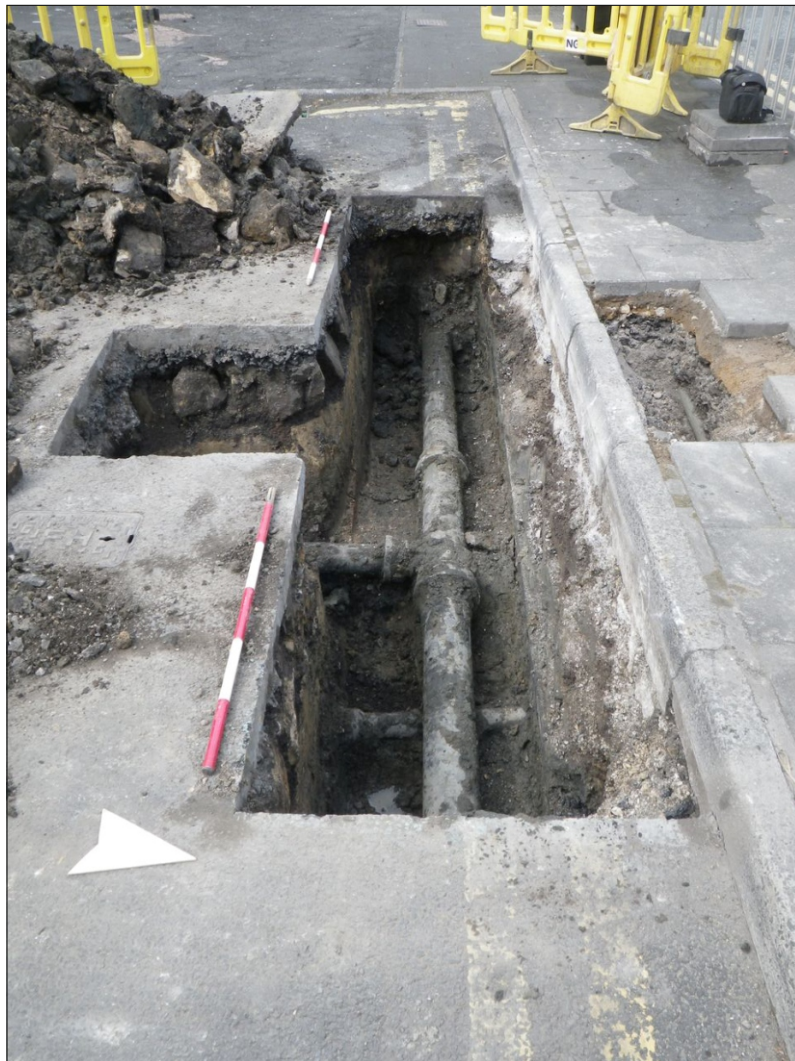
Plate 2

*615 West Road, Newcastle Upon Tyne: Trench 2,
general view showing re-used sandstone*

- 6.3 Trench 2 was on the opposite side of the Methodist Church, on the western corner of the junction of West Road and Baroness Drive. The trench measured 4.24m x 1.84m in an approximate 'T' shape and was excavated to a depth of 1.15m.

- 6.4 Again, no features of archaeological significance were identified. However, as with Trench 1 there were random sandstone fragments ranging from small to larger blocks located directly beneath the modern tarmac, these were very frequent. The sandstone was located within a mixed matrix of dark grey silt, grit, coal and shale suggesting use of colliery waste as levelling material for the modern road surface. This is further supported by the underlying natural which appeared to have been levelled beneath the sandstone matrix. Some of the sandstone blocks showed signs of rough shaping but no visible dressing marks, suggesting that they may have derived from Hadrian's Wall. The sandstone matrix had a depth of 0.49 m and ran the length and width of the trench. The underlying natural was the same as in Trench 1.
