CLIFTON AND ACOMB LEAD RENEWALS, YORK

Archaeological Monitoring Report

Development: Lead water pipe replacement

NAA report number: 18/02

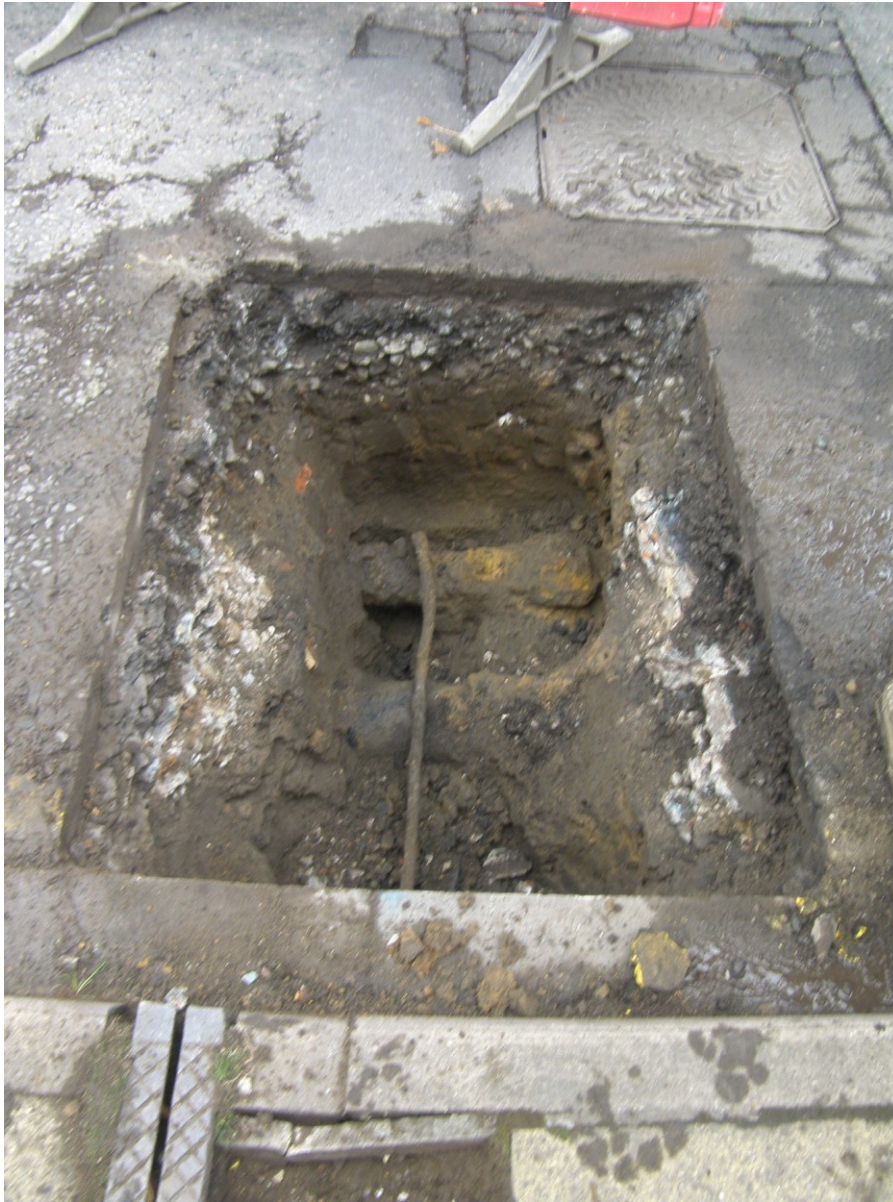
Plate 1. Typical lead replacement pit (Clifton Green) showing two cast iron water mains (one capped with concrete) and small diameter lead pipe. A further service is indicated by the manhole and the paler fill in the rear of the pit

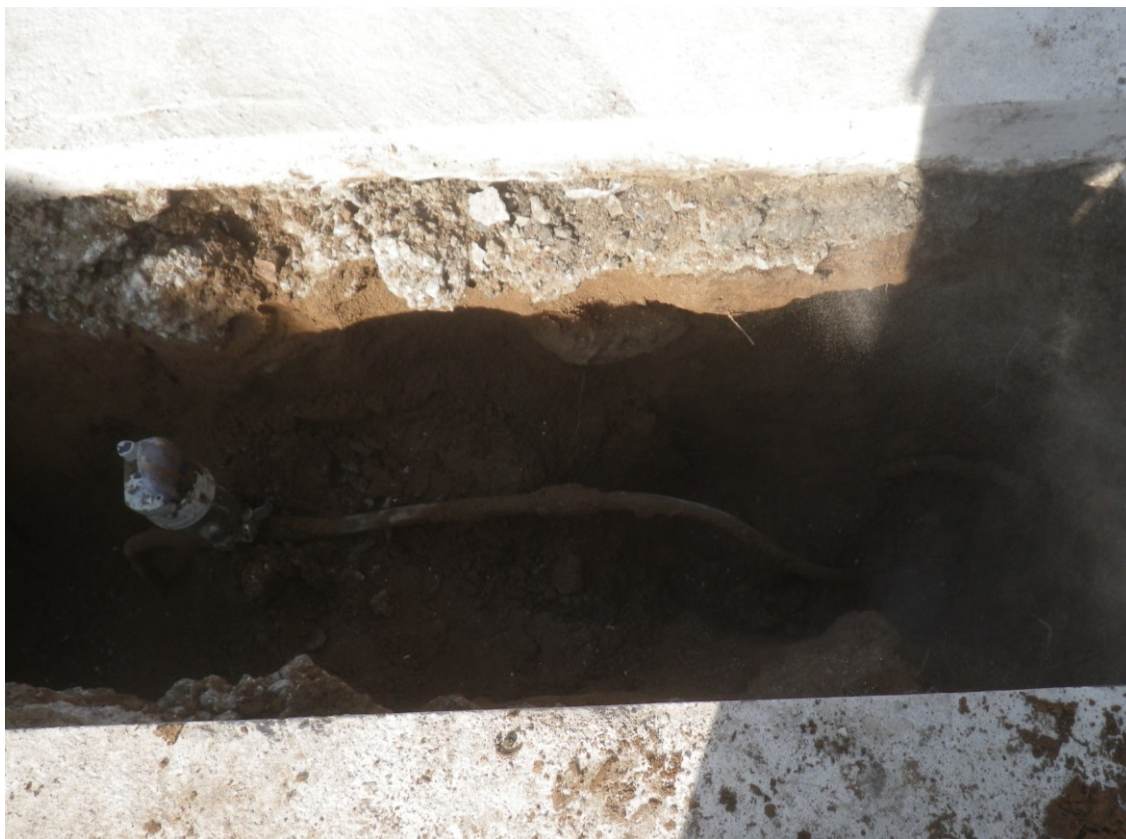
2.3 A total of 60 pits, averaging 0.6m x 5m x 1.6m, were excavated on the east side of Beckfield Lane. Within most of the pits, the excavations encountered only redeposited sand, however between numbers 194 to 196 (coordinates SE 56901 52765 to SE 56895 52693; Fig. 2), regular shaped sandstone blocks (Plate 2) were present within the redeposited fill. It was considered that these may represent the disturbed remnants of the Roman road, Dere Street, which passed through the area in this approximate location. Unfortunately, the anticipated route of the road was somewhat further to the south, and there were no finds or other archaeological features, so the interpretation remains speculative.

Plate 2. Beckfield Lane, Acomb: stones possibly derived from Roman road in otherwise sterile backfill

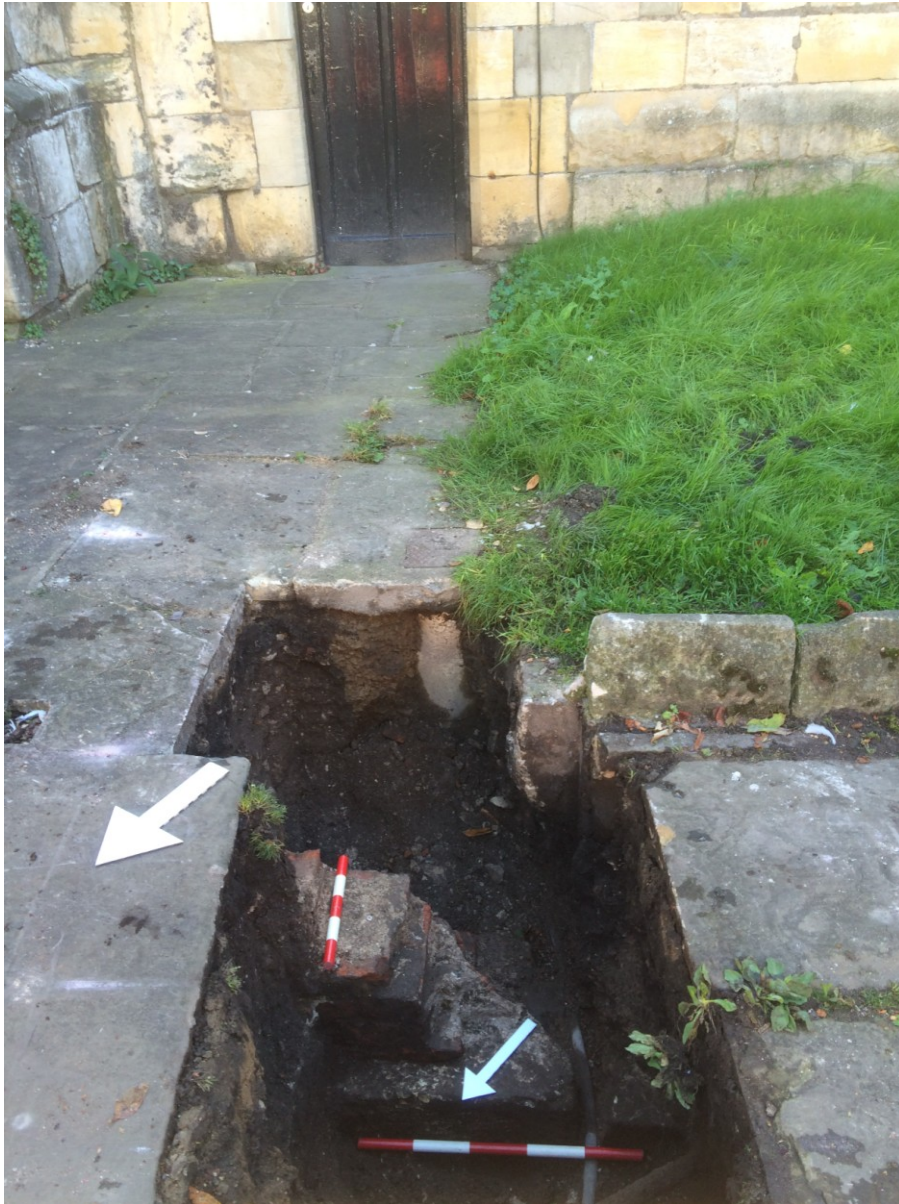
- 2.8 Marygate was the only street where there were definite archaeological remains. In a pit close to the Abbey Gatehouse, the footings of the front wall of a terrace of cottages were uncovered (Plate 3), comprising up to five courses of early brick with lime mortar upon a stone footing. The interior of the brickwork still retained its lime plaster (Plate 4). Cut into the stone footing was a channel containing a lead water pipe, probably originally serving the demolished dwelling but still in use today. The terrace of houses was situated to the west of the Abbey Gatehouse with the rear of the house abutting the Abbey wall (as per existing buildings on Bootham road). The York Archive holds two images of the terrace, an engraving from 1860 and a photograph from 1880. Historic mapping indicates that the cottages were demolished in the late 19th or early 20th century.

Plate 3. Marygate: footings of 19th-century terraced cottage showing gateway to abbey in background and inserted lead pipe

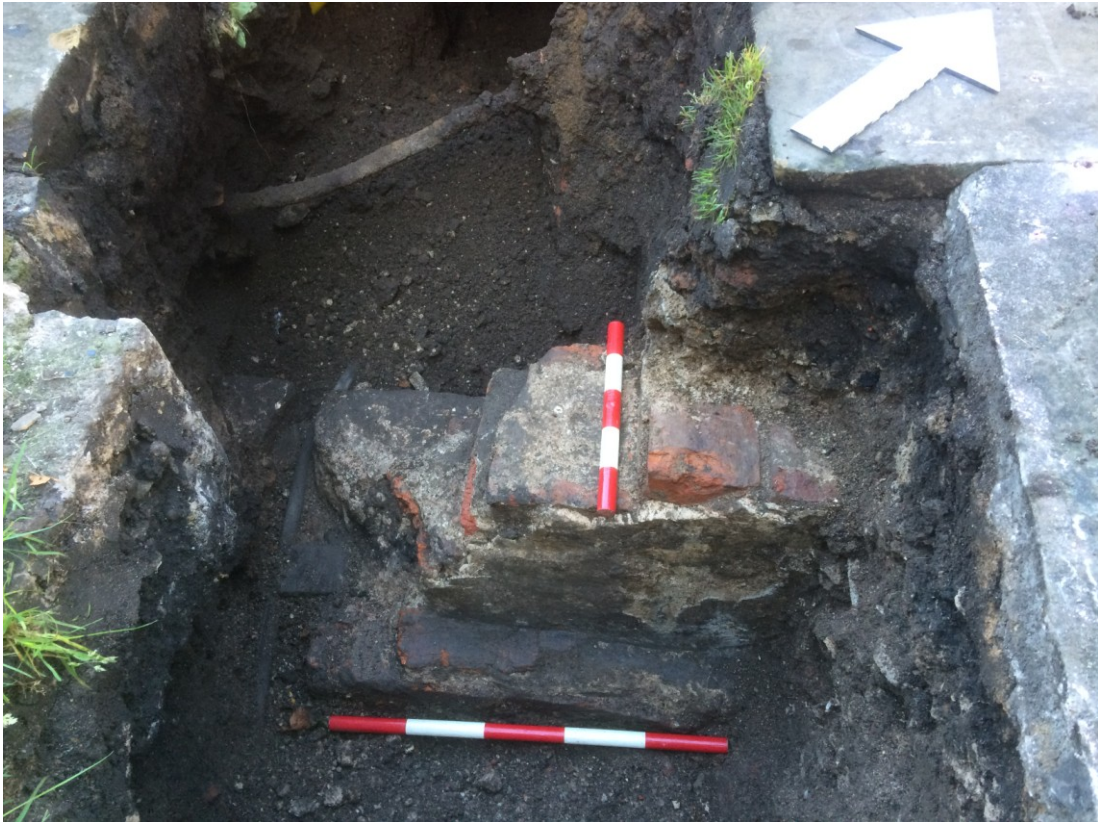
Plate 4. Marygate: interior face of wall footing showing lime plaster still in situ

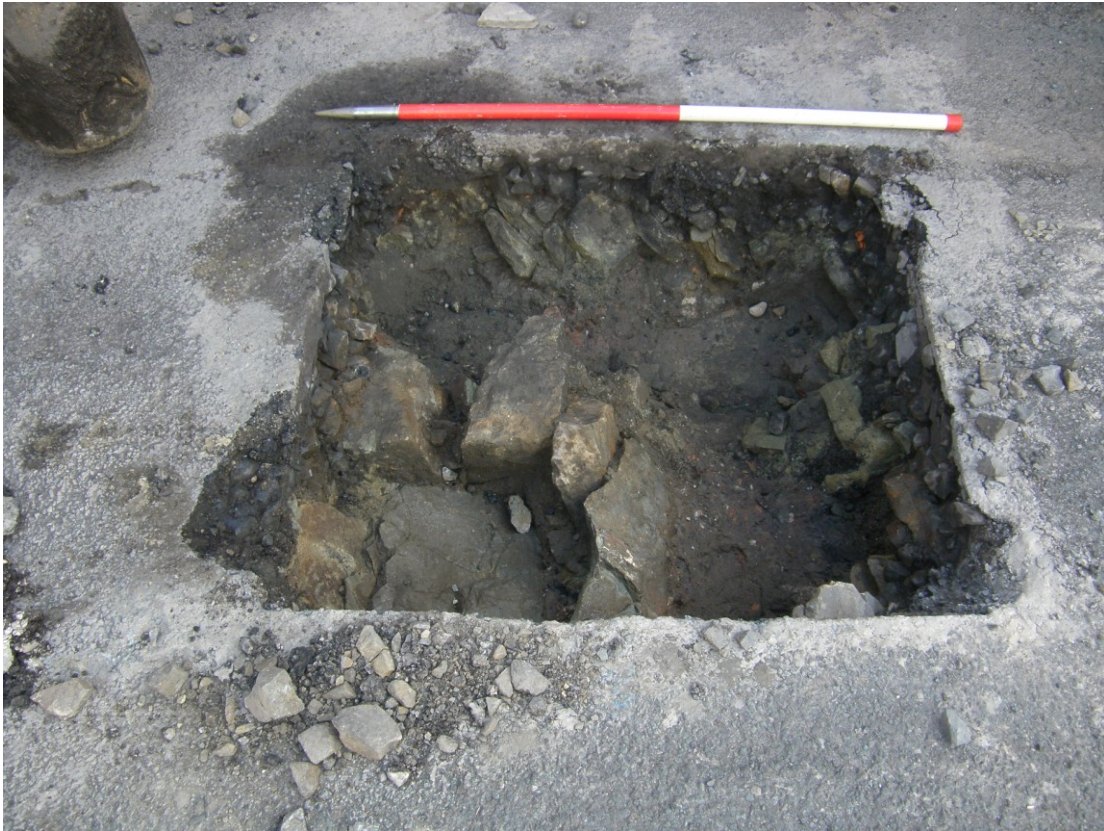
- 2.10 North Parade comprises terraced housing dating from c. 1905. A total of 49 pits were excavated within the roadway; the renewal also necessitated the removal of two paving slabs outside the entrance to each house, from the kerbside to the ownership boundary/gateway. Removal of the tarmac/ hardcore layer (up to 0.3m in depth) revealed a sandstone foundation layer (up to 0.5m in depth; Plate 5) which changed to a brick and rubble foundation in the last fifteen metres at the eastern end of the road. Initially it was thought that the stone was an earlier road surface, but once a larger area had been exposed, the pitched stones were clearly unsuitable for traffic, and it was probable that the road was thought to require a more sturdy foundation, possibly due to soft ground. In most of the road this foundation deposit had not been disturbed since the road was constructed, apart from areas where repairs had been carried out on services.

Plate 5. North Parade: pitched sandstone blocks used as road foundation
