Joseph Holt Ltd

The Abbey, 1 Hard Lane, Dentons Green,
St Helens, WA10 6TL

Archaeological Building Survey

05 March 2019

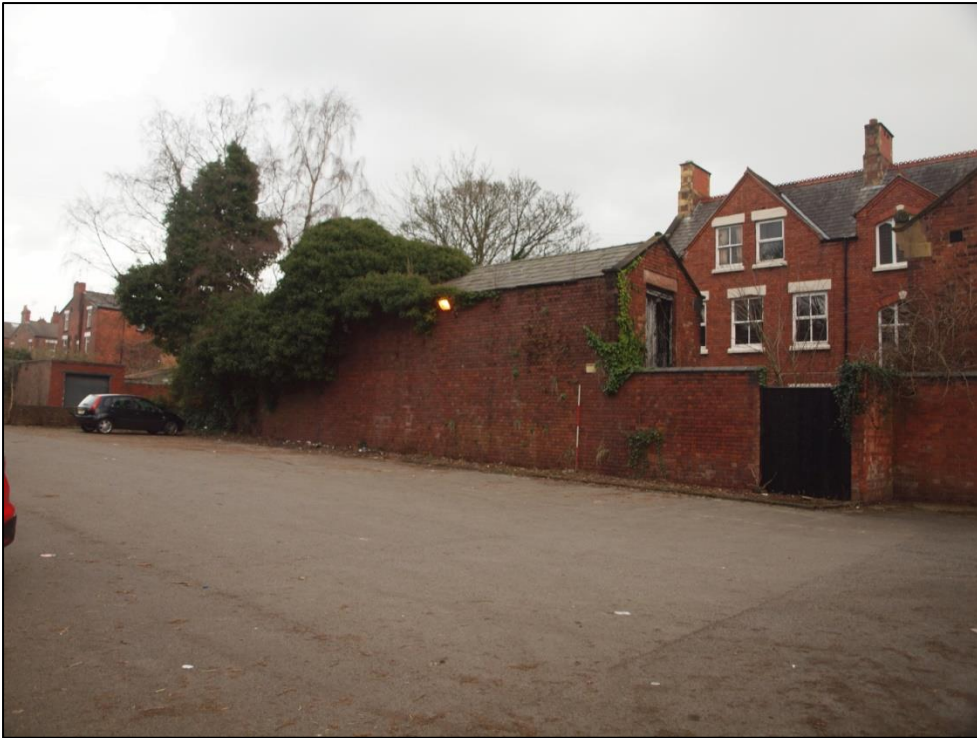
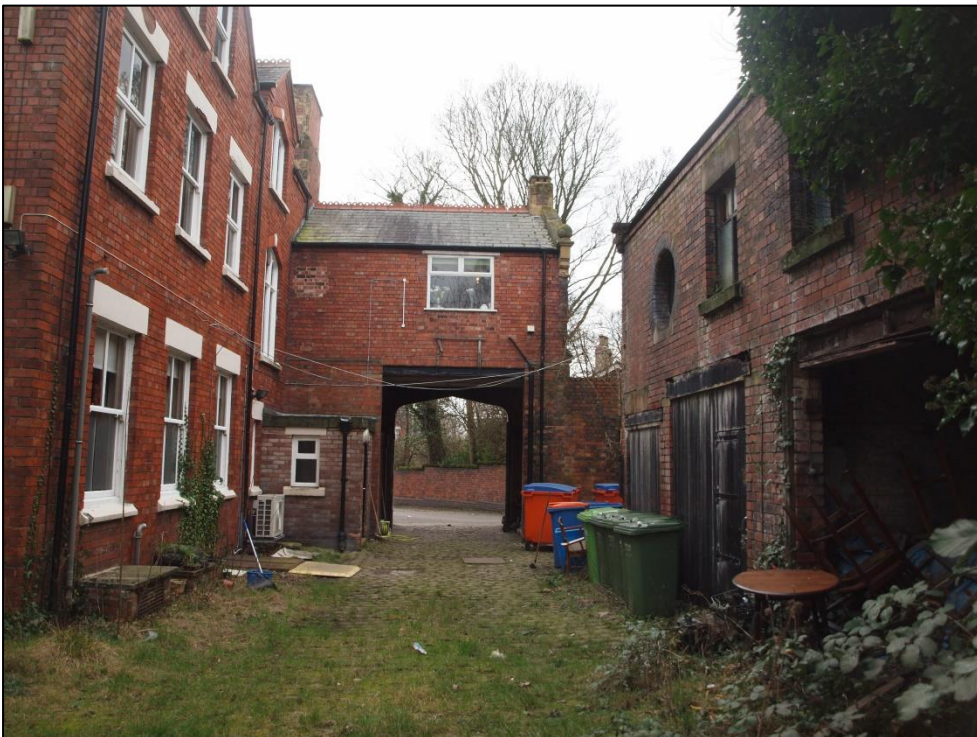
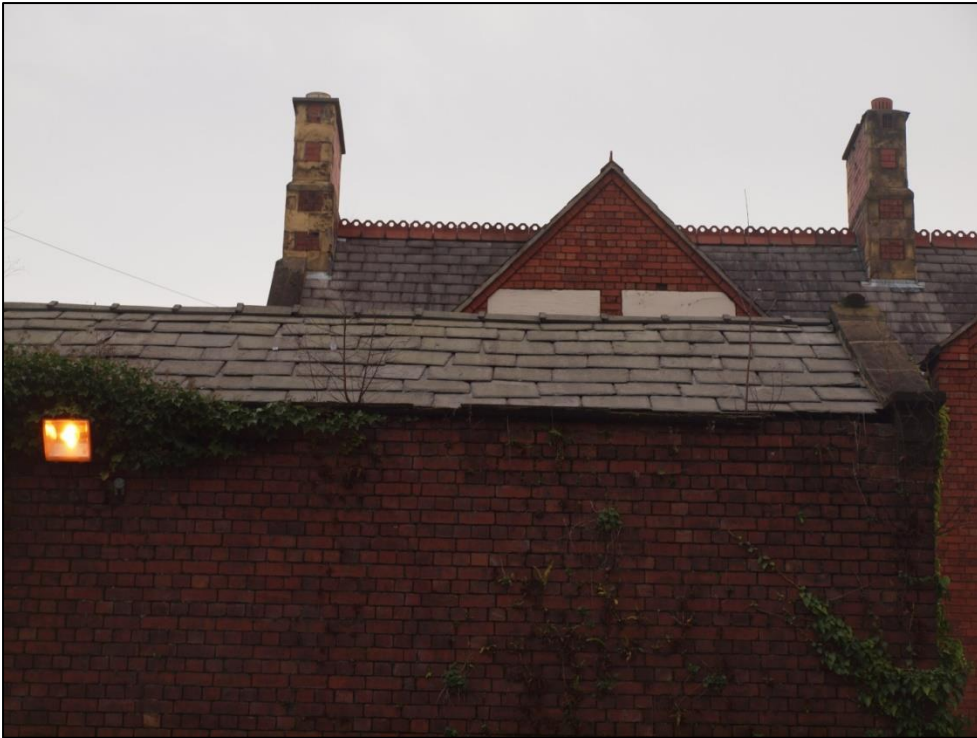
Plate 1: General shot of the outbuilding and the rear of the Abbey Public House

Plate 2: General shot of the yard showing the rear of the Abbey Public House (left) and the outbuilding (right)

Plate 3: Detail of slate roof

- 6.1 (Plates 1 – 3) The building is rectangular and aligned roughly north – south, with the main frontage facing east. It is brick built in English bond with a double pitched roof of Welsh slate. The main building is of 2 bays with a final bay to the north formed by a lean-to. The building as a whole is in a derelict condition, with the northern end heavily overgrown.

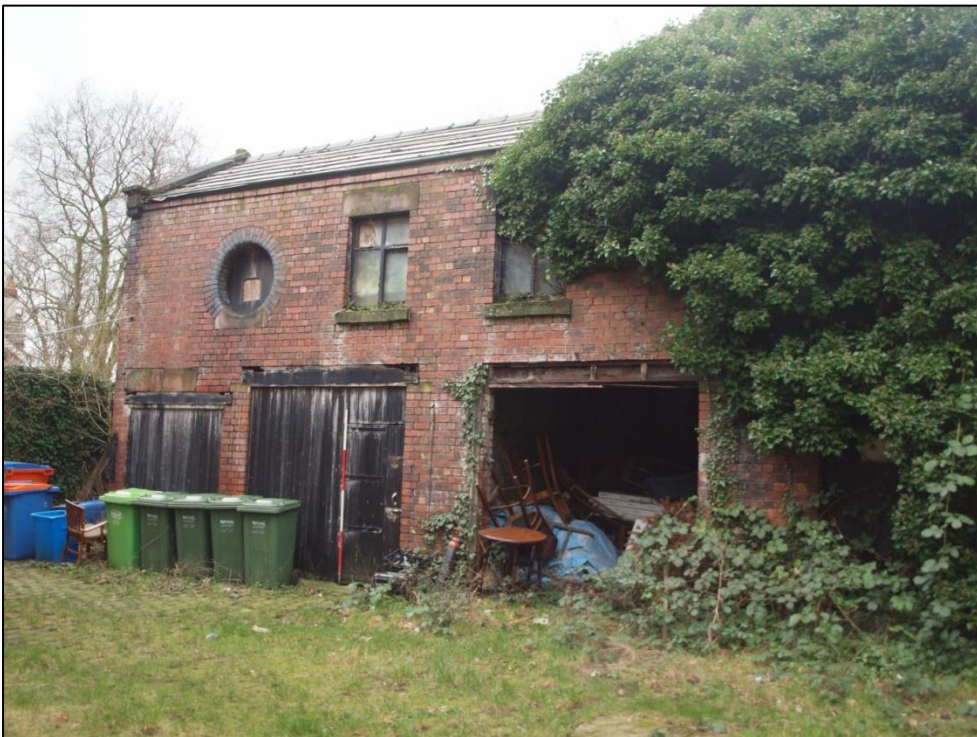
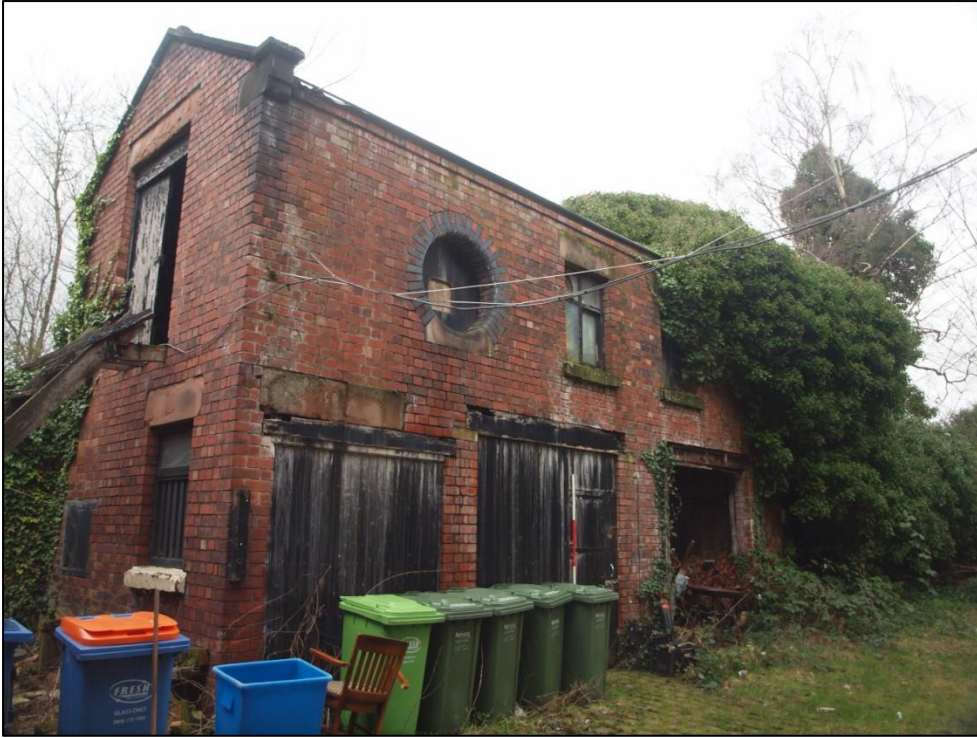
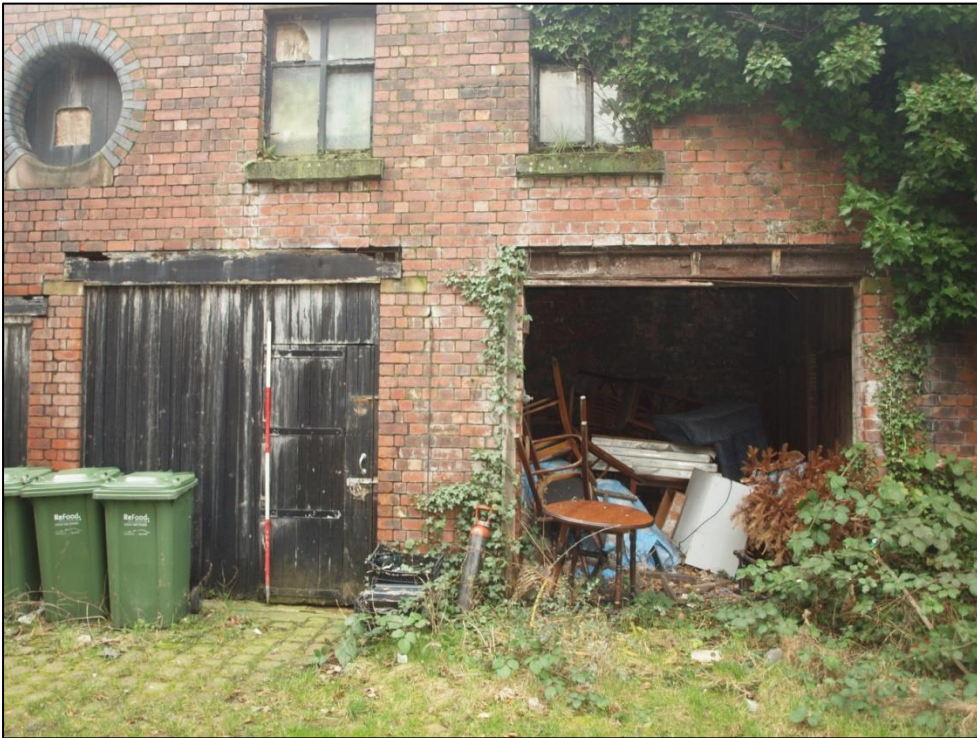
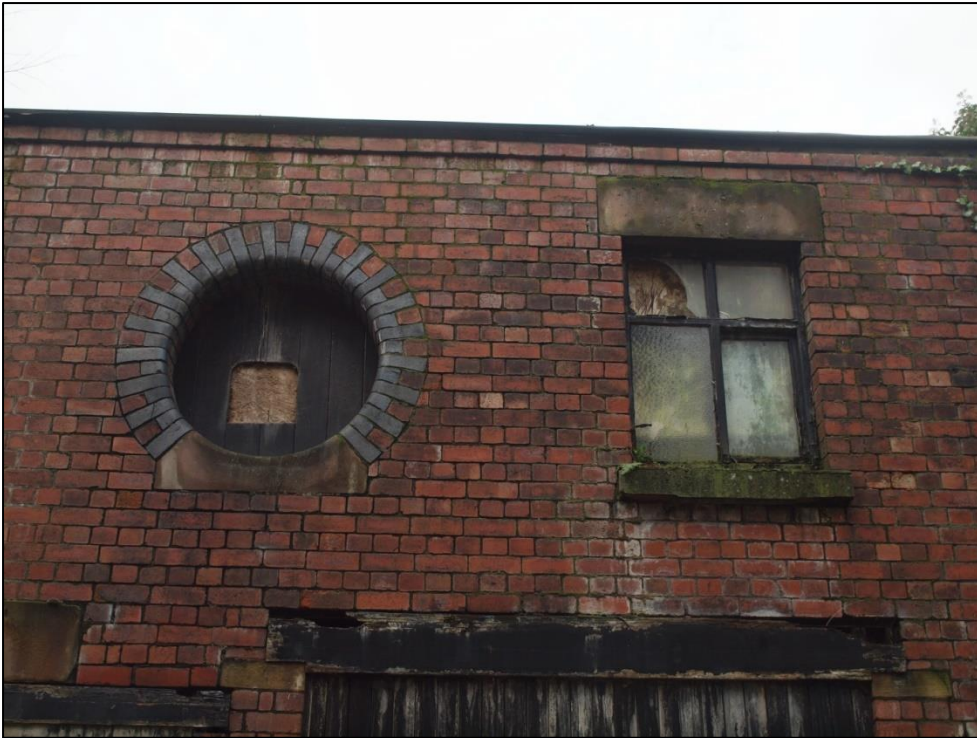
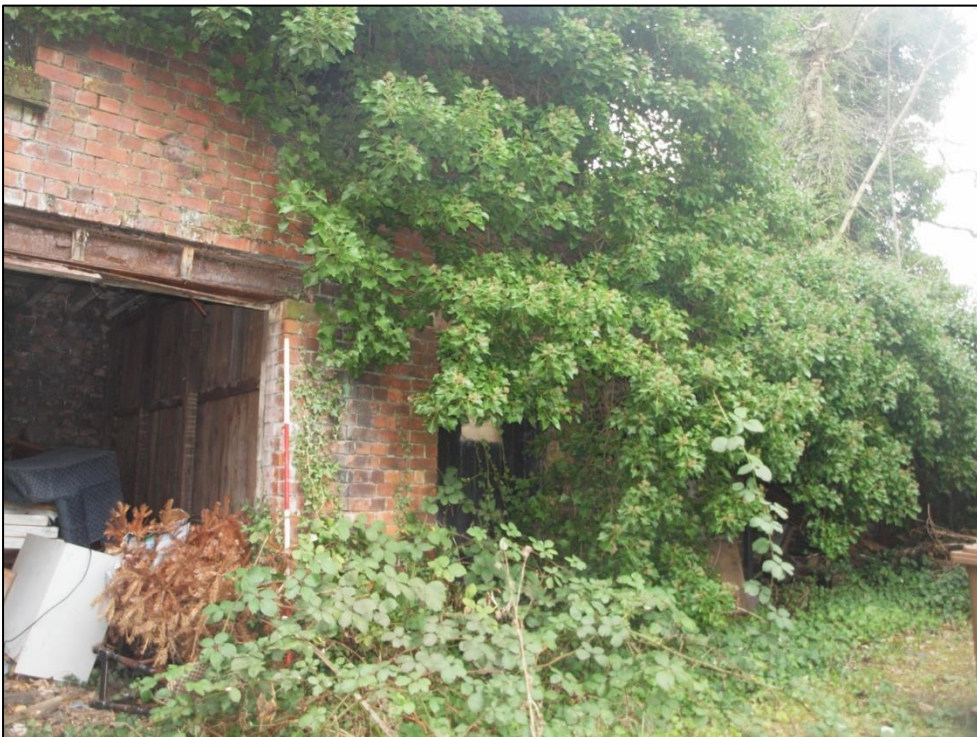
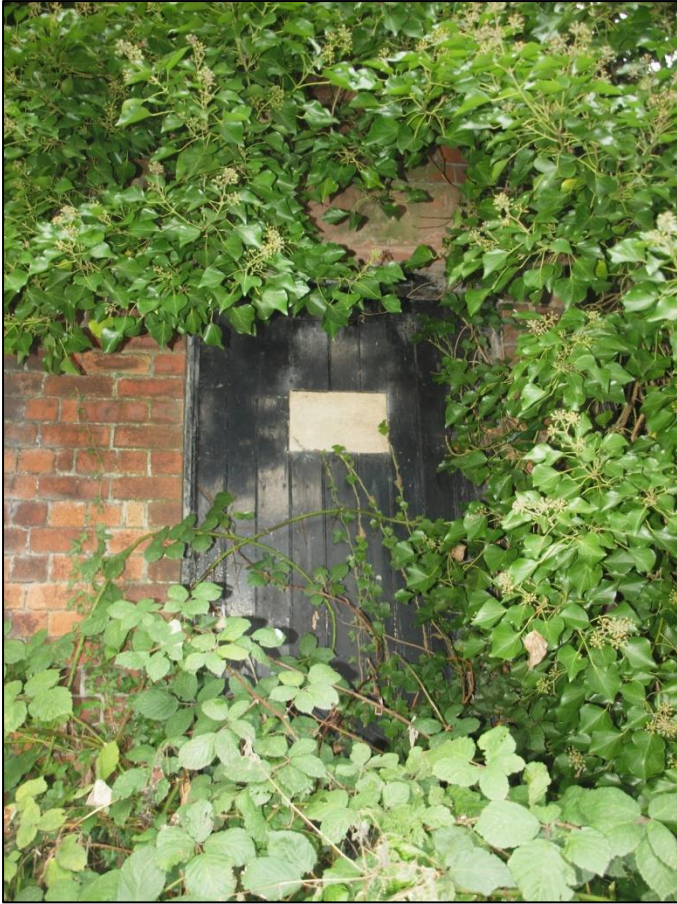
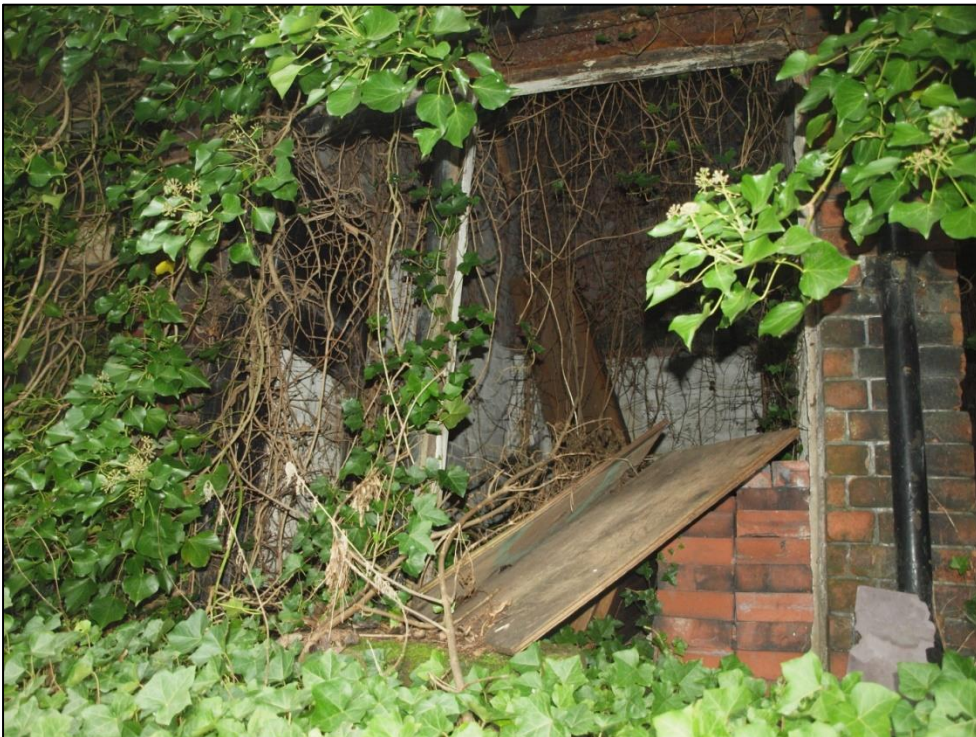
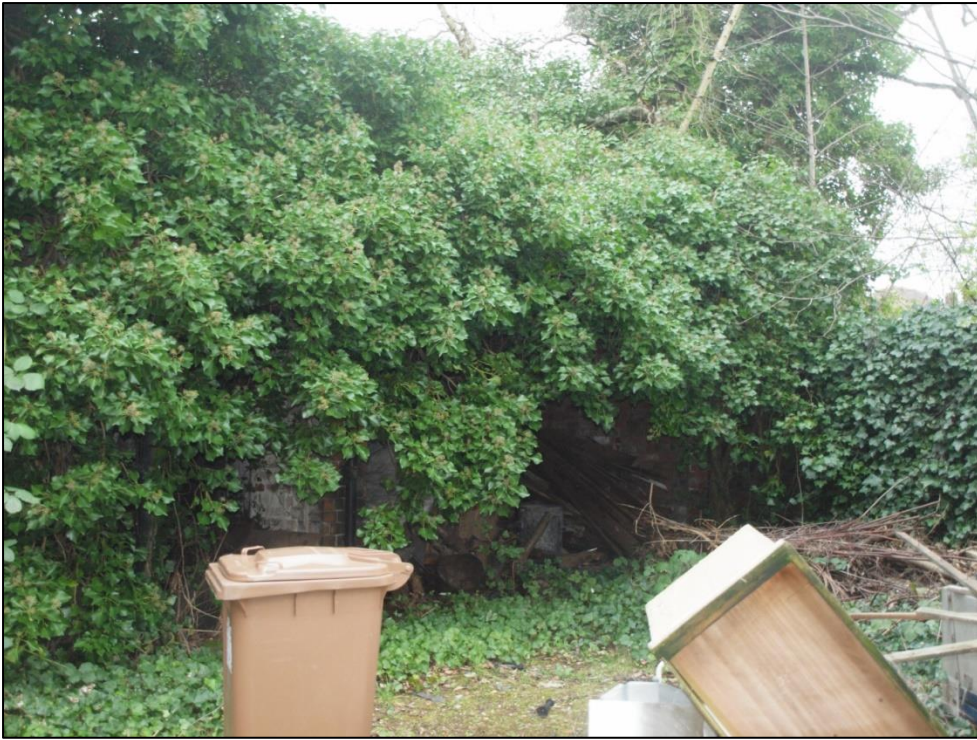
Plate 4: General shot of east elevation

Plate 5: Bay 1 of east elevation

Plate 6: Detail of inserted loading doors at south end of east elevation

Plate 7: Detail of first floor windows

Plate 8: Overgrown northern end of east elevation showing loading door to bay 2

Plate 9: Personnel door to bay 2

Plate 10: Southern loading door to bay 3

Plate 11: Northern end of bay 3

- 6.2 The eastern elevation (plates 4 – 11) forms the main frontage of the building, facing onto the rear yard of the Abbey Public House. At the southern end, is the first bay; at ground floor level a loading doorway has been inserted to the south side, with a timber lintel. Above this a heavy sandstone lintel is visible, suggesting that it replaced a personnel doorway. To the north is a further, larger loading door. This has a cast iron lintel covered with timber. Both doorways are blocked with timber, although the latter has a personnel doorway set within it. Both doorways lead into the first bay. At first floor level, a round pitching eye lies between the two doorways. This has a sandstone cill and engineering bull nosed brick around. To the north is a timber framed portrait window, with sandstone cill and lintel. To the north is bay 2. This has a large loading doorway at ground floor level with cast iron lintel. To the north a personnel doorway is located. This has a timber door hung, although is heavily overgrown. At first floor level, to the south side of the bay is a further timber framed portrait window, matching that of bay 1. Bay 3 is heavily overgrown. To the south side a loading doorway has been inserted and to the north the face is open, as a large loading doorway. This bay does not have a first floor, as it forms the lean-to.

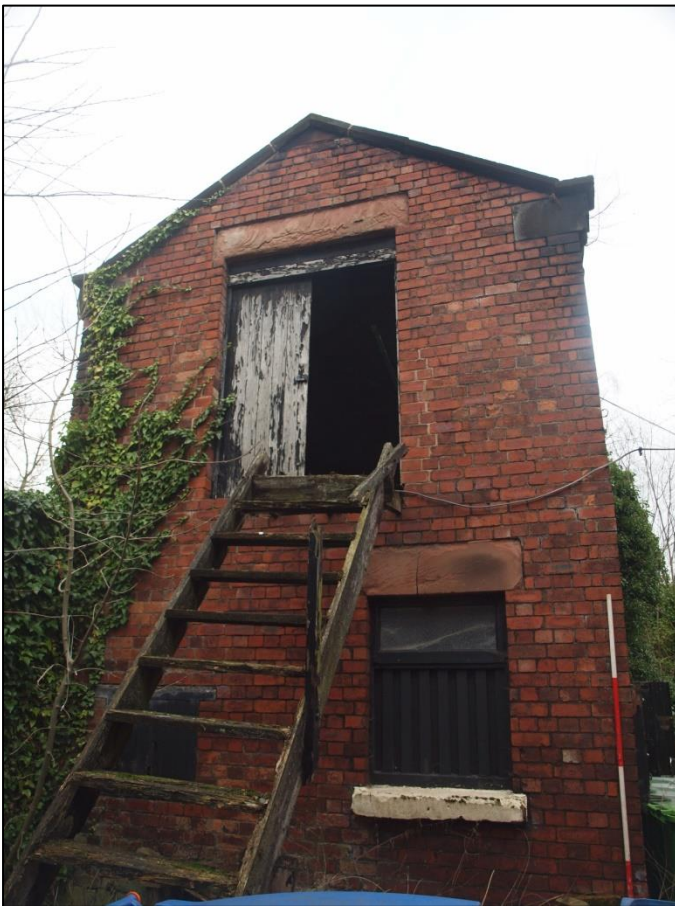
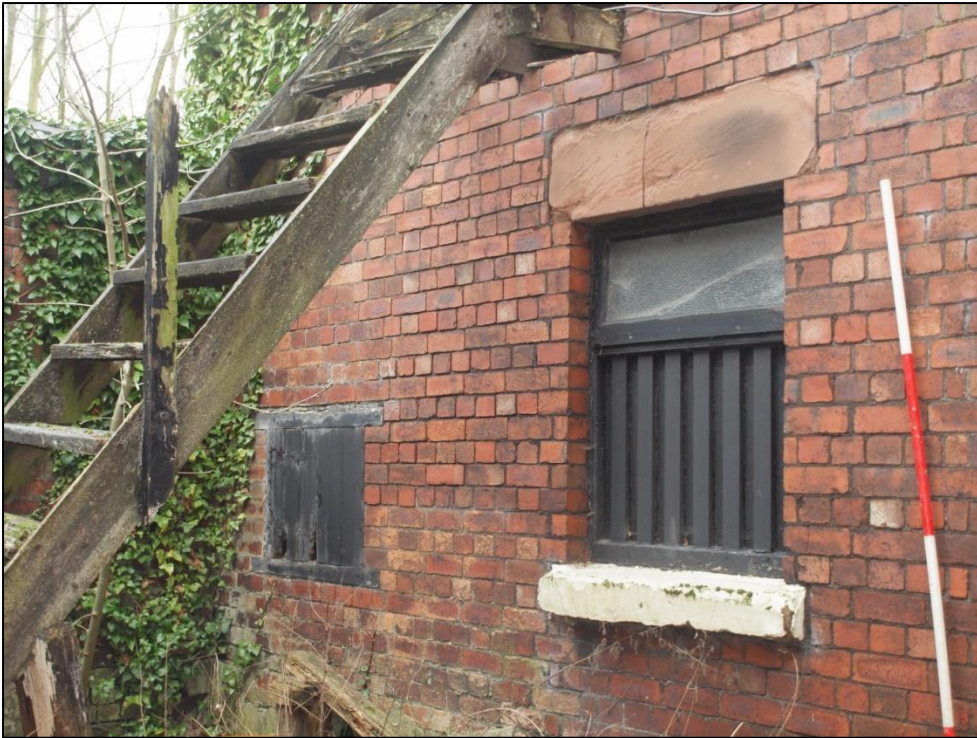
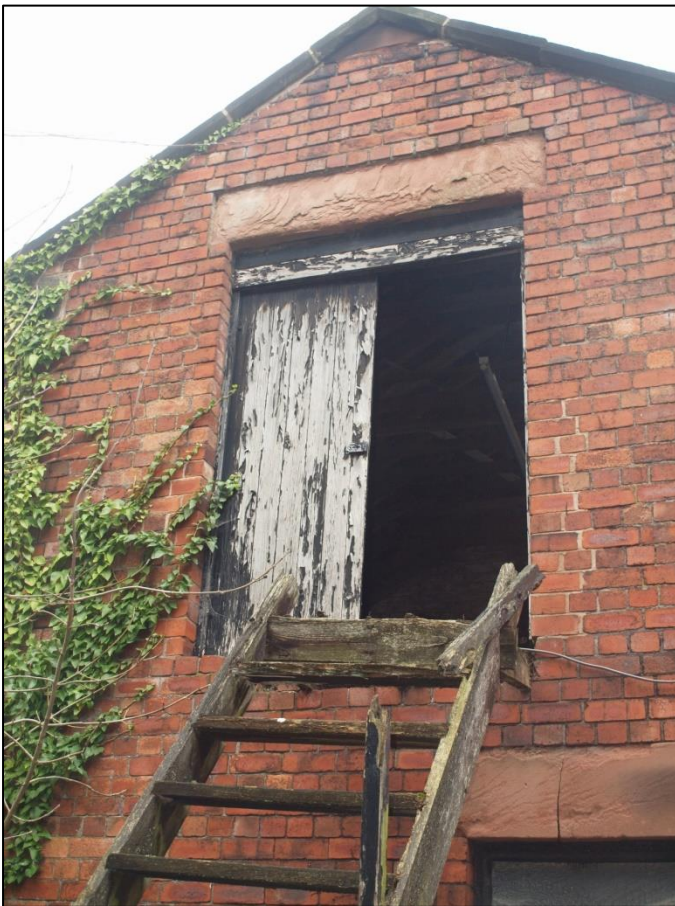
Plate 12: Southern gable

Plate 13: Detail of ground floor windows

Plate 14: Detail of first floor doorway

- 6.3 South elevation (plates 12 – 14). This forms the main gable end of the building also facing onto the yard. At ground floor level are a pair of timber framed windows. That to the east is a timber framed casement with a heavy sandstone lintel and whitewashed sandstone cill. The window to the west is timber framed landscape window, fitted with a timber shutter. At first floor level, in the centre of the face is a wide double doorway. This has a sandstone

lintel above and has a pair of timber double doors hung. To the east a rough joint is visible, suggesting that the doorway may have been widened. A set of timber steps lead up to the doorway from the yard, although these are rotten. The gable is topped with sandstone coping and has sandstone blocks at the eaves.

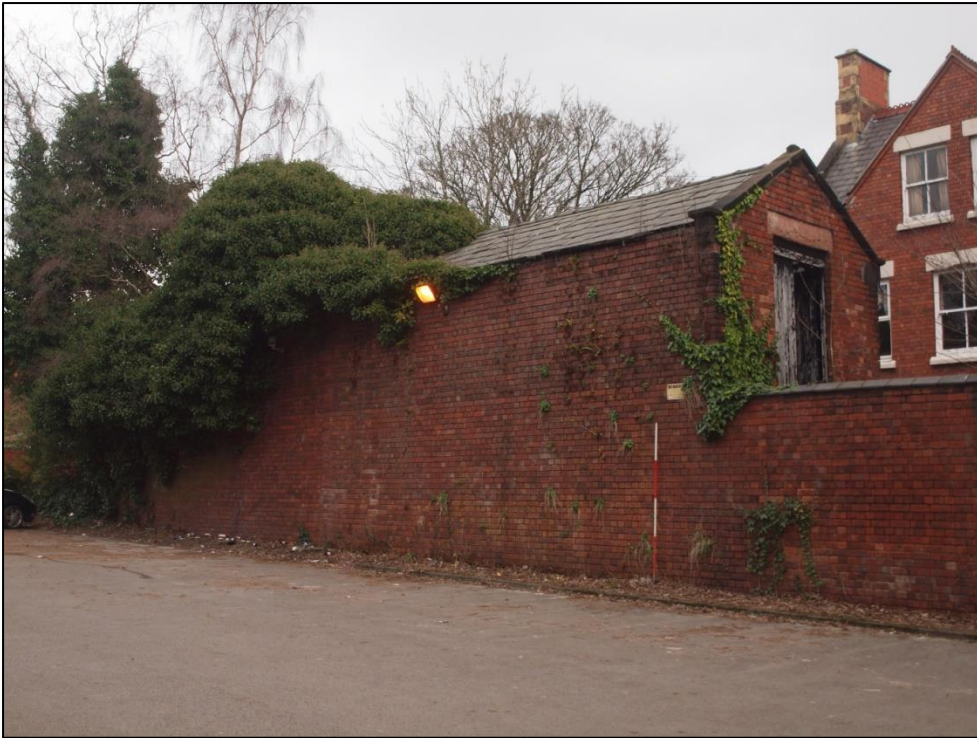
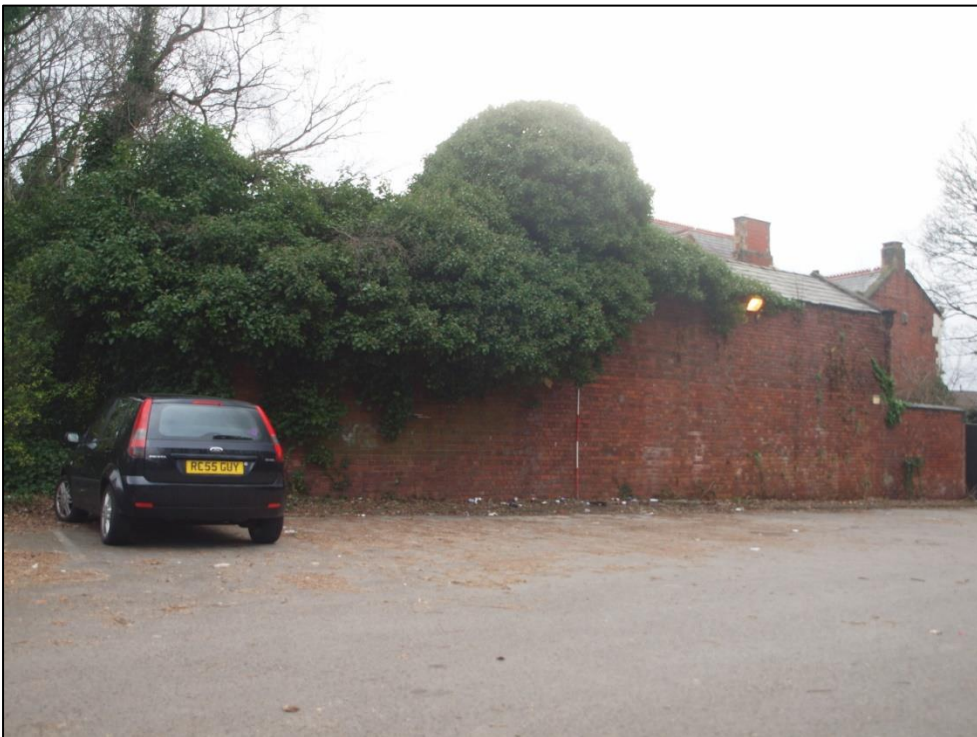
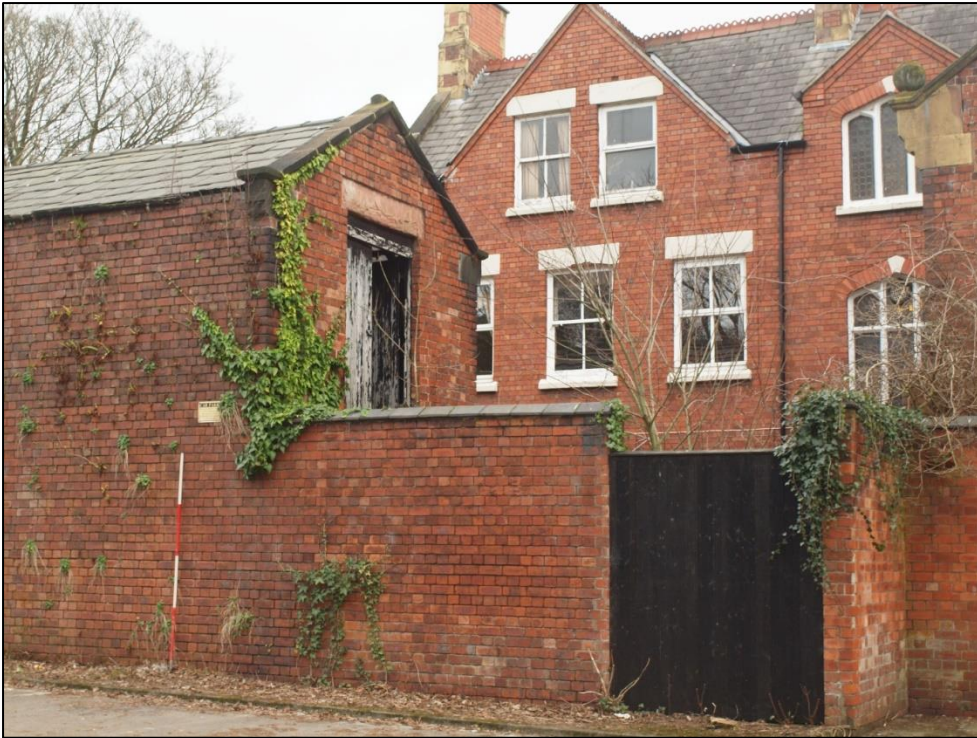
Plate 15: West elevation

Plate 16: West elevation showing overgrown north end

Plate 17: Wall of west elevation continues south with gate to yard

- 6.4 West elevation (plates 15 – 17). This elevation fronts the carpark and is featureless. The northern end is once again overgrown. To the south the face continues as a single story wall with a gate inserted.
- 6.5 North elevation (plates 18 & 19). This forms the end of the lean-to and is heavily overgrown, obscuring any features.

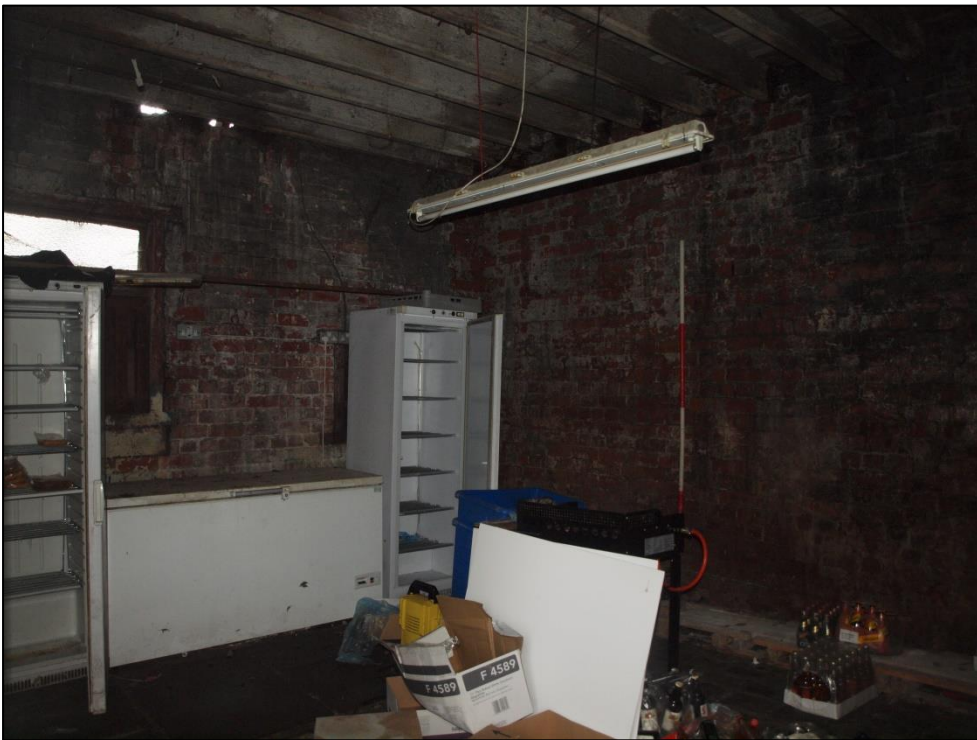
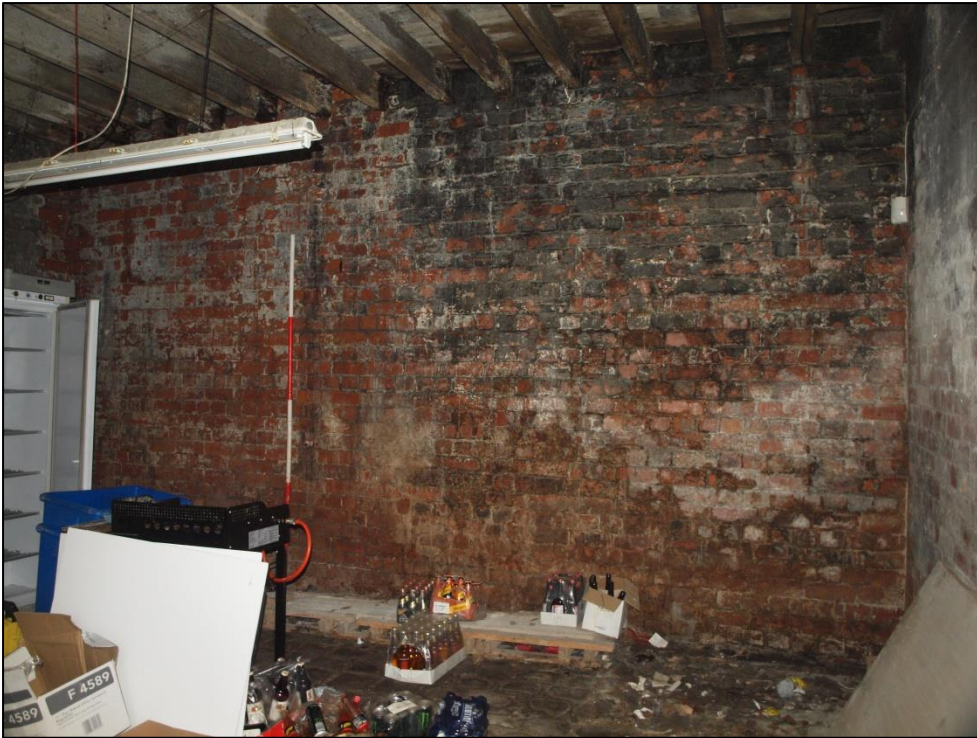
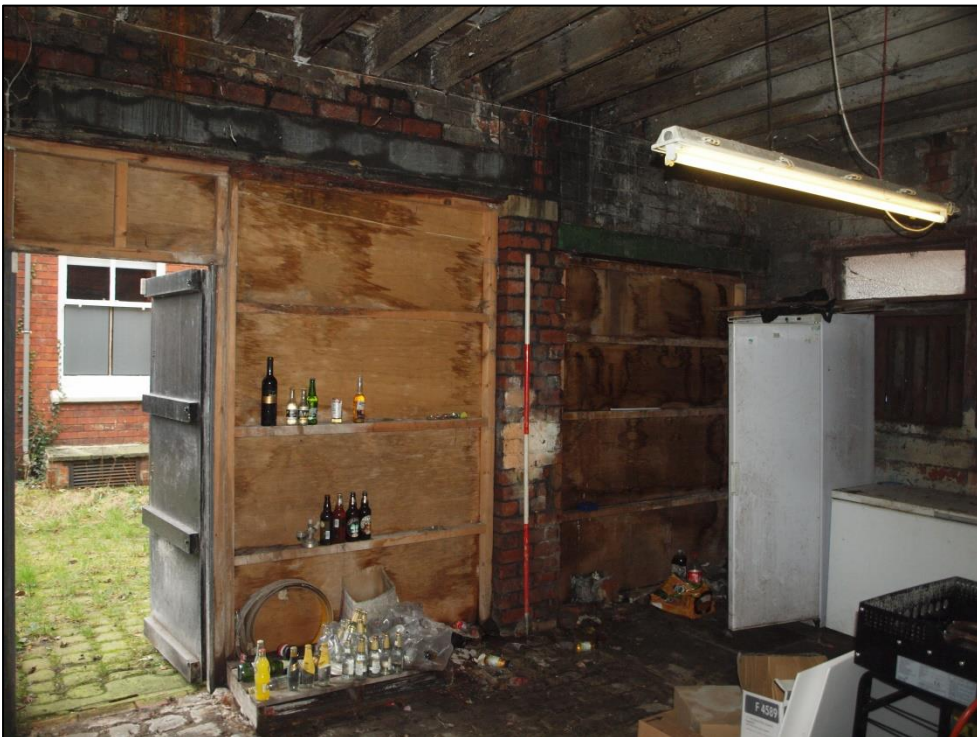
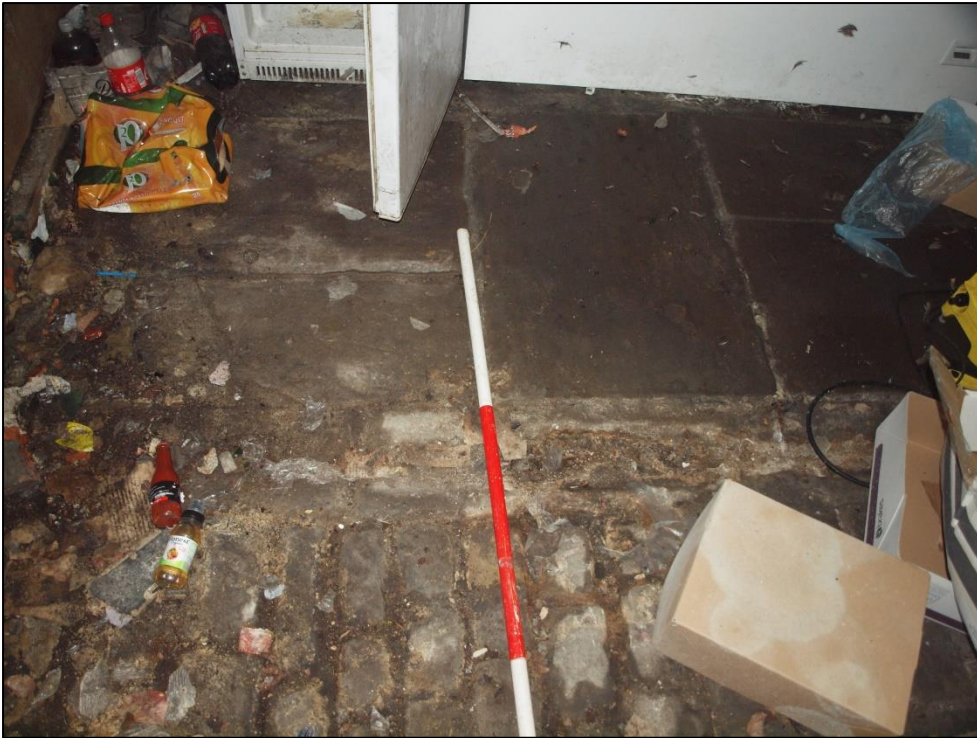
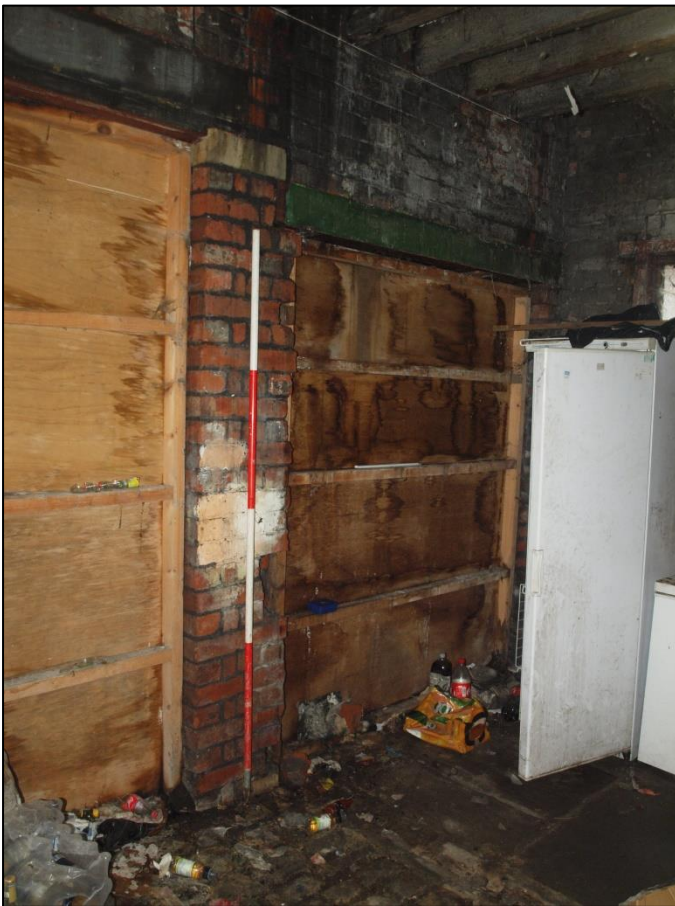
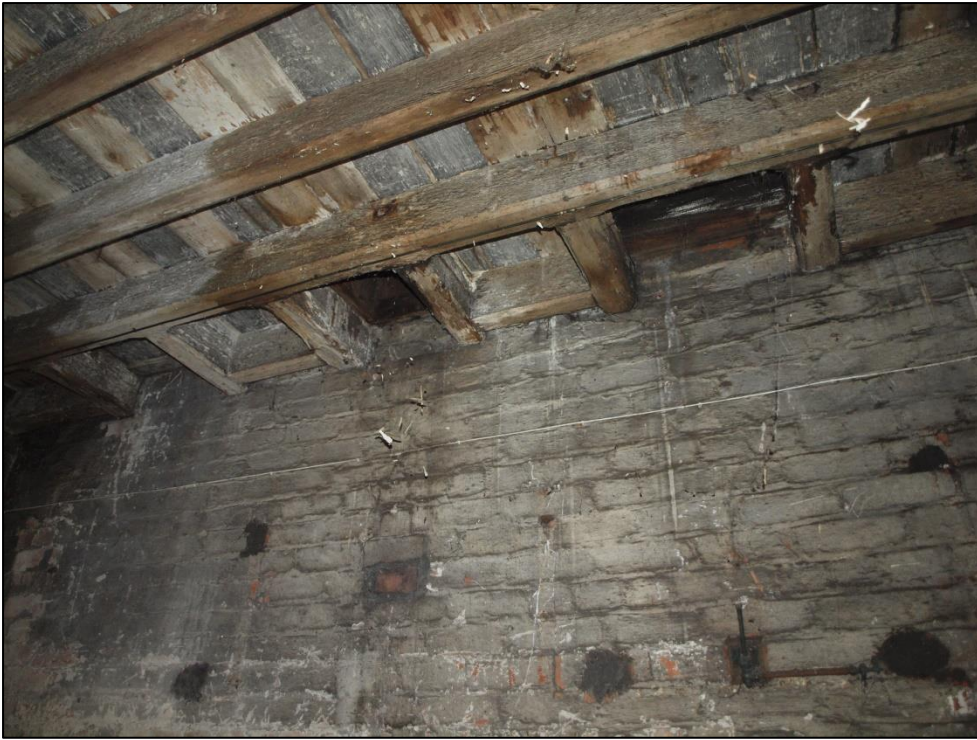
Plate 20: Bay 1 interior

Plate 21: Bay 1 interior

Plate 22: Bay 1 showing loading doorways

Plate 23: Flagged and cobbled surfaces in bay 1

Plate 24: Detail of doorways

Plate 25: Detail of hatches in bay 1 ceiling

- 6.6 At the southern end the personnel doorway within the loading door gives access to the interior of bay 1 (plates 20 – 25). This has a cobbled floor to the north side with flags to the south, both separated by a drain channel running from the west wall to the east. The walls are bare brick, although traces of whitewash are still visible, and the ceiling is open to the machine cut timber joists of the floor above. To the north side three hatches lie in the ceiling, likely for food hoppers.

- 7.1 The outbuilding appears to have been erected as a combination shippon and storage barn by John Almond around the turn of the century. The first two bays appear to have been used for animal housing. In bay 1 three stalls would have been along the north wall, with feed dropped through the hatches from the first floor into the stalls. The same would have happened in the second bay, along the south wall. The floor to bay 1 also suggests animal housing, with the drain channel. Further confirmation can be seen in the southern end of bay 1, where the large loading doorway opening has replaced a personnel doorway, evidenced by the sandstone cill. This is still present in bay 2, which was likely a mirror image of bay 1.

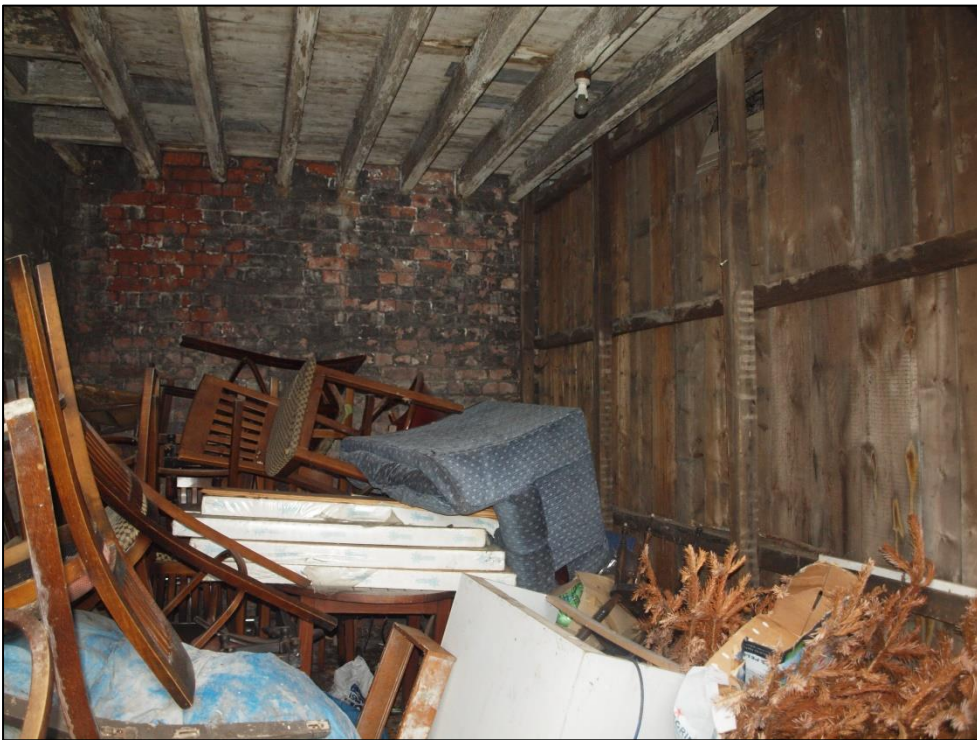
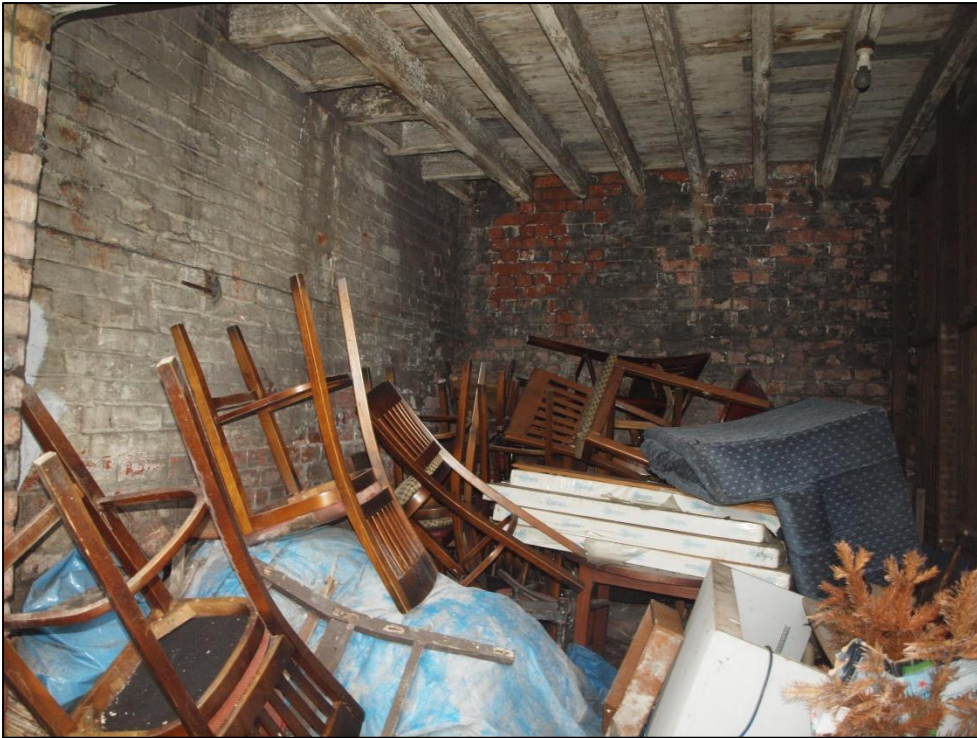
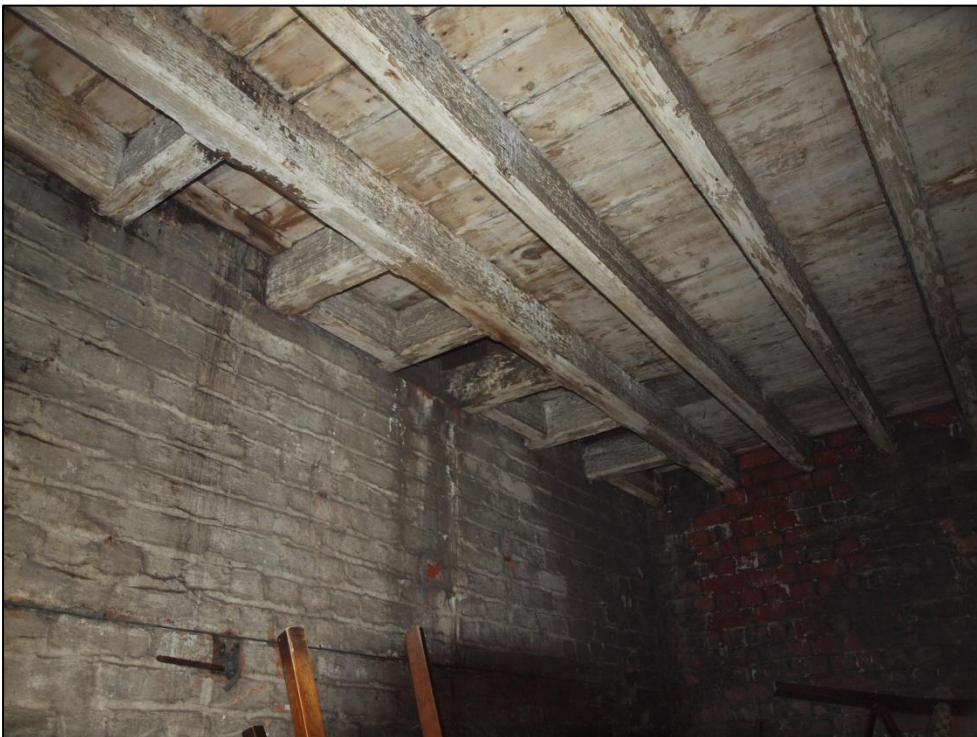
Plate 26: Bay 2, southern end showing inserted timber wall

Plate 27: Bay 2 southern end

Plate 28: Detail of hatches in ceiling of bay 2

- 6.7 To the north the second bay (plates 26 – 28) is accessed via the loading doorway. This does not have a door hung and is open to the exterior. However, it was not fully accessible. The walls were once again brick with traces of paint and the ceiling open to the machine cut timber joists of the floor above. Again, to the south side of the ceiling were three hatches, mirroring those in the first bay. To the north side a timber wall has been inserted to create a separate room. This would have been accessed via the personnel doorway to the east side of the bay, but it was inaccessible.
