Joseph Holt Ltd

The Abbey, 1 Hard Lane, Dentons Green,
St Helens, WA10 6TL

Archaeological Building Survey

05 March 2019

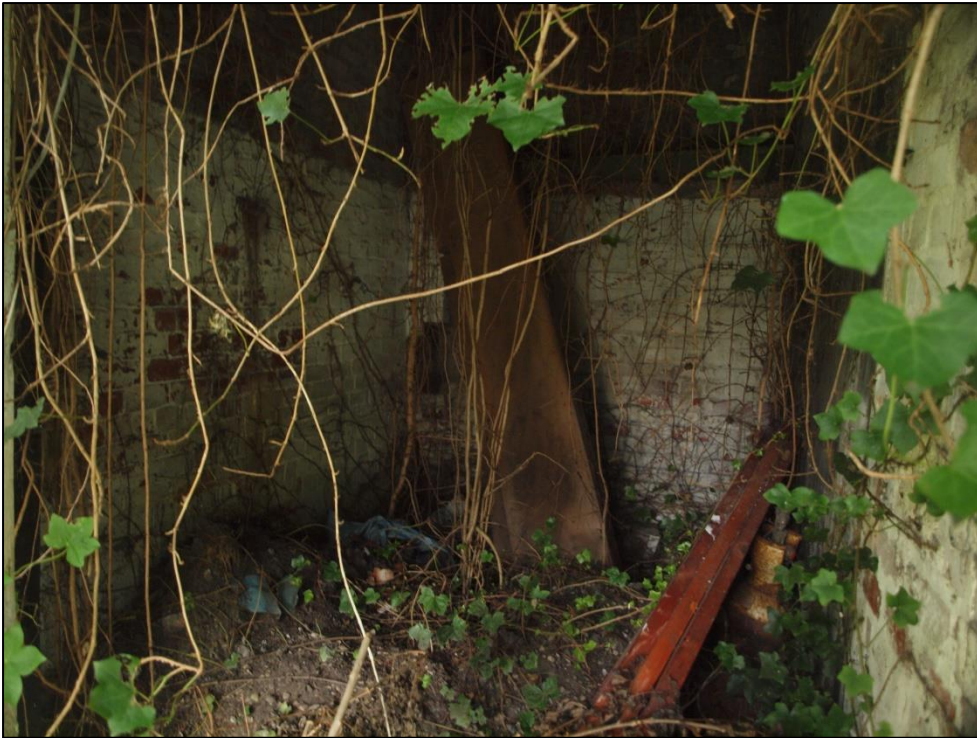
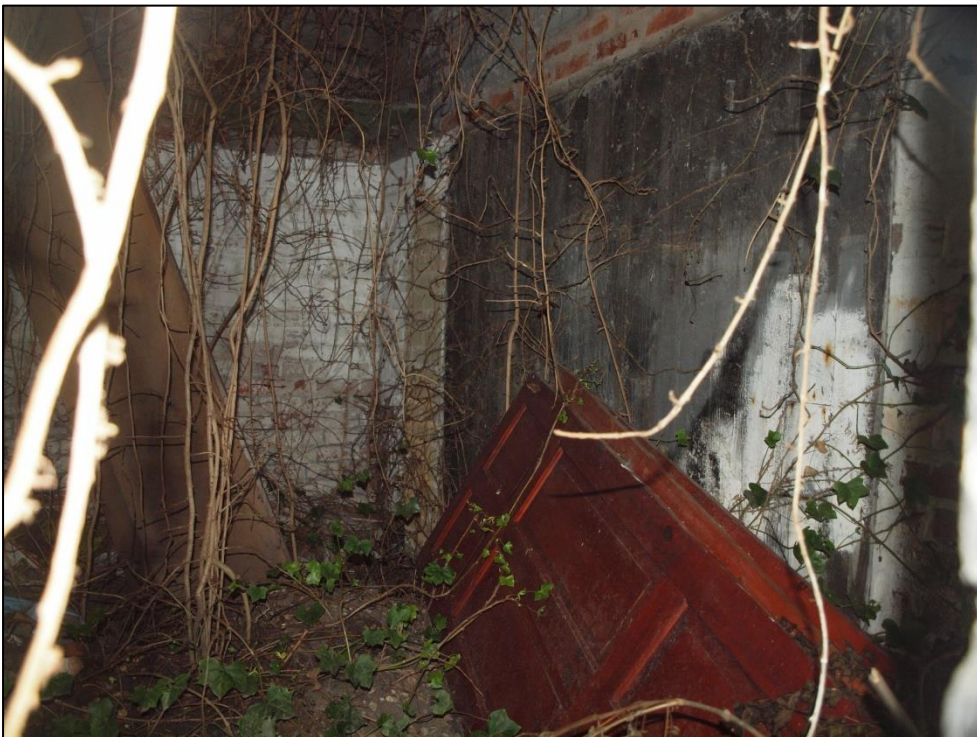
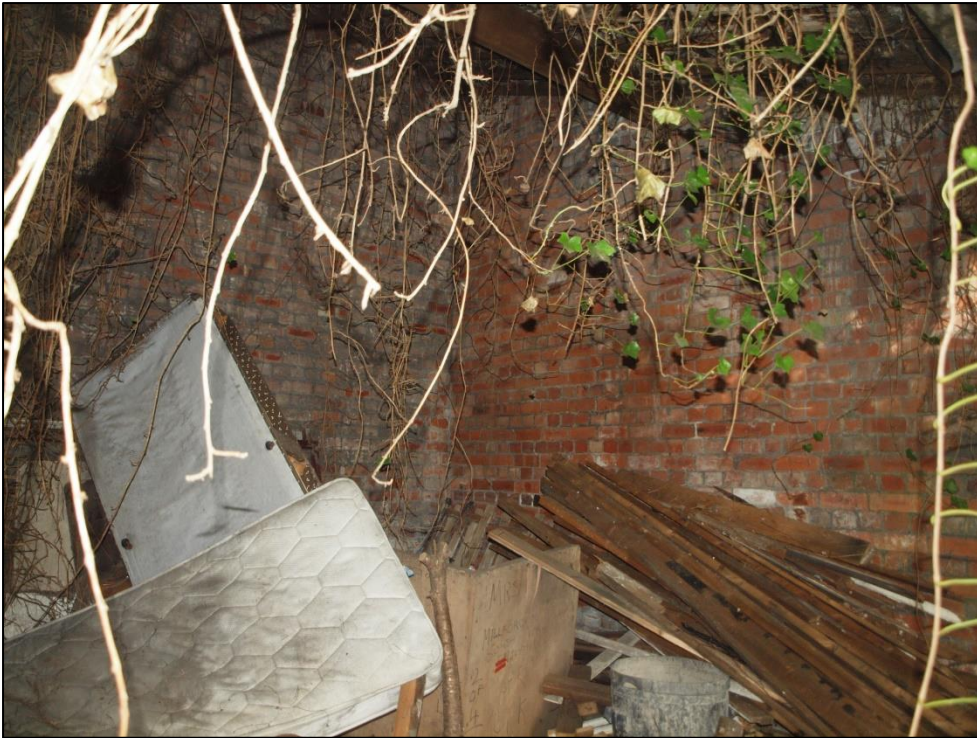
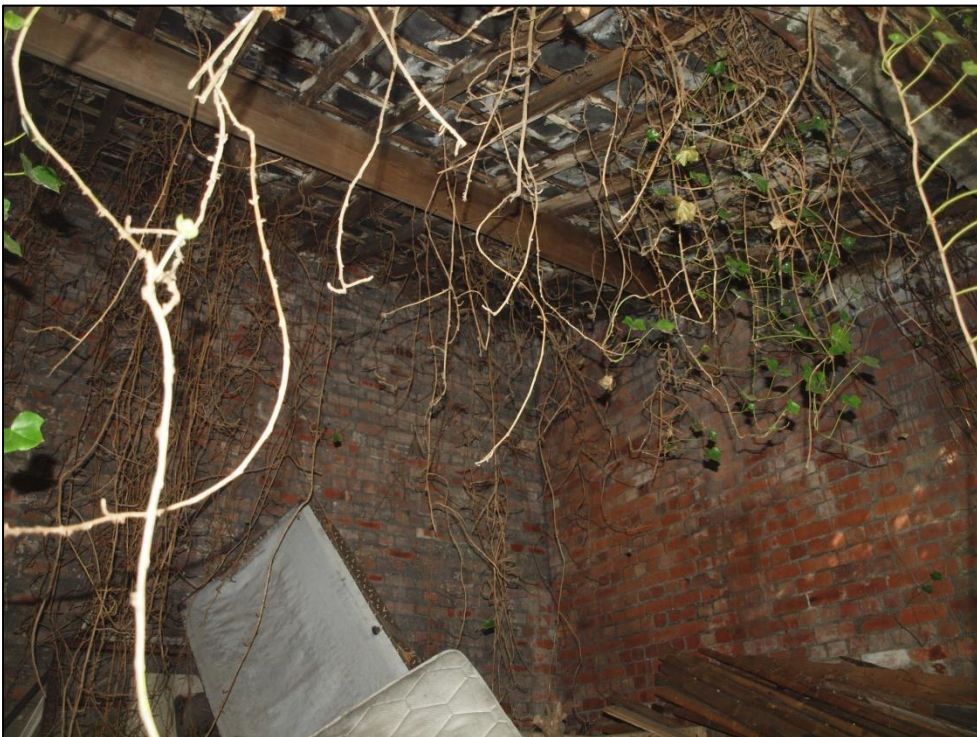
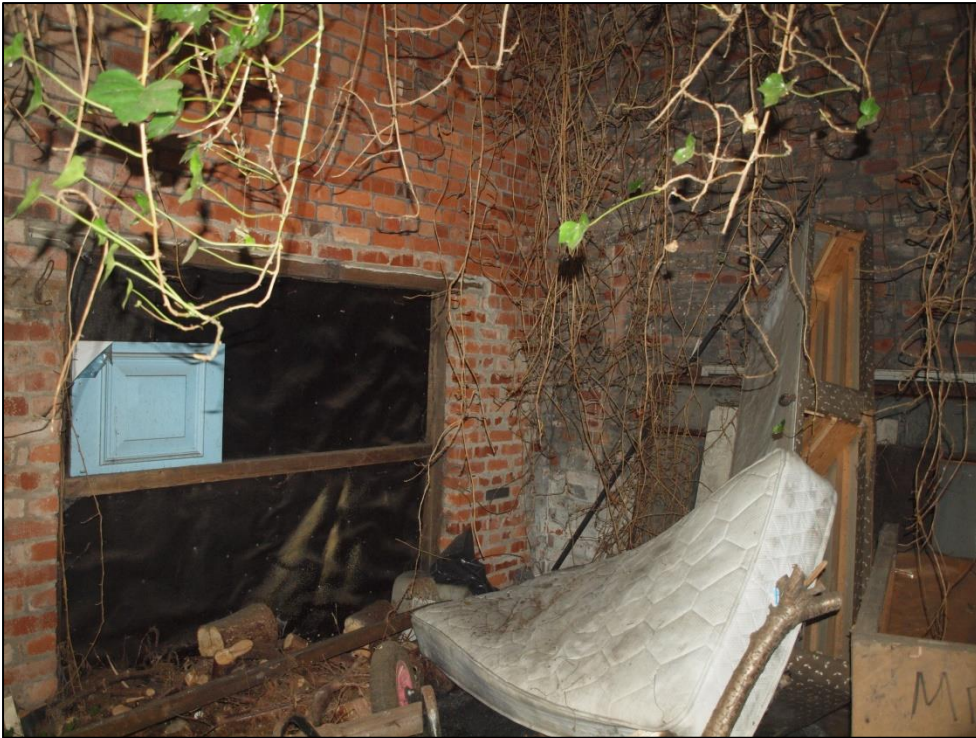
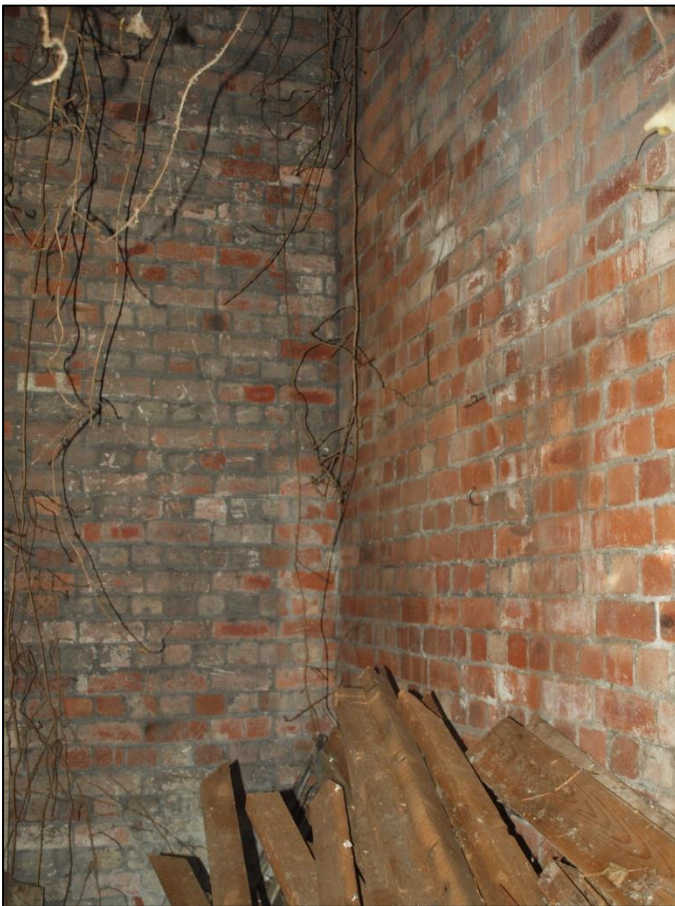
Plate 29: Southern end of bay 3

Plate 30: Southern end of bay 3

Plate 31: Northern end of bay 3

Plate 32: Detail of roof of northern end of bay 3

Plate 33: Inserted wall and opening in northern end of bay 3

Plate 34: Different brick between west wall (left) and redder brick of north wall (right) in bay 3

- 6.8 The south side of bay three (plates 29 & 30) was accessed via the southern loading doorway. Again, this area was only accessible visually. The walls were white washed brick and the ceiling open to the single pitch of the lean-to. This was supported on a single

machine cut timber purlin running north – south. To the north a wall has been inserted with a large opening within it, although this has subsequently been blocked with timber. To the north (plates 31 – 34) the room is much the same, although here the opening in the inserted party wall can be seen to have also been inserted. The north wall of the room also appears to be of a different, redder, brick, suggesting that it may have been rebuilt.

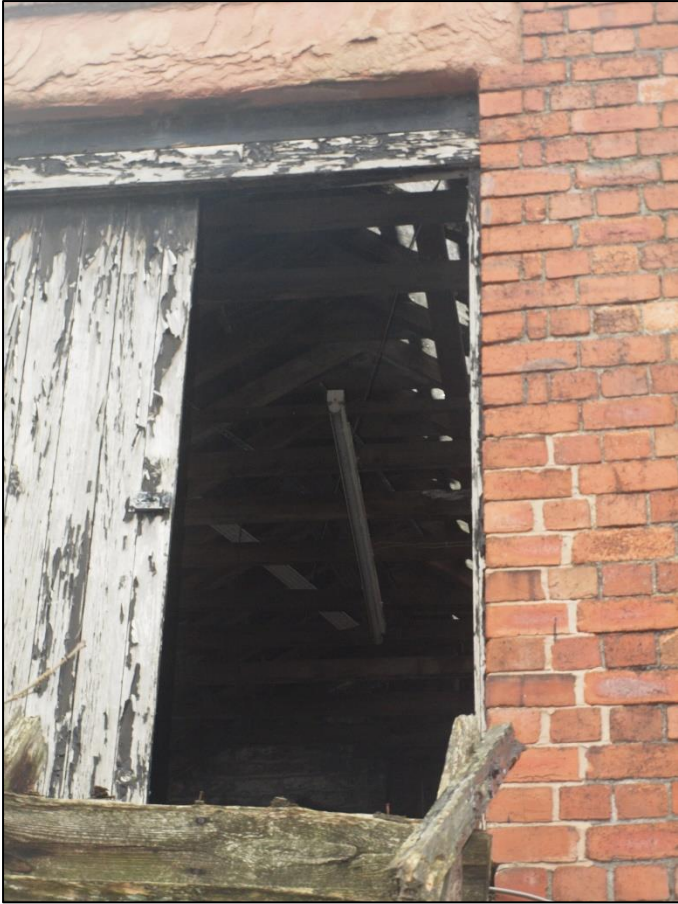
Plate 35: View into first floor showing roof trusses.

6.9 The first floor (plate 35) was inaccessible. However, from the exterior, through the first floor doorway, the roof could be seen to be supported on several (approximately 11) modern machine cut timber 'A' frame trusses.
