**Report on Archaeological Works at
29 Bedhampton Road, Havant, Hampshire**

May 2013

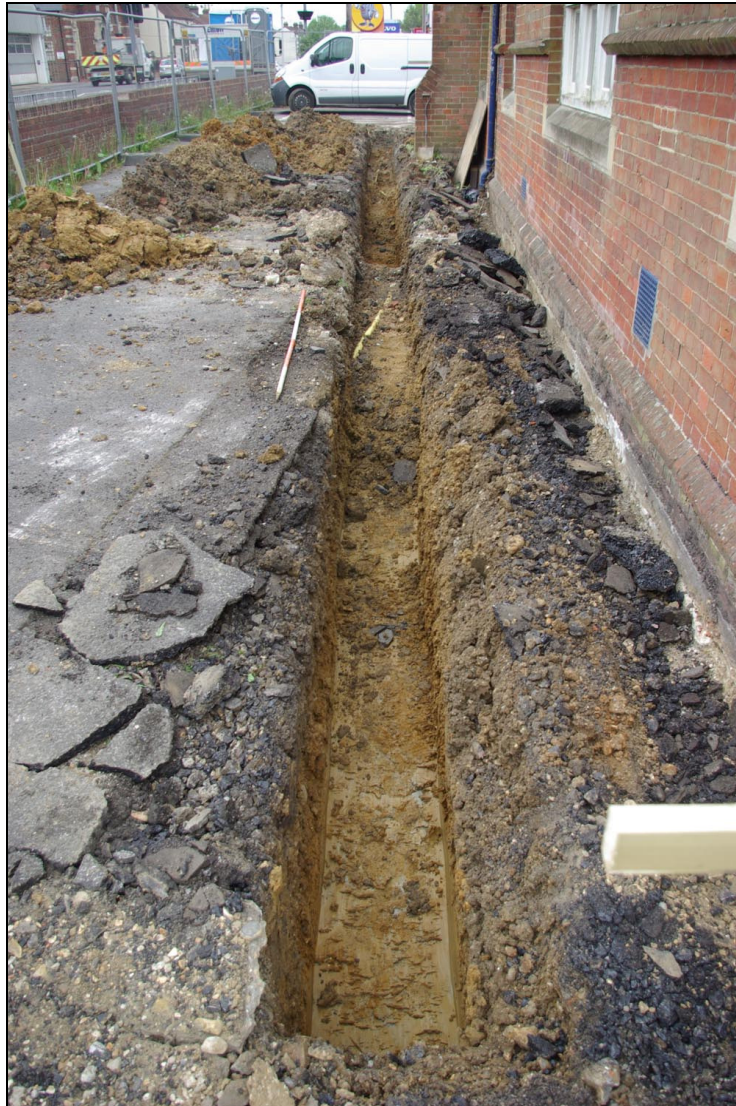
Figure 3 The watching brief trench looking east along its length. The scale is 2m.

3. No archaeological deposits were encountered in the trench. Below the modern tarmac surface and its associated make-up layer, was a layer of mid brown clay silt containing frequent chalk flecks, the base of which lay 0.4m below the current ground level. This silt layer would appear to be the old ploughsoil of the field within which the school was built. The chalk flecks are probably a result of the agricultural practice of spreading chalk on the fields to improve soil fertility.

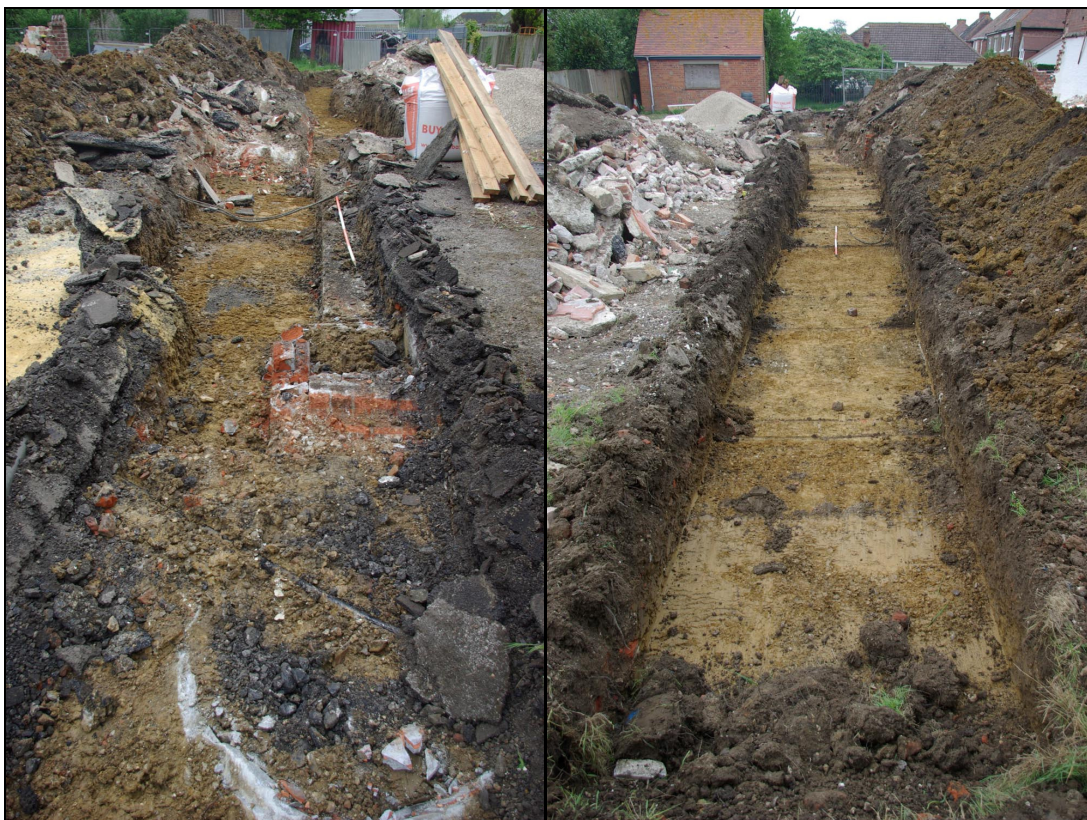
Figure 6 The investigation trench; the image to the left is taken from its west end, looking east; the image to the right is taken from its east end looking west. The scale is 2m.

3. No archaeological deposits were encountered in the trench. Below the modern tarmac and make-up layer in the western part of the trench, and the modern grass and topsoil in the eastern part, was the same layer of historic ploughsoil found in the watching brief trench above the undisturbed geology. Here it extended to a depth of 0.55m below current ground level as a result of the deeper layer of modern material above, but with the same overall thickness of c.0.25m. As in the watching brief trench there were a number of service pipes and cables crossing or running along the investigation trench (see Fig.5).

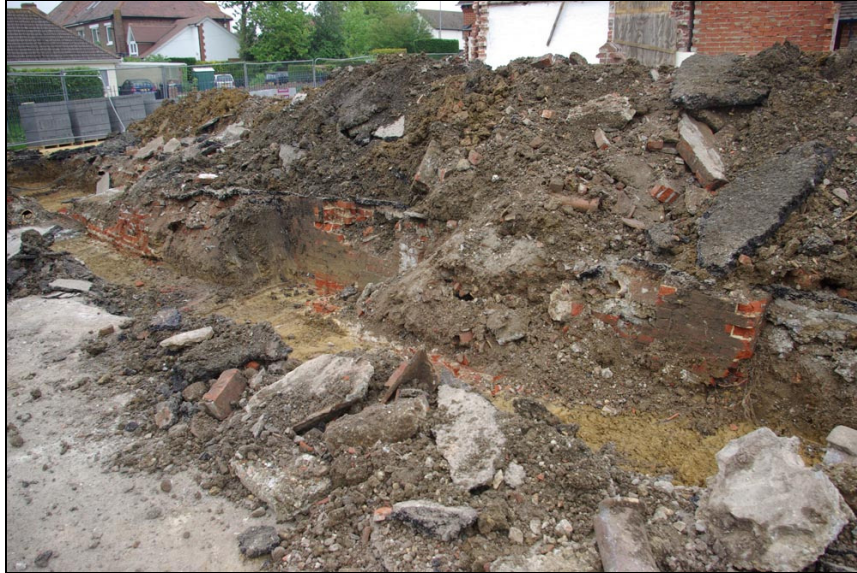
4. In the north face of the trench, towards its centre, a brick wall foundation was revealed. An examination of historic mapping reveals that this formed a part of the original school building demolished in the second half of the 20th century. The lowest two courses of the foundations have been built two brick's width wider than the wall above and sat within the surface of the clay/gravel geology.

Figure 7 The brick foundations, looking north-west.

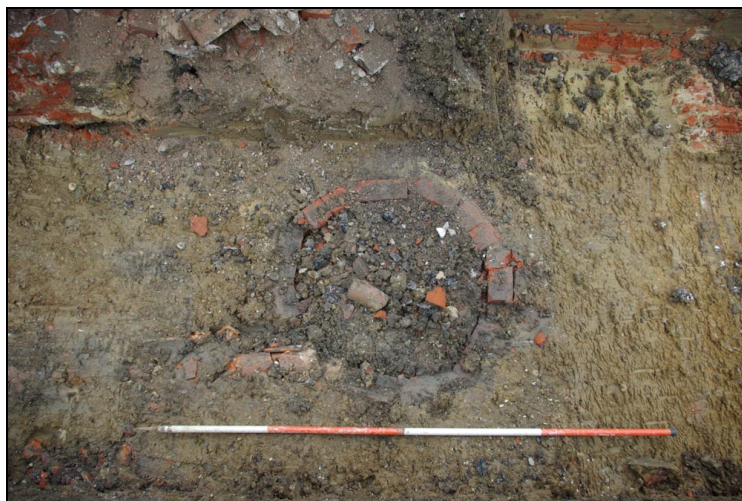
5. Immediately to the south of these foundations, and positioned approximately centrally to them, was a c.1m diameter circular brick-lined soakaway. Feeding into it from the west were two ceramic pipes, while other pipes entered from other directions at a slightly higher level and were removed during the excavation of the trench. It is probable, based upon its position and appearance, that this soakaway formed part of the original drainage system for the school.

Figure 8 The brick soakaway, looking north. The scale is 2m.
