**Report on a Programme of Archaeological Works at the
Cowdray Ruins, Midhurst, West Sussex**

July 2019

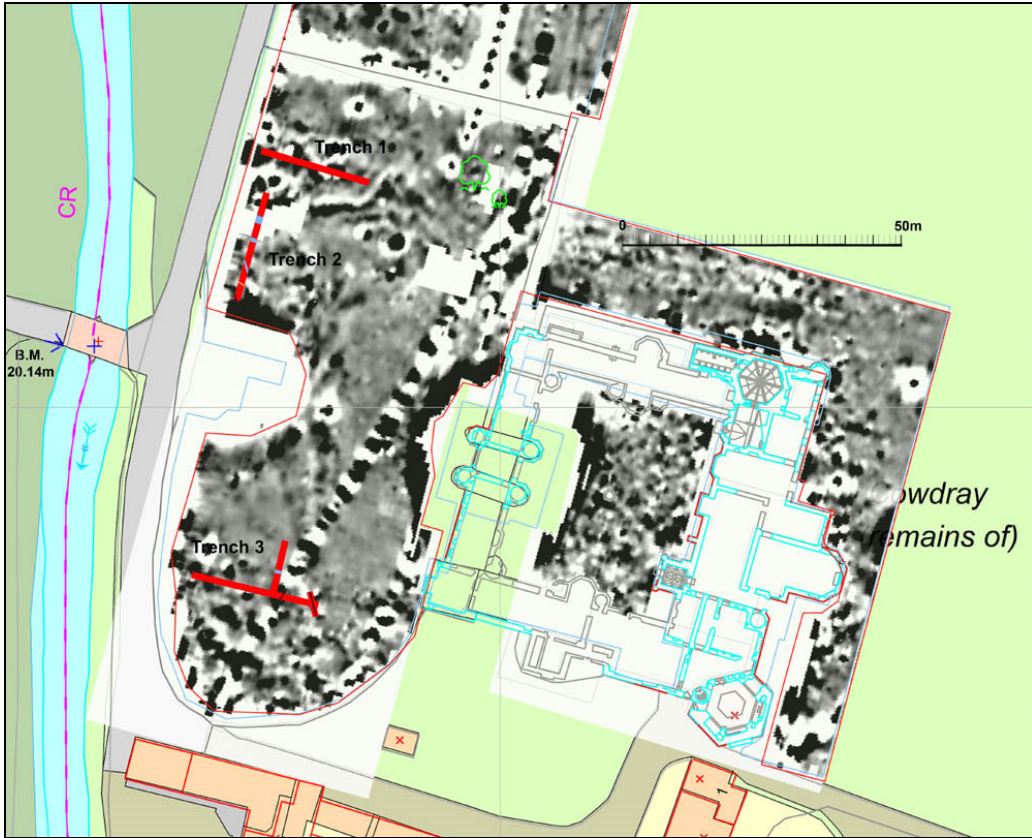
Figure 3 The 2005 magnetometer survey © Crown copyright. All rights reserved. License number: AL100036068

2. In April 2005, as part of works to conserve the Ruins, a geophysical survey was undertaken across the site, which revealed remains of an uncertain nature under the lawns to the west of the west front (Bartlett 2005). A number of these lie under the sites of the proposed marquees.

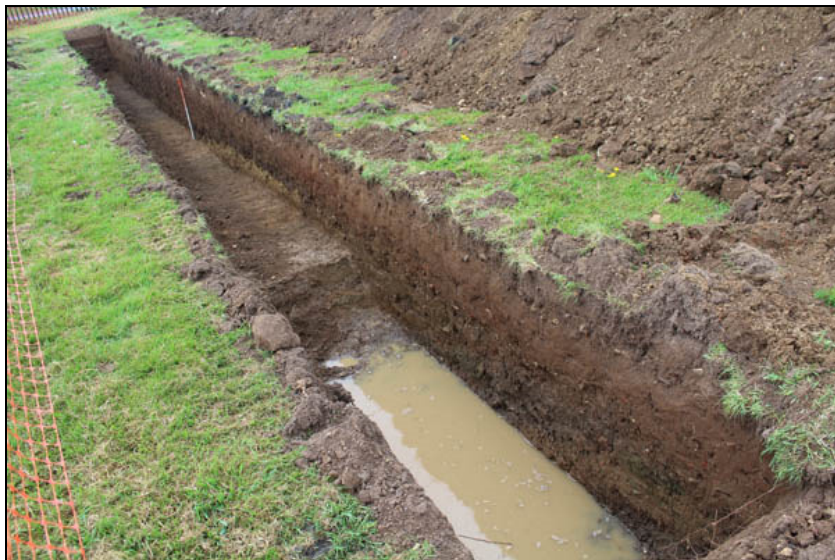
2. Trench 1 did not contain any archaeological features, artefacts or modern services, however the layers within it demonstrated that the ground in this location had been substantially raised in the past. The underlying Lower Greensand geology was not encountered anywhere within the trench, the deepest point of which reached 1.35m below the current surface. Instead succeeding layers of material had been laid down to raise the surface, sloping down from the east towards the river to the west. The deepest layers encountered, at the extreme eastern end of the trench, sloped at the steepest angle, suggesting that the edge of the infilled area may lie nearby, at short distance to the east of the end of the excavated trench.

3. The presence of brick and tile fragments within the lowest of the layers (11) of Trench 1, indicates that the depositing of all this material is likely to have taken place in the post-medieval period, possibly as part of the works involved in constructing the Tudor mansion. Layers 11 and 9 were composed of similar grey clay silt with frequent brick and tile fragments, while Layers 10 & 8 were of similar orange-brown clay sand, with only occasional such fragments. Capping these was a thin layer of Lower Greensand stone chippings (7), overlain by a grey-brown silt (6), again with frequent brick and tile fragments. Levelling the surface of these underlying layers, were three further deposits of silt (5, 4 & 3), capped by topsoil (1 & 2).

Figure 5 Trench 1, looking north-west.

4. The purpose of the archaeological trenching described above, was to investigate the potential impact of the positioning of marquees within three areas to the west of the Cowdray Ruins. The results have indicated that that below Trench 1 is likely to be free from any significant deposits. Here the ground would appear to consist entirely of make-up layers associated with the construction of the Tudor mansion, and any earlier features will therefore be deeply buried (below 1.2m), and no trace of any later features was recorded. The only *caveat* would be to avoid drifting to the west, were the large electric cable passes between Trench 1 and the existing railings, and to the east, where the make-up layers appear to end.

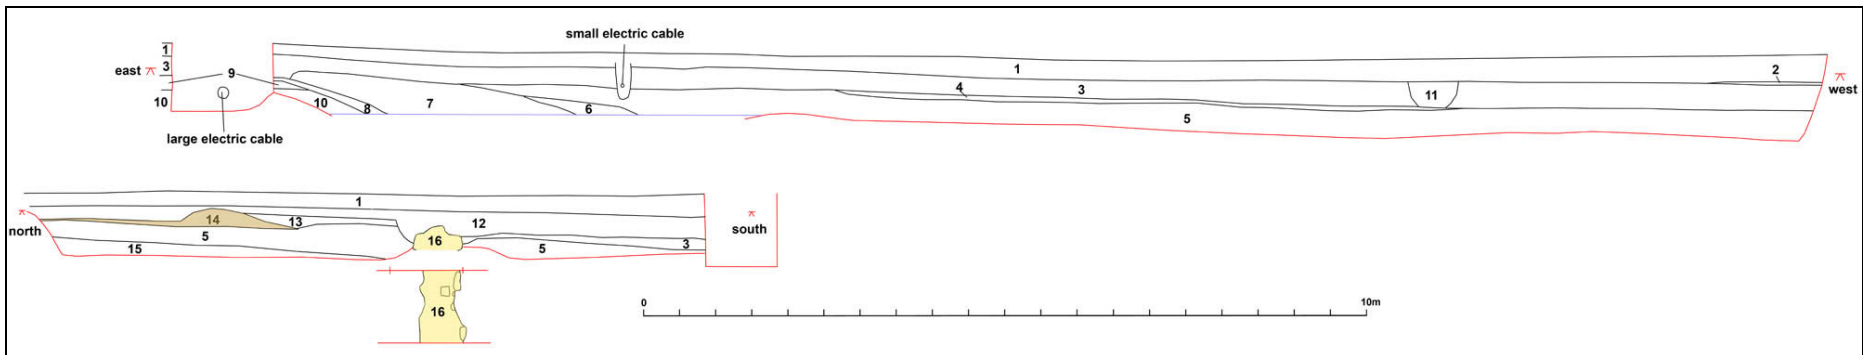
Figure 8 The south face of Trench 3 and the east face of its northern extension, with plan of the wall foundation (16)

10. Cut into the surface of Layers 3 & 5 was an east-west running wall foundation (16) composed of undressed Lower Greensand blocks, brick and tile, set in a yellow lime mortar, c.0.55m wide, c.0.35m deep and lying c.0.45m below the current ground surface. This is almost certainly the base of a wall visible in this location on the map of 1783 and on the Grimm drawing of 1782 (see Fig.16). It is perhaps significant that Layer 3, to the south of this wall, does not extend onto its north side, probably indicating the different histories of the two areas, with the latter being linked to the service buildings that lay to the south of the mansion, while the former lay within the much more important formal approach to the main entrance.

6. Trench 3 presents a more complicated picture. The main trench revealed no archaeological features of significance, save for the single small pit filled with 18th rubbish, the top of which lay c.0.3m below the current ground surface. However its northern extension contained the foundation to the southern flanking wall to the west front (0.45m depth), and the remains of the 18th century gravel drive (0.25m depth). While it is considered acceptable to hammer marquee/tent stakes into the latter, it would be less so with the former, due to its less forgiving composition. It is recommended, therefore, from an archaeological perspective, that any marquees/tents are kept to the south or north of this wall foundation.

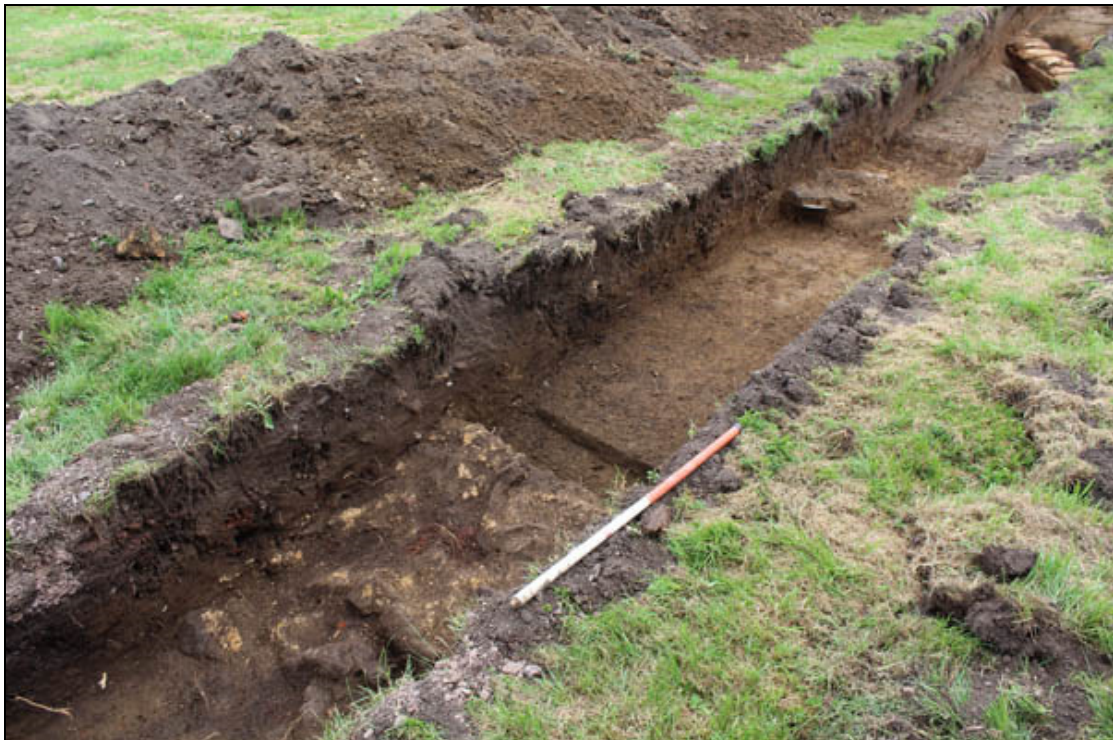
4. Trench 2 contained three archaeological features, together with an electric cable and a gas pipe, both the latter being towards the southern end of the trench. The northern of the archaeological features consisted of a wall foundation (1), c.1.3m wide and c.0.4m deep, composed of undressed Lower Greensand stones, set in a yellow lime mortar. This foundation had been dug into the surface of a grey-brown clay silt (3), presumably the upper surface of the underlying make-up layers observed in Trench 1. The wall it once supported has been completely demolished, with its remains covered by the existing topsoil (2), to a depth of c.0.45m. It is probable that this wall is that shown on an early 18th century map of the Cowdray mansion, one of two framing its west face (see Fig. 10). It appears to have been demolished later in the 18th century, since it does not appear on a subsequent map of 1783 (see Fig. 11)

5. To the south of this foundation (1), at a distance of c.3m, a spread of Lower Greensand stones and yellow lime mortar was recorded (4), c.0.5m thick and up to 1.2m wide, sitting upon the surface of the underlying make-up layer (3). It is unclear as to what this represents, it is unlikely to be another wall foundation, due to its shallow depth and ephemeral nature, and it is possible that it might be linked with the demolition of the wall to the north (1).

Figure 9 The wall foundation (1), the spread of stones and mortar (4) and the brick and stone culvert (8) in Trench 2

5. Trench 2, while containing archaeological features relating to the Tudor mansion, namely the foundations of the northern flanking wall to the west front, and a brick and stone culvert, showed that the overlying topsoil is thick enough to permit marquee/tent stakes up to 0.4m long, without damaging the remains below. Care should however be exercised in not exceeding this depth, partly due to the necessity to avoid damage to any archaeological remains, and partly because of the presence of the gas and electrical services located at the southern end of the trench.

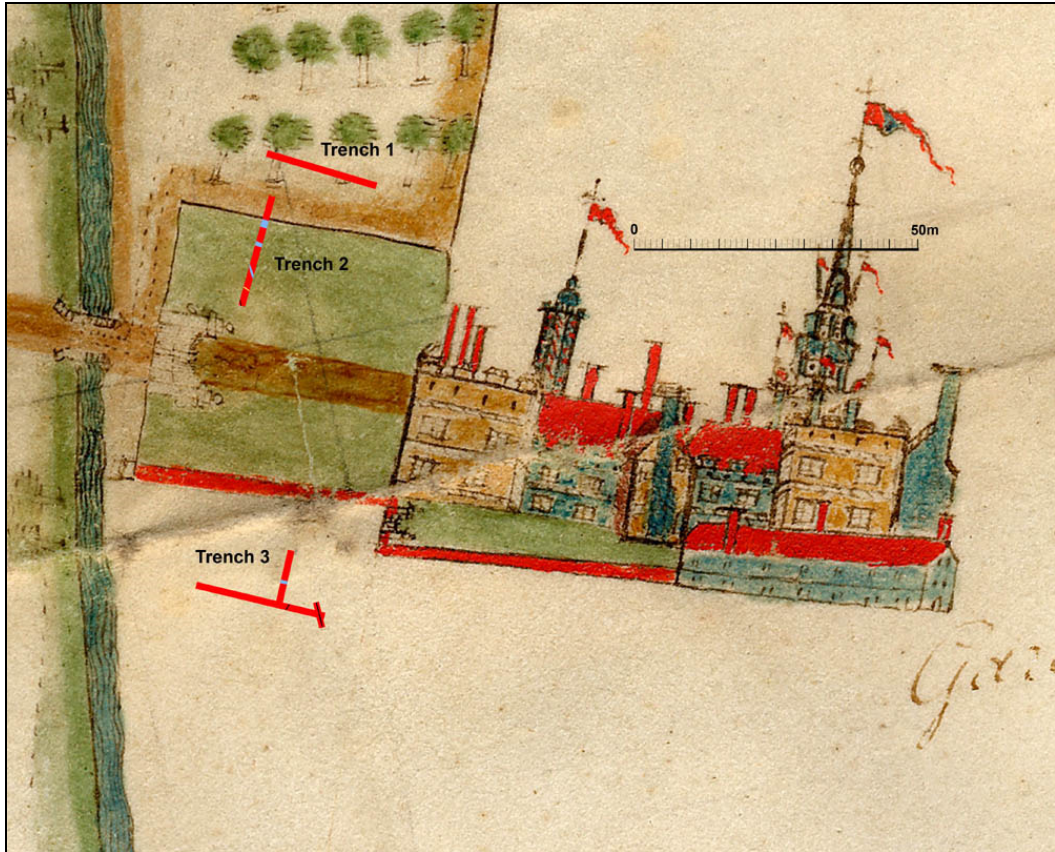
Figure 10 Map of 1712 showing the Cowdray mansion

2. It would appear from the earliest surviving map of the Cowdray mansion, dating to 1712, that its western elevation was flanked by two walls running east-west, either side of a central causeway approaching the main entrance. The foundations found within Trenches 1 & 3 are almost certainly those of these two walls. The southern is, admittedly, shown to the north of Trench 3 in Figure 10, but this is likely to be the result of the map-makers decision to illustrate the mansion as an elevation, rather than in plan; the wall in question clearly running off the southern corner of the building, which would, in practice, place it exactly where the foundation was found in Trench 3. It is not known whether these walls formed part of the original design of the mansion, but at some point in the later 18th century, it would seem that the northern was demolished, possibly at the same time that the approach was altered, with the formation of the looping drive seen on the 1783 map, which enters and exits the land in front of the mansion from the north. The remains of a part of this drive were found within Trench 3. The brick and stone culvert found within Trench 2 is almost certainly original to the Tudor mansion, and probably took rainwater from its rooves into the River Rother. The only other archaeological feature revealed by the trenching was the small pit filled with bottles within Trench 3. This lay in the area to the south of the entrance approach to the mansion, as defined by its two flanking walls, an area likely to have been associated with its kitchens and other service buildings. The pit was probably infilled with household rubbish in the mid-18th century.

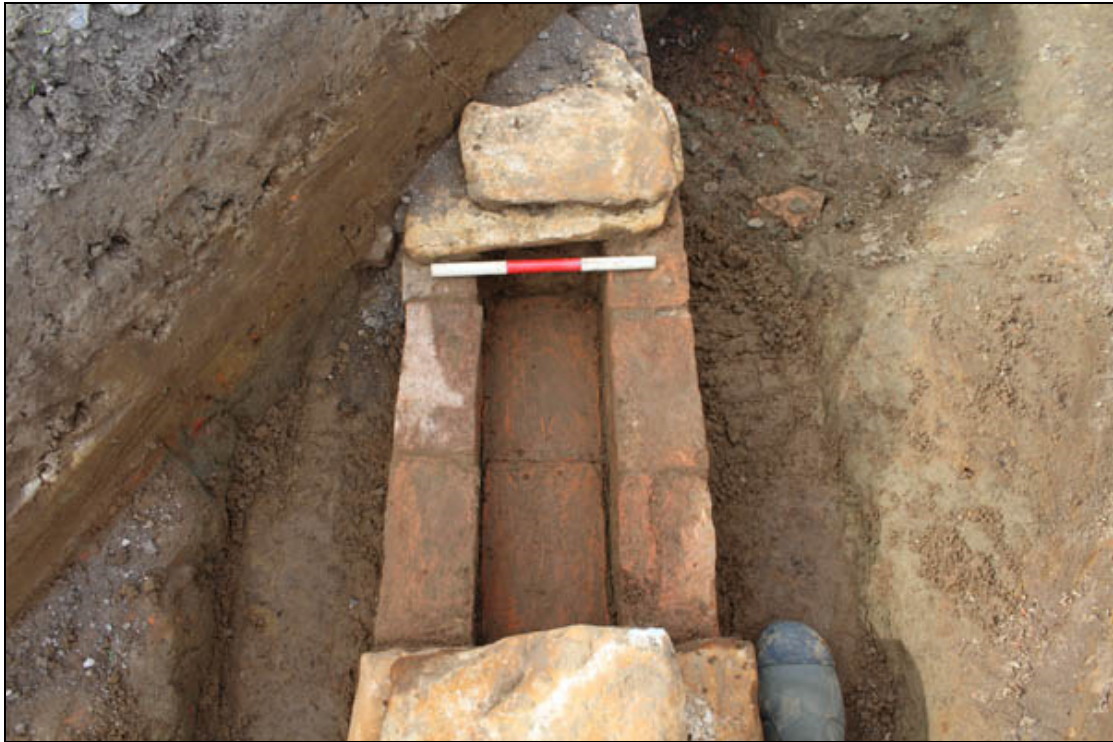
- The third archaeological feature within Trench 2 was a stone-capped brick culvert (8) running north-west to south east. It had been placed within a trench (9), c.0.55m wide, cut into a grey clay layer (6), containing frequent brick fragments, which in turn overlies a layer, (7), almost entirely composed of fragmented brick. Once the culvert had been inserted within the trench, it had been covered by a layer of yellow-brown sandy silt (5), with occasional brick and tile fragments, presumably forming the upper part of the make-up layers observed elsewhere, and underlying the existing topsoil (2). The culvert itself consisted of a side walls composed of three courses of bricks (5 x 10 x 22cm), capped with slabs of Lower Greensand stones, and lined at the base with peg tiles (27 x 16 x 1.3cm). The tops of the culvert capping stones lay c.0.45m below the current surface. It is likely that the culvert was for the discharge of rain-water away from the mansion to the west, towards the river.

Figure 12 Detail of the brick and stone culvert in Trench 2, after the capping stones have been removed, looking north-west

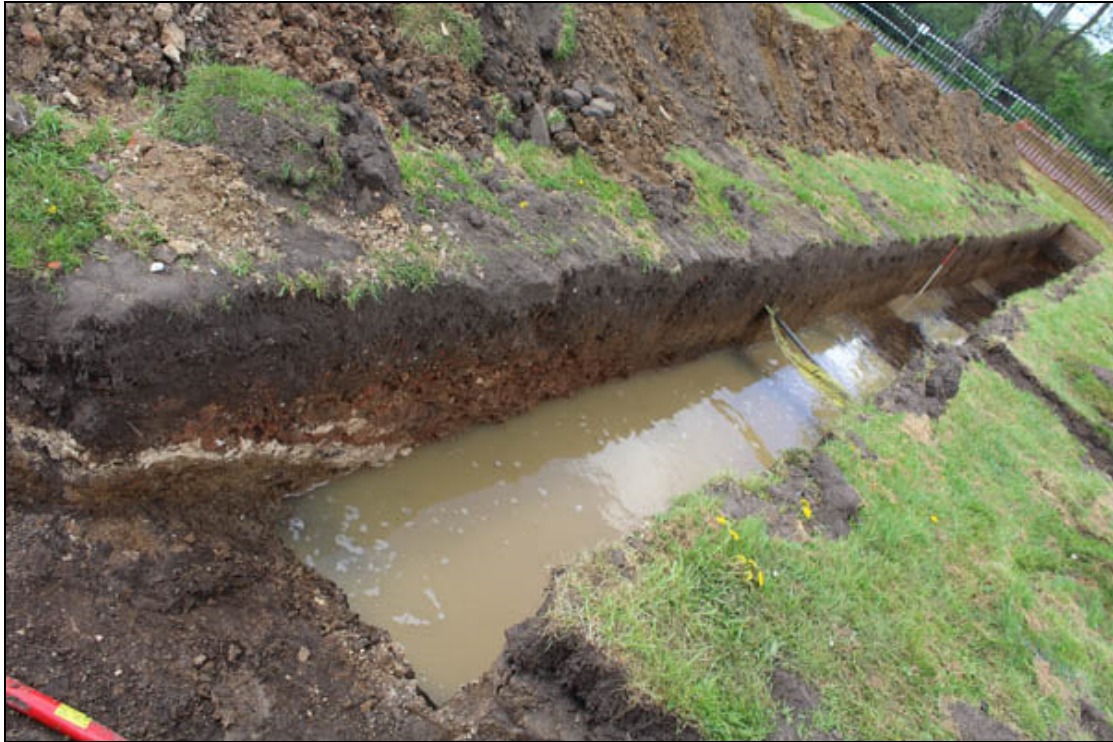
- Trench 3 again contained three archaeological features, together with two electric cables, the latter being towards the eastern end of the trench. The main east-west trench was found to consist of a similar build-up of layers as in Trench 1, with the underlying geology again not encountered even at its deepest point, c.1.2m below the current ground surface. At the eastern end of the trench, these layers, as in Trench 1, were observed to slope upwards more steeply, before seemingly levelling off at its extreme end, where two deposits (9 & 10) were more horizontal. Layer 10 was a grey-brown silt containing occasional tile fragments and oyster shells, while Layer 9 above was an orange brown

sandy silt, with a few fragments of tile. It is possible that these two represent the historic ground surface that existed before the raising of the land.

Figure 13 Trench 3, looking south-west

8. Layers 9 & 10 were overlain by a succession of make-up layers to the west, the lowest of which was composed of crushed chalk (8), below a reddish clay silt, containing abundant brick, tile and mortar fragments (7). Above this was a layer of grey-brown silt containing frequent Lower Greensand chippings (6), under an orange-grey clay (5) and a thin spread of yellow-orange clay-silt (4). These were all capped by a dark brown silt containing frequent charcoal (3), which may represent the last of the levelling layers. Cut into the latter was a small pit (11), part of which lay within the excavated trench. It measured c.0.7m in diameter and was c.0.4m deep, and within its fill was an assemblage of bottle glass and pottery, including three complete mallet-shaped wine bottles, a complete salt-glazed beer bottle and a small crudely made ceramic jar. The whole assemblage dates to the first half of the 18th century, and is probably contemporary kitchen waste. This pit, together with all the layers beneath, were capped by the modern topsoil (1).

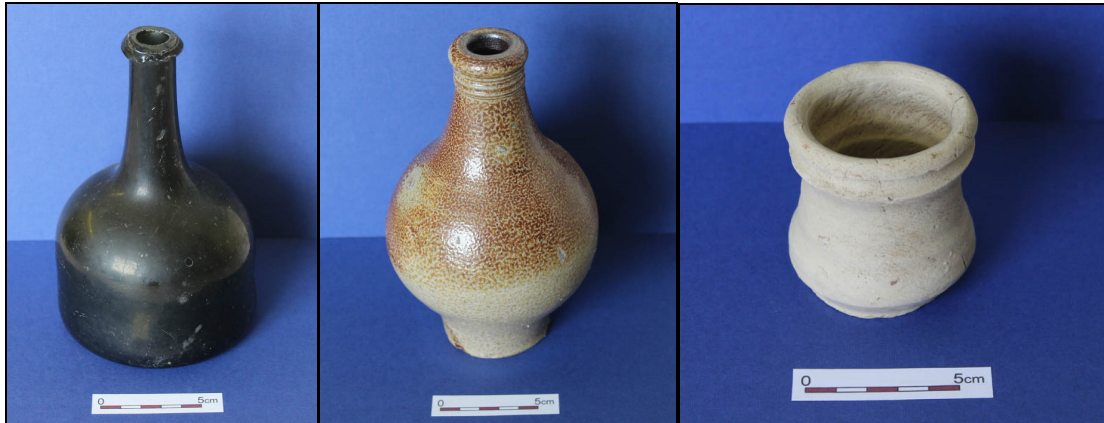
Figure 14 Pit 11 artefacts: one of three identical wine bottles, (left image, unknown provenance, c.1725-1750); the beer bottle (central image, possibly from the Fulham pottery, late 17th – mid 18th century); and the ceramic jar (right image, unknown date & provenance)

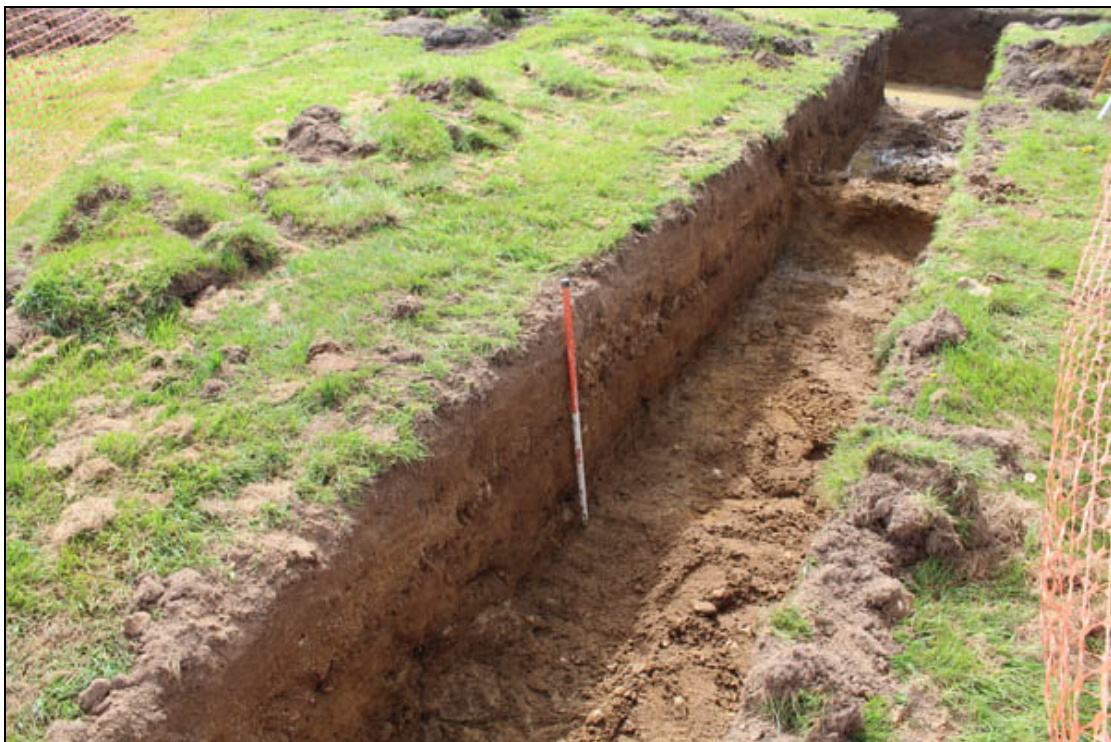
Figure 15 The spread of flint gravel (14) and wall foundation (16) beyond, within the Trench 3 extension

11. To the west of this wall foundation (16), a spread of flint gravel (14), up to c.0.2m thick, extending for c.3.5m and sitting upon Layer 5, is likely to be the remains of the looping drive again seen on the 1783 map and 1782 Grimm drawing. This lay only c.0.25m below the current ground surface. Above these was a succession of yellow-orange sandy-silts (13 & 12) topped by the modern topsoil (1), all of which would appear to have been laid down following the demolition of the wall (16) and the dis-use of the drive.

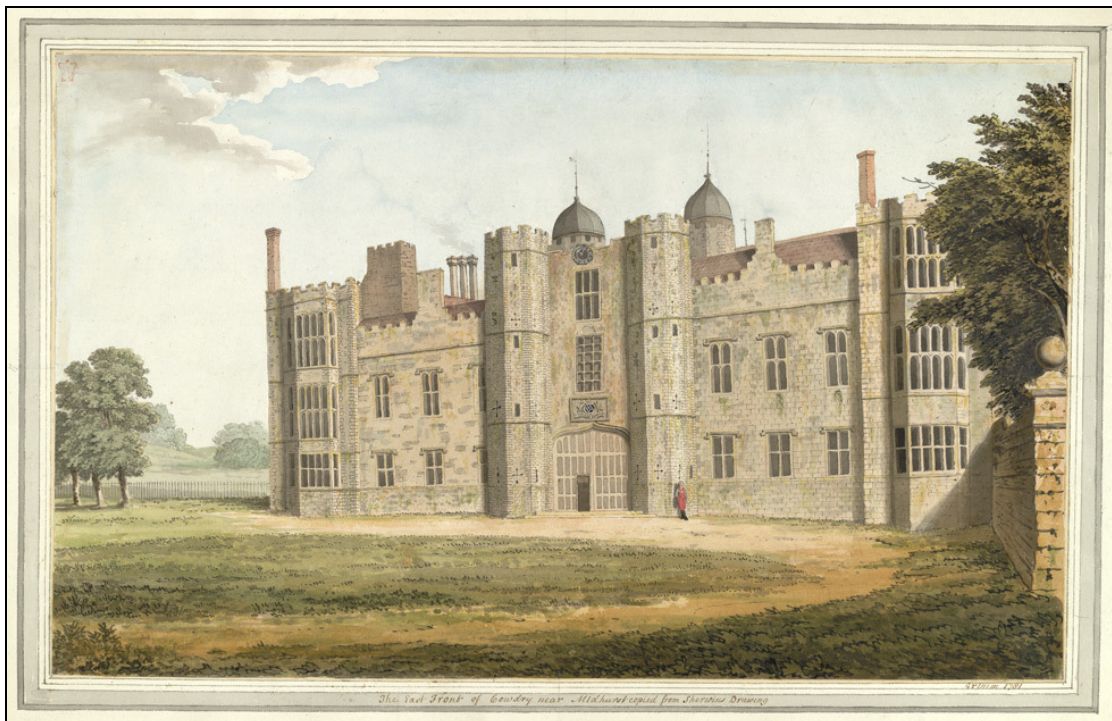
Figure 16 Drawing by S.H.Grimm in 1782 of the west front of the Cowdray mansion, showing the wall (to the right) and the gravel drive
