**Report on a Programme of Archaeological Works at
Arundel Castle Cricket Club, Arundel, West Sussex**

April 2019

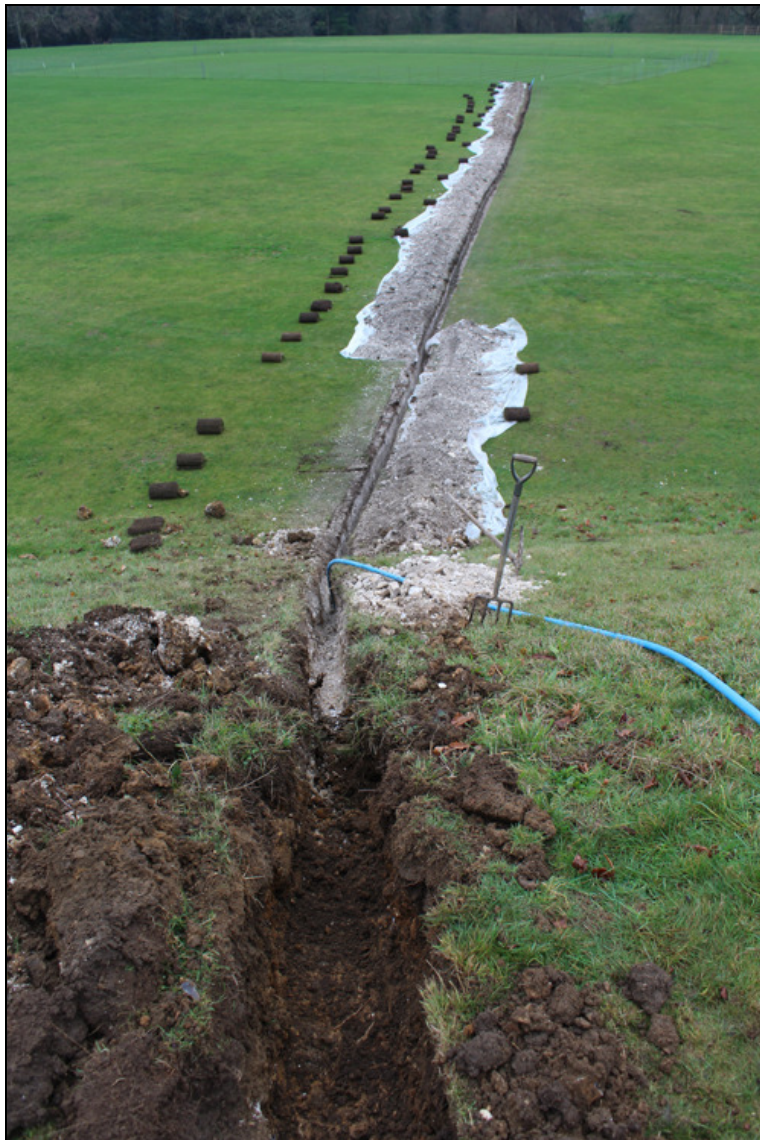
1. The trench throughout was c.0.3m wide and varied from c.0.25 – 0.4m deep, except at its northern end, where a larger trench, c.2.5 x 1.5m, was excavated in order to locate the existing water pipe and enable the connection of the new. For much of its southern part, from just below the top of the current terraced slope around the cricket boundary, any deposits overlying the chalk had been removed by the construction of the cricket pitch in the late 19th century, and no archaeological features were noted.

Figure 2 South end of the new water pipe trench, looking south

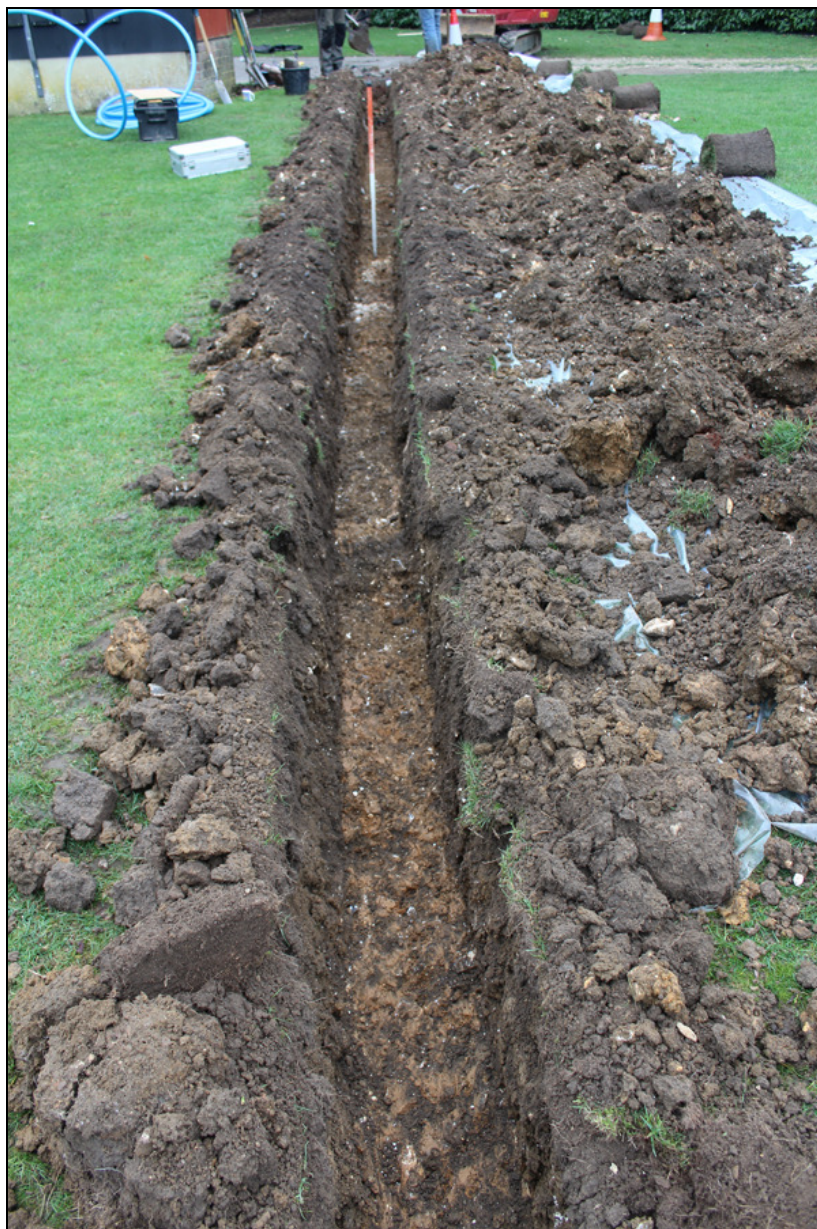
Figure 4 The water pipe trench north of the terraced slope, the pit/ditch lies just behind the 1m scale

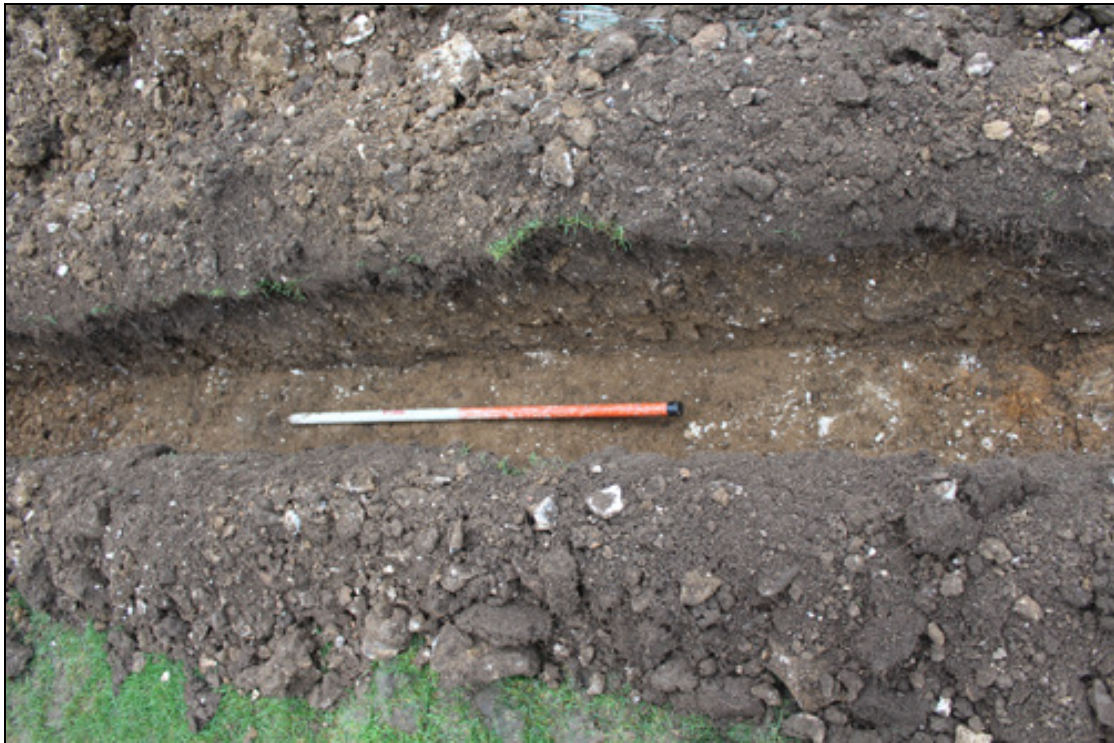
Figure 5 The pit/ditch within the water pipe trench, looking south-west. The 1m scale lies over

1. The excavation of the water pipe trench revealed only one archaeological feature, a ditch or pit lying c.8m to the north of the northern edge of the terraced slope to the current cricket pitch. The date and nature of this feature are uncertain, since it was not excavated, lying, as it did, below the level to which the trench was dug. All deposits to the south of the terraced slope have been destroyed when the cricket pitch was created in 1895.

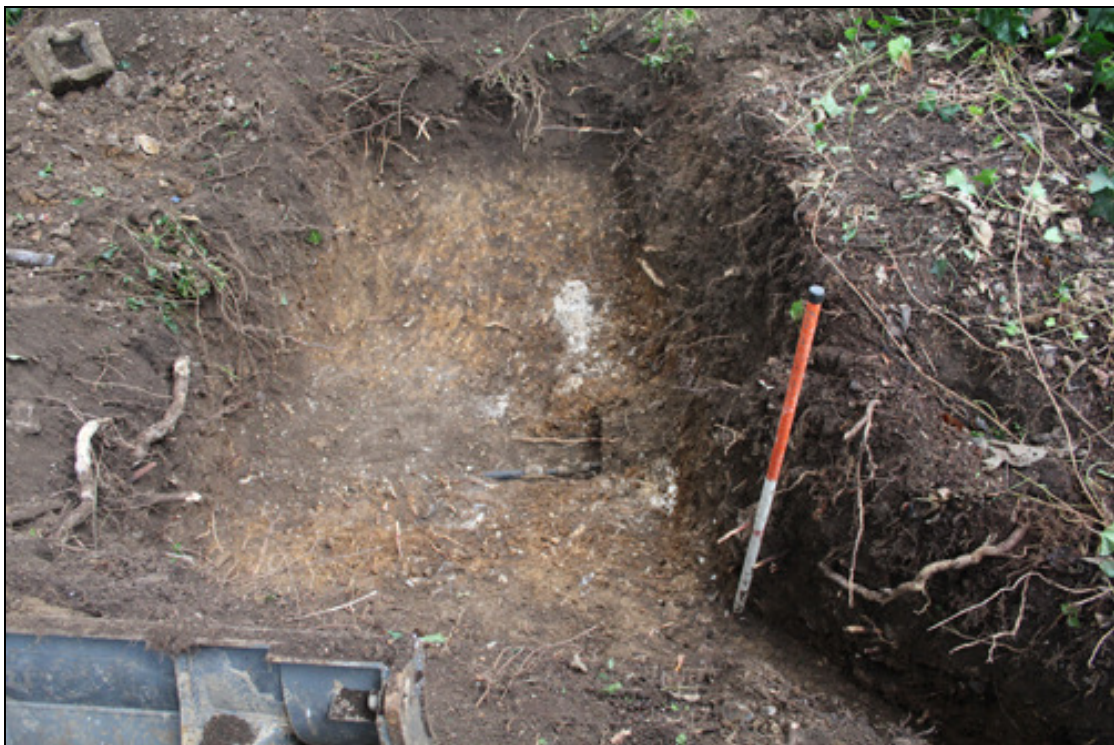
Figure 6 The larger trench to the north-west of the shed, looking north-west

3. To the north of the current track, the trench remained within the thickness of the current topsoil until it reached the existing shed on the other side of the hedge. To the north-west of this shed, a larger trench was excavated to locate the existing water supply. Aside from this modern pipe, it did not reveal any archaeological features, the soil deposits in this location consisting of c.0.2m of mid-dark brown silty topsoil, containing frequent unworked flints, overlying a light-mid brown silty subsoil, again with frequent flints. Below this was the natural clay with flints, cut into which to a depth of c.0.4m, was the existing water pipe trench. Overlying all these layers was a spread of dumped soil, up to c.0.45m thick, formed from the spoil generated during the construction of the neighbouring shed.
