**Report on a Programme of Archaeological Works at Westons  
Farm, Iping Road, Milland, West Sussex**

September 2018

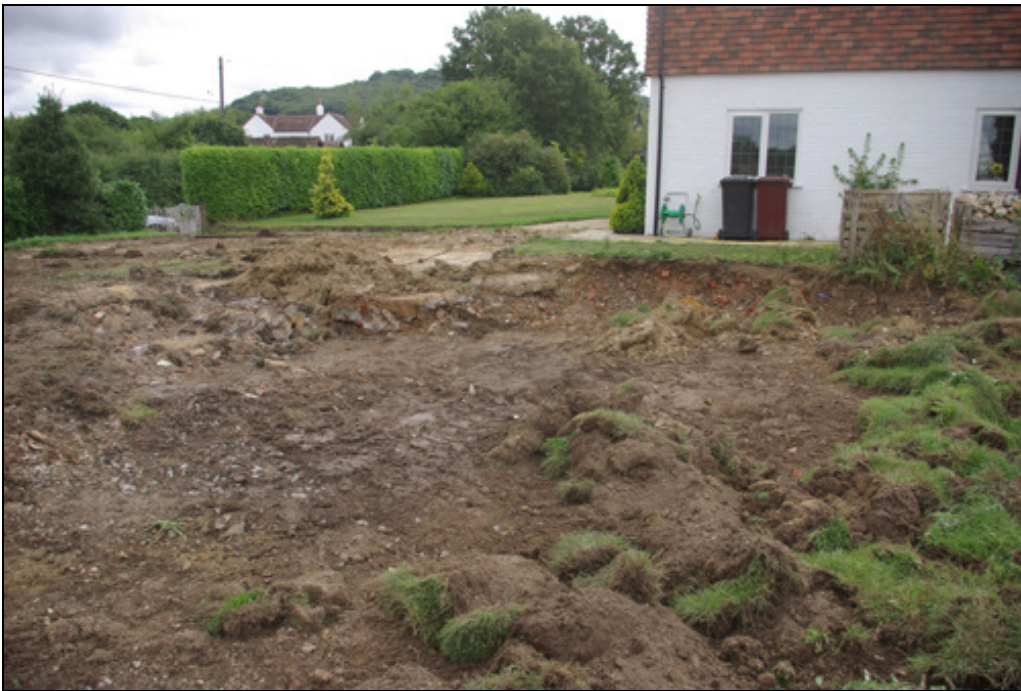
1. The pile of recent building rubble to the north of the house was removed down to the surface of the ground, as it existed prior to previous construction works, and the remaining soil gently graded across the site to remove any undulations. Penetration into the modern topsoil was minimal and no archaeological features or artefacts were noted.

**Figure 4** Area 1 after the removal of modern building rubble, looking south

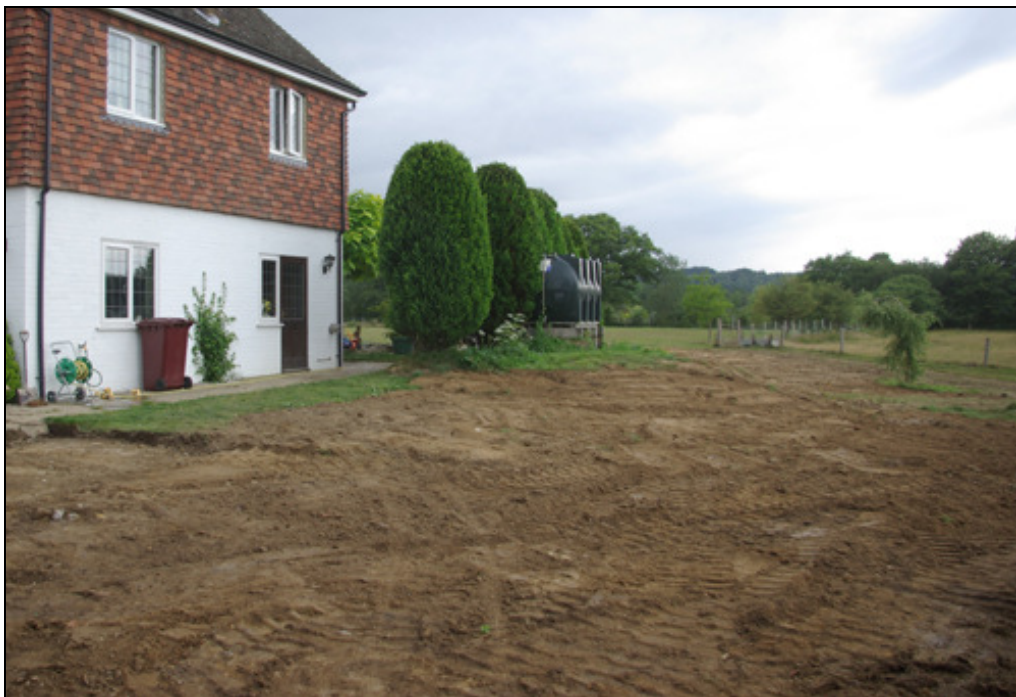
**Figure 5** Area 1 after grading, looking west

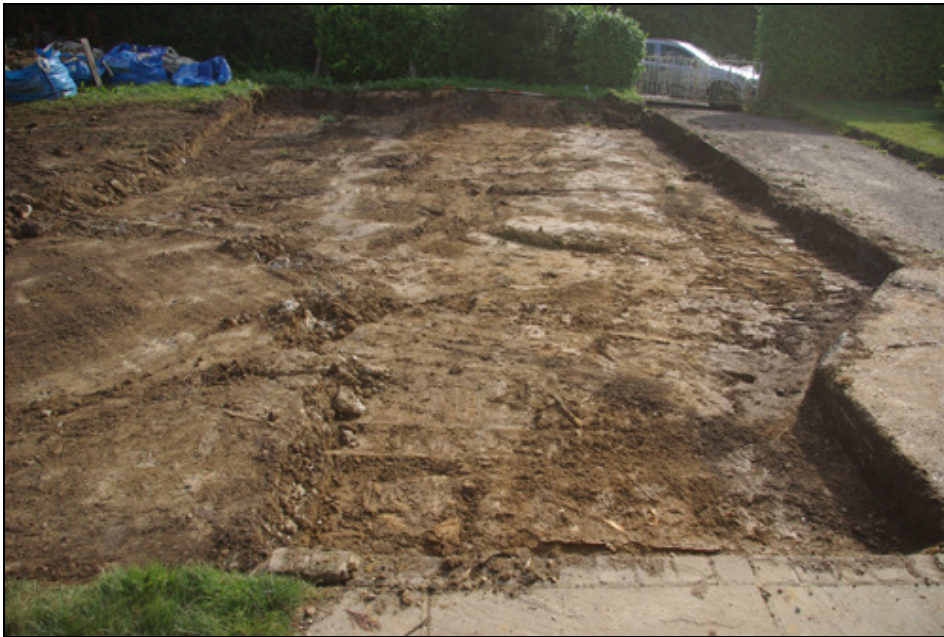
**Figure 6** Area 2, looking east

1. The modern ground was lowered by c.0.3m throughout the area, this exposed the line of a probable boundary ditch or service trench running northeast to southwest across the northern part of the trench, c.4.5 - 6m to the north of the current driveway. To the south of this ditch, immediately below 0.1m of topsoil, was a layer of re-deposited clay/soil containing occasional brick debris. To its north, the overlying topsoil thickened to beyond the depth of the trench. The re-deposited clay/soil layer was probably laid down when Weston's Farm was built – there is a noticeable rise in the ground level from the field to the north.

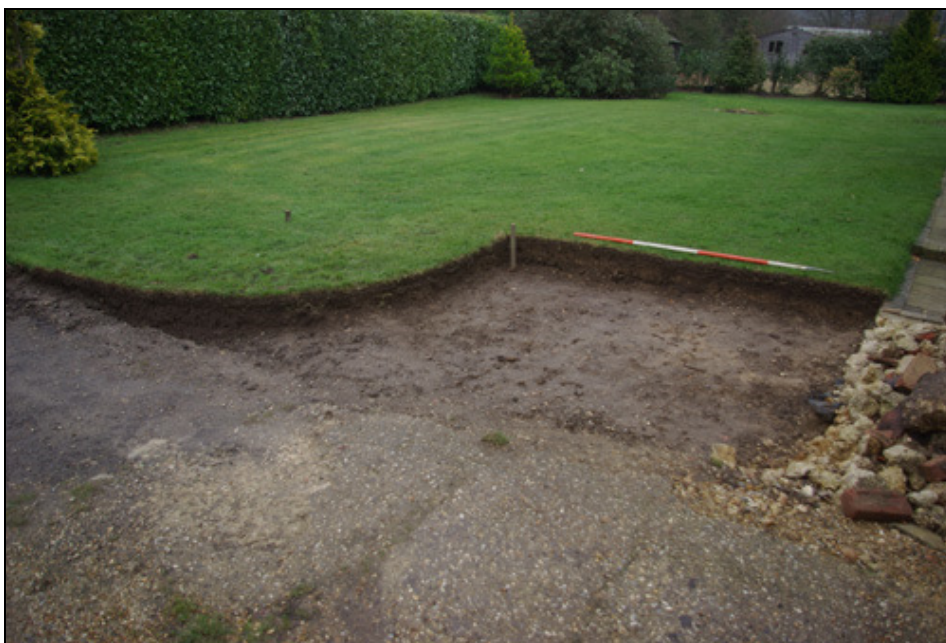
**Figure 7** Area 3, looking southeast

1. The modern topsoil was lower by less than 0.3m in this area, with the underlying re-deposited clay visible in patches. No archaeological features or artefacts were noted.

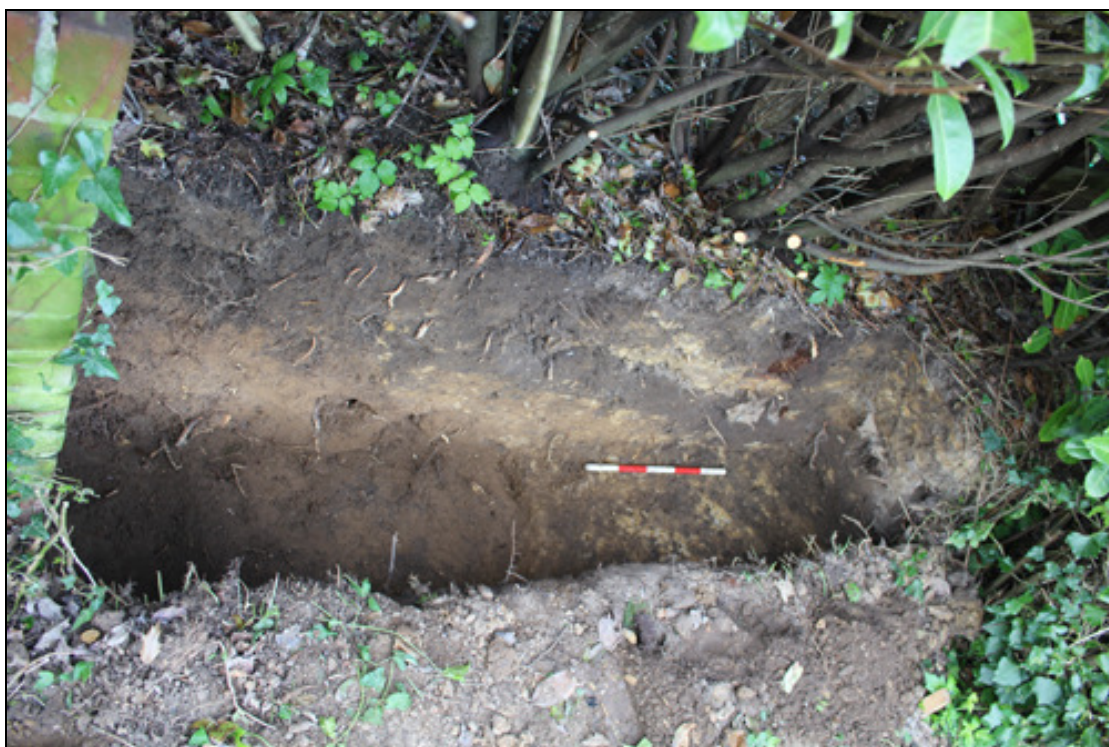
**Figure 8** Trench 4a, look west

1. A short stretch of trench (c.2.25m long, c.0.5 wide and c.0.6m deep), for an extension to an existing boundary wall (4a in Figure 3), revealed the continuation of the boundary ditch or service trench seen in Area 2. This was again cutting a layer of re-deposited clay/soil, and was itself filled with bands of clay and topsoil.

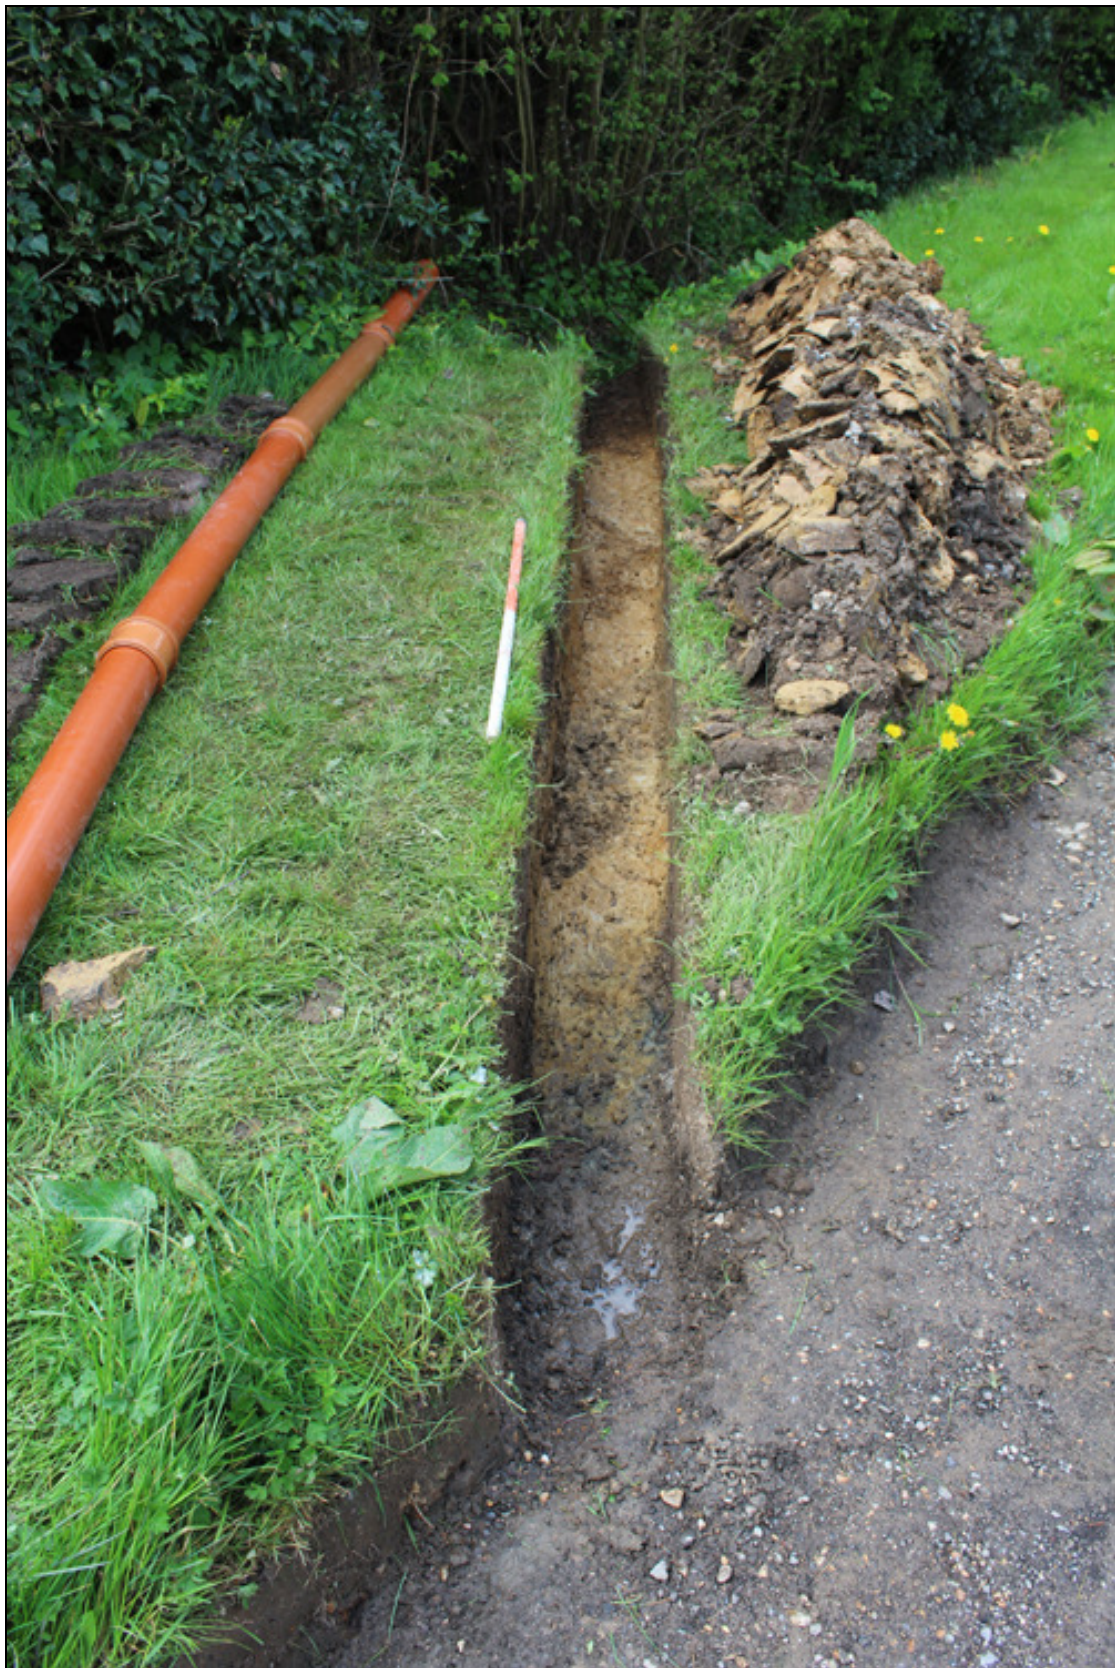
**Figure 9** Trench 4b, looking northwest

2. To the north-east a second short trench (c.4m long, c.0.4m wide and c.0.35m deep) was excavated to take rainwater off the road into an existing road-side ditch (4b in Figure 3). Below c.0.2m of topsoil, the undisturbed Weald clay was reached. No features were noted cut into it, save for a modern service trench running parallel to the road.

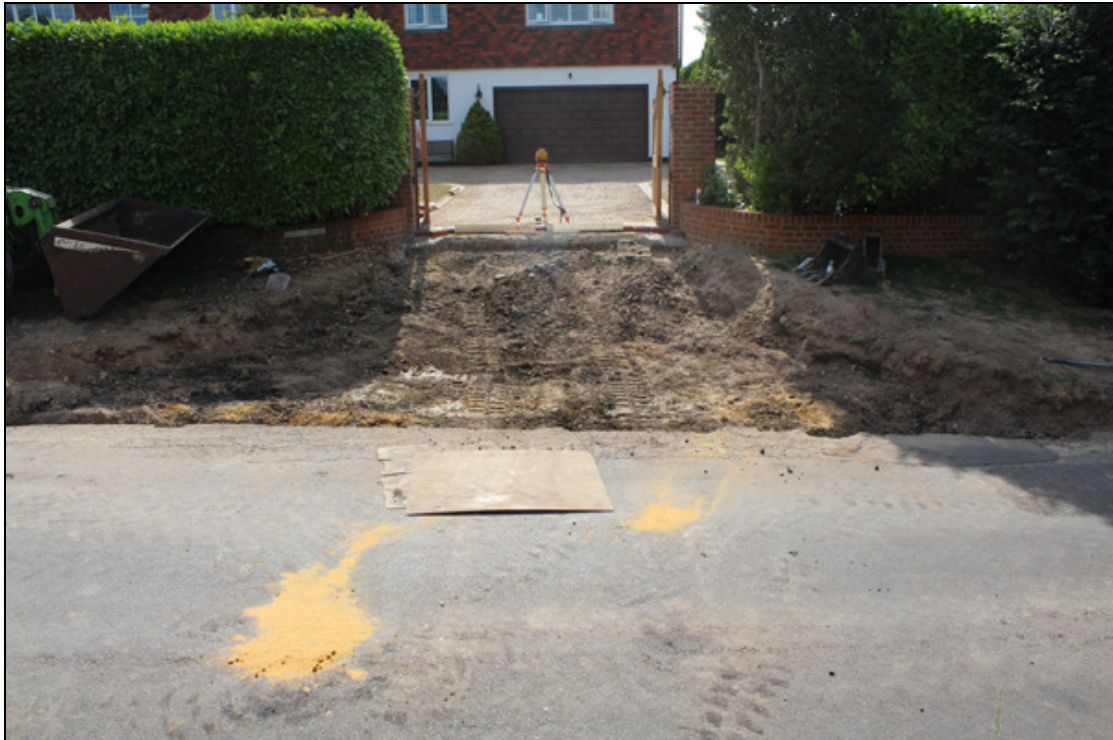
**Figure 10** Area 4, looking west

3. The main part of Area 4, to the south, over the location of the new drive and its gate piers, revealed the same sequence of layers. At the base was the undisturbed Weald clay, only observed between the edge of the Iping Road and the continuation southwards of the service trench noted in Trench 4b, where a deeper cutting was made to take a new curb. Above this were layers of re-deposited clay soil, containing varying quantities of building rubble, as noted in Areas 2 and 3 and Trench 4a. The total depth of this layer would appear to be as much as 1.4m at its highest point, by the current house, sloping steeply up from the road to c.1m deep by the new gate piers; presuming that the underlying clay does not slope up to the west to any marked degree, a slope not suggested by the local topography, which instead falls from north to south.

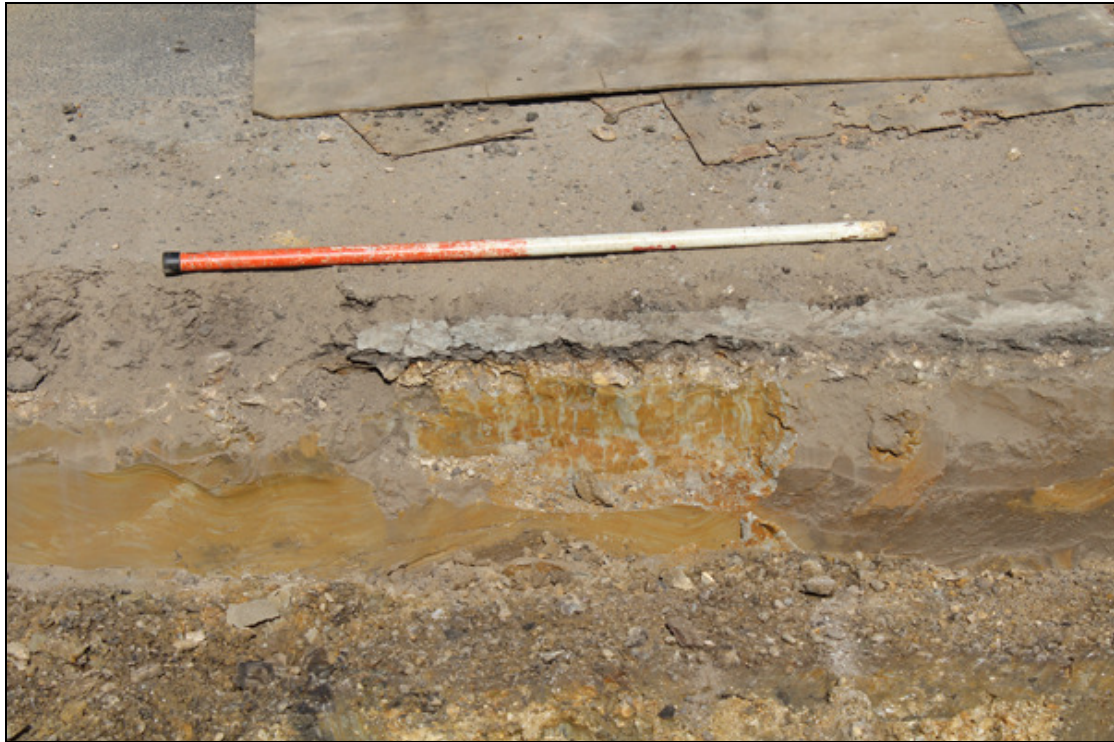
4. No trace of the Roman road was observed at the eastern edge of Area 4, where it met the western edge of the modern Iping Road, merely successive layers of modern tarmac on a thin bed of gravel, c.5cm thick. While it is possible that this gravel is a survival of an ancient road surface, its comparative cleanness suggests that it is modern. It would instead seem likely that the wear of centuries of traffic, and/or the groundworks associated with the creation of the modern road, have removed all trace of the Roman road.

**Figure 11** The edge of the modern Iping Road, looking east
