**Report on a Programme of Archaeological Works at
Pitlands Farm, Up Marden, West Sussex**

April 2018

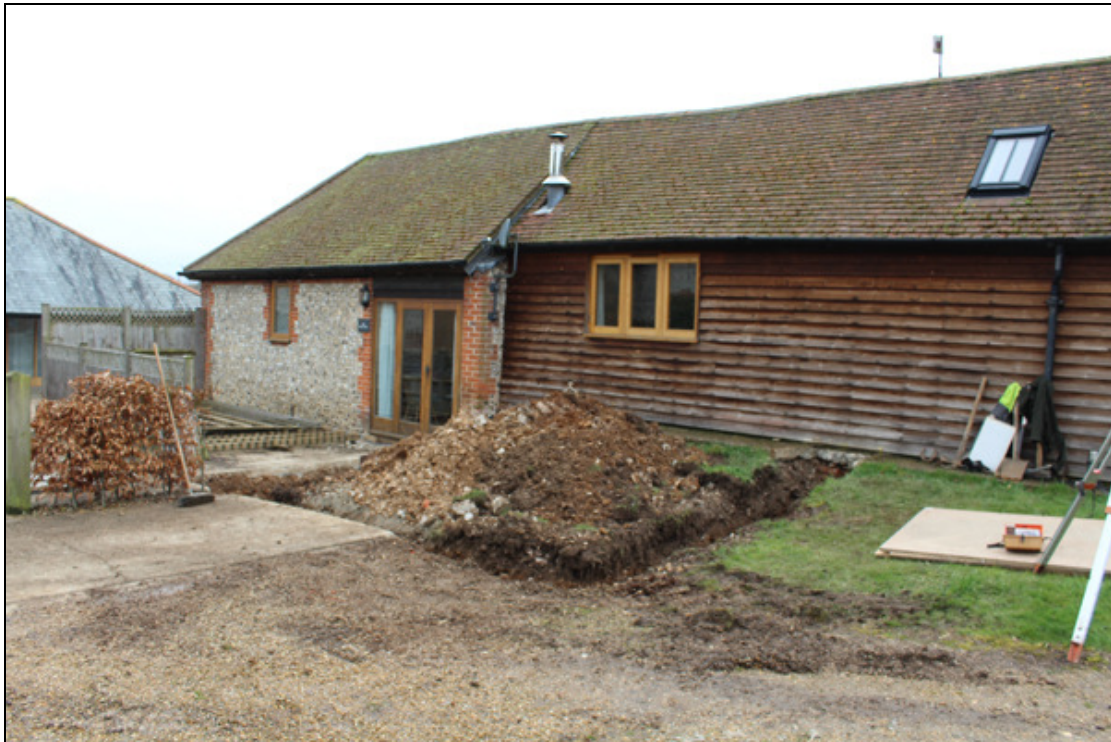
Figure 4 The excavated trench, looking south-west

1. It had initially been planned to excavate a trench covering the entire footprint of the proposed extension, but the decision was taken that the existing concrete yard surface would be retained under its floor, with only the foundation trench for its walls cutting through to the layers below. In the light of this, the evaluation trench encompassed the whole footprint of this foundation trench (see Fig. 3).
2. Within the southern and eastern arms of the foundation trench the modern concrete yard surface was found to sit directly upon the underlying clay-with-flints geology. The northern arm lay just beyond the limit of this concrete, and here the upper layer was instead composed of a loose dark grey/brown topsoil, containing frequent unworked flints.

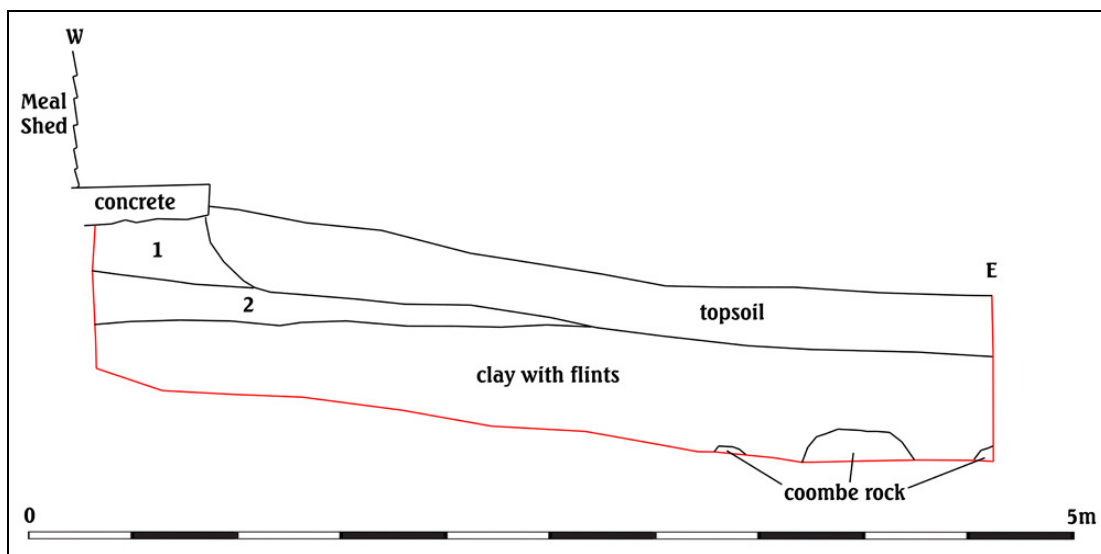
Figure 5 The north section of evaluation trench

3. Only at the western end of the northern arm of the foundation trench were additional layers recorded. Above the natural clay-with-flints was a deposit of mid grey/brown silt (No.2 in Fig.5), up to c.0.25m thick, containing frequent flints. This was overlain by a layer of mid grey/brown silt (No.1 in Fig.5), up to c.0.3m thick, containing frequent fragments of chalk and flints. Both these layers sloped away to the east, suggesting that they have been truncated. No artefacts were recovered from either of these layers.

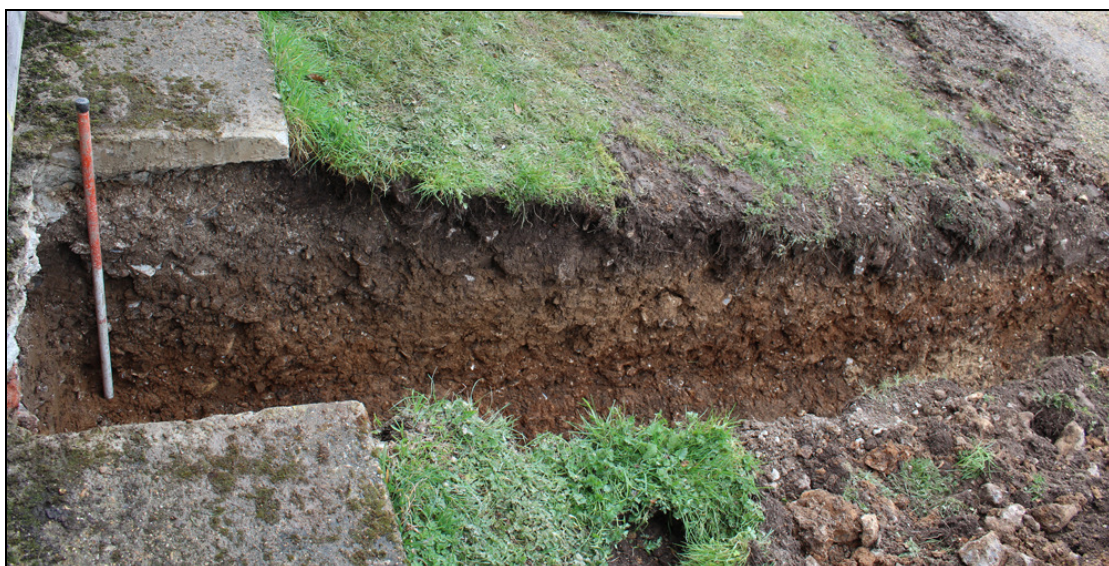
Figure 6 The north section of evaluation trench, looking north
