**Report on an Archaeological Watching Brief at South Park
Moat, Grayswood, Surrey**

January 2018

This document sets out the results from an archaeological watching brief carried out at South Park Moat, Grayswood, Surrey during works to seal a leak to the dam. The dam forms part of a medieval moated site which is a Scheduled Monument (No.1012791).

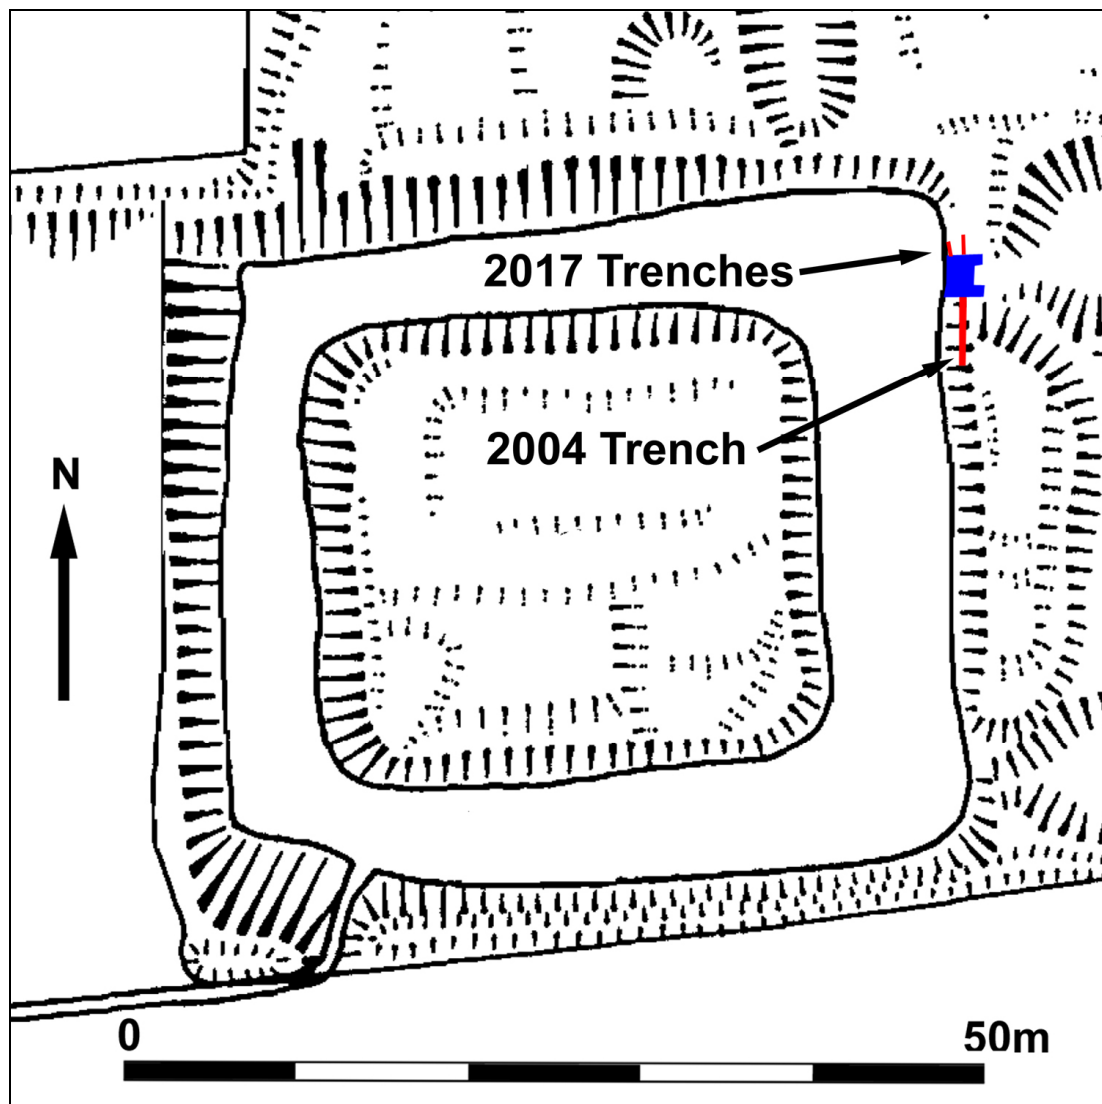
Figure 3 Plan of the 2004 and 2017 trenches. The existing sluice is marked in blue

1. The original intention of these works had been to simply replicate the repair undertaken in 2004, on the south side of the sluice, this time on the north side. Accordingly a north-south running trench, c.0.4m wide, c.2.15m long and c.1.4m deep, was mechanically excavated immediately to the north of the sluice along the centre of the dam. In the event the design of the existing sluice turned out to be rather different from that anticipated. It had been assumed that it consisted of two parallel stone walls running from front to back of the dam, with the sluice pipe and channel running between. In reality what was revealed were two pairs of concrete pillars either side of the gates at front and back, but with no wall in between. If a seal were to be placed within the trench as excavated in its intended position, it would have done little to halt the leaking of water from east to west, since there was nothing solid to butt the sealant against. In the light of this a second trench was cut c.1.4m to the west, and butting up against the north side of the north-west pier of the sluice. This trench was again c.0.4m wide, but only c.1.6m long and c.1m deep.

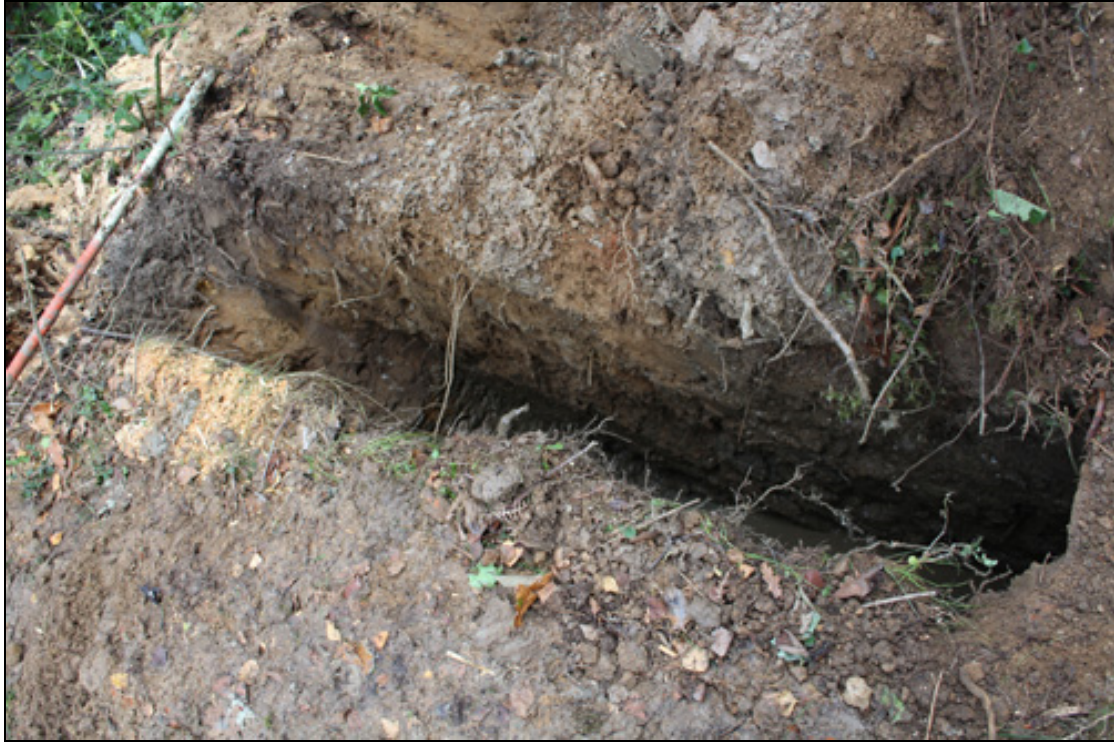
2. Both trenches revealed the same deposits: against the sides of the sluice, and extending c.1.2m to the north, was a mixed deposit of sandstone, clay and loose silts. There were frequent signs of root action, which had probably had the effect of further loosening this material, and thereby permitting the constant leak around the north side of the sluice. To the north of this deposit, and extending beyond the limits of the trench, was a more consistent layer of yellow/brown sand/sandstone, as had been found in the 2004 works to the south. This sand/sandstone forms the original dam, running north-south, with the more mixed material being the backfill associated with the various phases of sluice gate. Neither trench penetrated to a depth sufficient to reveal the underlying buried soil recorded to the south in 2004.

Figure 4 The eastern trench, looking north-east

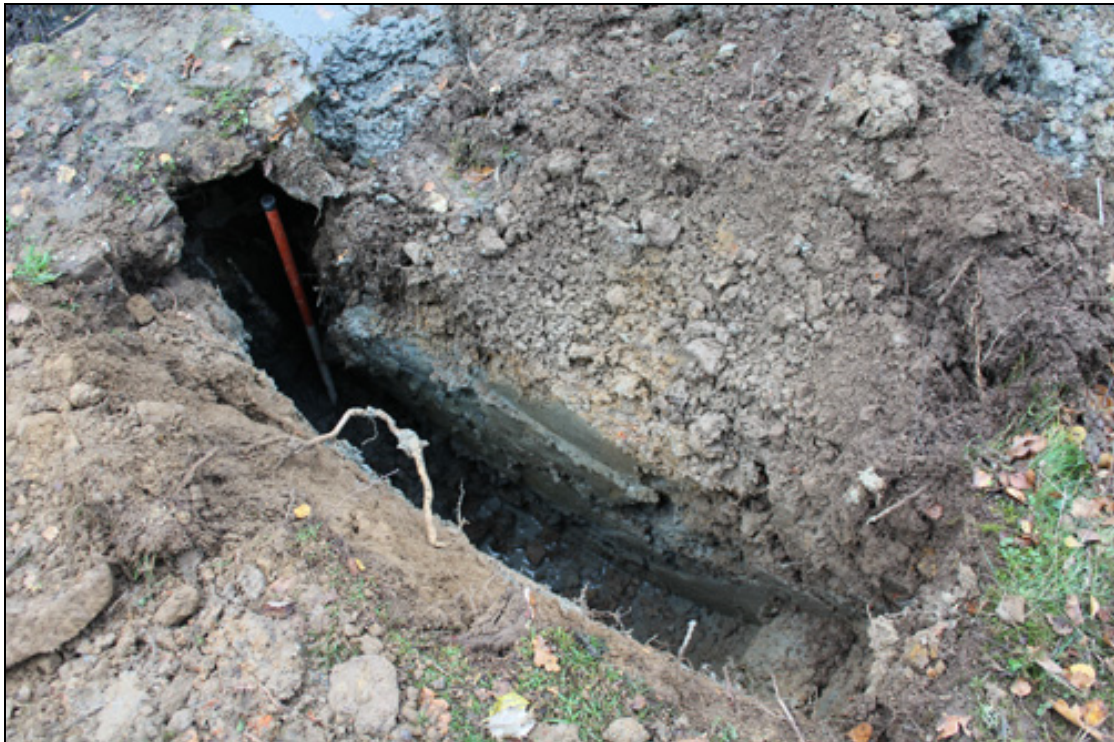
Figure 5 The western trench, looking south-west

3. Once the base of the north-western sluice pier had been reached, excavation ceased, and the southern end of the western trench was backfilled with Bentonite clay, pressed up against the pier, to make the necessary watertight seal, with the top c.0.3m finished off in concrete. The remainder of the trench, and the whole of the eastern trench, were backfilled with their own spoil. Due to the narrowness of the trenches, and the instability of the sides, no attempt was made to enter them to clean and record in detail the sections, instead a photographic record was made, together with an annotated plan, including observations of what was visible from the surface.

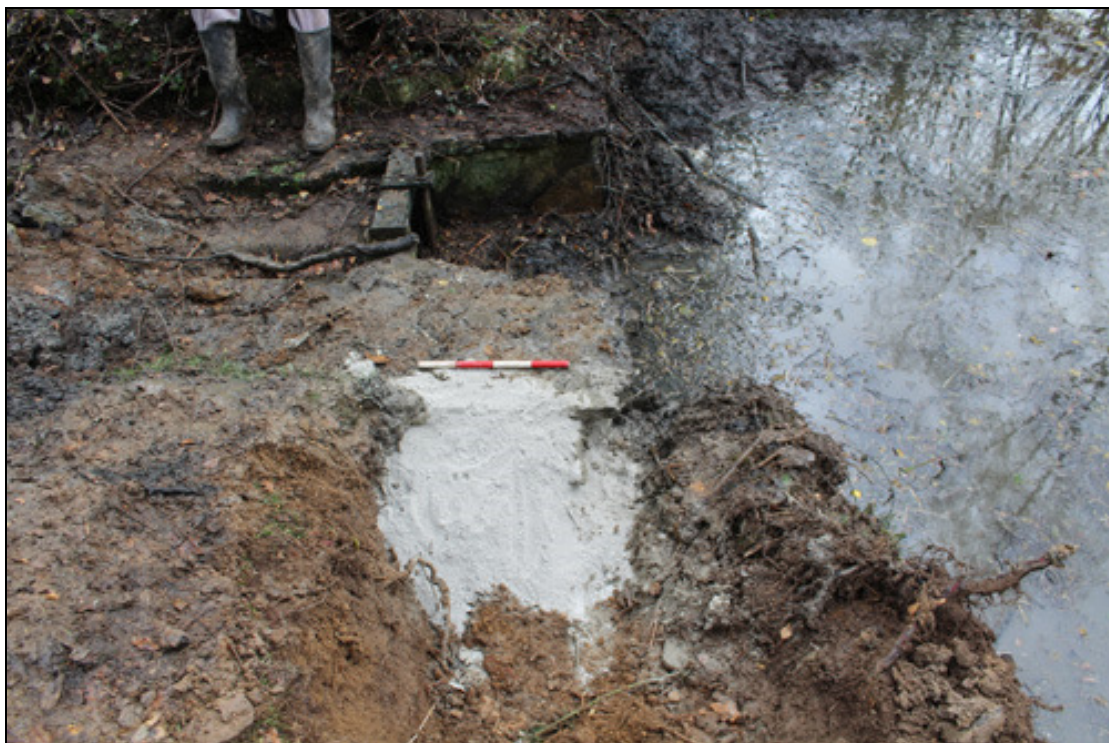
Figure 6 The western trench after sealing and backfilling, looking south towards the sluice
