**Report on Archaeological Works at Fernhurst Furnace,
Fernhurst, West Sussex**

January 2018

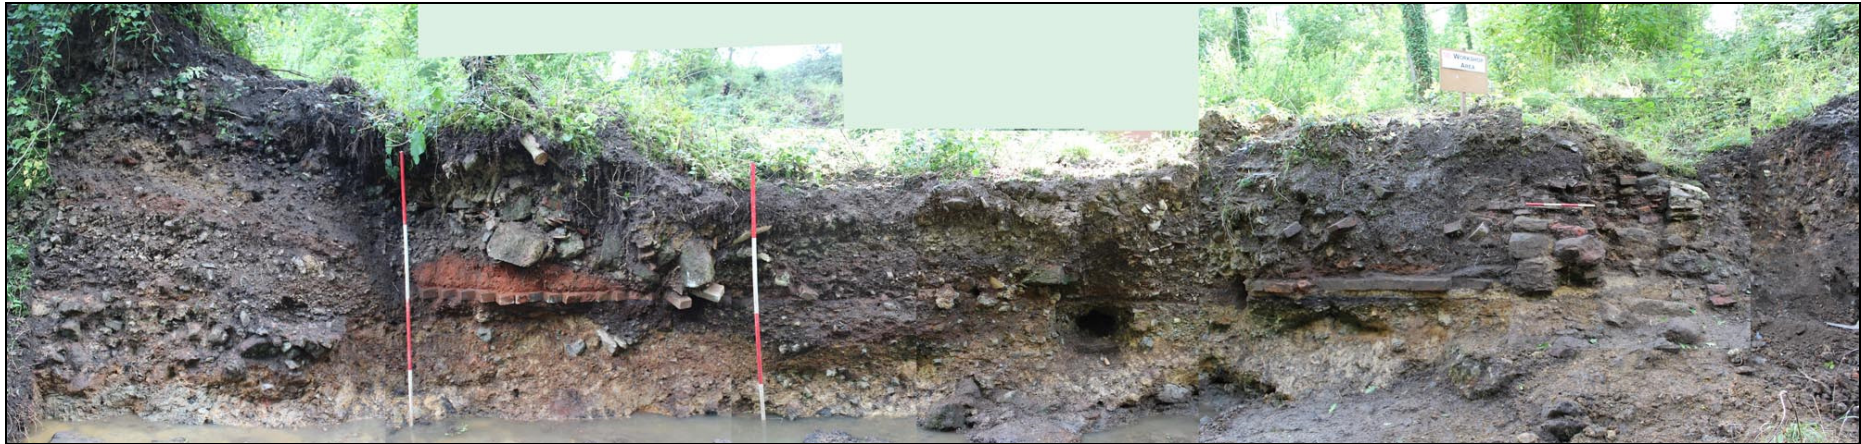
Figure 5 Photographic composite of the 2017 Section, the scales mark the principle changes in direction

RESULTS (see Figures 3 & 5)

1. A fourteen metre long section was cleaned and recorded along the south side of the tail-race, approximately 4.5m shorter than the earlier 1989/1992 section, but including all the key archaeological features then identified, all of which have survived the intervening years with only minor damage, perhaps due to their height in the section and the protection afforded by vegetation growth.
