**Report on a Programme of Archaeological Works at
Pitlands Farm, Up Marden, West Sussex**

September 2016

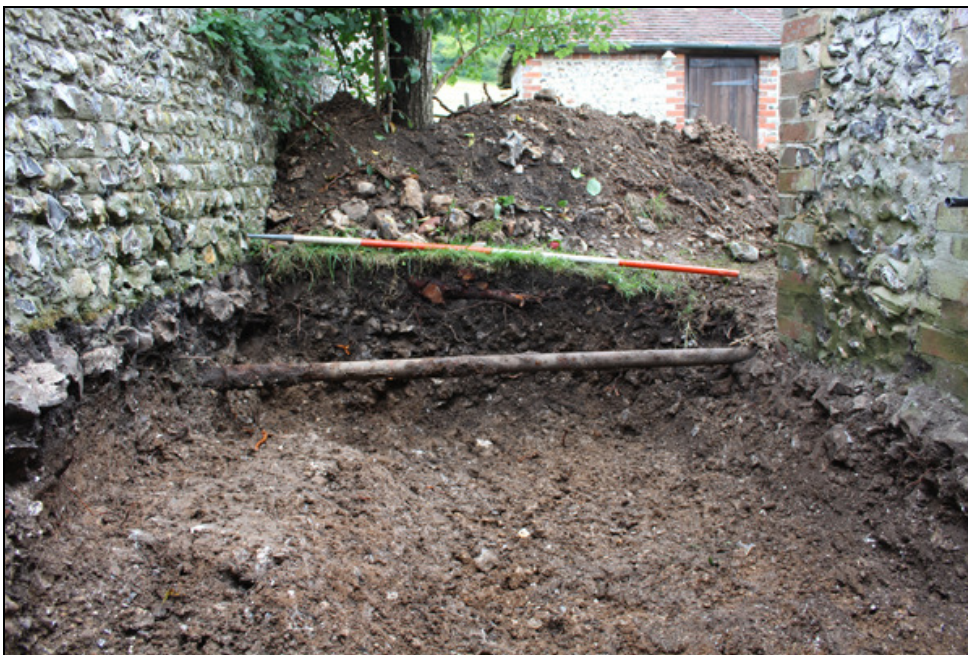
Figure 5 The east face of the Investigation trench, showing the flint retaining wall to the left

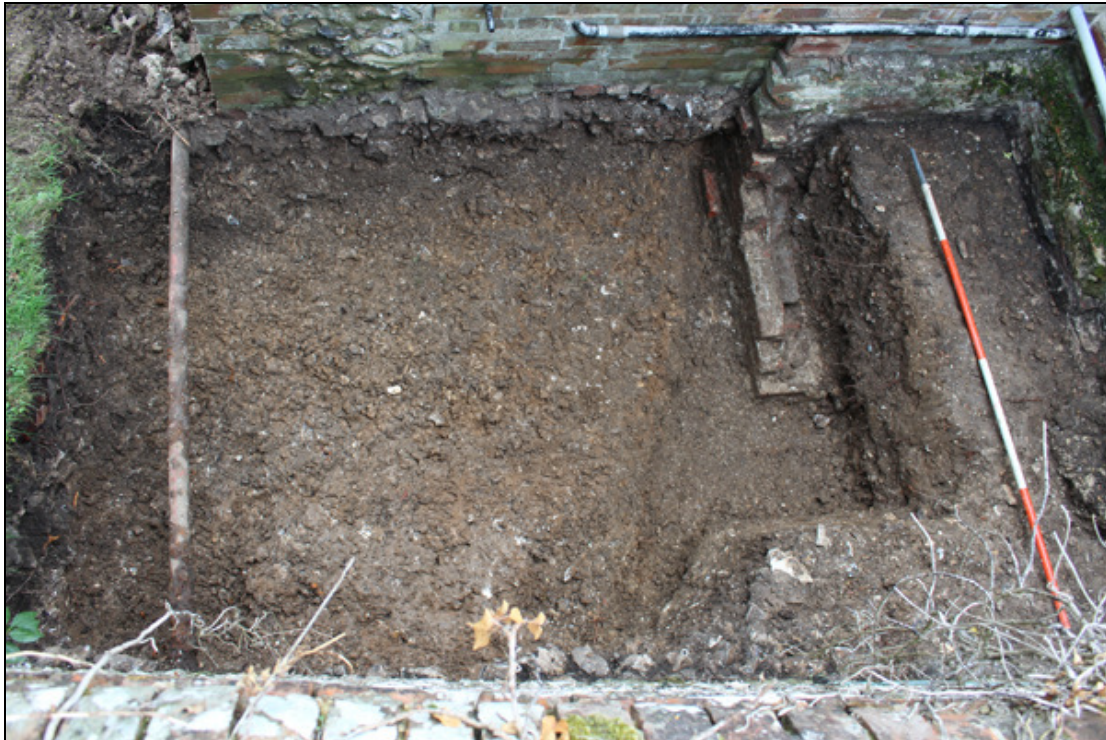
Figure 6 The investigation trench, looking south
