## **Durford Abbey Farm, nr. Rogate, West Sussex**

Report on an Archaeological Evaluation  
& Mitigation Statement for Re-Development Works

July 2013

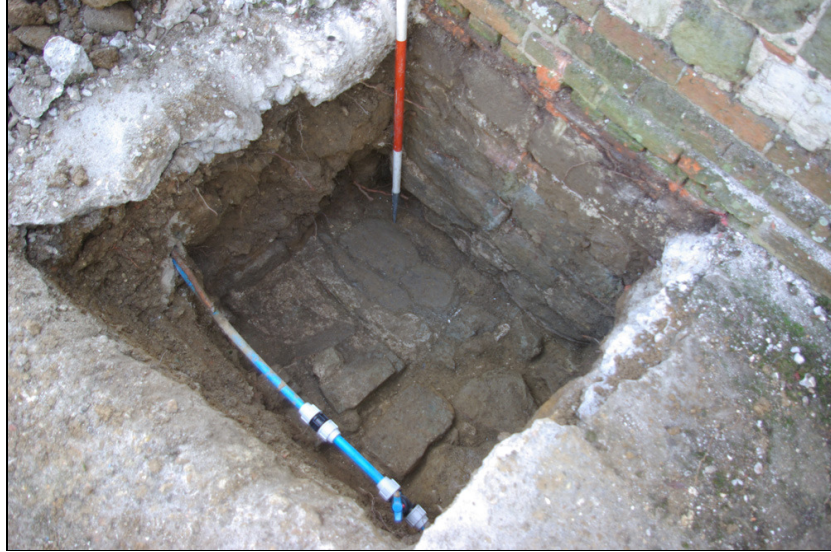
**Figure 5** Trench 2, looking south-west. The scale is in 0.5m bands.

1. Trench 2 was positioned against the eastern end of the north wall of the stables in order to examine the nature of both the ground conditions and the foundations. The trench was approximately one metre square and 1.1m deep, with a small slot against the west face dug down to 1.5m deep.

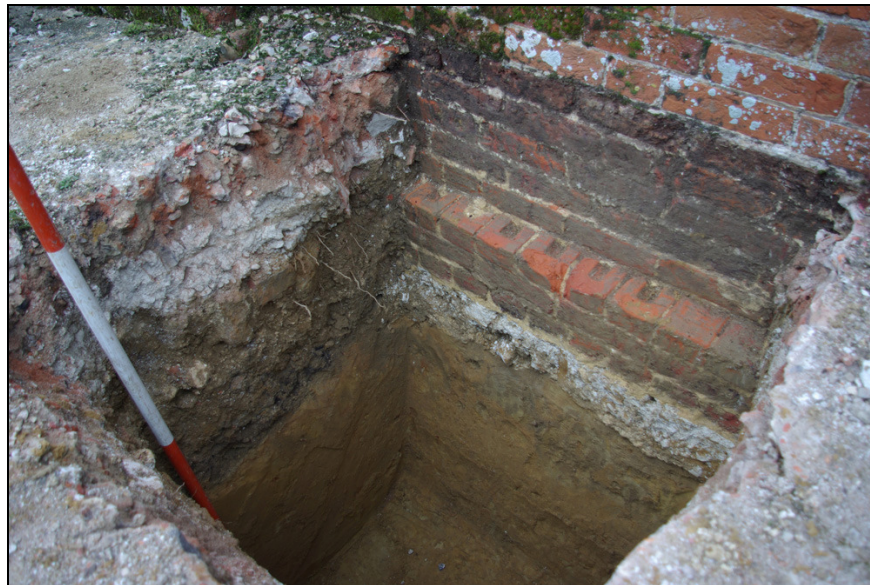
**Figure 8** Trench 3 looking north-west. The scale is in 0.5m bands.

1. Trench 3 was located against the south wall of the cow house, at its western end, in order to examine the nature of both the ground conditions and the foundations. The trench was 1.45m deep and approximately one metre square.

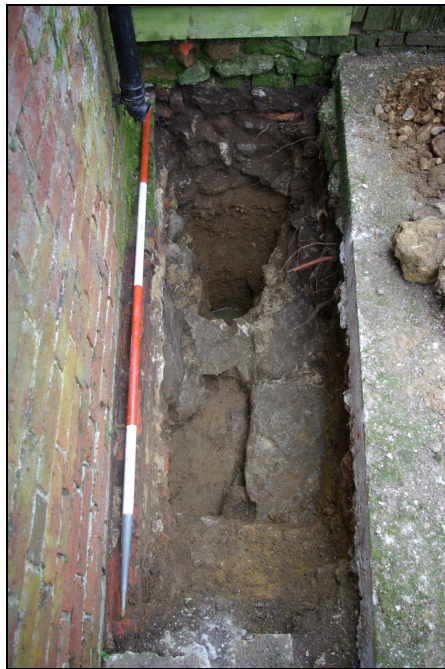
**Figure 12** Trench 4 looking east. The scale is 2m.

1. Trench 4 was located in the angle formed by the walls of the cow house and barn in the north-east corner of the existing courtyard, in order to examine the nature of both the ground conditions and the foundations of both buildings. The trench was 1.05m deep, with a small slot dug down to 1.4m. It was 2.2m north-south and tapered from 0.95m at its east end to 0.6m at its west. This unorthodox shape was dictated by that of the slab of concrete that overlay the trench.
