**An Archaeological Watching Brief at
Durford Abbey Farm,
West Sussex**

10th December 2003

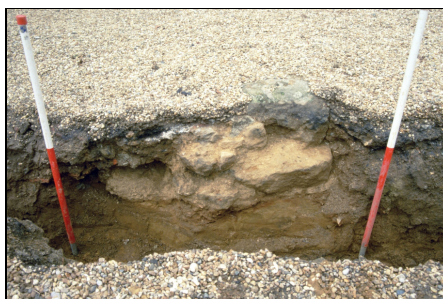
1. The assumption that any medieval remains must lie at some depth, meant that in the case of the Abbey church, the obvious had been overlooked at Durford. The foundations of what must have been one of its walls are actually visible amongst the gravel of the current drive (see **figures 3 & 6**). These foundations, composed of greensand blocks set in a yellow mortar, were dug into undisturbed geological sand and extended to only 0.4m deep.

Figure 6 The foundations of the Abbey church, note the large stone exposed on the surface.

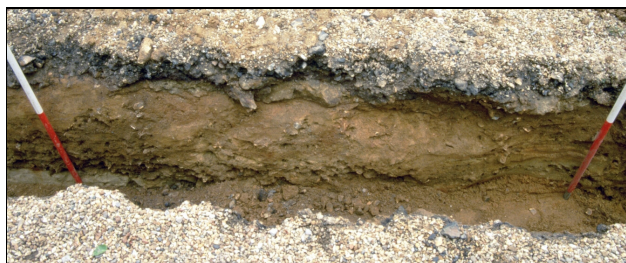
3. But where, then, was the north wall? The very shallow depth of the southern wall foundations could have meant that the northern wall had been completely robbed away, and this is quite possible. However, a close examination of the trench sides revealed what may be the very last course of the foundations 5.5m to the north (see **figures 3 & 7**).

Figure 7 A few blocks of greensand visible in the trench side – possibly the northern wall of the Abbey church.

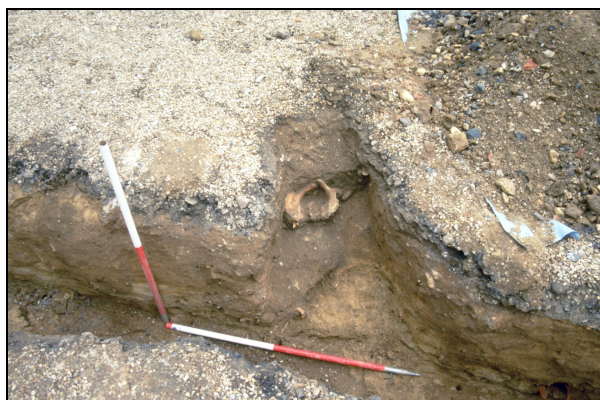
1. Six medieval graves were revealed, four in trench one and two in trench two (see **figures 3, 5, 8 & 9**). The graves were only partially excavated, but appeared to all contain articulated skeletons aligned east-west. The grave fill of one contained a sherd of medieval pottery. None of the graves was discovered at a distance of more than 5 metres from the barn which now forms the northern side of the farm yard. It therefore seems probable that the graveyard does not extend much beyond that limit. The graveyard's dimensions to the west and east are unknown, but it should be assumed that it could run for the length of the now demolished Abbey church.

Figure 9 The southern pair of graves in trench one, view of the pelvis uncovered when an attempt was made to take the water pipe trench east.

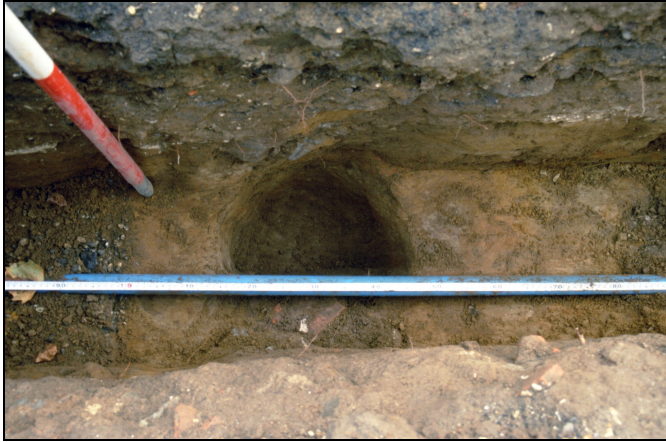
Figure 10 Post-hole, possibly associated with abbey cloister.

1. Just over one metre to the south of the Abbey church, a post-hole was excavated covered by a layer of post-medieval rubble and soil (see **figures 3 & 10**). It is possible that this post-hole is of medieval date and was emptied of its post when the Abbey was demolished. If so, its position suggests it may have been a support for the Abbey cloister, which seems to have been in a constant state of disrepair from the 14th century onwards.

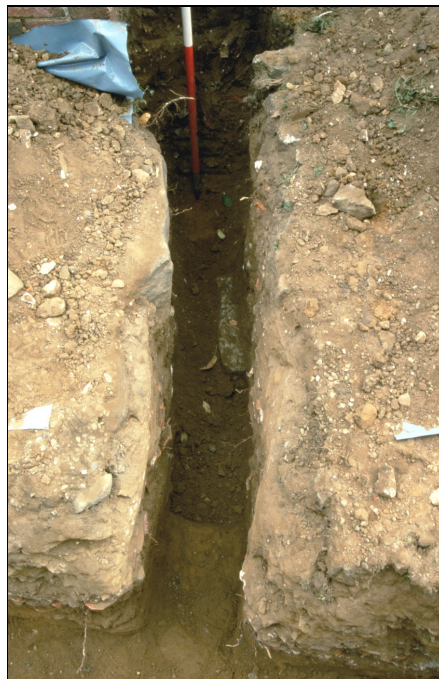
Figure 11 Pit with large, square greensand block.

2. To the south, where a short stretch of additional trench was added for a garden tap, part of a pit was discovered cut into the sand (see **figures 4 & 11**). The pit

contained at least one large greensand block, which appeared to be *in situ*, rather than loose rubble. The material surrounding this stone and filling the pit was post-medieval in date. It is unclear what function this pit may have performed.

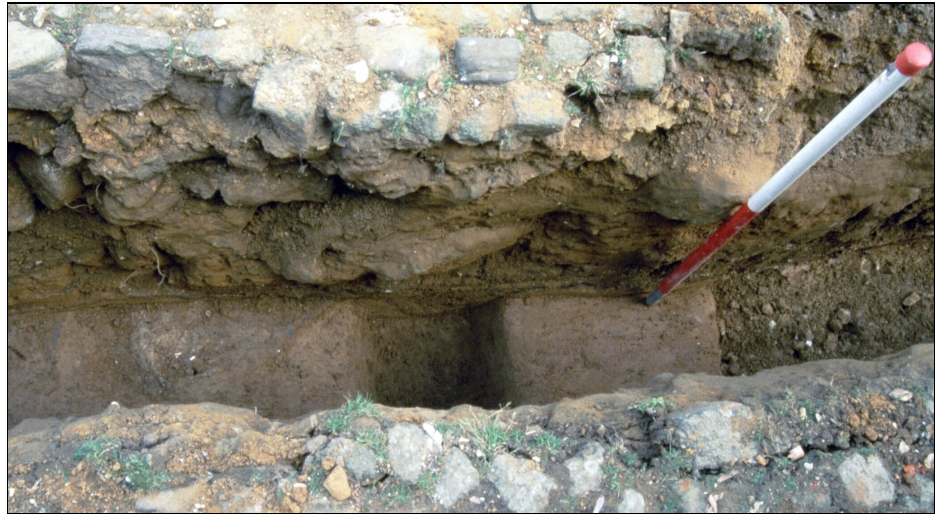
Figure 12 Possible medieval culvert carrying rain water from west range of abbey.

- Further to the south, near to the end of the trench, a shallow ditch was revealed running east-west, again filled by post-medieval rubble (see **figures 4 & 12**). From its size and shape it is possible to see this ditch as a culvert draining rain water from the west range of the abbey buildings.

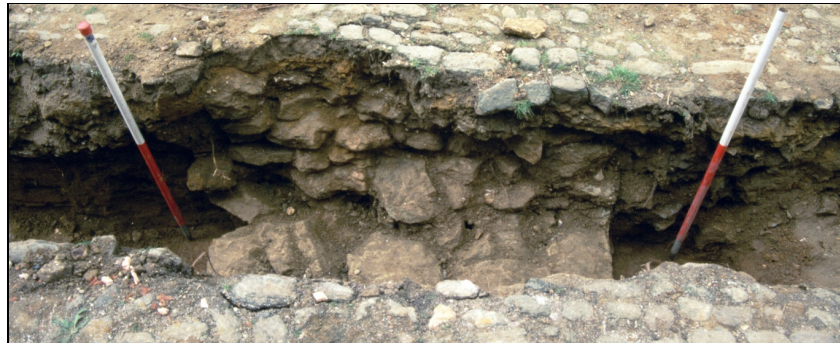
- The most obvious feature in trench one belonging to the post-medieval period was the east-west running wall at its southern end (see **figures 4 & 14**). What this wall was, is not clear – the most likely possibility is that it is the northern

wall of the central large projecting chimney seen in the Grimm drawing of 1782 (see **figure 15**). A number of large stones visible in the base of the trench further to the south, at the point where it turns west towards the current house door, may represent the chimney's south wall.

Figure 14 The northern wall of the chimney.

2. This interpretation is supported by the traces of ash apparent at the base of the trench between these two points. No trace was found of the floor of the fireplace, and it must be assumed that this was removed when the chimney was knocked down.

3. Towards the base of the north wall, and incorporated within it, a single brick was found which dates the structure to second half of the 16th century at the earliest. This would indicate that the chimneys were added after the Dissolution and before the Grimm drawing.

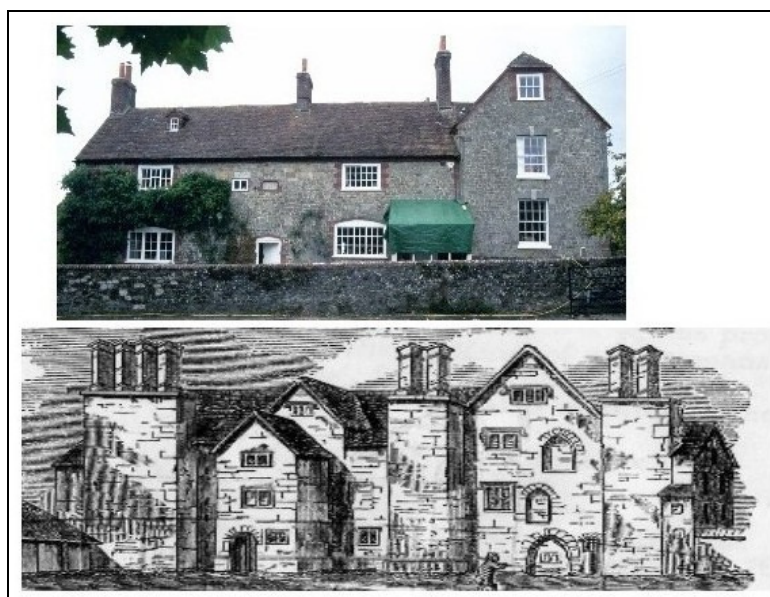
Figure 15 The Grimm drawing of 1782, compared with the current farm house. Obvious errors of scale in the drawing have been corrected.

4. Second the building shown on the Grimm drawing bears a striking resemblance to the Stawell house, in that both consist of a north-south block linked to a higher east-west block (see **figures 1 & 15**). The only differences being that the Stawell house has new windows, doors and chimneys, indicating a similar form of alteration as that carried out by the Mervyns two hundred years earlier.

5. The only other alteration which appears to have taken place is the removal of the short stretch of building which continues beyond the east facing gable shown on the Grimm drawing (see **figure 15**). This used to form the link between the Abbot's lodging and the west end of the Abbey church against which it butted. The southern church wall foundation found in trench one lines up with the north end of the house shown on the Grimm drawing, a position which is now occupied by the current garden wall (see **figure 8**). The removal of this end of the Grimm house has resulted in the present north façade of the

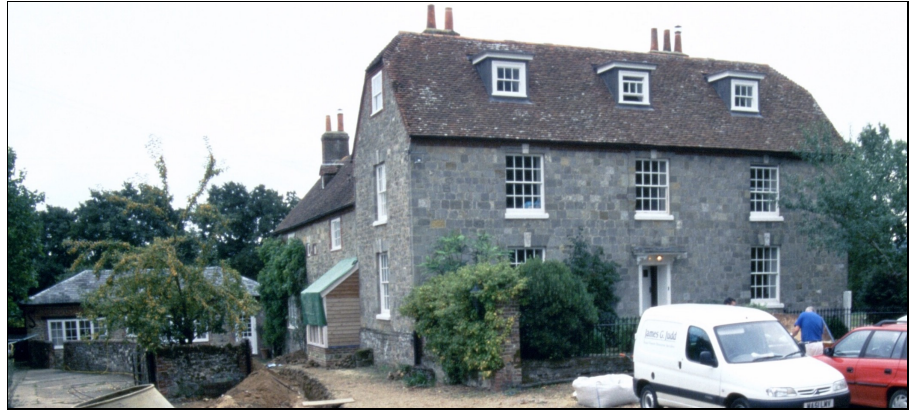
farm house, which is composed of much more finely dressed blocks than the other faces of the building (see **figure 16**).

Figure 16 North face of the current farm house.
