Durford Abbey Farm, nr. Rogate, West Sussex

Report on an Archaeological Evaluation

March 2008

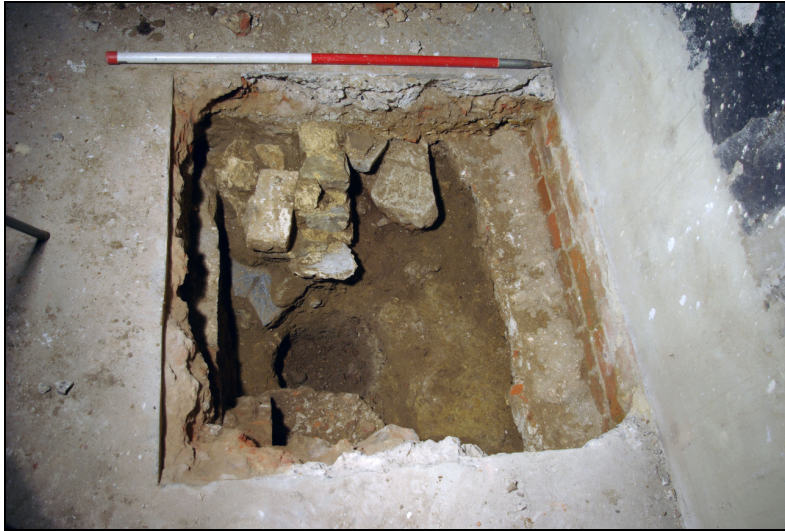
1. Trench 1 was located at the western end of the Cow House against one of its internal concrete partitions. It was placed there to investigate the nature of the footings to the partitions. The footings (3) were found to be of concrete, projecting 0.25m out from the wall and extending to 0.38m in depth below the current floor surface.

Figure 4 Trench 1 looking west. The scale is 1m.

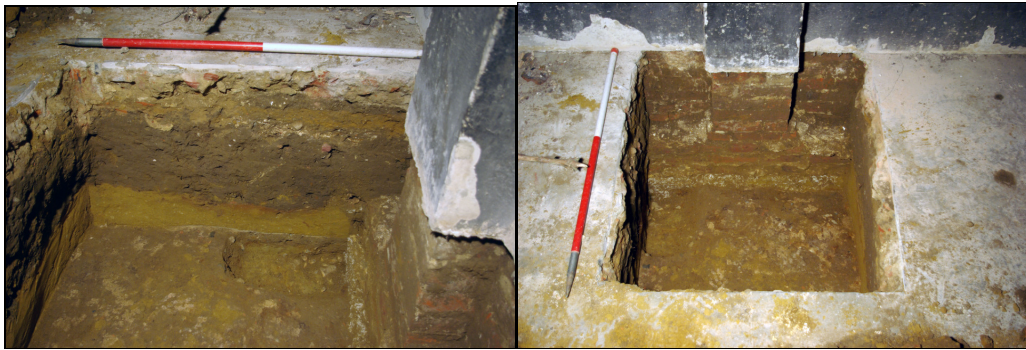
Figure 6 Trench 2 looking east and south. The scale is 1m

1. Trenches 2 & 4 were almost identical in their results. Both were placed against the south wall of the Cow House to investigate the half-columns supporting the ends of the tie-beams of its roof. Together with Trenches 5 & 6 they revealed that the Cow House walls and the half-columns sit on a foundation of brick on crushed chalk. The base of the bricks in Trenches 2 & 4 (7 & 6) being c 0.6m below the current floor level. The base of the crushed chalk was not reached in these trenches.

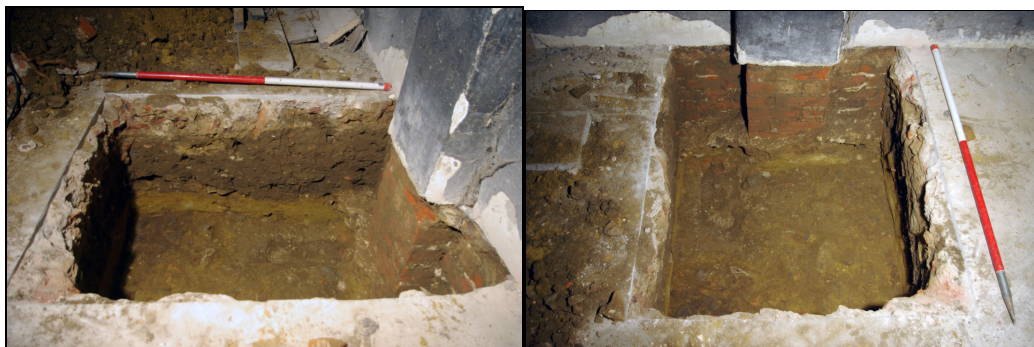
Figure 7 Trench 4 looking east and south. The scale is 1m.

2. Inside the brick walls the deposits were very similar, below the concrete floor (1) and its make-up layer (2) was a thick deposit of dark brown soil (3) containing frequent fragments of tile, brick, upper greensand and chalk. Below this layer was a spread of clean yellow sand (4) which overlay a surface (5) in both trenches. The nature of these surfaces was different in each trench, with that in Trench 2 lying at 0.66m below the present floor and being composed of flint and soil, while in Trench 4, lying at 0.6m, it contained numerous fragments of upper greensand and tile, in addition to flints. A small area of Trench 2 was excavated below the level of this surface and it was found that it sat directly upon a flinty clay/sand (6) taken to be the undisturbed geology.

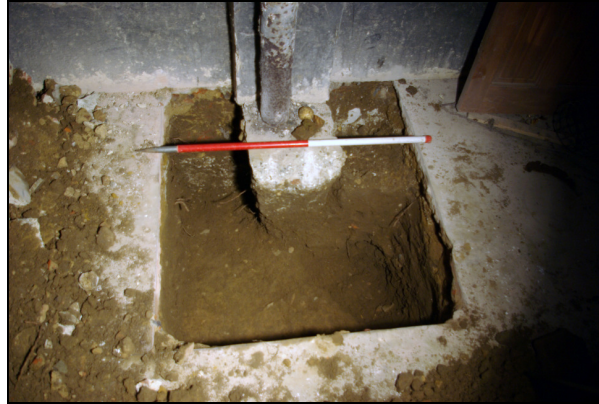
Figure 10 Trench 5 looking north. The scale is 1m.

1. Trenches 5 & 6 provided further information regarding the construction of the Cow House. Trench 5 was placed against its north wall, to investigate another of the half-columns supporting the tie-beams and Trench 6 was against the outside of its east wall. The foundations were again seen to be of brick (7 & 6) sitting on a crushed chalk foundation (8), with the chalk being 0.32m in depth. There was a significant difference in depth to the foundation in these two trenches to that recorded in Trenches 2 & 4, with the north and at least part of the eastern wall foundations being c.0.2m higher.

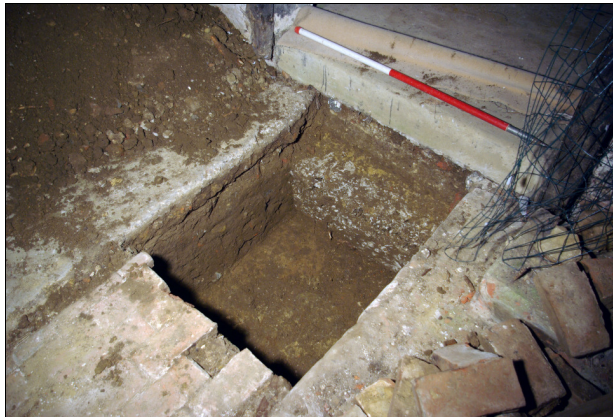
Figure 11 Trench 6 looking south-west. The scale is 1m

2. In these trenches, below the current floor surface and make-up (1 & 2), there was a thick layer of dark brown soil with rubble fragments (3), very similar to that in trenches 2 & 4, but whereas in these latter trenches the base of the foundations was below the level of the underlying deposits, in Trenches 5 & 6 the builders of the Cow House seem to have been content with digging them only to the base of this soil layer.

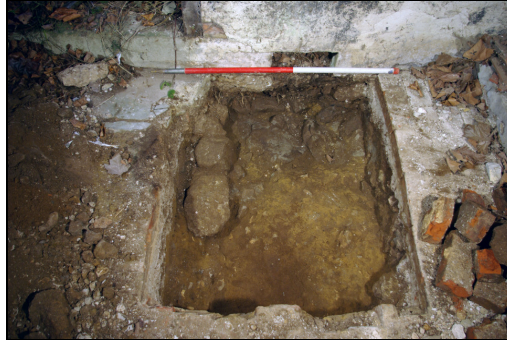
Figure 14 Trench 7 looking east. The scale is 1m.

1. In Trenches 7 & 9 the wall of the extant early 17th century barn was found to rest upon the remains of an earlier wall foundation of upper greensand (5 & 3). It would appear that the barn wall is narrower than that of the earlier, and that it does not run exactly parallel since in Trench 7 the upper greensand wall projects 0.3m, whereas in Trench 9 it is 0.5m. The foundations of the earlier wall in both trenches has been dug down into the clay/sand undisturbed geology (4 & 5), and its depth was not ascertained.

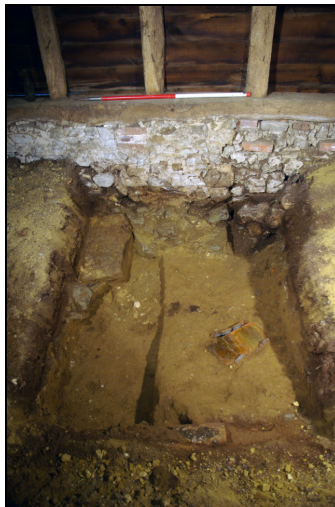
Figure 15 Trench 9 looking east. The scale is 1m

2. There was also evidence for further early walls in both trenches, seemingly with shallower foundations, suggesting they may be internal to any building. In Trench 7 the upper greensand blocks projected westwards at the northern end of the trench, and in Trench 9 a possible robber trench was identified (4) again running westwards. The depth of the remains of all these earlier wall foundations was only 0.2 – 0.25m below the current floor of the barn.

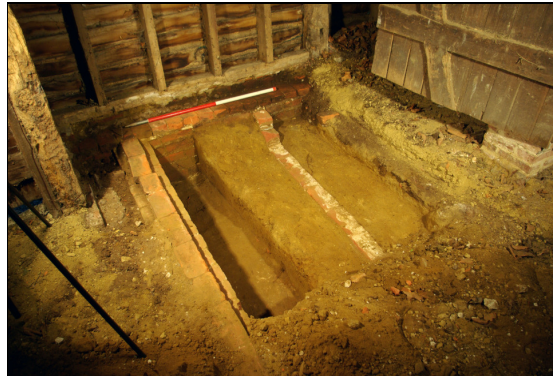
Figure 18 Trench 8 looking north-west. The scale is 1m.

1. Trench 8 proved to be unproductive in providing information on the survival of archaeological remains under the barn floor due to the presence of a 19th or 20th century brick structure (9) which completely filled it. Only a part of this structure was revealed making it difficult to suggest what it may have been. The western side was formed by a brick wall of uncertain width, but extending to 0.58m in depth below the timber barn walls and the southern side by a wall one brick length wide, but the eastern and northern sides lay outside the trench. At least one internal subdivision lies within the structure, which was visible in the northern half of the trench, differentiated from the southern wall by being only one brick width wide. The whole structure seems to have been set into the undisturbed clay/sand geology (5), with a gap between the barn's entrance bay and itself filled in with soil and rubble (8).

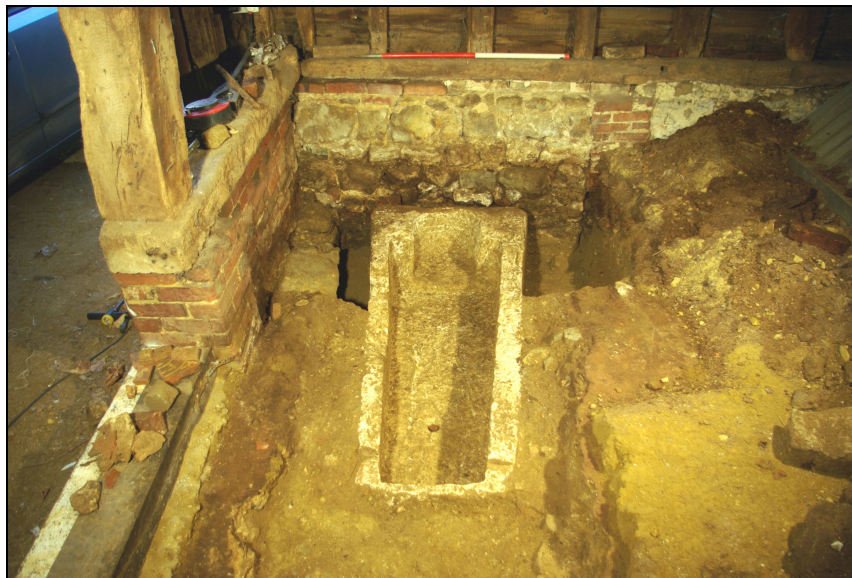
Figure 20 Trench 10 looking west. The scale is 1m

1. The most significant discovery in Trench 10 was a chalk sarcophagus (5) discovered immediately below the present floor surface. The sarcophagus was 1.98m long and 0.82m wide at its western end, tapering to 0.57m wide at its eastern end. It contained a hollowed out cavity for the interment which left walls 0.11m thick along the long sides and only 0.7m at the eastern end, with a separate head cavity at the western end. Two round holes had been punctured through the base of the sarcophagus, roughly evenly spaced along the centre line of the body cavity. It is unclear whether these were part of the original design, although other medieval stone sarcophagi have similar features.

2. It seems probable that the sarcophagus is not in its original location, since it sits within a large depression or pit cut into the clay/sand geology, the sides of which were not revealed in the trench. This depression had been filled with a dark sandy/soil (4) containing fragments of medieval floor tile, early brick and one piece of carved upper greensand. The sarcophagus had also suffered some damage at its eastern end where the top of the sides had been cut down by a few centimetres; there would seem to be no reason for this in its current location and was therefore presumably done elsewhere, before the sarcophagus was deposited here.

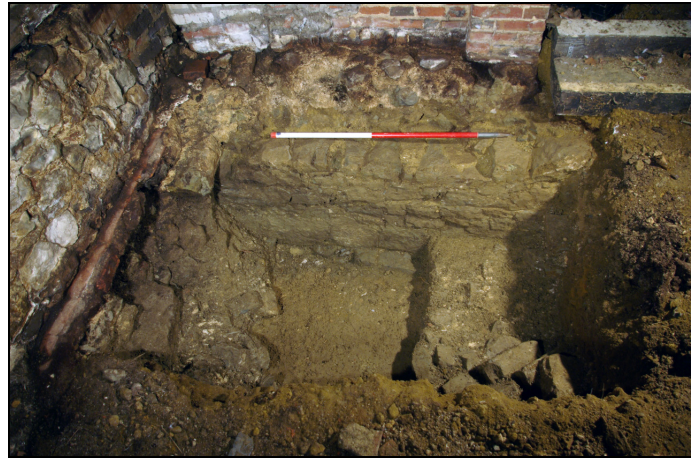
Figure 22 Trench 11 looking north. The scale is 1m.

1. Trenches 11 & 12 both exposed wall foundations ((7 & 6) which are almost certainly part of the remains of the medieval monastery at Durford and which are also likely to be the north and south walls of one building or room. Both were of substantial depth and width, although their full dimensions were not visible in both trenches, being 0.9m wide as revealed in Trench 12 and over 1m below the current barn floor in trench 11. Both were composed of upper greensand blocks roughly faced, coursed and set in yellow mortar. On the south side of the wall in Trench 11 and the north side of that in Trench 12, and presumably infilling the space between, the ground was made up with greensand rubble, gravel and soil (5), presumably from the demolished building which had stood above.

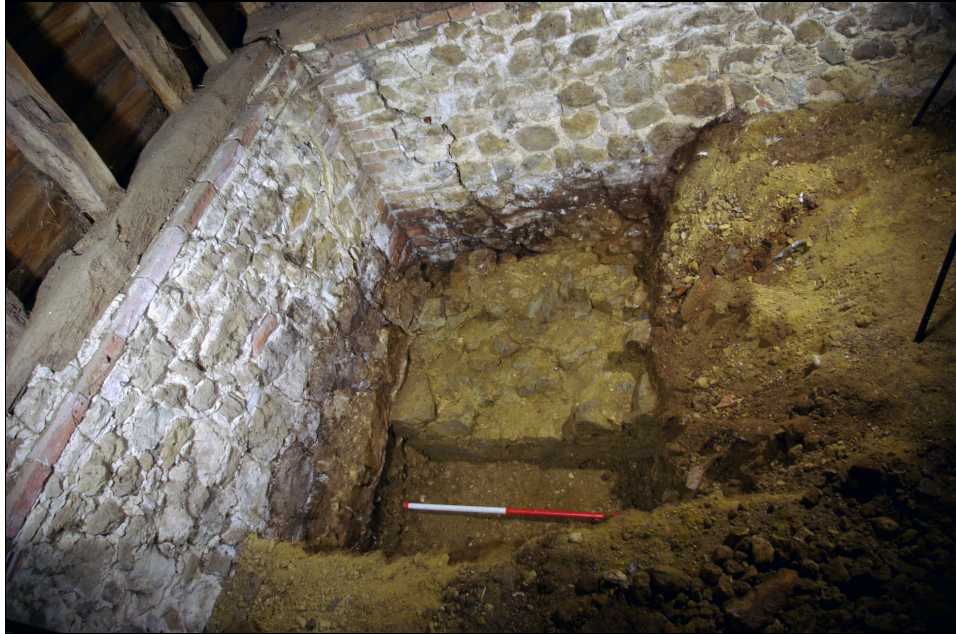
Figure 24 Trench 12 looking south. The scale is 1m.

2. The barn, which overlies both foundations, is set upon them only where it crosses their line, leading to structural problems seen particularly in Trench 12, where the south-east corner of the barn has settled exposing cracks in its fabric; these cracks have been repaired with mortar at some point in its lifetime. The barn wall footing in both trenches is composed of upper and lower greensand blocks and occasional bricks (2&3) with bricks as quoins and as a capping layer (1). There was a thin layer of soil (4) between the rubble in-fill and the base of the foundations in Trench 12 which may have exacerbated the settlement problems.

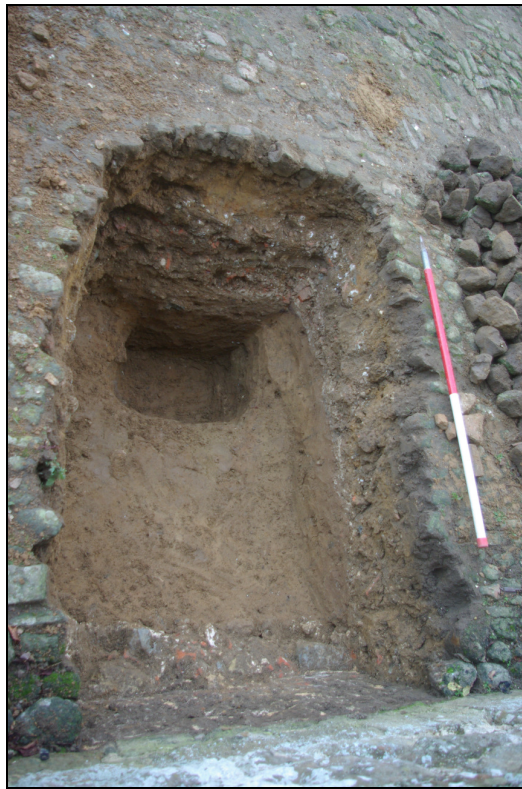
Figure 24 Trench 13 looking east. The scale is 1m.

2. The foundations (7) to the Farm House were found to start 0.48m below the current ground level. They were composed of mortared greensand rubble and were 0.45m wider on the exterior than the wall above. Interestingly the foundations had been dug from the level of the top of the sand/clay geology (5), and then a thick layer of soil and rubble (3) had been spread over the area to raise the ground surface leaving c0.5m of the house wall underground. This layer of soil and rubble contains stone, tile and brick rubble, including medieval floor tiles. Above this layer was the current cobble surface (1), sitting on clean sand in places (2).

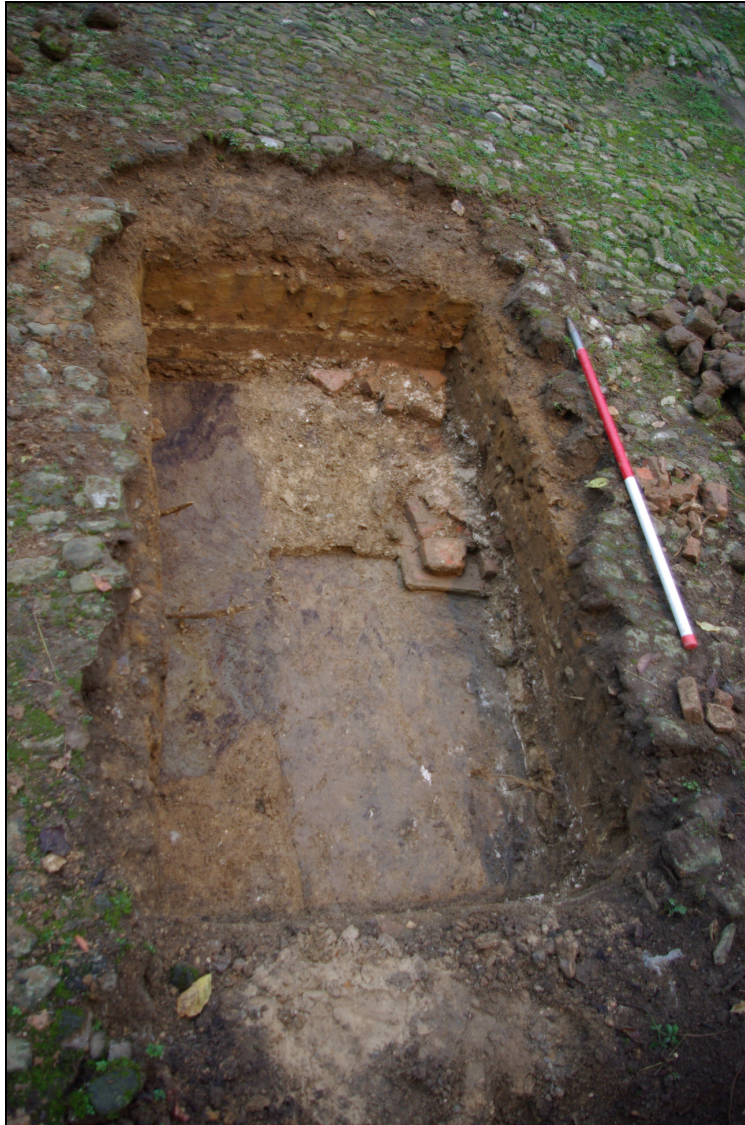
Figure 26 Trench 14 looking east. The scale is 1m.

1. Trench 14 was located to the south of Trench 13, extending 3.5m eastwards from the wall of the Farm House. It was excavated in order to assess the impact of re-landscaping proposed for this area. Significant archaeological deposits were found to lie at a depth of 0.42m below the current cobbled surface (1), overlain by levelling and make-up layers of sand and soil containing building rubble (1-5 & 13). The western end of the trench could not be excavated to the level of the archaeological deposits due to the presence of two service pipes (12 & 14).
