**Report on an Archaeological Watching Brief at
Southsea Castle, Clarence Esplanade, Southsea, Hampshire**

February 2021

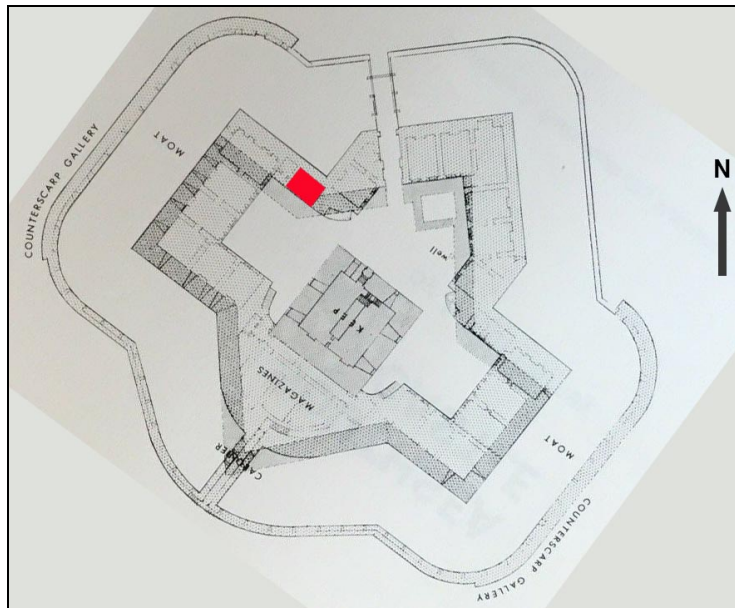
Figure 2 Plan from Corney's guide to Southsea Castle (Corney 1968), showing the location of the toilets (in red) and the Tudor fortifications (in dark grey)

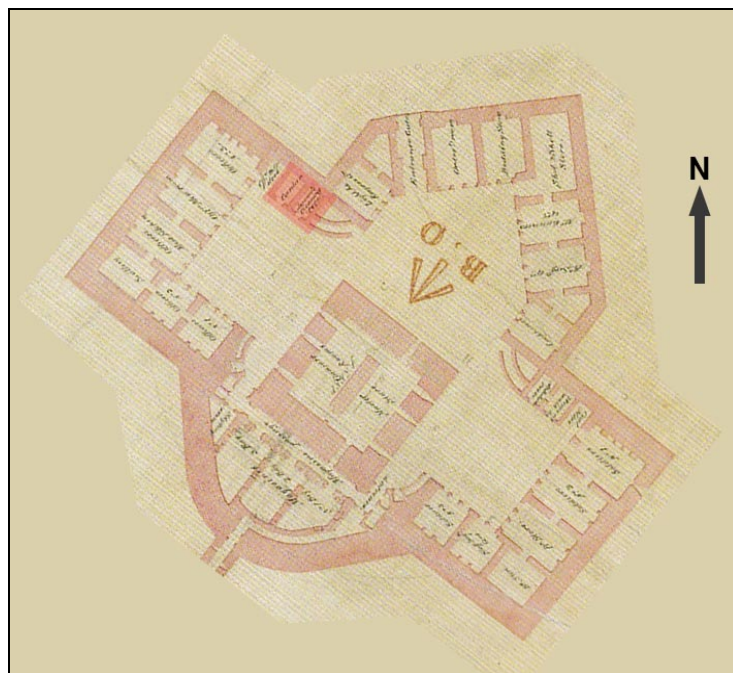
Figure 3 1834 plan of Southsea Castle showing the area of the toilets shaded in red

2. The West Bailey toilets are located within two of the casements on its north-eastern side, constructed c.1813, and labelled on a plan of 1834 as “canteen” and “cleaning room” (see Figure 3). The outer wall of the original 16th century fort lies immediately to the south of these casements, under the West Bailey (see Figure 2). During refurbishment works in 1963 the line of these fortifications was revealed and marked by the existing stone setts (Brooks, p.20 & Scarrow, p.14-5).

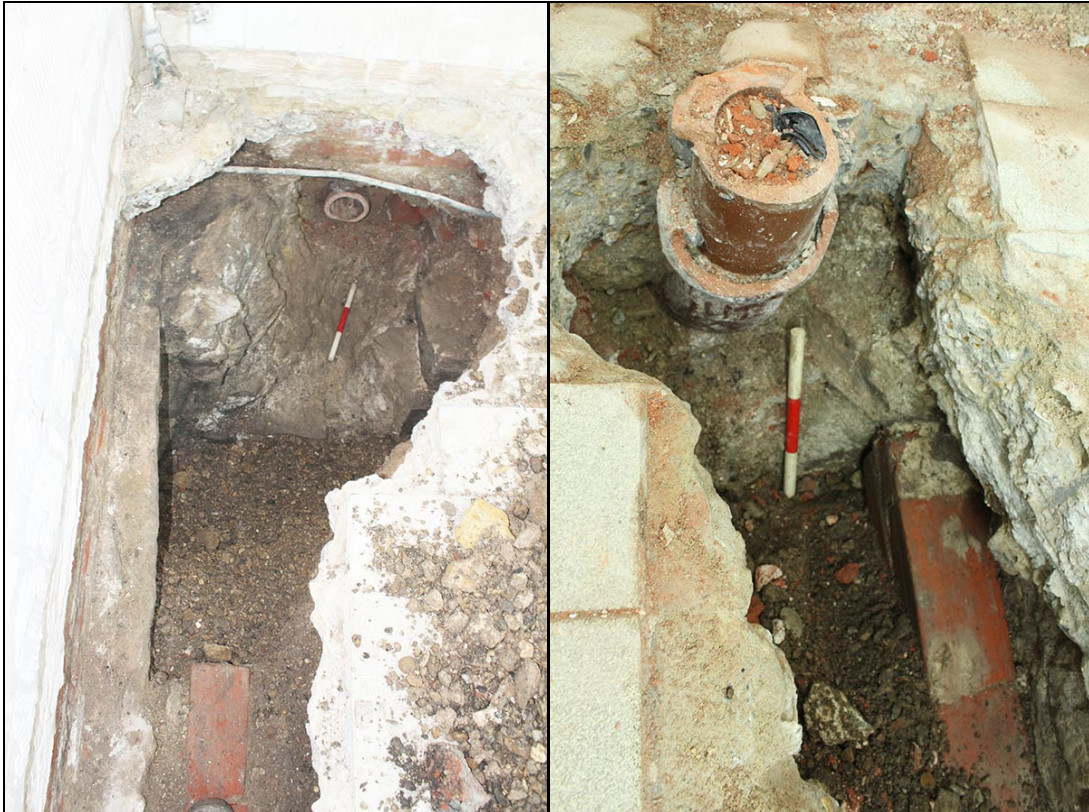
little of the wall was exposed in this location. In the eastern trench, the existing 1960's pipe had to be cut back in order to make a secure connection, resulting in the emptying of part of its trench and the exposure of more of the Tudor wall. The Tudor wall was found to be composed of undressed stone blocks bonded in a white mortar. Traces of a hard grey mortar render were found at its extreme eastern end, at which point it appeared to be turning to the north-east, which would fit with Corney's reconstruction (see Figure 3).

Figure 5 The Tudor wall as seen in the eastern trench (left) and western trench (right), both looking south-west

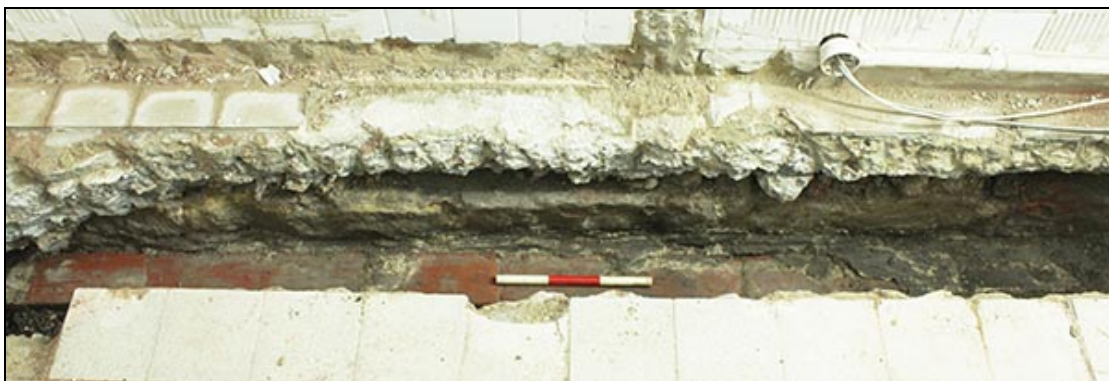
Figure 6 The early 19th century stone wall (behind the scale) and brick sleeper wall (under the scale) in the western trench, looking north-west

2. Butted up against the Tudor wall in both trenches was a footing running at right angles to it to the north-east, and lying 0.25m below the existing floor in the western trench, and 0.2m below in the eastern trench. This was composed of dressed stone blocks, possibly robbed from the facing stones of the Tudor castle. The footing supported the brick casement walls above, and is assumed therefore to belong to the early 19th century re-modelling of the castle. The base of these footings exceeded 0.9m below the current floor level in the eastern trench, where it was excavated to a greater depth to facilitate the required pipe connection.

3. Running parallel to these stone footings were brick sleeper walls, two courses deep, 0.3m below current floor level in the western trench and 0.36 below in the eastern. It is assumed that these once supported a suspended timber floor in each casement. At the south-western end of the eastern trench, where the overlying layers of dirty gravel (2) and soil & rubble (1 – the base for the modern concrete and tile floor) were removed, it was possible to see that the brick sleeper wall was bedded on a deposit of clean gravel (3). The latter extended below the base of the trench, but neither the Tudor wall, nor the early 19th century footings, were dug through it. It is assumed, therefore, that this gravel was used to infill the space between these enclosing walls. If, as seems likely, the ditch of the Tudor castle lay immediately outside its outer wall, then it would need to have been infilled as part of the works associated with its enlargement in the early 19th century, and this gravel may well have performed this role. The depth of the stone footings to the casement walls, and the fact that they do not cut this gravel deposit, might suggest that they were built up from the base of the ditch before the gravel was laid down.
