**Report on an Archaeological Watching Brief at  
St. Marys Church, Portchester, Hampshire, PO16 9QW**

August 2023

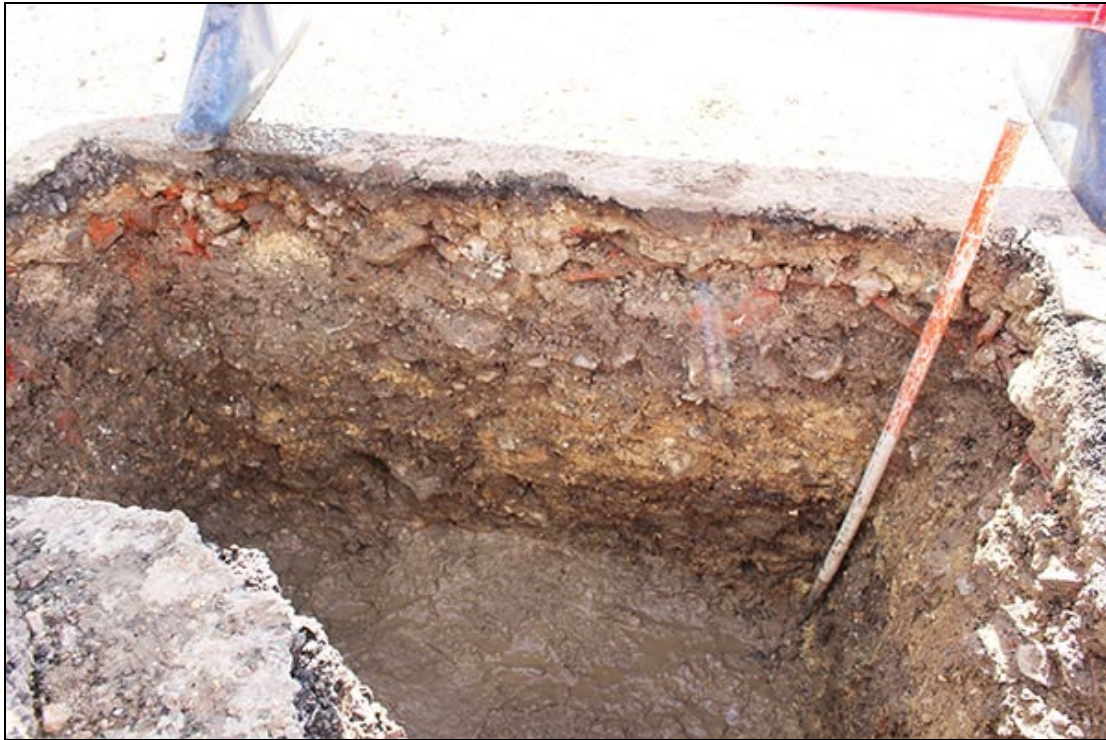
**Figure 5** Southwest face of the excavated trench showing the five make-up layers, with Feature [9] cutting them to the left

3. Cut into the above layers were three modern pits, the earliest of which was the trench for the water pipe [10] which was filled with a mid-grey/brown silt (7) containing flint and occasional tile and brick fragments. Cutting this pipe trench was the corner of a later feature [8] filled with dark brown silt with frequent flints (5). A second similar feature [9] lay in the south corner of the trench, filled with similar material (6). The first of these [8] matches up with the position of the southwest corner of one of Cunliffe's trenches excavated in 1966 (Cunliffe, B. 1975, p.184-5 & Fig.107). The second would appear to be the edge of another trench dug in modern times, with local anecdotal opinion being that it is one of several pits dug in the latter part of the 20<sup>th</sup> century to locate the position of the water pipe.
