**St. Mary's Church, Broadwater, West Sussex**  
Report on the Archaeological Works  
August 2005

## NON-TECHNICAL SUMMARY

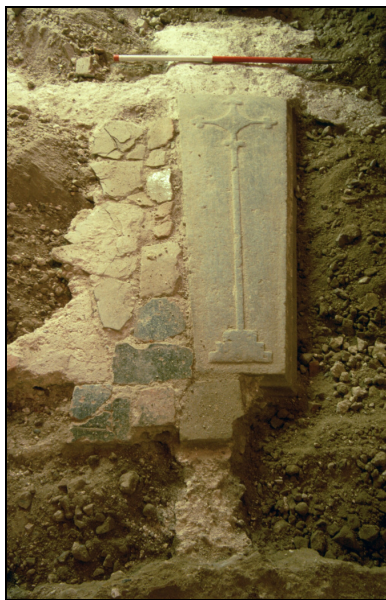
**Fig. 4** Photograph of cross slab 153, looking west.

1. The earliest surviving burials visible on the surface of the soil layer were represented by the two floor slabs 153 & 115. The former is a cross slab which, based upon the design of the cross, would appear to be of a late medieval date. It is uncertain whether this lies in its original position since the floor surrounding it is later in date and has been lapped up over its sides. The other grave, 115, is a plain floor slab, again it pre-dates the floors built up around it, but in this case seems to be in its original position, since the trial hole placed against its northern edge indicated an associated grave fill below.

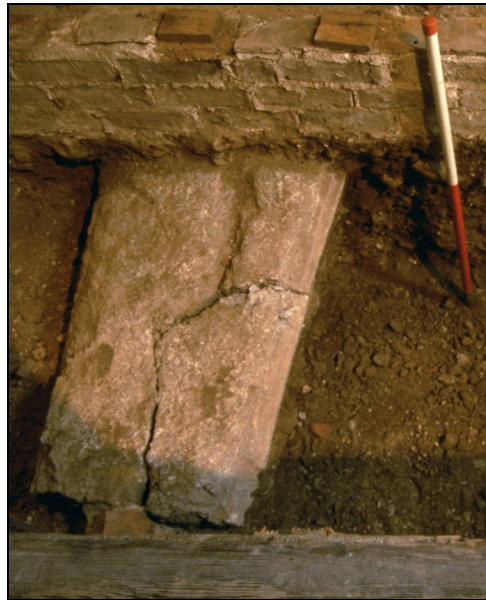
**Fig. 5** Photograph of floor slab 115, looking west

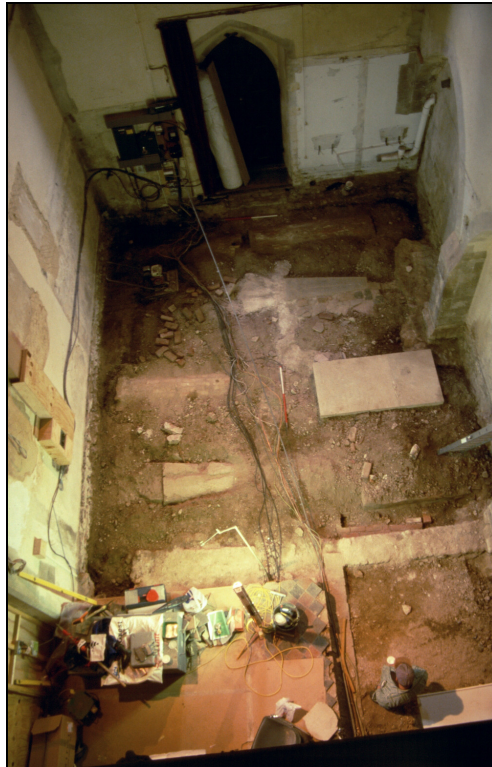
**Fig. 8** Photograph of the North Transept looking north from the tower.
