**St. Mary's Church, Slaugham,  
West Sussex**

Report on an Archaeological Watching Brief

April 2008

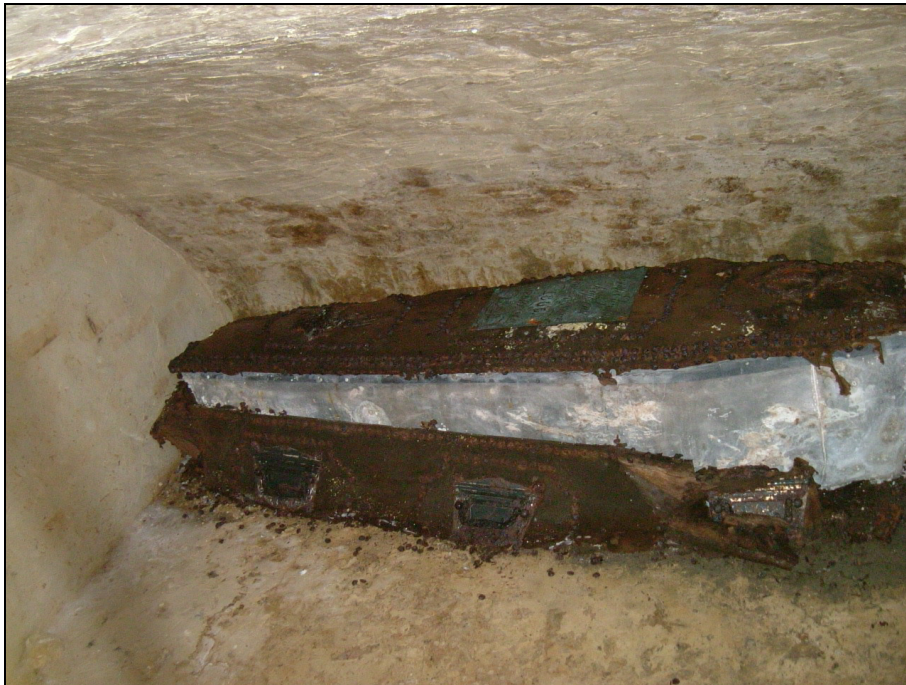
2. A separate brick arch had been constructed at a later date, probably in the early 19<sup>th</sup> century, to seal the flight of steps which led down into the vault. A small opening found in this latter brick arch enabled a camera to be lowered into the space below, which revealed the steps descending to the south and ending just short of a brick shelf upon which sat a wooden coffin, enclosing one of lead. The copper name plate set on to the wooden coffin was only partially legible, but appeared to date to 1805 or 1806. Only two persons would fit with this date, Ann Sergison (d. 1806) and "a lady named Sparrow, descended from the Mortons, ..... the last of the [Covert] family buried at Slaugham" (d.1805) (Dengate 1929 p.38). It would seem probable that it is Sparrow who is buried here, partly because it is she who was a Covert, even if not in name, and partly because the last digit on the coffin plate is more likely to be a '5' than a '6'. There is some room for doubt however, since the traces of the name above the date do not readily fit with 'Sparrow'. Whichever is the true identity of this final addition, it is clear that the rest of the vault had been bricked up in advance of its interment, since a wall visible to the immediate east of the coffin obstructed any glimpse of the rest of the vault.

**Figure 4** The 'Sparrow' coffin.

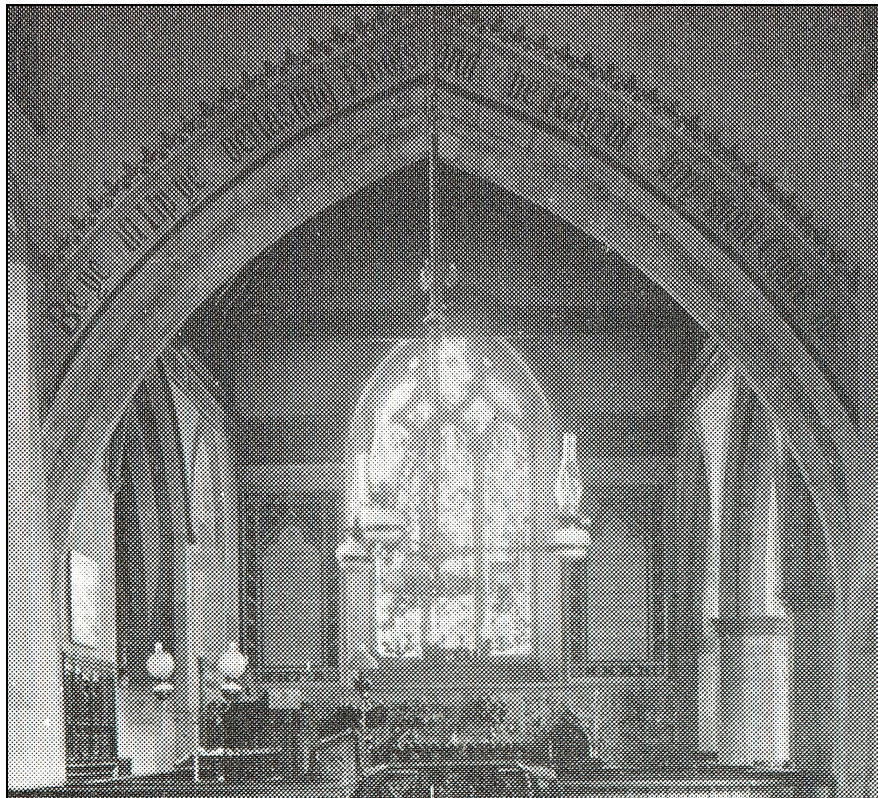
**Figure 6** 19th century photograph of the chancel, showing the wall paintings.

1. As part of the internal re-decoration of St. Marys, the existing walls were treated with paint stripper. This revealed traces of wall paintings probably created during the 1860 renovations. These paintings were found in three locations within the church: over the chancel arch facing the nave, on the side walls of the chancel above the arches and on the east wall of the chancel. Little remained of the original paintings in the first two locations due to the strength of the paint stripper used, but a contemporary photograph indicates a single decorated band containing a quotation from Psalm 24, “Be ye Open Up ye Everlasting Doors And the King of Glory Shall Come In”, over the chancel arch and two further bands on each side of the chancel.

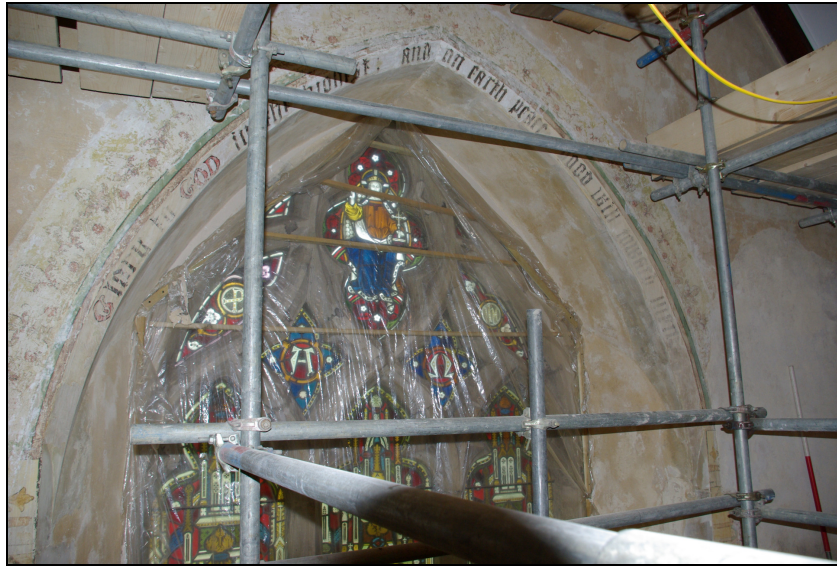
**Figure 7** Traces of the biblical quotation over the east window.

2. More remained of the wall painting on the east wall of the chancel since a weaker stripper was used. This consisted of a further band of decoration over the east window containing a quotation from Luke’s Gospel “Glory to God in the highest and on earth peace goodwill toward men” and two decorated panels on either side. Within the two panels the lettering, where visible, suggested that they may have contained the Ten Commandments and possibly one of the Creeds. All of these wall paintings had been subsequently painted over.
