**39 – 47 Claremont Road, Portsmouth**  
Report on a Programme of Archaeological Works

April 2008

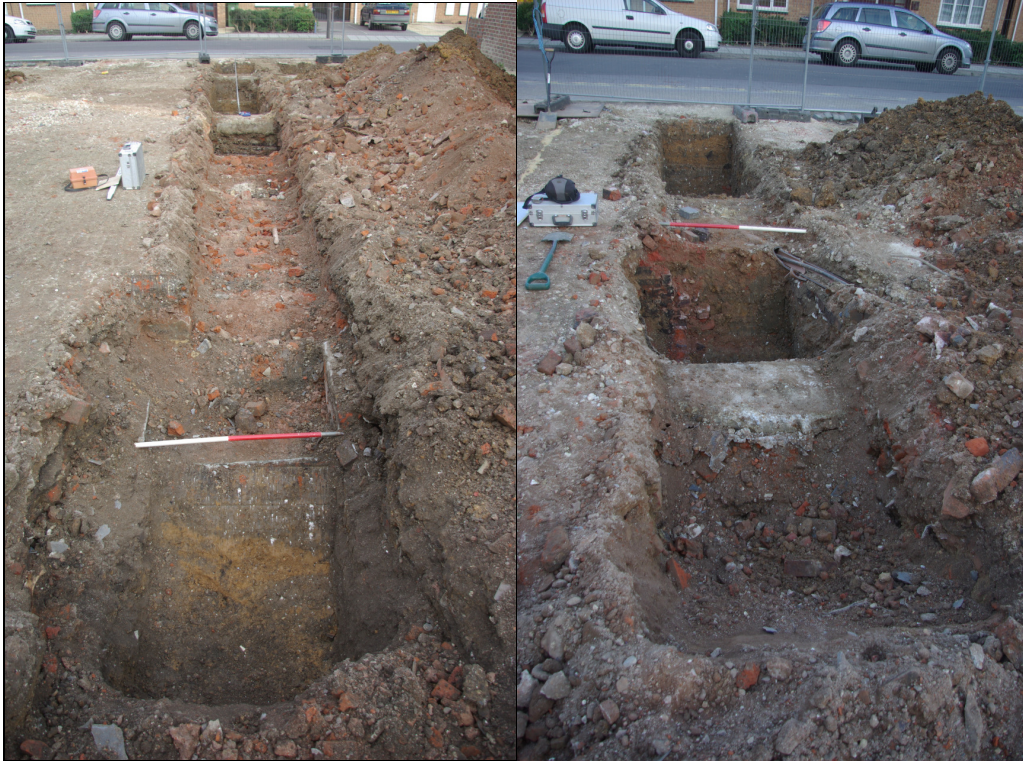
**Figure 3** Trench 1 & 2 looking east. The scale is 1m.

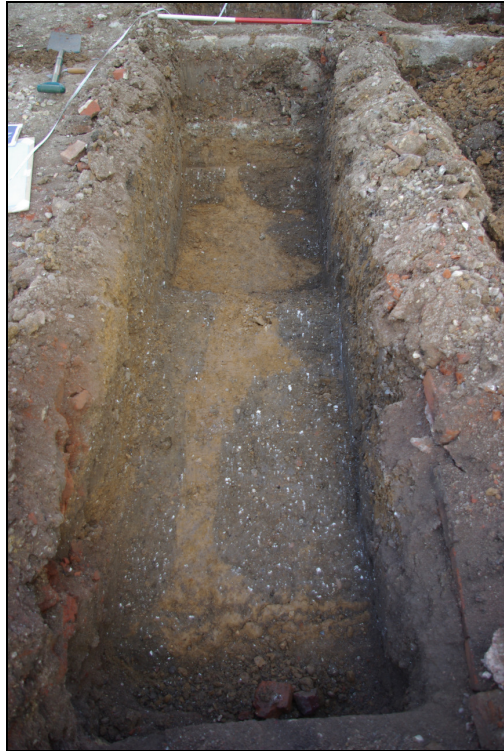
**Figure 4** Pits 3 - 7 in Trench 1, looking west. The scale is 1m.

2. Dug into this brickearth were pits (2 – 7, 15, 21, 23, 24, 26 & 36) of varying depth, found in all trenches. These ranged from 0.28m to 0.45m deep and were uniformly back-filled with dark brown silt containing occasional chalk, oyster shell, charcoal and brick. The presence of the bricks, together with two sherds of pottery also recovered from these pits, indicates a post-medieval date for the back-filling of these features. Their frequency, irregular size and shape, suggest that they were probably dug to extract the brickearth.

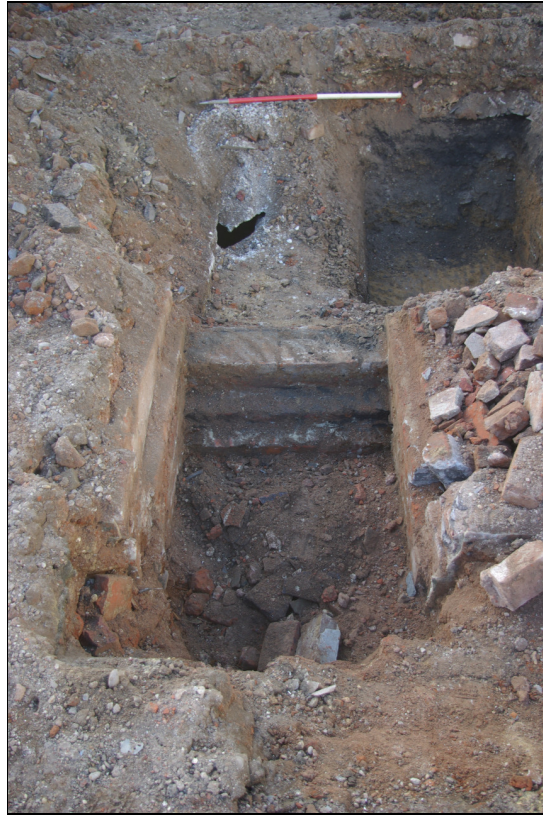
**Figure 8** Trench 3, looking west, showing the cellar steps and in the background a hole punctured through the concrete cap to the soak-away. The scale is 1m.

4. The first evidence for any dwellings on the site is the remains of the late 19<sup>th</sup> century terrace, visible on the 1896 OS mapping. The front brick wall (11) of this terrace was found in Trench 1, together with its foundation cut (12). In Trench 2, where this front wall was again to be expected, it was found to have been destroyed by later development and only its foundation cut remained (29). Attached to the front of the terrace in Trench 2 were the remains of a further brick wall (27), which probably represents the remains of a coal chute. The rear wall of the terrace was found in Trenches 1 and 3, together with the remains of the steps to the cellars (14 & 18). The cellars themselves had been back-filled with rubble (8, 17 & 31), presumably from the demolition of the terrace, and where this was removed to its base, it was found that the cellars must have been c1.5m deep when in use. To the rear of the terrace evidence was found for a contemporary rain-water drainage system. A pipe trench in Trench 1 (16) was found running north-south, which may well have run into a large chalk-lined soak-away, c. 2.25m deep, the edge of which (33 & 34) was revealed in Trench 3. A second pipe (37) was seen running towards the back of the terrace from this soak-away.
