Report on a Programme of Archaeological Works at St. Mary's Church, Broadwater, West Sussex

September 2009

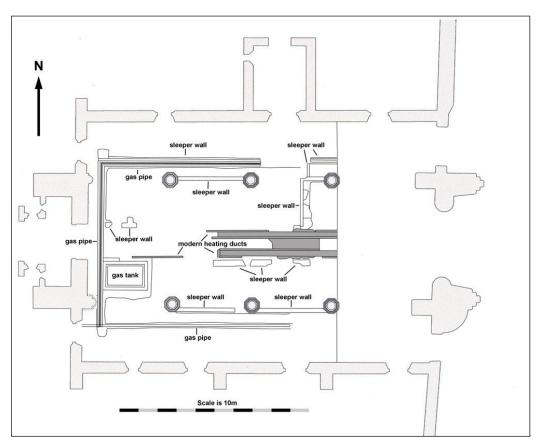
Figure 2 Plan indicating the position of late 19th century or modern features.

- The removal of the extant pews and tiled floor, together with their supporting sleeper walls, was largely carried out in advance of any archaeological work, following the agreed methodology. The depth to which ground excavation had to be carried out was equal to that of the surviving surface thus revealed. Archaeological work therefore consisted of cleaning this surface and recording any features visible at this level.
- 2. A few remnants of brick sleeper walls had been left in situ following the initial clearance, together with parts of the modern heating ducts in the central aisle (see fig. 2). These sections of duct had been a recent repair of the original Victorian system, probably installed in the 1860's, which was powered by gas, the pipes and storage tank for which remained in place (see fig. 2).

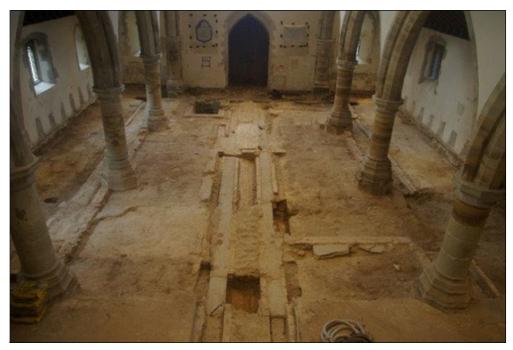
Figure 3 The interior of the church after the cleaning of the floor. The brick vaults are clearly seen running up the centre of the image.

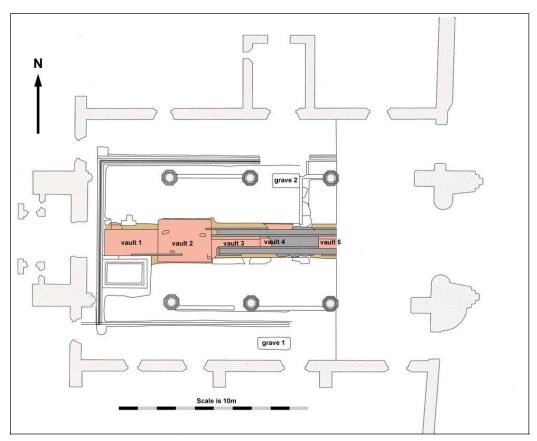
Figure 4 Plan showing the position of the vaults and graves.

3. Of particular importance to the construction of the new floor was the locating of significant voids within the nave. The most extensive of these being a series of brick vaults running from the west door up the centre of the nave (see fig. 4). Five were recorded in total in a line end-to-end. Vault 1 was 2.8m long and 1.7m wide. Vault 2 was 2.8m long,

2.2m wide. A void in the top of this vault permitted a view of the interior, which revealed the presence of two lead coffins, one adult and one juvenile. The coffins had originally been cased in wood, which had subsequently decayed and fallen away. The roof of the vault exhibits some signs of having been re-made, presumably on the occasion of the second burial. Vault 3 was 2.6m long and probably 1.7m wide (estimated since both sides not visible). Vault 4 was 2.3m long and 1.7m wide. A void noted during the works in 2005 (WSA 2005) allowed for a view inside, which revealed a single lead coffin with the name plate of an Elias Kirke aged 18 and dated 1827 (due to the poor light this reading is not certain). Vault 5 was only partially revealed, with 1.15m lying within the recorded area, the remainder being under the retained concrete surface to the east.

- 4. The appearance and construction of the vaults suggested that they were all broadly contemporary and of a comparatively late date. Burial within churches tended to die out in the middle decades of the 19th century and it is therefore likely that all the vaults date to a period of approximately 1800 1850. They must certainly have been in place before the 1860's renovations, since the heating ducts run along the tops of the vaults.
- 5. In addition to these vaults, two graves were recorded which had been dug through the exposed floor surface (see fig. 4). That in the south aisle, grave 1, was 1.7m long and 0.65m side and that under the north arcade, grave 2, 1.45m long and 0.75m wide. It was not clear whether grave 2 ended before the remains of the sleeper wall at its east end or

extended under it, if the latter then it would obviously be longer. It is not possible to date either of these graves, although they both are earlier than the 1860's floor. Both were left unexcavated.

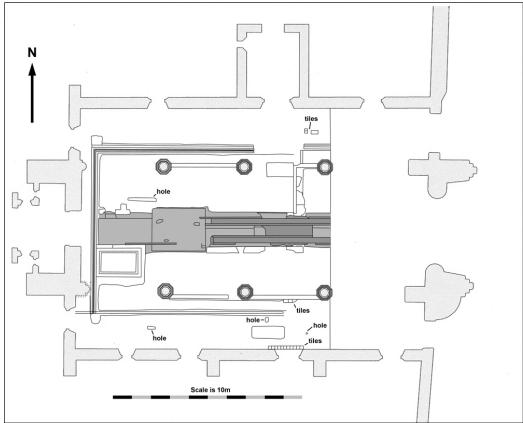
Figure 5 Plan showing the surviving tiles and holes associated with earlier floors.

6. The surface visible below the removed Victorian floor was composed of a trodden clay soil with traces of overlying white mortar surviving in patches. It was possible in places to see underlying layers, where they had been cut into by later features: there appeared to be at least one more layer of mortar sitting upon trodden earth, which in turn formed the surface of disturbed soil of an undetermined depth. In a locations in the nave floor tiles were preserved in situ sitting upon the mortar (see fig. 5), although these survivals were less frequent than had been found in the north transept (WSA 2005). As had been noted in the transept the tiles were not all uniform, suggesting that isolated patching was the norm, rather than the wholesale relaying of the floor at any one time. The sizes and types of tile found fit in with the types recovered in 2005, with three sizes then being recorded (4 ½ inch or 11.5cm, 7 inch or 18cm & 9 1/4 inch or 23.5cm), some examples being glazed in yellow or green. The 4 ½ inch included some with a fleur-delis in yellow or white painted upon them, although none of these were found in the nave. To the east of the recorded area, under the retained concrete at the end of the south aisle, an area of in situ tiles was

revealed extending c.1.5m west of the entrance into the south transept and projecting 1m from the south wall. These were all unglazed 7 inch tiles. Without taking up more of the concrete it is not possible to state why these had survived in this location.

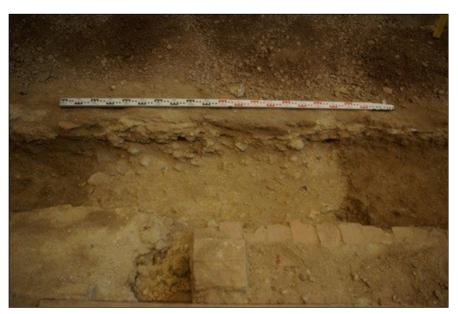
- 8. The most significant feature found within the two trenches was a wide foundation composed of flints in a loose white mortar (see fig.8). Again it was clearly earlier than the floor surfaces above, but no other dating evidence was apparent. Its width varies across the two trenches, with it being 1.15m wide in the northern and 1.65 in the southern. It is

possible that such a substantial foundation relates to either the pre-Norman church or to the early phase of the current building, before the extension of the nave in the late 12th century (Mayo 1995). Possible evidence of a later alteration was also revealed at the bases of five of the six pillars separating the nave from the aisles. In each case stone bases were partially revealed during the cleaning of the surviving floor surface, a number of which appear to be off-set from the pillars they support (see fig.8). This may be a result of alterations recorded as taking place in the 15th century when the pillars and there bases were remade (Mayo 1995).

Figure 6 Wall foundation in the southern beam trench, looking south. The scale is 2m.

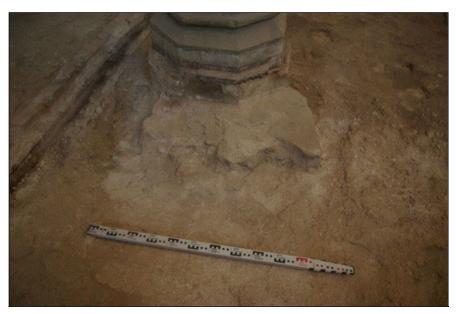
Figure 7 Base of the north-west column within the nave, showing the earlier stonework, looking east. The scale is 1m.

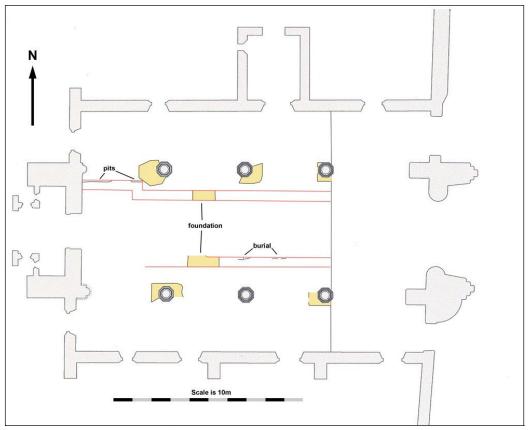
Figure 8 Plan showing the two beam slot trenches (in red) and the possible medieval features

- 7. The presence of the brick vaults in the nave required that they be bridged with reinforced concrete supported on two beams running parallel. The trenches for these beams were excavated under archaeological supervision and were 0.5m wide and 0.3m deep (see fig.8). After the removal of the surviving floor layers, as described above, the remaining 0.15 0.2m consisted of disturbed soil, presumably created by burials. In only two places were articulated human remains encountered, both in the southern trench. The western of these consisted of a skull (in the trench edge) with its right arm; the eastern consisted of just the right arm. Both burials were left in situ. At the western end of the northern trench the edges of two rubble-filled pits were revealed. These were clearly earlier than the surviving floor deposits, but little more can be determined about them.

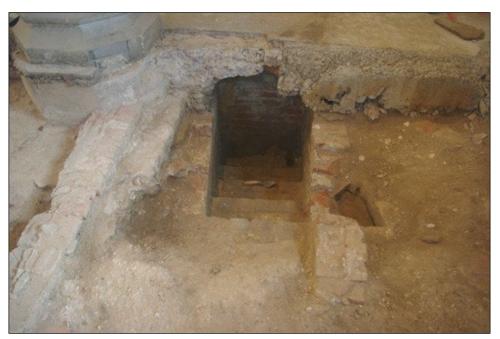
- 9. At the eastern end of the south aisle a void filled with loose rubble was discovered. Upon excavation it was found that the rubble covered a flight of steps, 0.95m wide, running east under the retained concrete. Along the south side of these steps and then turning north at the base of the fourth step was a brick wall of obviously later date. An opening was made in this wall so that a camera could be inserted to view what lay beyond. Behind the blocking was a burial vault approximately 1.75m north-south and 2.25m east-west (see fig 11). At the far side the earlier bricks survived only as column a single brick wide in the centre of the vault rising from floor to ceiling. Either side of this the wall was composed of more recent brickwork. Otherwise the vault's walls were composed of the same bricks as the steps. The roof of the vault, however, was again of the later bricks. Lying upon the floor of the vault, amidst much rubble, were two skeletons with their heads to the west. Despite the disorder of the interior, these appear to have been little disturbed, although the later wall at the east end seems to have been built partially on where their feet should lie. Attached to the south wall was a semi-circular shelf of approximately 0.25m diameter, it probable that this once carried at statue of a saint or of the Virgin Mary.

Figure 9 The steps leading down to the De La Warr vault.

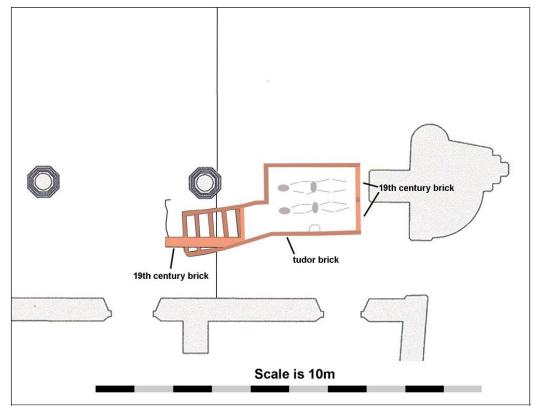
Figure 11 Plan showing the De La Warr vault in the south-east corner of the nave.

- 10. The identity of the occupants and the date of the vault are almost certainly given by the memorial that now resides in the south transept.

This originally stood facing west in front of the blocked doorway into the transept and records the burial place of Thomas, Lord de la Warr and his wife, who died without issue in 1554. The date for all the later walling and re-roofing may be associated with the moving of the memorial in 1826, or could be later and linked to the renovations of the 1860's. This later date could be indicated by the fact that the blocking wall seems to support the east end of a sleeper wall.
