**Report On An Archaeological Watching Brief At St. Mary's Church,
Washington, West Sussex**

June 2012

NON-TECHNICAL SUMMARY

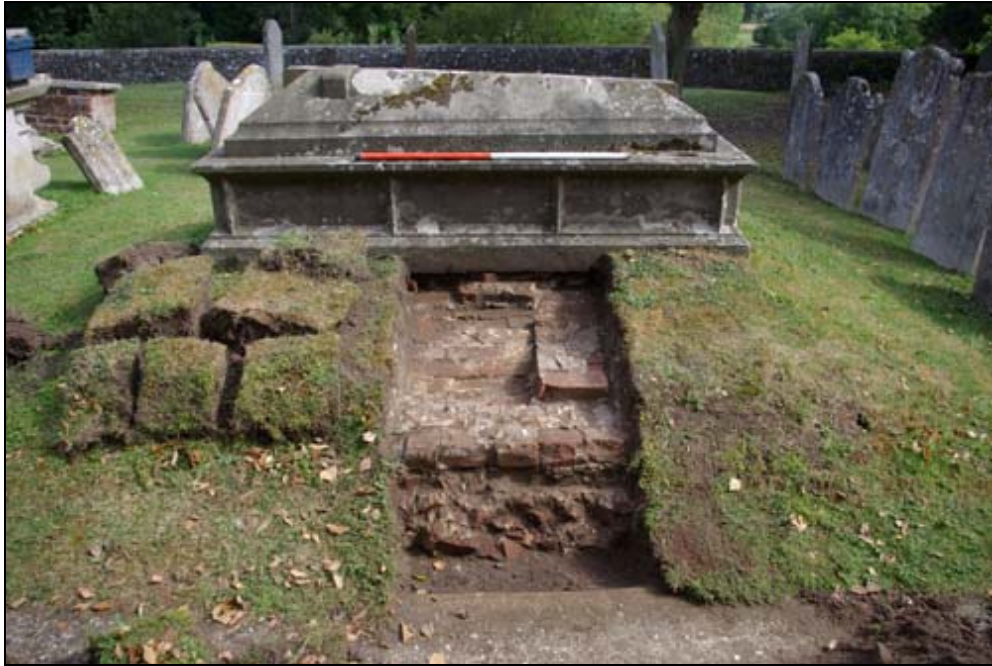
1. On the 9th July 2009 a small trench was opened up between the tomb to the Sandham family and the north wall of the church, in the location of the proposed WC extension. The purpose of the trench was to determine how far the underground portions of the tomb extended beyond that of the above-ground chest tomb. It was discovered that below the chest tomb lay a large brick-lined grave projecting 1m beyond it to the south, its southern edge being only 1.9m from the church wall.

Figure 3 The Sandham Chest Tomb and the part of the underlying arched brick-lined grave, looking north. The scale is 1m.

2. A brick was removed from its arched roof which revealed that six coffins were within, in two layers of three. The overall depth of the grave was about six feet. Where discernable the coffins consisted of an outer box of wood and an inner of lead. The entrance to the tomb was probably from the west, the bricks at this end showing clear evidence of a blocked opening. The panels on the chest tomb record seven individuals, all members of the Sandham family, six of which were interred below, while the seventh was buried in South Africa. There are eight panels on the tomb, three on each long side and two at either end, they are inscribed as follows (clockwise from the east end):

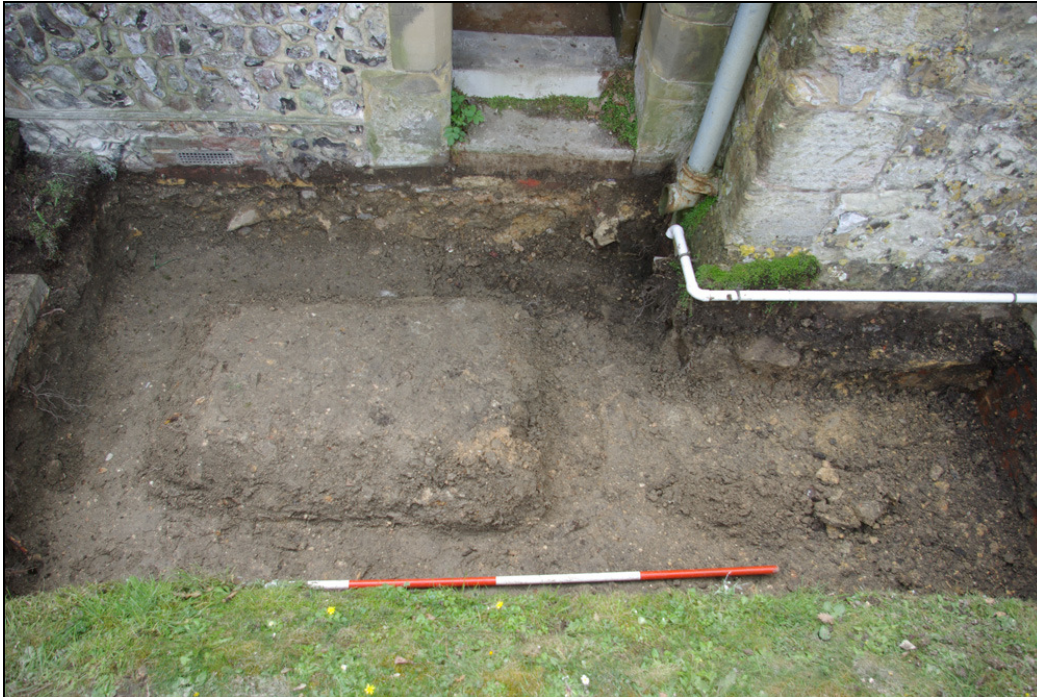
Figure 5 The WC trench after excavation, looking south. The scale is 2m.

3. Only the head and upper chest of SK2 lay with the excavated trench. It had apparently removed the lower legs and feet of SK1 when interred and lay at the base of the trench 0.45m below the extant path. SK3 lay within the south end of the service trench, which ran north from the WC trench. This trench was excavated to a depth of 0.7m, but only this one skeleton was found. Only the lower legs of SK3 were seen within the trench and they lay 0.5m below the extant path. SK4 was represented by only the upper part of the skull, lying at 0.3m below the path.
4. All the human remains were re-buried within the churchyard.

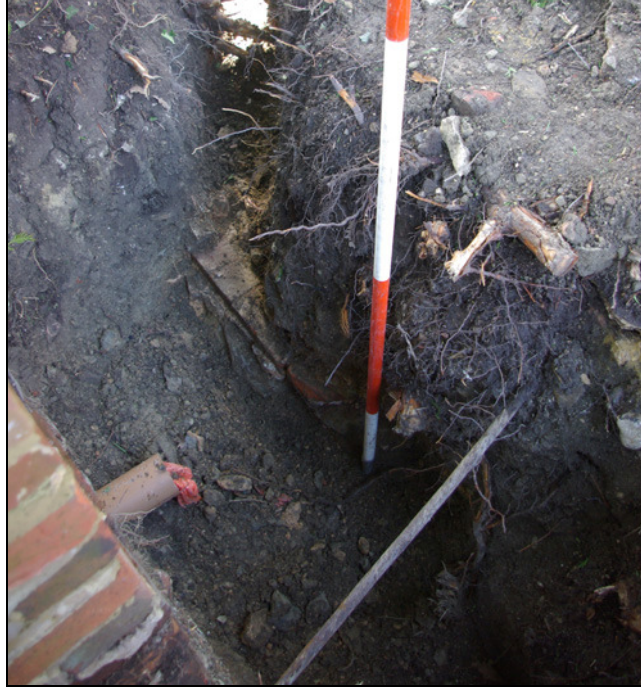
distance of 0.55m from the existing flint churchyard wall and at a depth of 0.7m below the existing surface, were the remains of a brick wall running east-west. Since it lay at the base of the service trench little of this wall was seen, but it is possible that it was an earlier retaining wall for the churchyard, of unknown date.

Figure 6 Left of centre are the remains of the brick retaining wall at the base of the trench, looking south-east. The scale is divided into 0.5m sections.

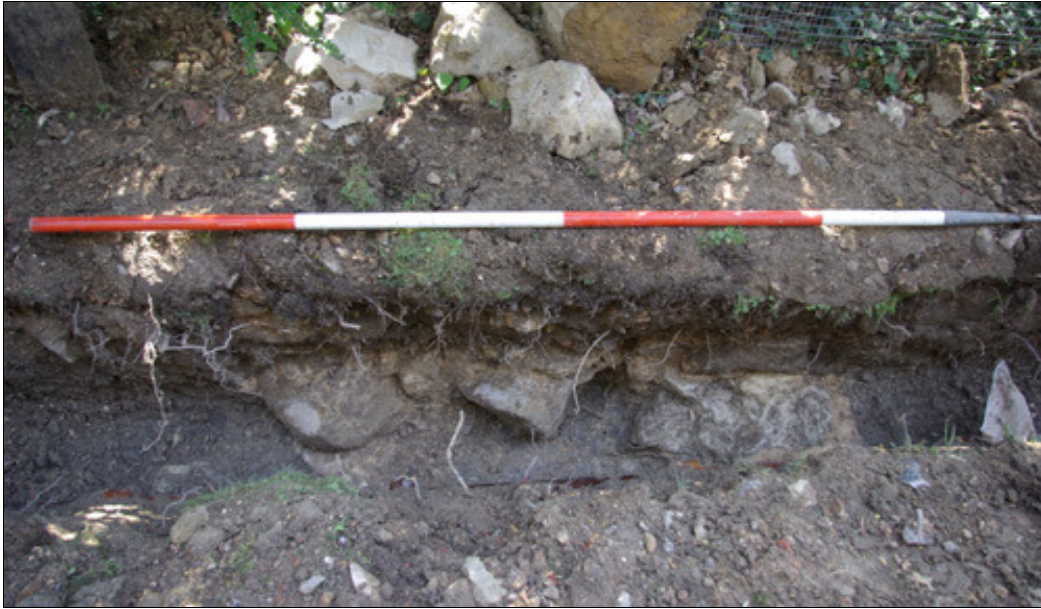
4. As the service trench passed the east window of the current chancel, a stone foundation was revealed at a depth of 0.3 - 0.5m below the existing ground surface. It was composed of undressed upper greensand blocks set in a yellow mortar. It had been badly damaged by previous disturbance, particularly by the ceramic pipe noted above. It was c.1.5m wide and appeared to be running east-west. It is not known what this may represent or to what period it can be assigned. It clearly pre-dates the ceramic pipe, which is likely to be 19th or early 20th century and probably pre-dates the AD1866 chancel, since it would seem too close. Its proximity to the churchyard boundary, the other side of which is considerably lower, would suggest it did not extend far in that direction. A possible explanation is that it is the base for an earlier monument, demolished when the chancel was extended in the 19th century.

Figure 7 The stone foundation looking east. The scale is 2m.

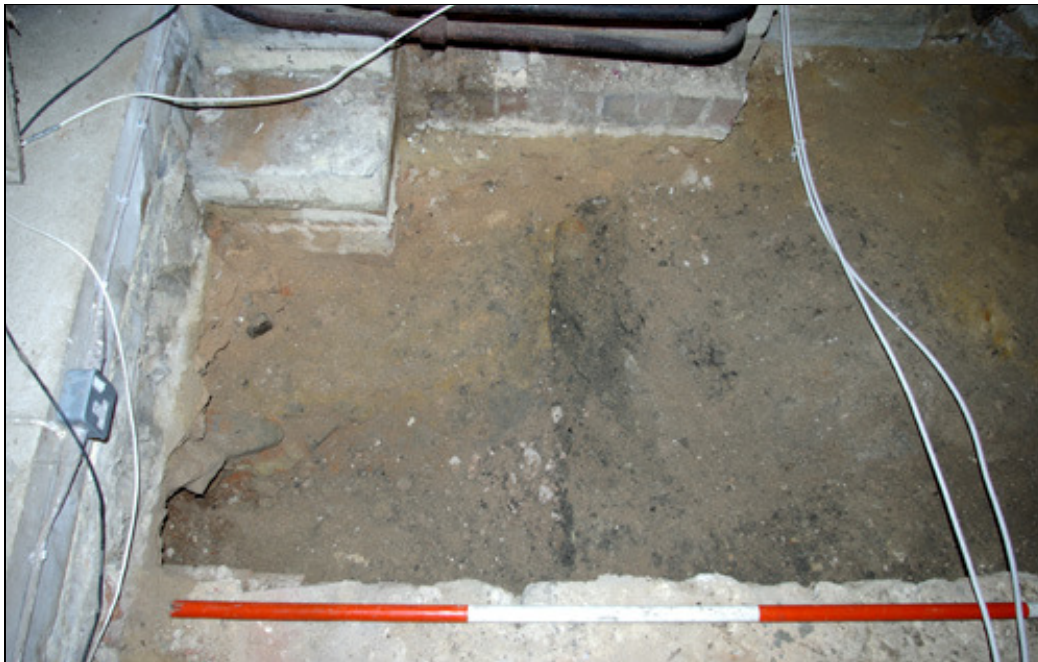
1. A small 'L'-shaped trench was excavated at the east end of the nave, to the south of the central aisle, on 10th May 2012 for a new sleeper wall. Below a 0.15m layer of white mortar rubble associated with the Victorian floors was a layer of dark brown soil of unknown depth. Through this had been cut a 0.9m wide wall foundation running north-south and composed of Upper Greensand rubble set in red sand with an overlying skim of yellow mortar. This foundation had been in turn cut to the north by a brick wall, which ran east-west, under the central aisle of the nave and on under the chancel floor.

2. The stone wall foundation is likely to be that supporting the original medieval wall dividing the nave and chancel, which was demolished as part of the 19th century alterations. The brick wall which has cut through this is probably linked to an earlier heating system within the church, since it would only have been inserted after the medieval chancel arch had been demolished, making it too late in date to be a brick-lined grave.

Figure 9 The trench at the east end of the nave, looking south. The medieval wall foundation is to the left of the image. The scale is in 0.5m divisions.

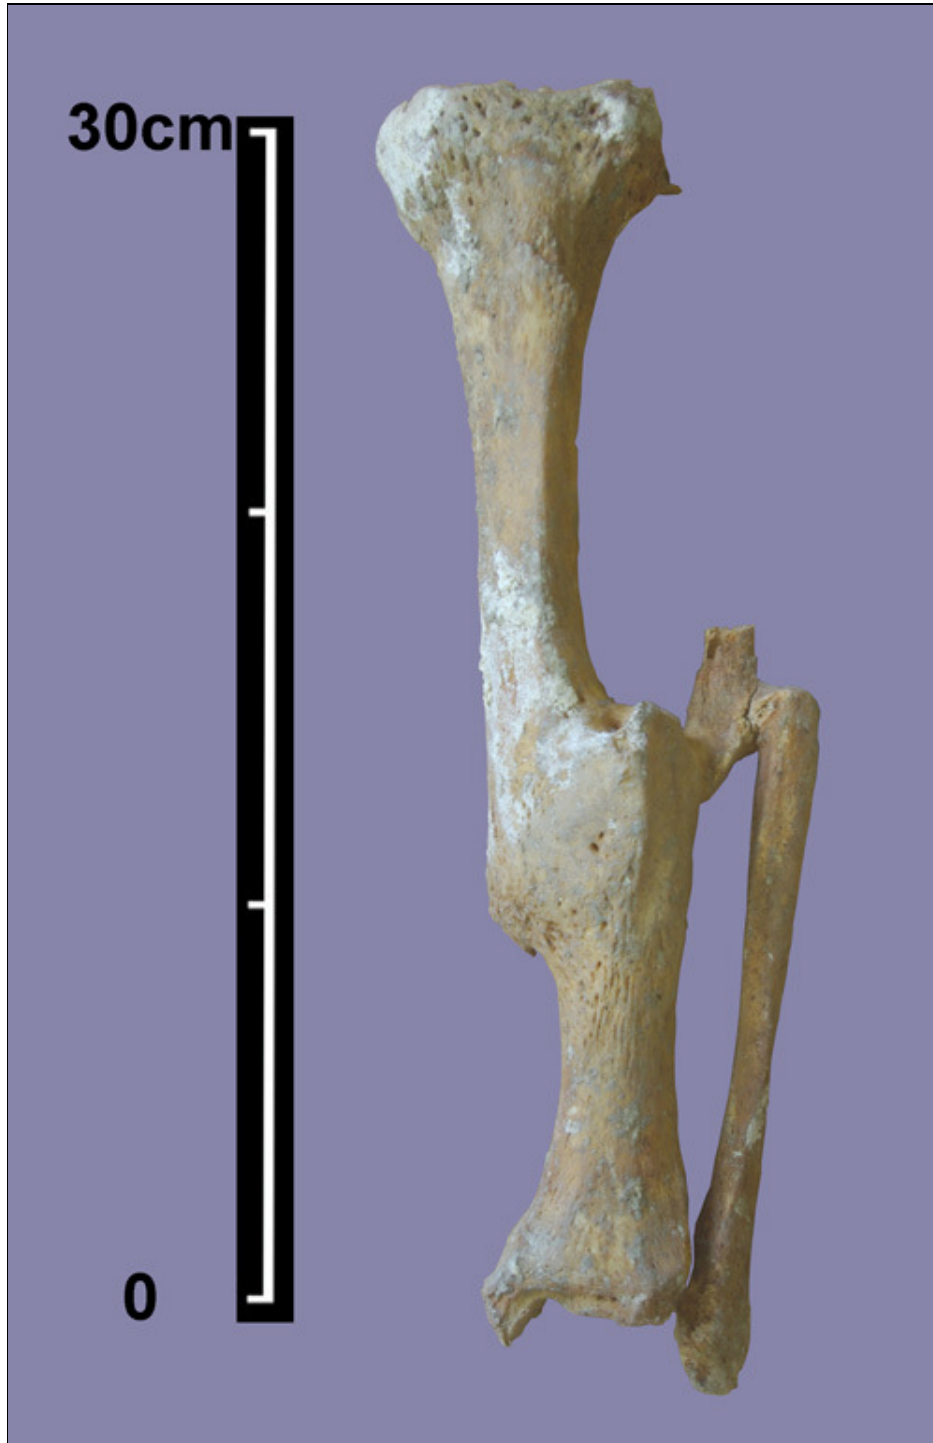
Figure 10 Tibia and Fibula found in the trench at the east end of the nave.

1. Within the backfill of the trench cut through the wall foundation for the brick structure were found the disarticulated fused tibia and fibula of a human leg. These showed clear signs of a major double fracture which had subsequently healed, with the upper parts of both bones having slipped c.5cm down and the whole fusing together.

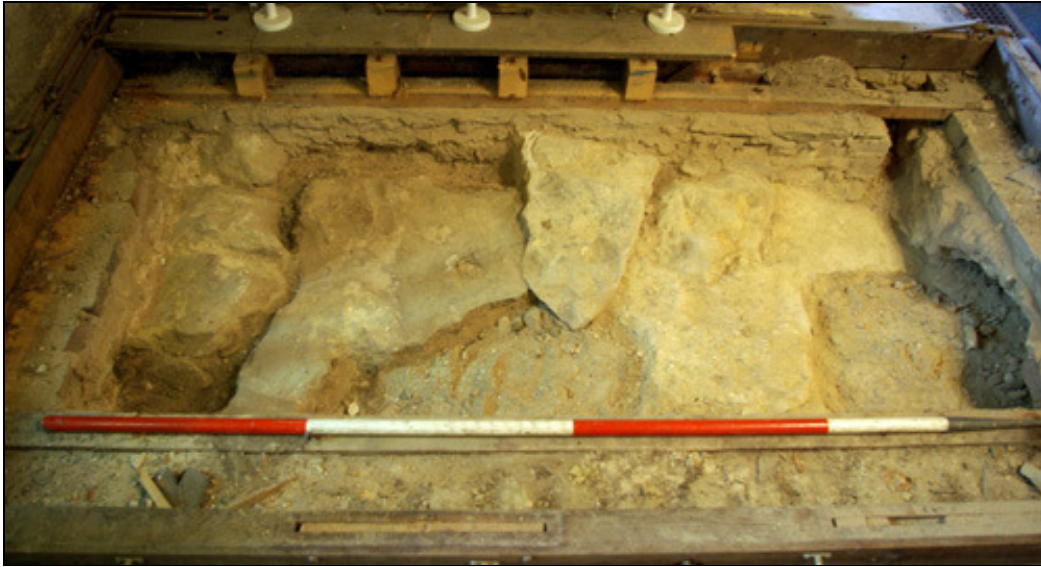
3. The white mortar layer was removed only in the trench's western half, in order to reach the required depth, revealing the stone foundation to the existing church tower at its western end. This was composed of undressed Upper Greensand blocks set in white mortar. It had been dug into the same dark soil found elsewhere under the church floors, although here the soil's surface was compacted hard. This dark soil had been cut to the east by a pit filled with brick rubble and by another feature partially filled with two large undressed Upper Greensand blocks. These stones may represent a second wall foundation running north-south, but this was not clear from the limited amount of excavation undertaken.

Figure 12 The trench below the pew platform at the west end of the nave on the north side of the central aisle, looking north. The scale is 2m.

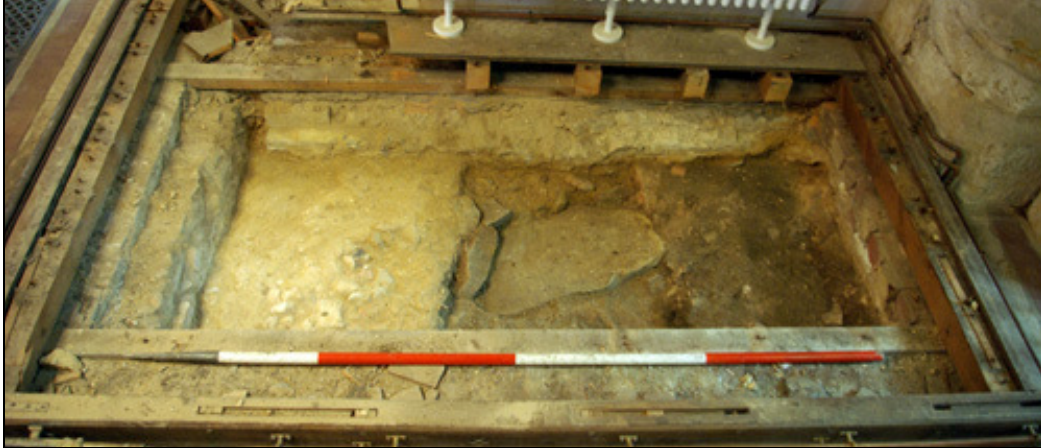
5. Towards the centre of the trench the dark soil layer contained a large Upper Greensand stone, together with several smaller. It is possible that this relates to the possible wall foundation found in the centre of the northern trench, however the alignment does not quite match and they may just be loose stones.

Figure 14 The trench below the pew platform at the west end of the nave on the south side of the central aisle, looking south. The scale is 2m.

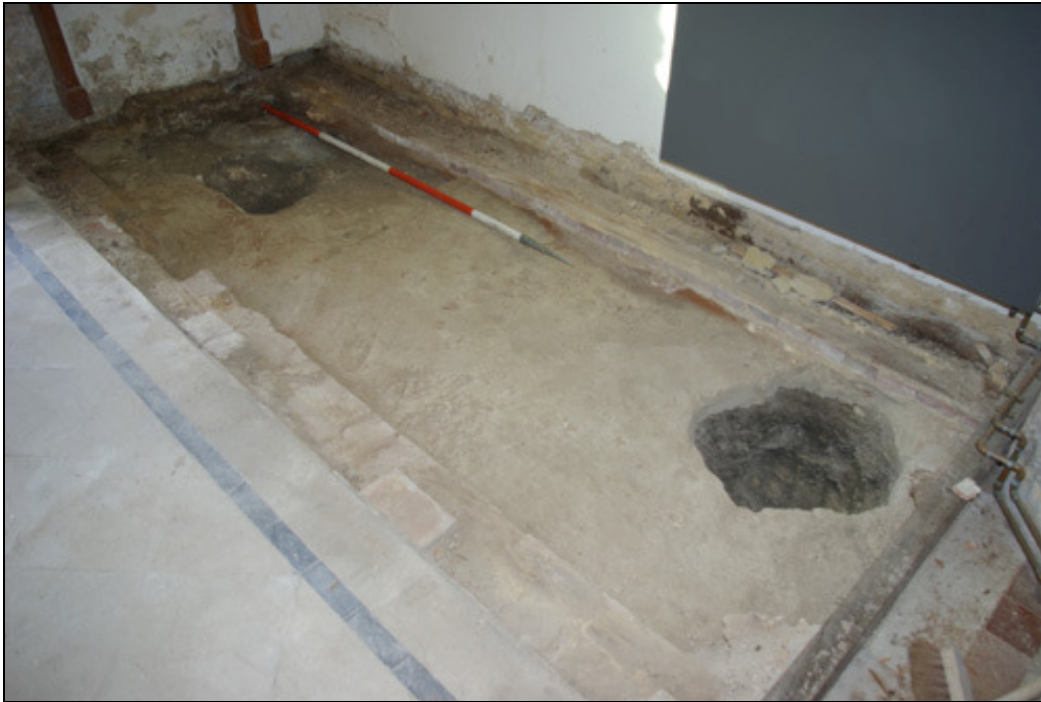
2. The northern trench contained the usual white mortar rubble, overlying all earlier deposits, found throughout the church. Just to the east of the centre of this trench a shallow rectangular hole (0.45m x 0.17m x 0.05m deep) had been made in the white mortar within which were the remains of a wooden post. Below this mortar was a thin layer of red sand, over a 0.1m thick layer of crushed Upper Greensand, which in turn sat upon the dark brown soil found elsewhere beneath the church floor. Dug through all these layers were two pits, one in each corner, both c.0.45m in diameter and depth. Their bases were formed by the undisturbed Upper Greensand, which was 0.5m below the existing tower floor. A second pair of pits was found within the southern trench in the tower, in corresponding positions, although it was noted that the north-western of the pits (Pit 2 in fig. 15) was slightly out of alignment, possibly due to the presence of the large Upper Greensand rock imbedded within the underlying dark soil. The rectangular hole and these circular pits may have contained supporting timbers for an earlier first floor within the tower.

Figure 16 The northern trench in the tower, looking north-west. The scale is 2m.

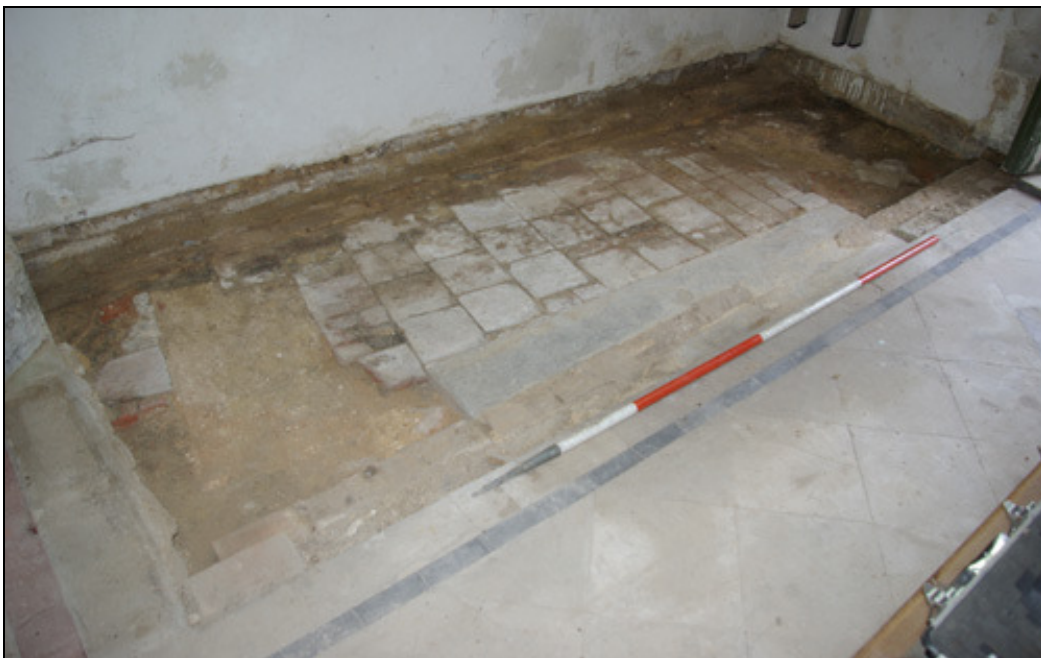
3. The southern trench did not contain the usual white mortar rubble, instead a layer of dust was removed to expose the remains of a tiled floor. The tiles of which this was composed were c.21m square, 4cm

Figure 17 The southern trench in the tower, looking south-west. The scale is 2m.

4. Set within the tiles was a ledger stone, only part of which extended into the trench, the remainder lying underneath the central aisle of the tower. That part of the inscription visible stated:

5. The ledger stone has clearly been inserted into the pre-existing tile floor, since the tiles have been crudely cut to allow for it. There is also a patch of brickwork at the western end of the surviving floor, which is probably also a later alteration.

7. The dating of the tiled floor is not clear, it must precede the 18th century ledger stone and is either contemporary with, or later than, the late 15th or early 16th century tower. There was no trace of an earlier floor below it, although trodden earth may well have sufficed. Both the tiled and

crushed greensand floors were preserved *in situ* under the new flooring.

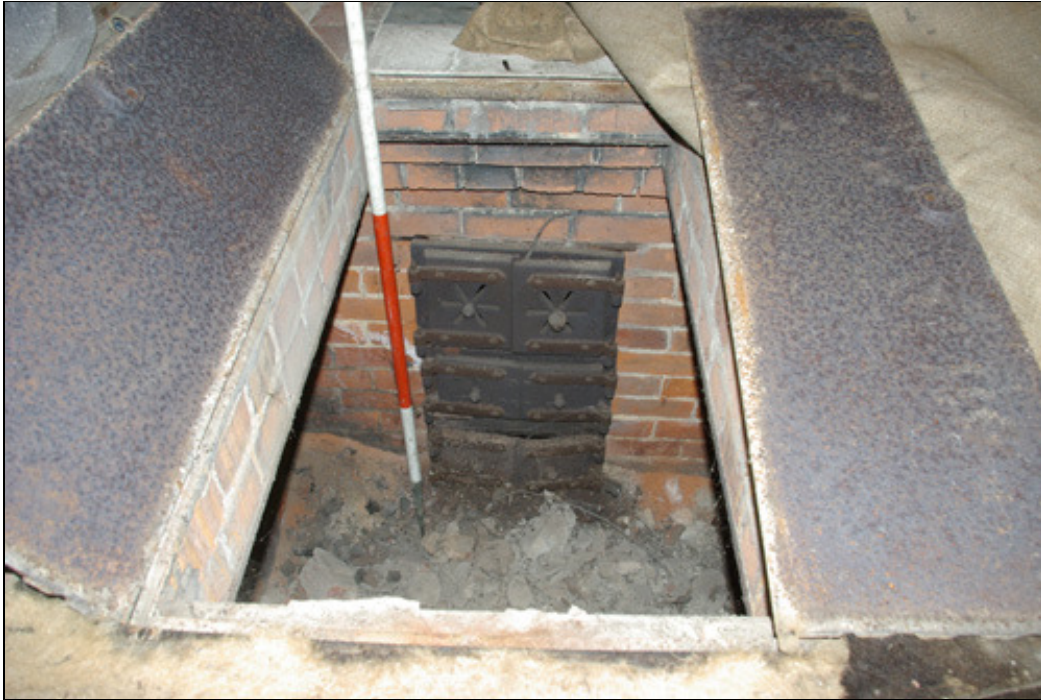
Figure 18 The brick chamber containing the front of the stove, looking north. The scale is divided into 0.5m sections.

1. The removal of some aluminium plates from the floor of the nave on the 20th April 2012 enabled a limited photographic record to be made of the Victorian heating system of the church, and in particular of the stove. The stove sat beneath the floor of the south aisle, immediately to the east of the font. The front of the stove was accessed through an iron grille in the floor leading to a small brick chamber.

2. The basic principal of the system was that cold air was introduced at a low level into the chamber within which the stove sat, which, when heated by the stove, then travelled around the church under the floor and up through iron grilles. The smoke from the stove exited along a pipe running north from its rear. The stove was manufactured under patent by John Grundy's of Tyldesley, Manchester. Graffiti on the cement sealing it in records that it was installed by H. Allen on November 2nd 1889.

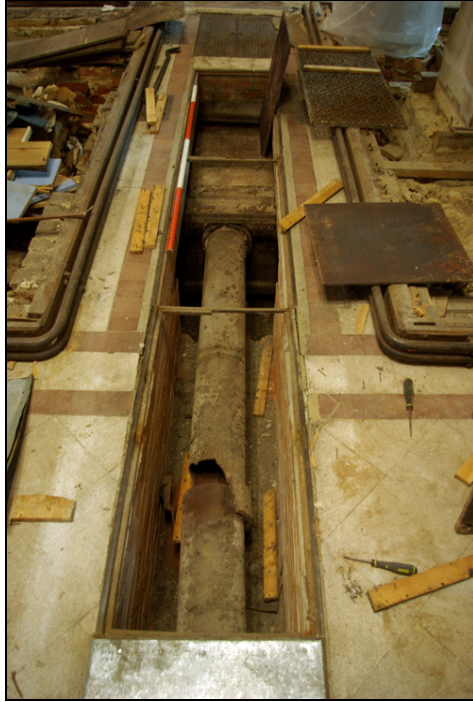
Figure 19 The exhaust pipe exiting from the boiler, looking south. The scale is 2m.
