**Report on a Programme of Archaeological Works at
Chesworth House, Denne Road, Horsham, West Sussex**

September 2009

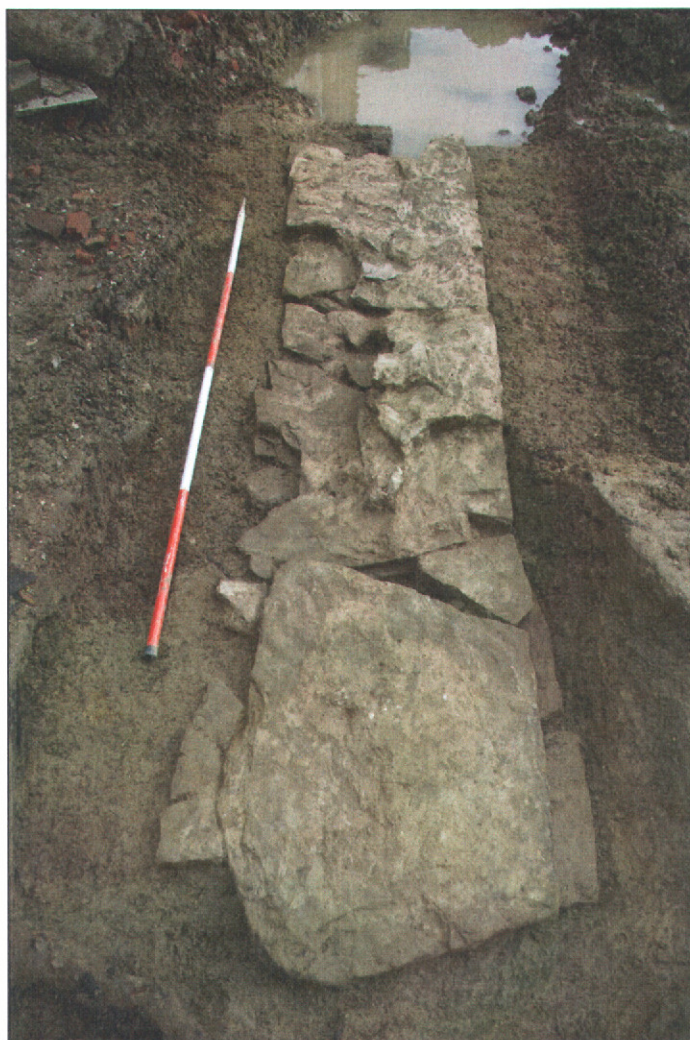
4. Only a 3.4m long stretch of the stone wall footing survived. At its southern end it appears to stop 2.5m short of the existing house lobby. This end is almost certainly not the result of earlier demolition, since to the north the wall footing sits within a shallow trench dug through the natural clay into the underlying gravel, whereas at this point that trench ends and the clay remains undisturbed to the south. At its northern end any continuation of the wall has been completely removed by modern development, however the small area of soil visible in what remains of the walls footing trench suggests that it had been robbed away before the cutting of the foundations for the 20th century buildings that replaced it.

Figure 5 The stone wall footing looking north. The scale is 2m.

5. The footing itself is composed of Wealden sandstone (Horsham stone), only one or two courses deep and 0.7m wide, which sits directly upon the natural gravels. Upon this foundation traces of a yellow mortar survived, which seems to have been the bonding material for the wall proper above. The wall itself was probably composed at least in part of lower greensand block-work, since two large examples of this were dislodged from the footing during the removal of the overlying soil.

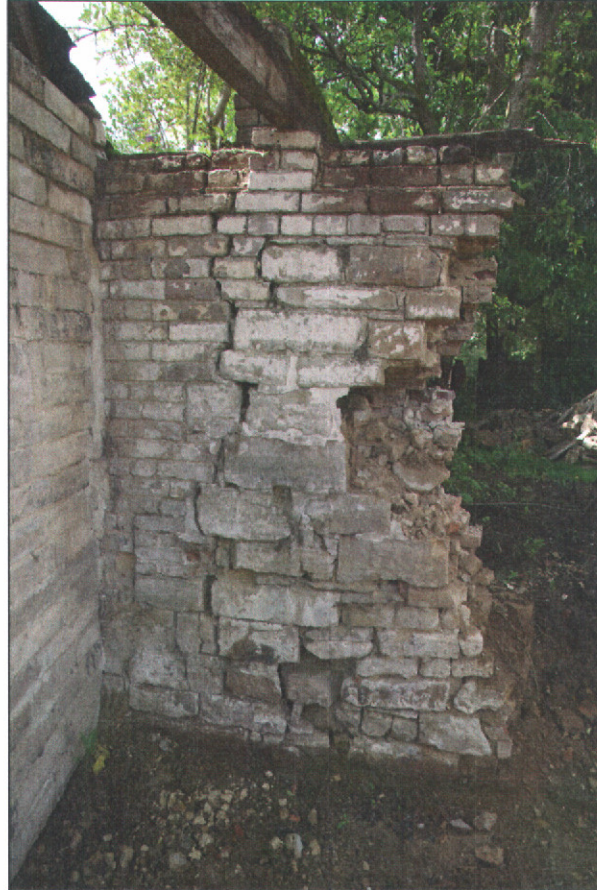
8. The evidence from Trenches 1 and 2, together with that from the historic maps and the visible remains, indicates that a stone wall, faced on its interior with bricks, once surrounded a garden courtyard to the east of Chesworth House. The date of construction for this wall was not established from these excavations, however the surviving brickwork is

strikingly similar to some of that used for the main house and is certainly not modern. The north-western stretch of this wall had clearly been demolished in the 20th century, but the whole northern section, which had been re-used in the late 19th century as the back wall to the cart shed, was permitted to be demolished as part of this development. The eastern side still survives.

Figure 7 The surviving part of the north courtyard wall as re-used by a late 19th century cart-shed, looking south.
