Character area 12: King's Staith

Historic Core Conservation Area Appraisal

York City Historic Core Conservation Area Appraisal- 12: Kings Staith and Coppergate

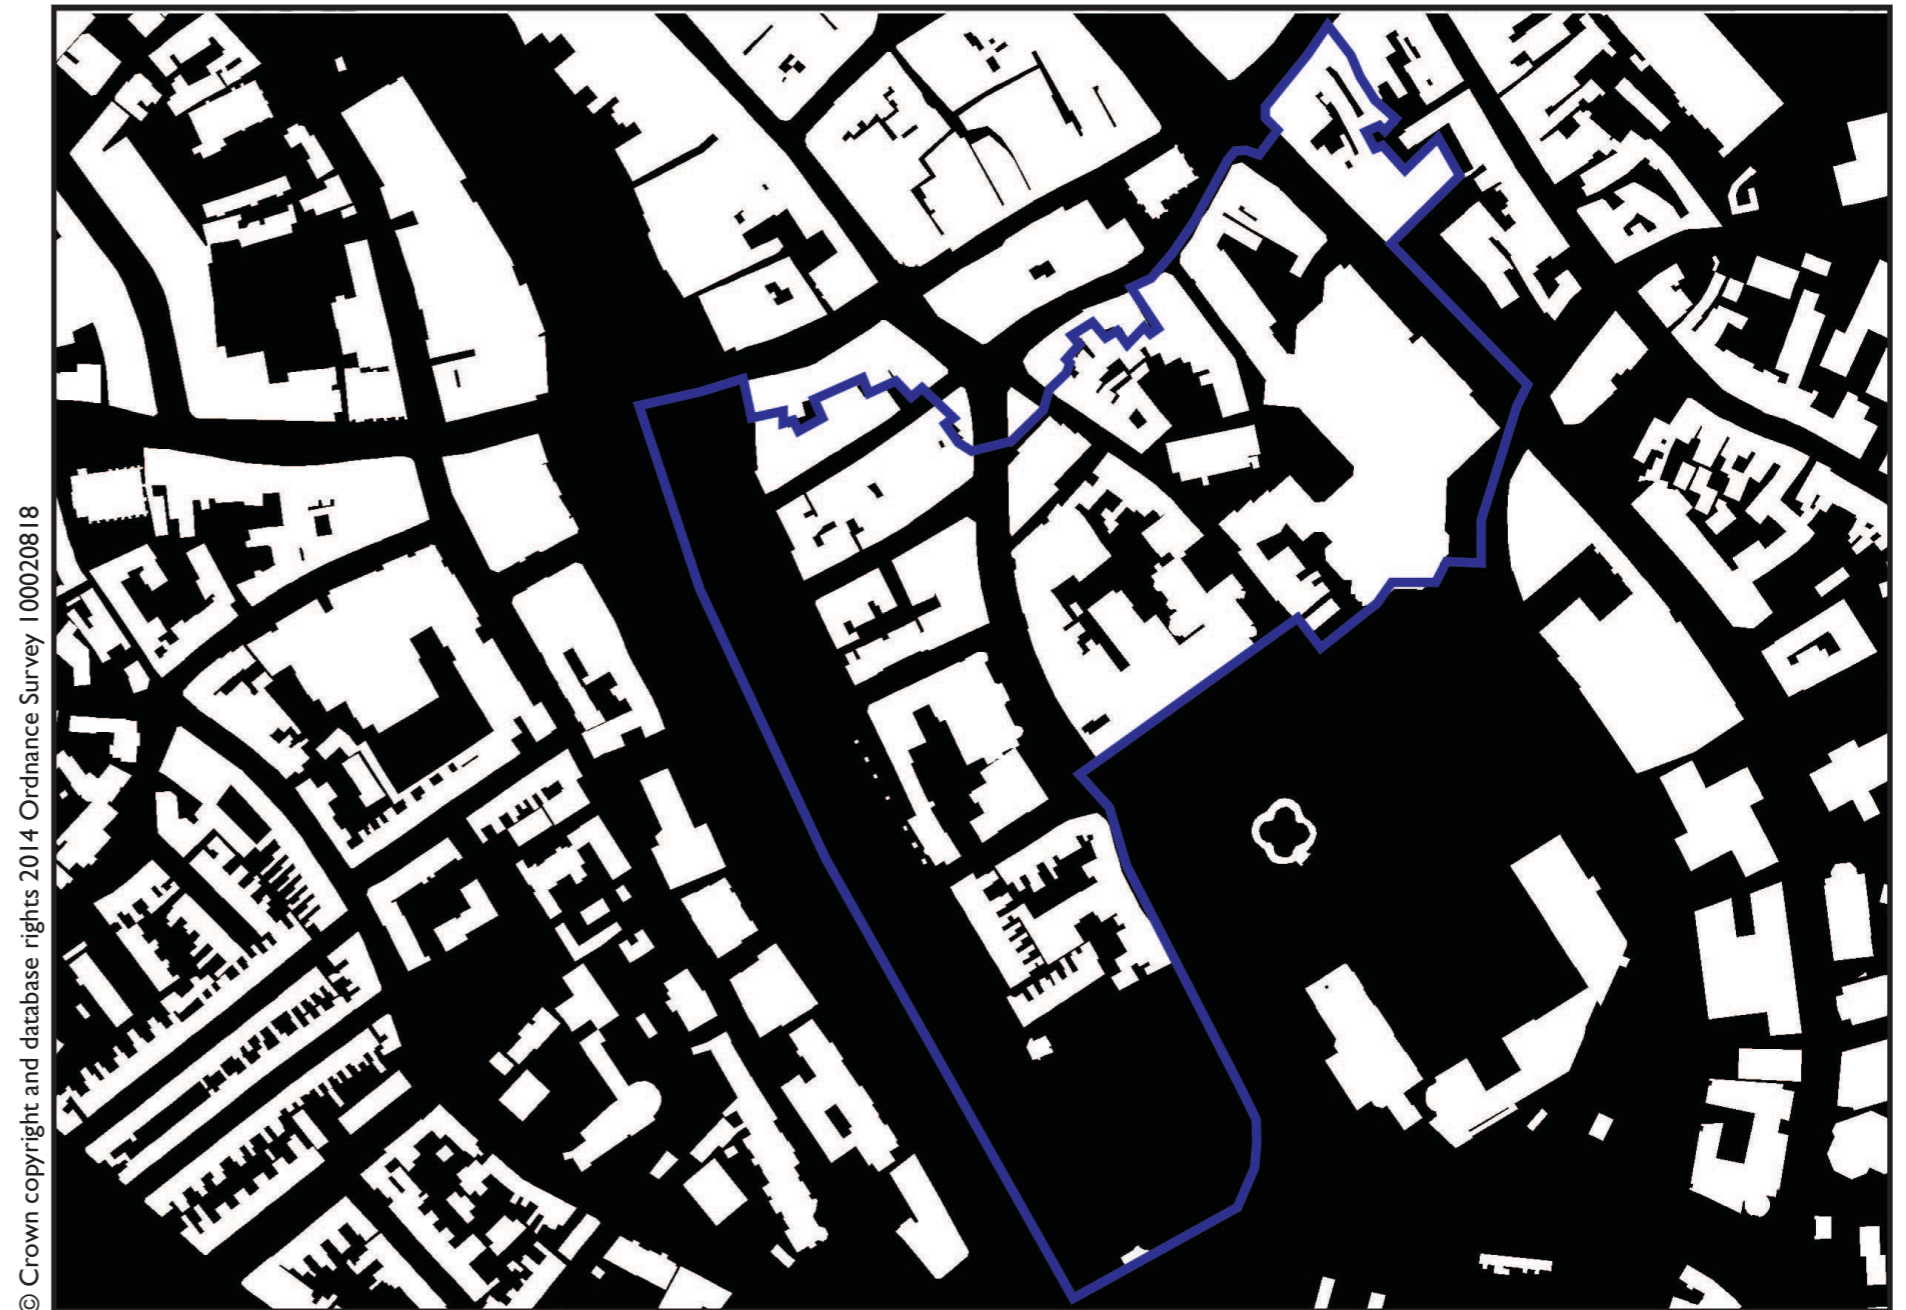
Figure ground map with built environment shown as white on black.

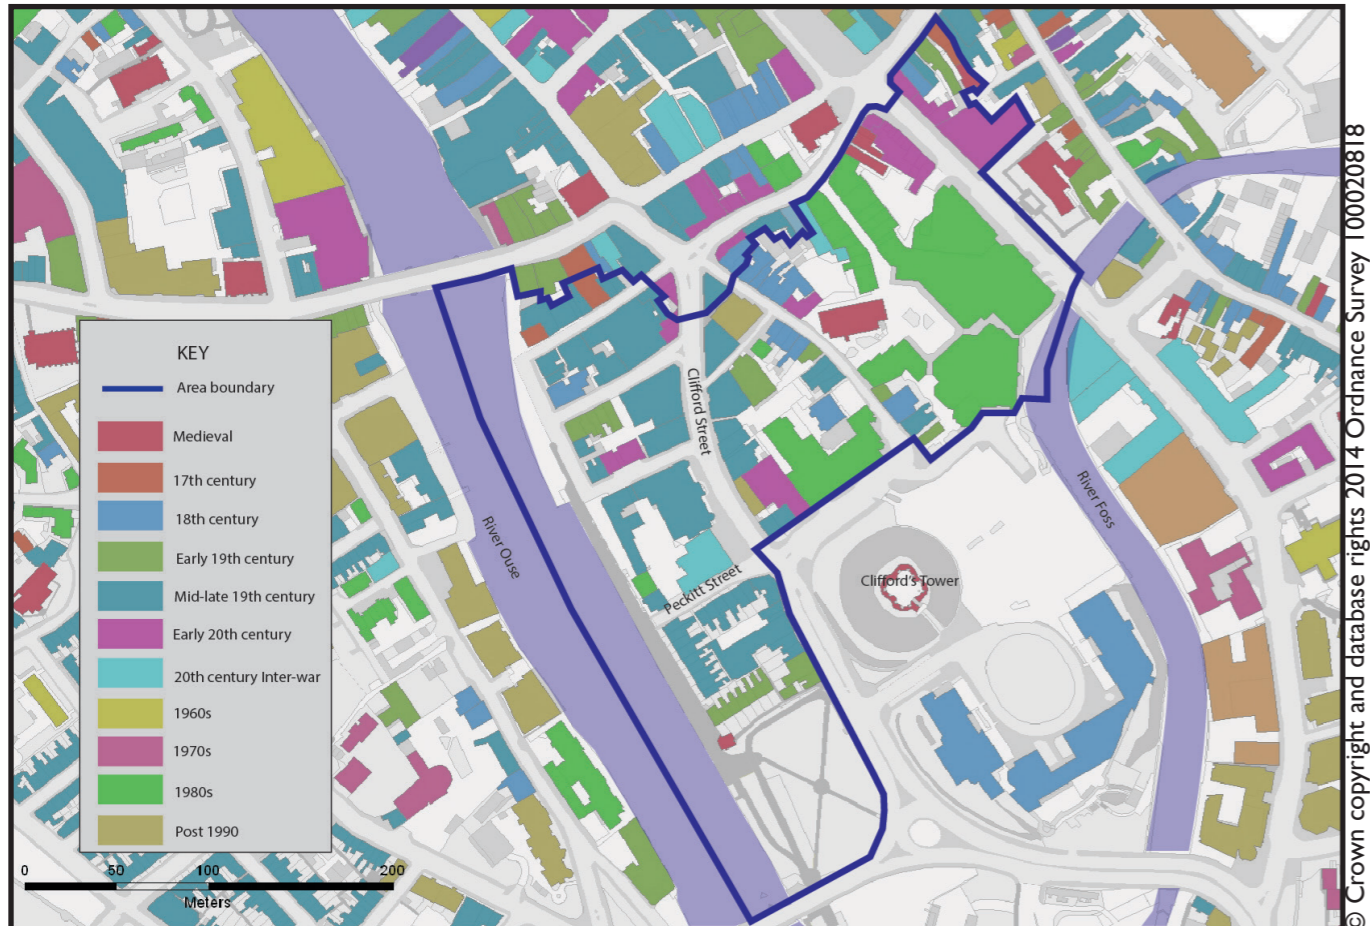
Below: Plan showing the construction dates of the buildings within the area.

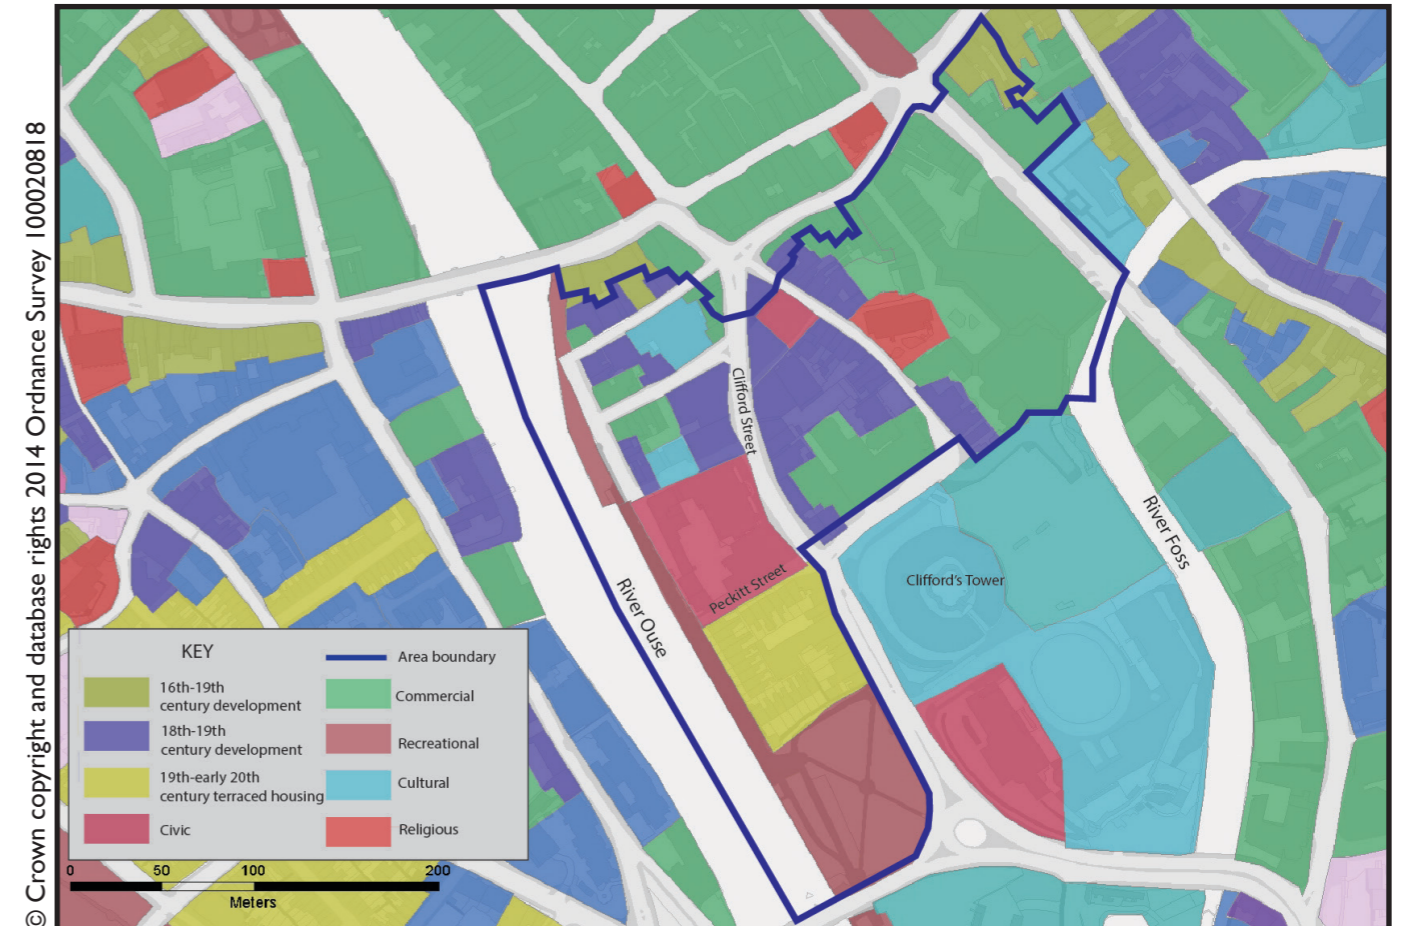
Below: Plan showing the Broad Type characterisation of the area.
