HISTORIC BUILDING RECORDING

NO. 7 ORCHARD STREET, CAMBRIDGE

October 2014

Project Ref: 14-1084

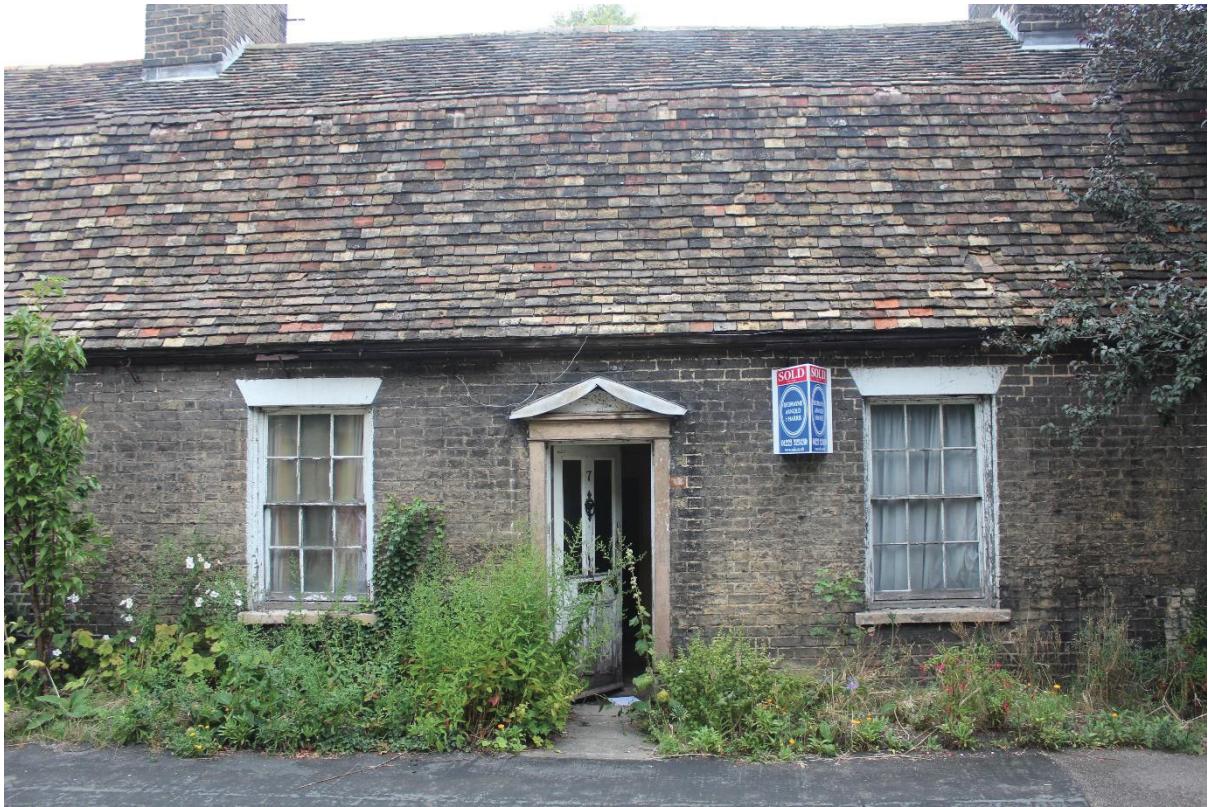
Plate 1 - Front Elevation

6.01 The principal material of the front elevation of No. 7 Orchard Street is gault clay brick, set in Flemish bond. In common with the rest of the terrace, No 7 retains the unbroken tiled mansard roof, with a steel sloping angle to its lower portion which flares slightly as it reaches the eaves. Beneath the eaves is a moulded timber cornice which runs the length of the terrace, protected by the sprocketed eaves, and the cast iron guttering, where it is still *in situ*.

6.02 The elevation has a central neo-classically inspired doorway with flanking pilasters, entablature and pediment hood. The pediment is covered with lead for protection. The door itself is a four-panel timber door with glazed upper panels. The door is, despite being of an appropriate form, probably not contemporary with the house, and has modern brass fittings where they are still *in situ*.

6.03 The door is flanked on either side by 6-light box sash windows, both of which appear to retain their original panes and glazing bars. These are original, displaying typical early C19 form without horns. The windows have stone cills and voussoired brick arches above, both of which have been highlighted in white paint. The windows are set back into the street facing façade which is of gault brick, as are the large axial chimney stacks. The stack to the west of No. 7 has been slightly rebuilt, although retains much of its original form. The stack on the east side of No. 7 is largely unaltered and also has no chimney pots, these having been added later to the other chimney stacks in the terrace.

6.04 Overall, whilst in neglected condition, the front elevation remains relatively unchanged from its original form.

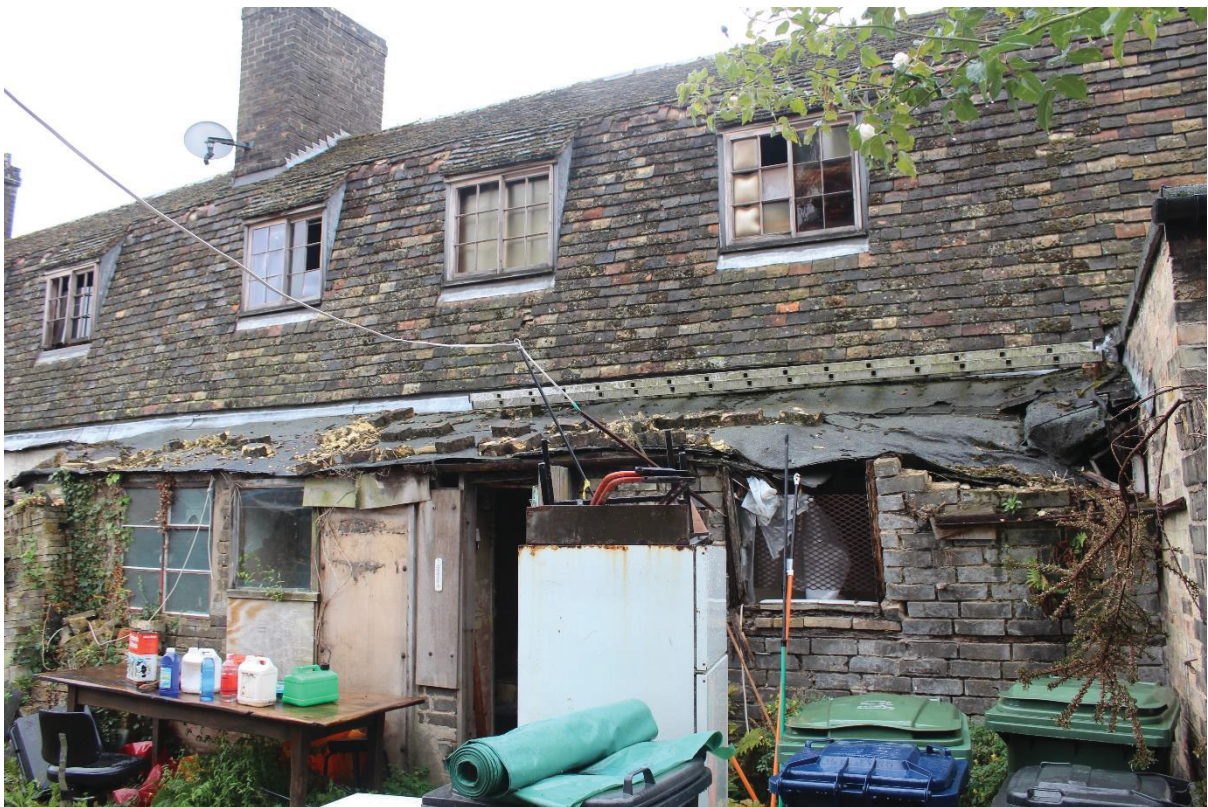
Plate 6 - Rear elevation

6.05 The rear of No.7 is much altered from its original form. At ground floor level there is a lean-to extension of gault brick, laid in poor quality stretcher bond, spanning the entire width of the property. This is a later addition to the house, and comprises what was originally a 'kitchen and bathroom area'. The lean-to extension is in an obviously poor condition, and is supported by RSJs and lacks a roof, one of its windows, and one of its external doors. The other external door is boarded up.

6.07 The first floor of the rear elevation remains in reasonable condition, comprising the rear section of the mansard roof. The windows are 6-light horizontal 'Yorkshire' sliding sashes, but are C20 replacements. The western-most window retains most of its glass, but some has been replaced and one pane is missing. The central window has no glazing, and has plastic sheeting attached on the inside. The eastern window is has two pans missing, but is otherwise intact. The rear of the eastern chimney stack has a satellite dish attached.

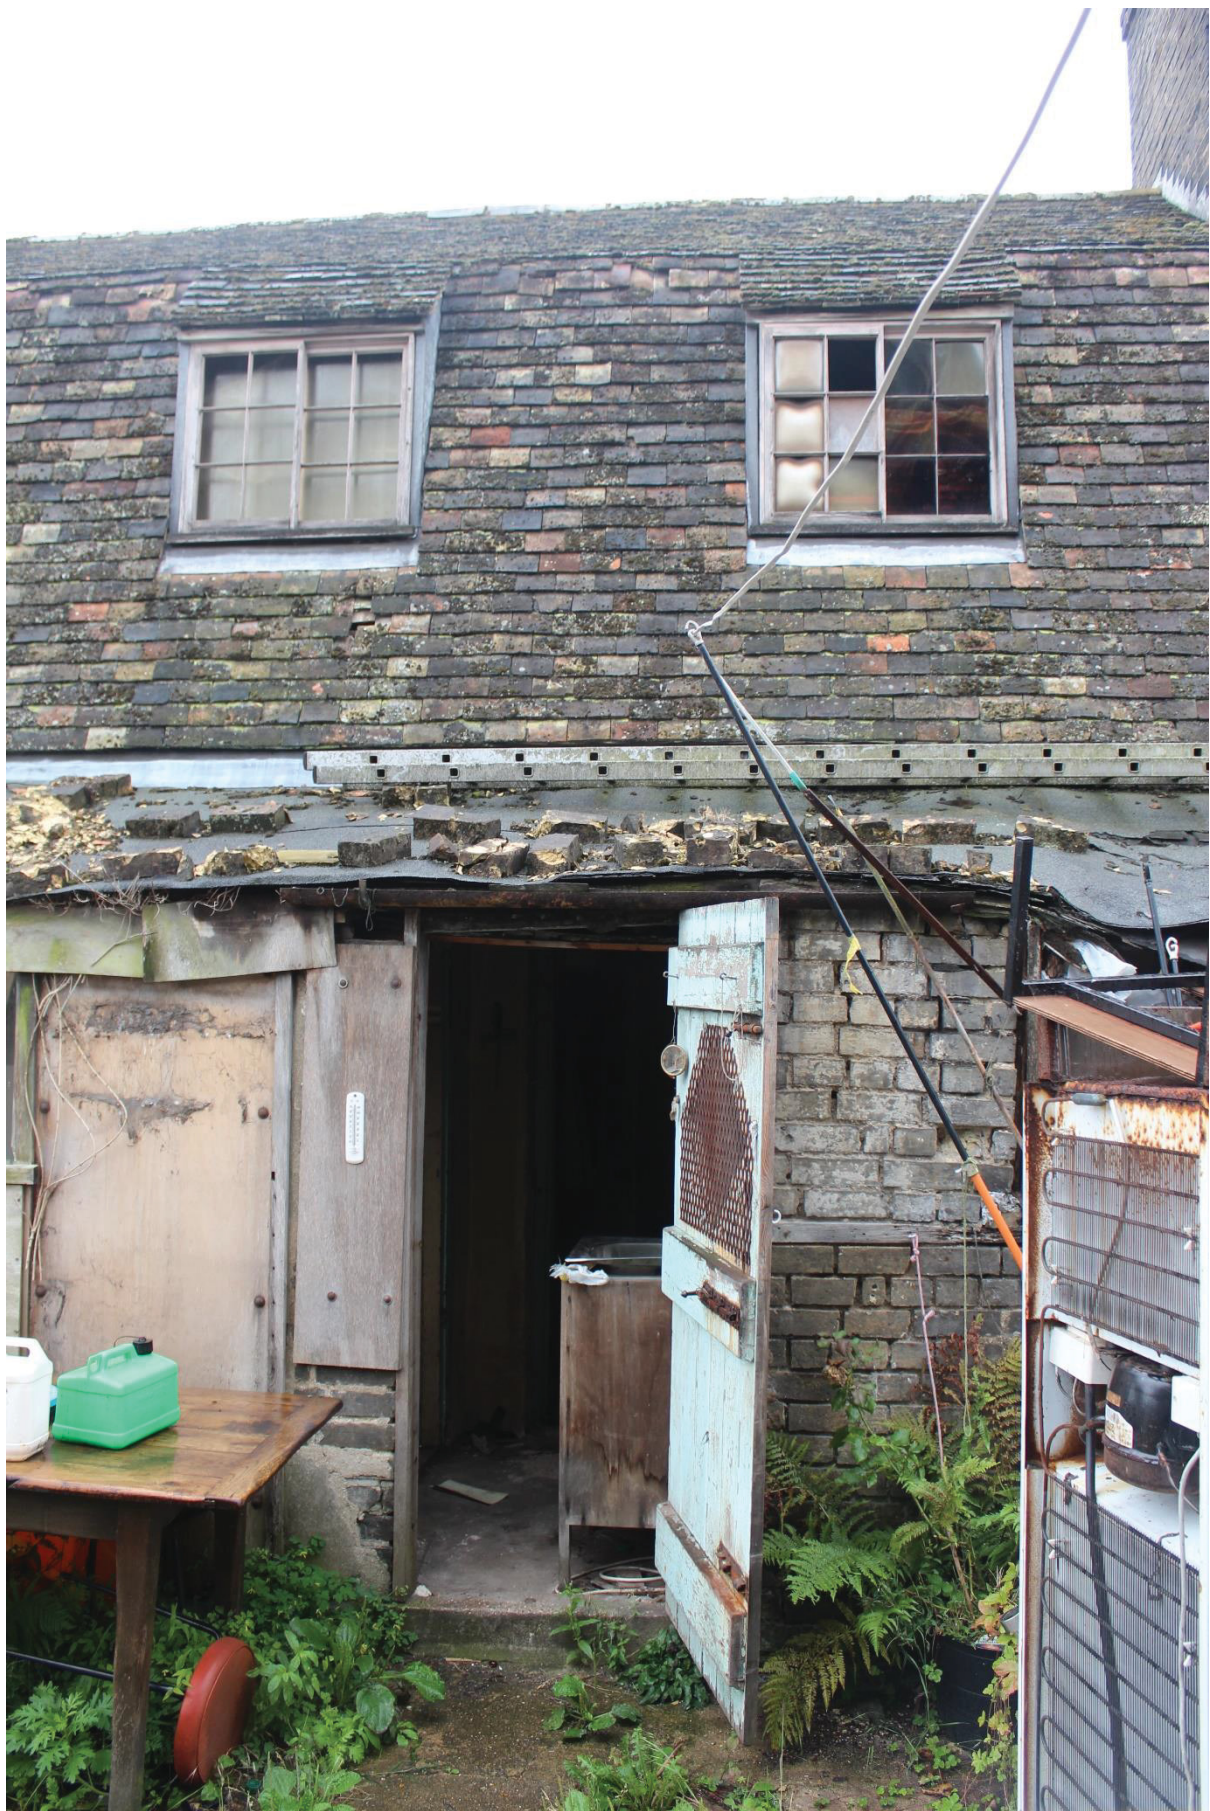
Plate 7 - Rear elevation and doorway to rear lean to.

6.06 Originally divided in two internally with separate rear doors, it has been knocked together to create a single space. The stairwells up to the first floor of the house open directly into the interior of the structure, suggesting that it may have been added at the same time as the building was subdivided. One surviving window is an iron framed 6 light casement dating from the mid C20, which, judging by the cementitious mortar used to bed it in, is a later insertion into the structure. The other is a wooden framed window, which may represent one of the original window openings, as its position is mirrored by the semi-collapsed window opening on the east side of the door.

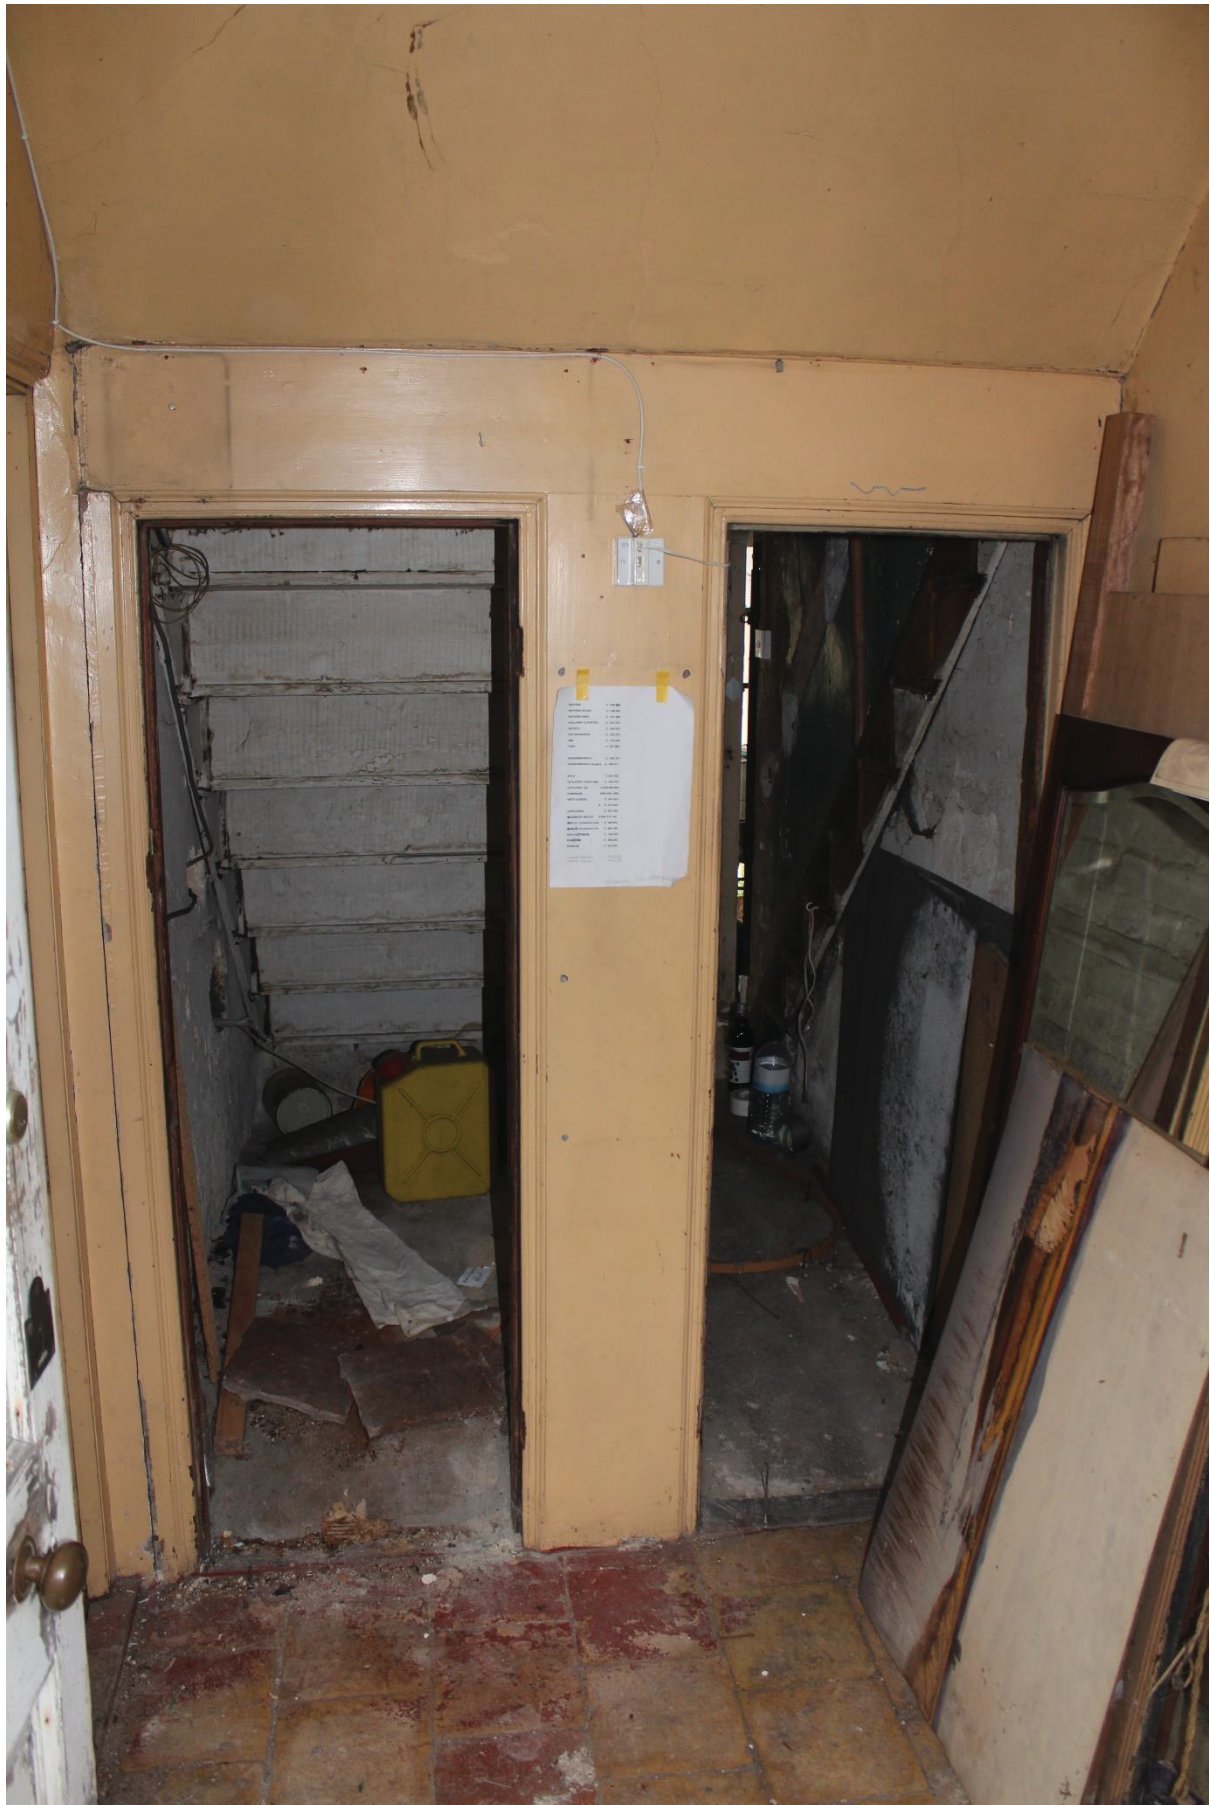
Plate 8 - Interior of hall, looking north.

The front hall is tiled with what were terracotta coloured tiles, but these have since been worn down to a yellowish colour. The hall has doors either side leading originally to the two living rooms of the divided house. In front are two 'cupboards under the stairs'. These probably date from the mid-late C19, when the house was divided into two, but do not retain their doors. The 'cupboard' to the right forms a corridor to the rear of the house, the stairs themselves having been removed up to head height (the remainder serving as food storage shelves). The doors to the living rooms are set at a dog leg, due to the original layout of the hall and single staircase that required the door on the right to be set further towards the front, as seen in the adjacent No.8. The door frames retain what appear to be their original moulded architraves in places, although they are in neglected condition.

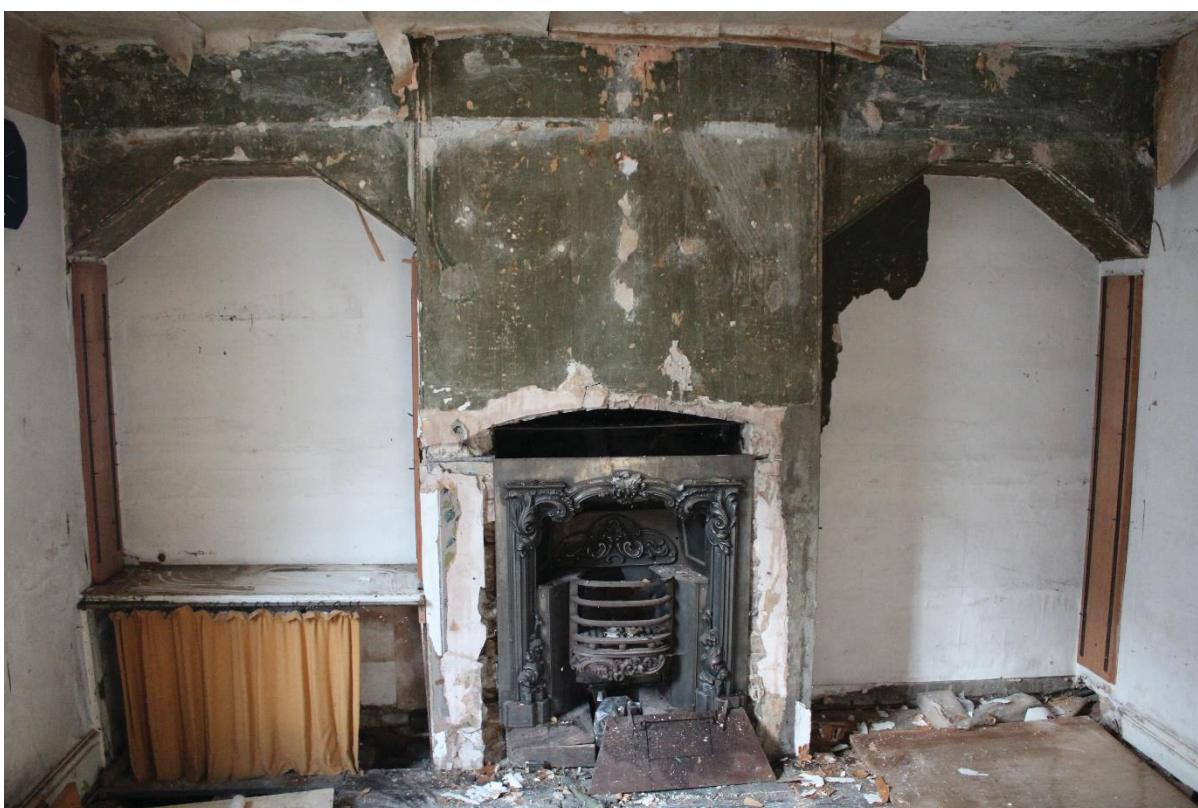
Plate 12 - Interior of west front room, showing fireplace and semi-octagonal alcoves.

6.08 The western front room retains few obvious original features. The fireplace is an ornate Edwardian cast iron grate and surround, which is clearly a later insertion – possibly very recently judging by the surrounding plasterwork. The chimneybreast and flanking semi-octagonal alcoves are plastered, and following removal of modern wallpaper, appear to have a dark green paint covering. Where skirting board remains, it is likely that this at least dates from the time the house was partitioned, and may be original. The door to the hallway is a four panel type, typical of the early-mid C19, and is probably an original feature, although it has later furniture attached. The door to the rear of the house is similar, also typically C19. As noted above, the sash windows at the front of the house appears to be original.

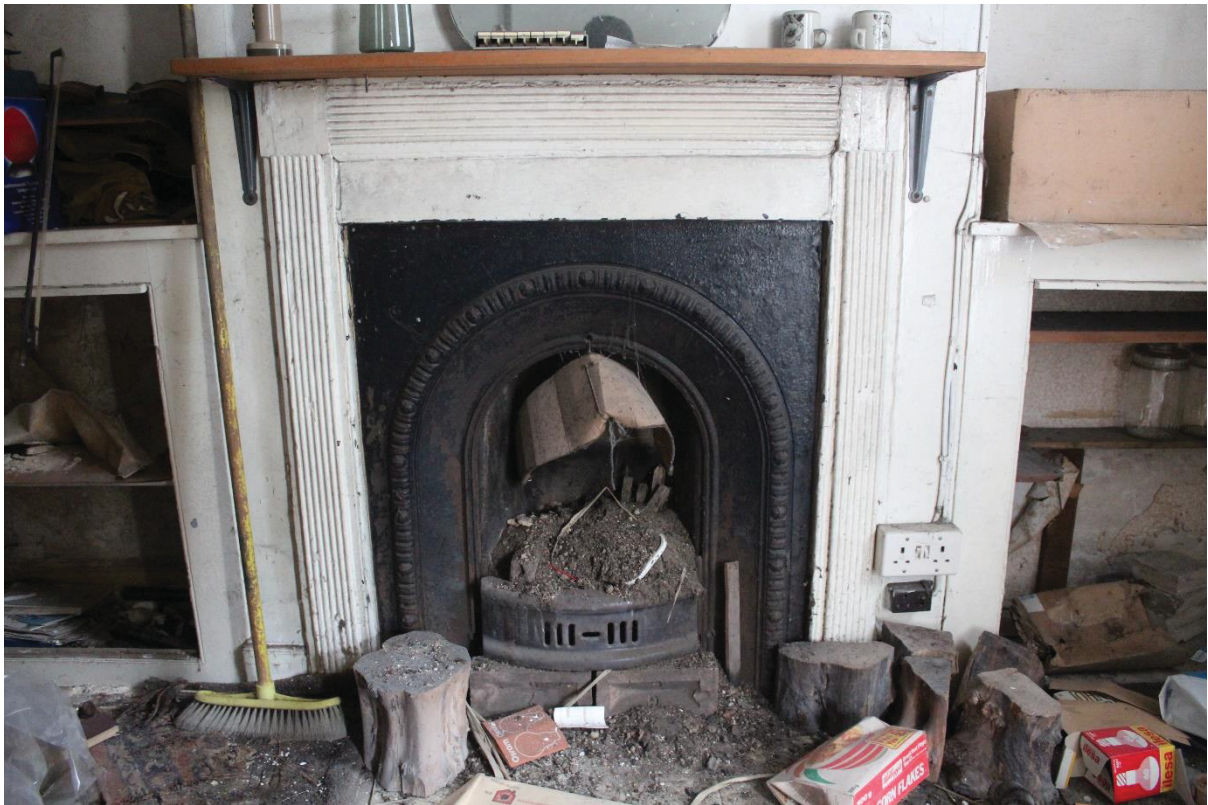
Plate 17 - Fireplace in east front room.

6.09 The eastern ground floor room is almost a mirror configuration to the western one. It also retains few obvious original features. The rounded cast-iron fire place is typical of the later C19, probably dating around the 1870s. The semi-octagonal alcoves (as also seen in the western room) to either side of the fireplace may have been originally constructed in order to allow the flue from an external fireplace and water heater to pass through the house and up into the existing chimney stack. These features may date from the partition of the house, due to their being no need for a secondary flue prior to the construction of the outbuilding.

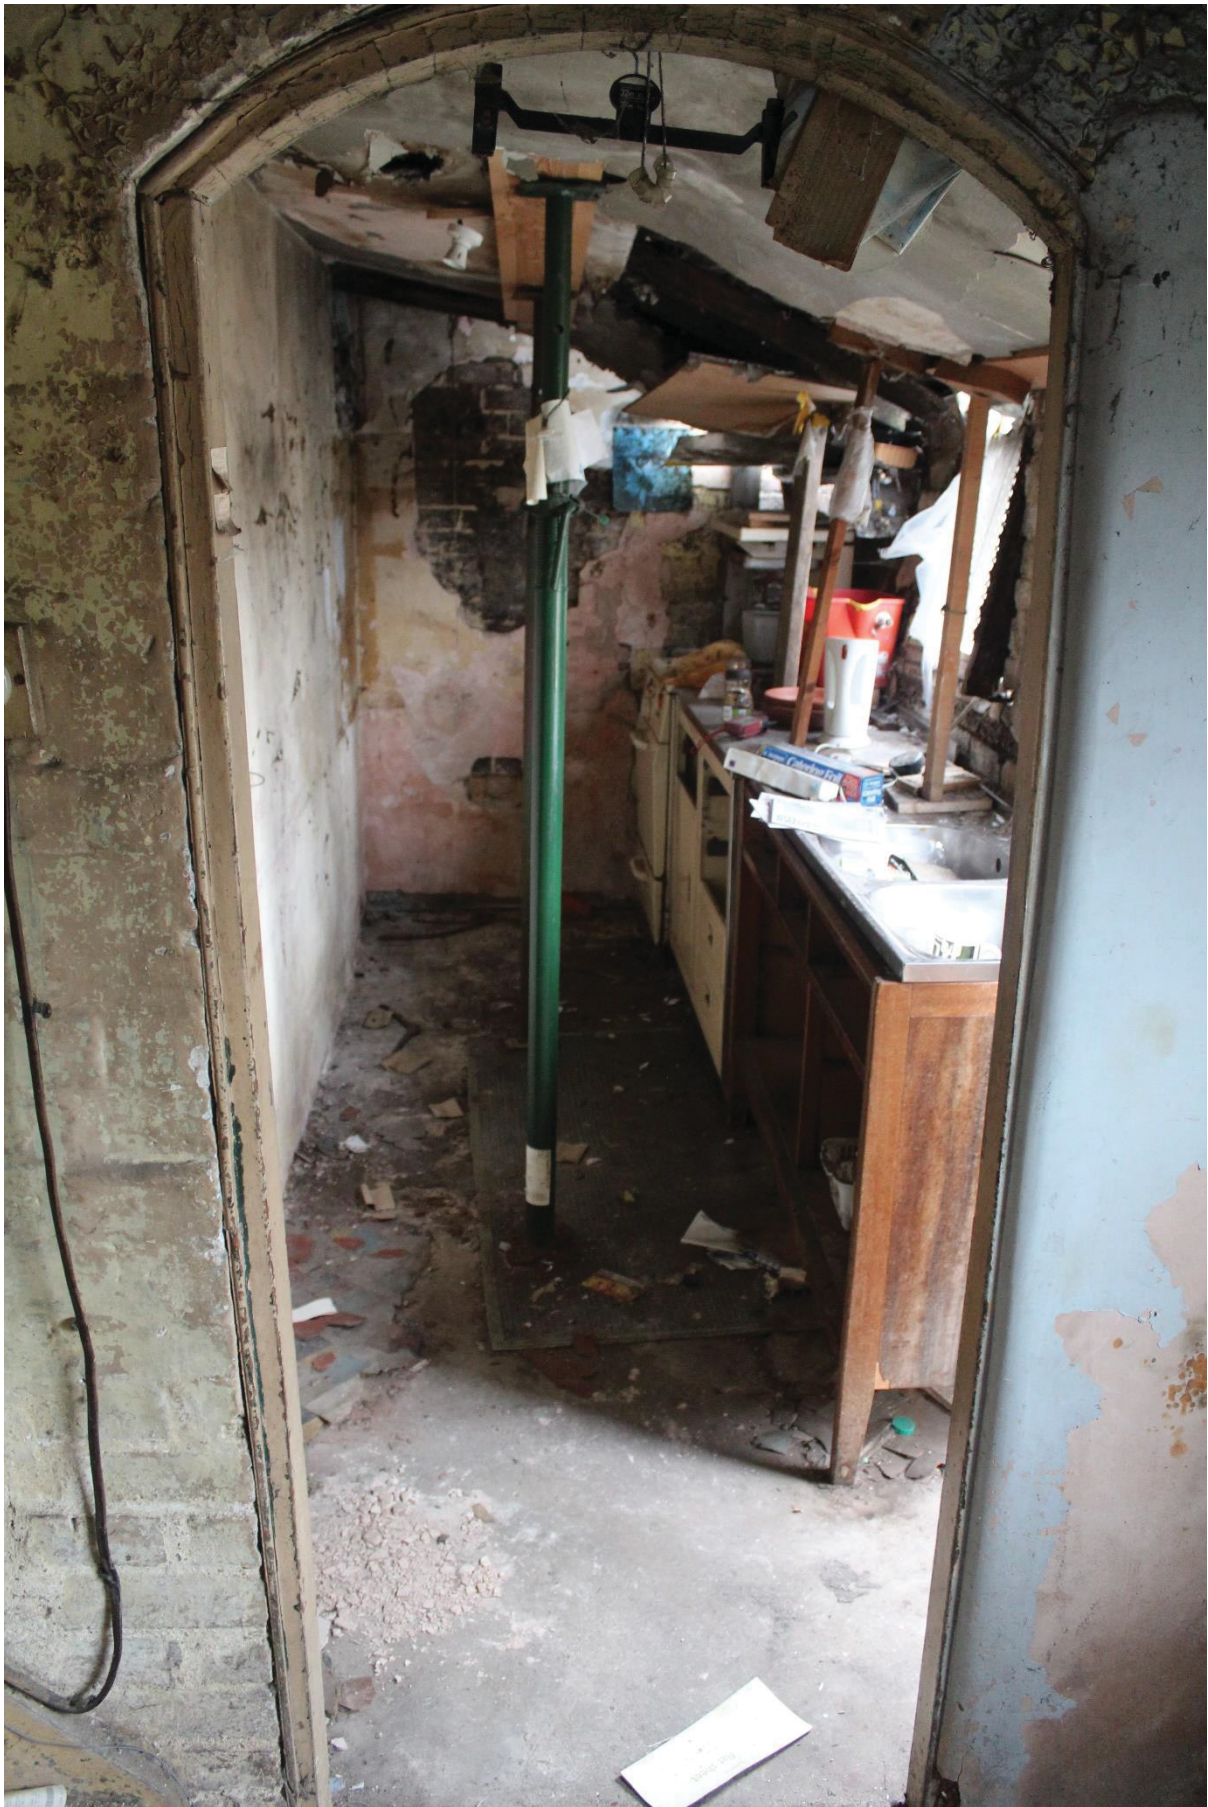
Plate 18 - Interior of rear lean to looking west.

6.11 In the rear lean-to is a kitchen and bathroom area. Historically these were two separate spaces, one associated with each side of the house. The brick dividing wall originally ran between the two staircases into the lean-to, but this has been knocked through more recently, as is evidently the case upon inspecting the brickwork at the base of the stairwells. There were two small entrance halls between the rear doors and arched entrances to each side of the lean to. The arched doorway survives on the west, but has been removed on the eastern side where an RSJ now holds up the structure. On the east side the lean-to also contains a blocked doorway to the room inside, which may, prior to the partition of the house, have provided access to a similar scullery extension to that on the rear of the adjacent No.8. The doorway with the C20 door leading to the interior of the house is a later insertion.

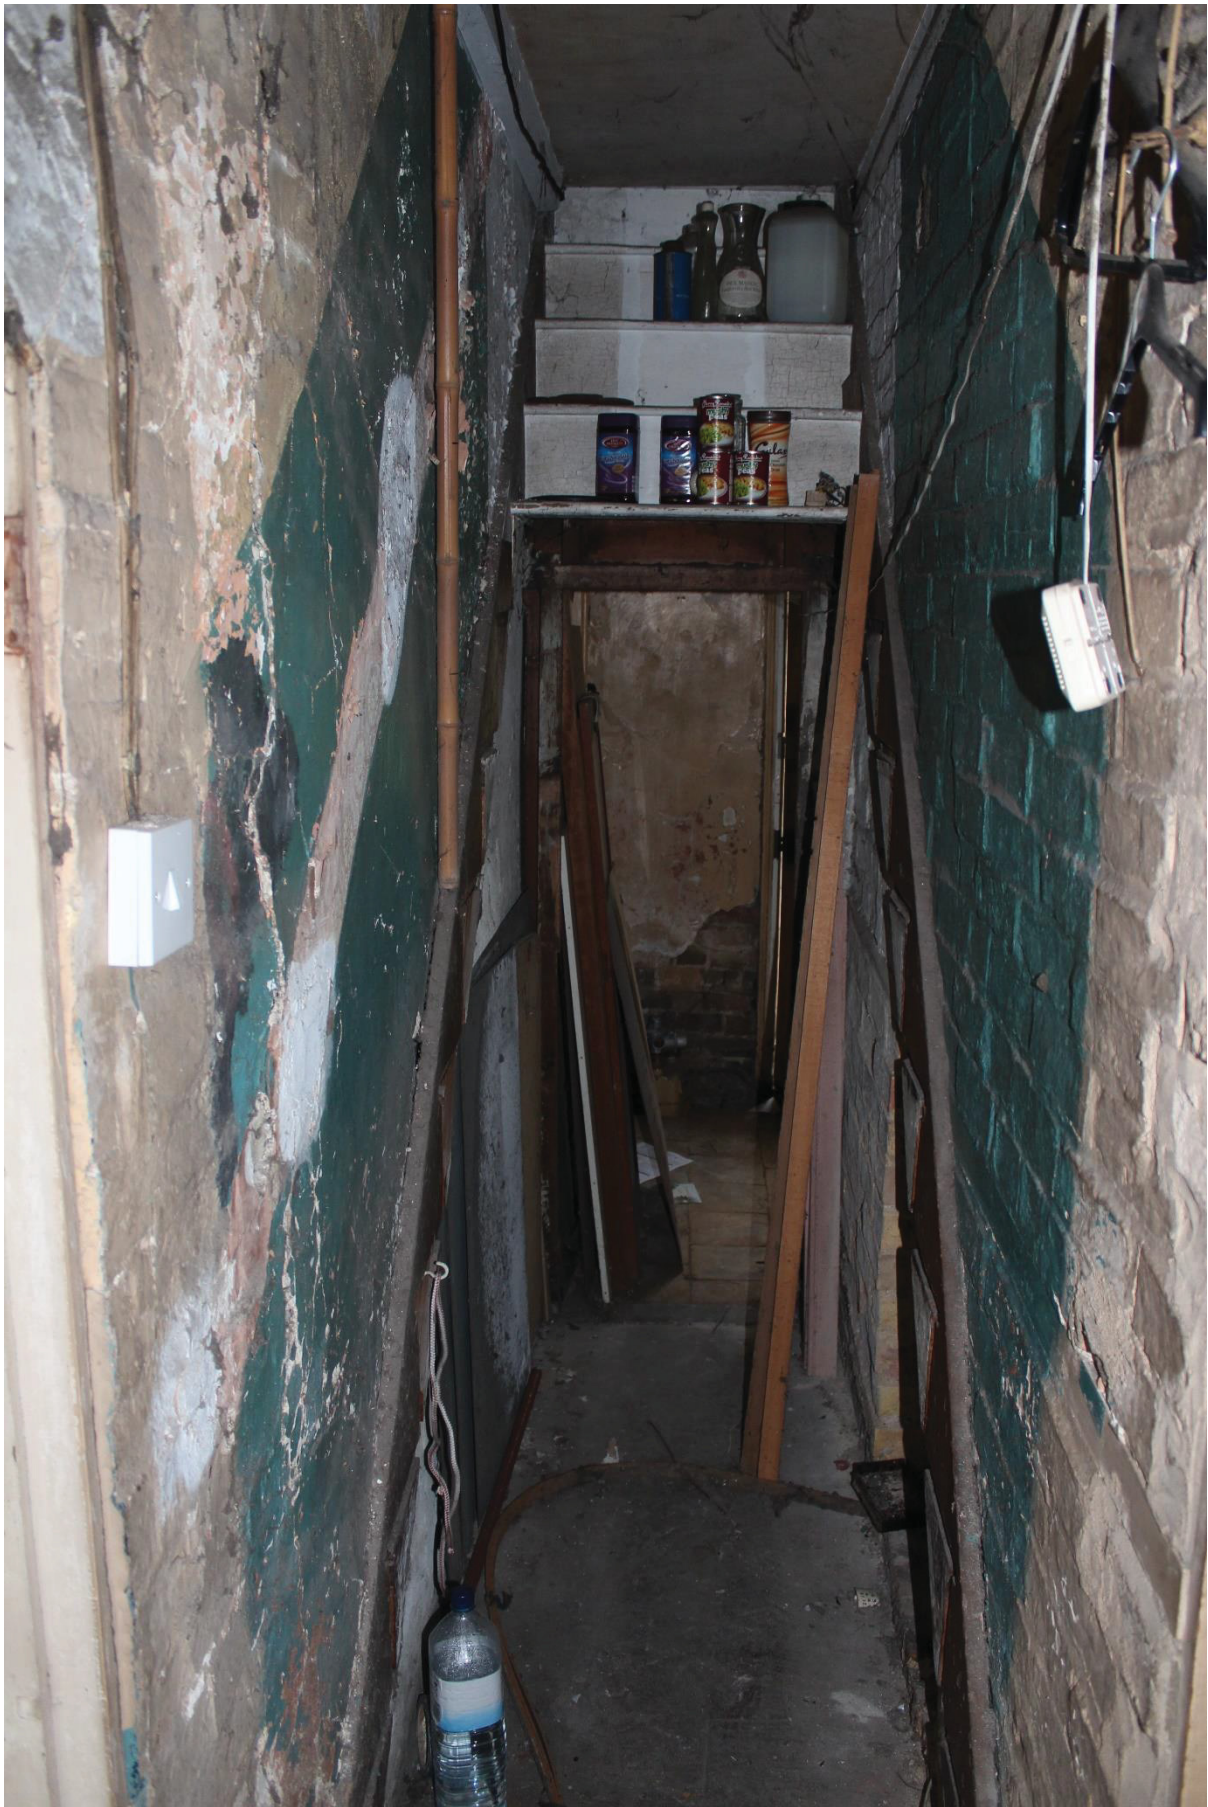
Plate 24 - Remains of east stairwell.

6.12 Only the western of the two inserted stairwells dating from the partition of the house survives, as discussed above. To the east the supports for the treads remain attached to the wall, but only four steps at the top are in situ, above which the stairwell has been boarded over. The other stairwell remains usable, providing access to both upstairs rooms following the removal of the partition wall at first floor level. At the top of the stairs the central risers for the stairwell have been inserted into the existing fabric of the first floor landing, cutting through the remaining historic floorboards.

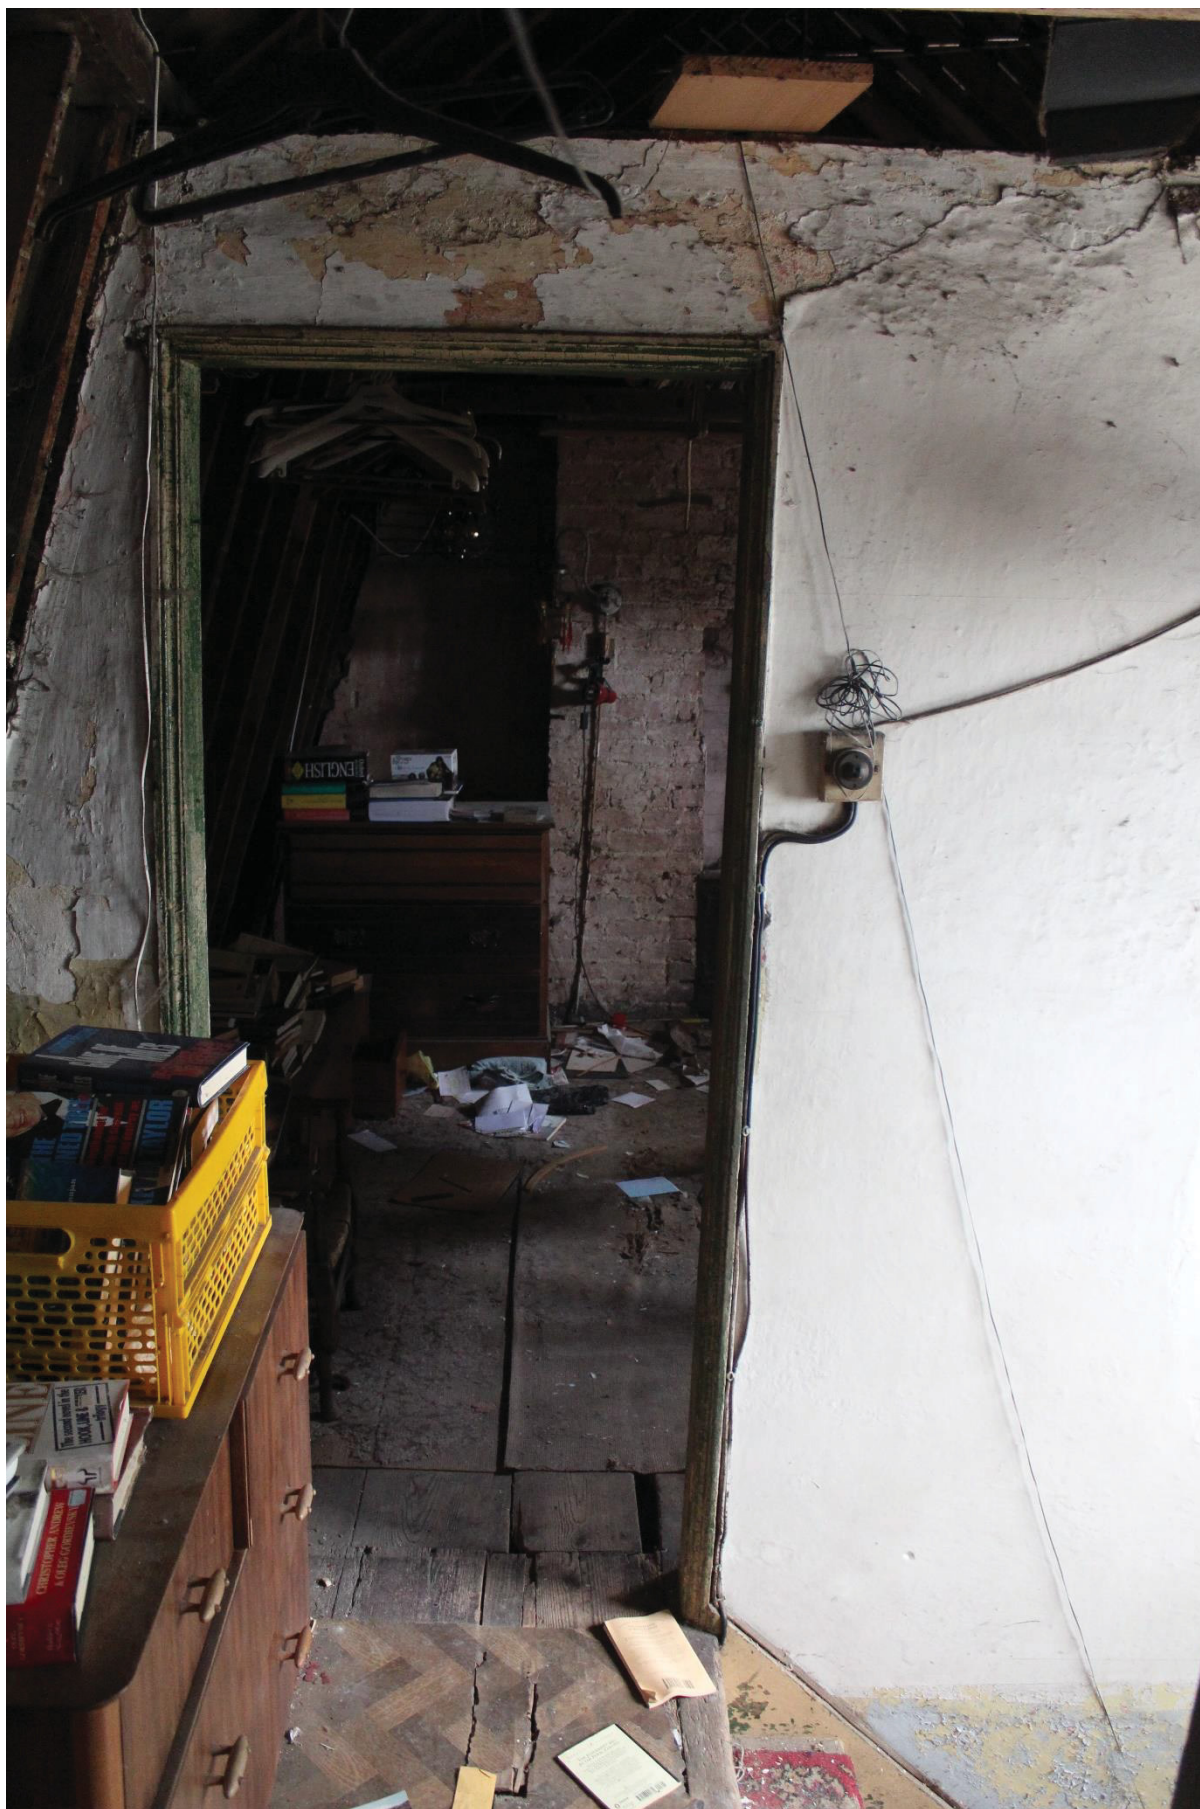
Plate 28 - Looking west on landing.

6.13 In the landing area on the first floor, the partition wall has been removed allowing free movement across the width of the cottage, probably in an effort to make the cottage into a more liveable space. This has exposed the width of the original stairwell and opened up the central casement dormer window. The floorboards on the landing retain obvious scarring where the internal brick partition wall has been constructed on top of them, with holes where some sort of pinning or battening has been inserted. The original joists underneath the floorboards remain. The construction of the wall using the floorboards as a base illustrates the poor quality construction of the partitioning works carried out, and the probable haste in which they were done.

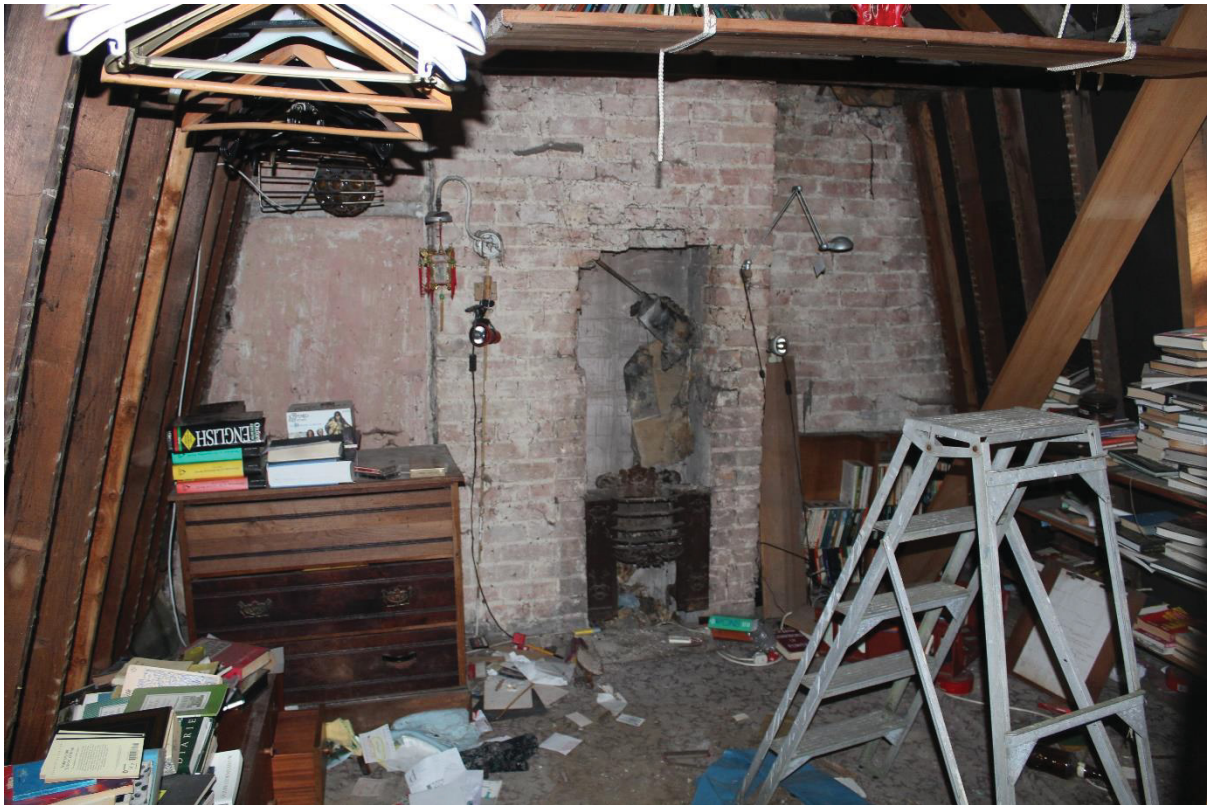
Plate 30 - Interior of west bedroom, looking west.

6.15 To the west, the architrave of the door is historic, and may predate the partition. The door is missing on the west side of the house, but survives on the east. The western room appears to retain very few historic features. There is evidence of an earlier ceiling surviving in the form of holes in the main ceiling beams, and earlier lath and plaster wall material on some mansard roof rafters. The brick fireplace has been enlarged insensitively, although the lower section of the opening remains in its original form, and has a cast iron fireplace. The fireplace itself is of a Georgian style roughly contemporary with the construction of the house in 1825, although its floral decoration seems perhaps slightly too ornate to have been an original to the house given the social status of the intended tenants.

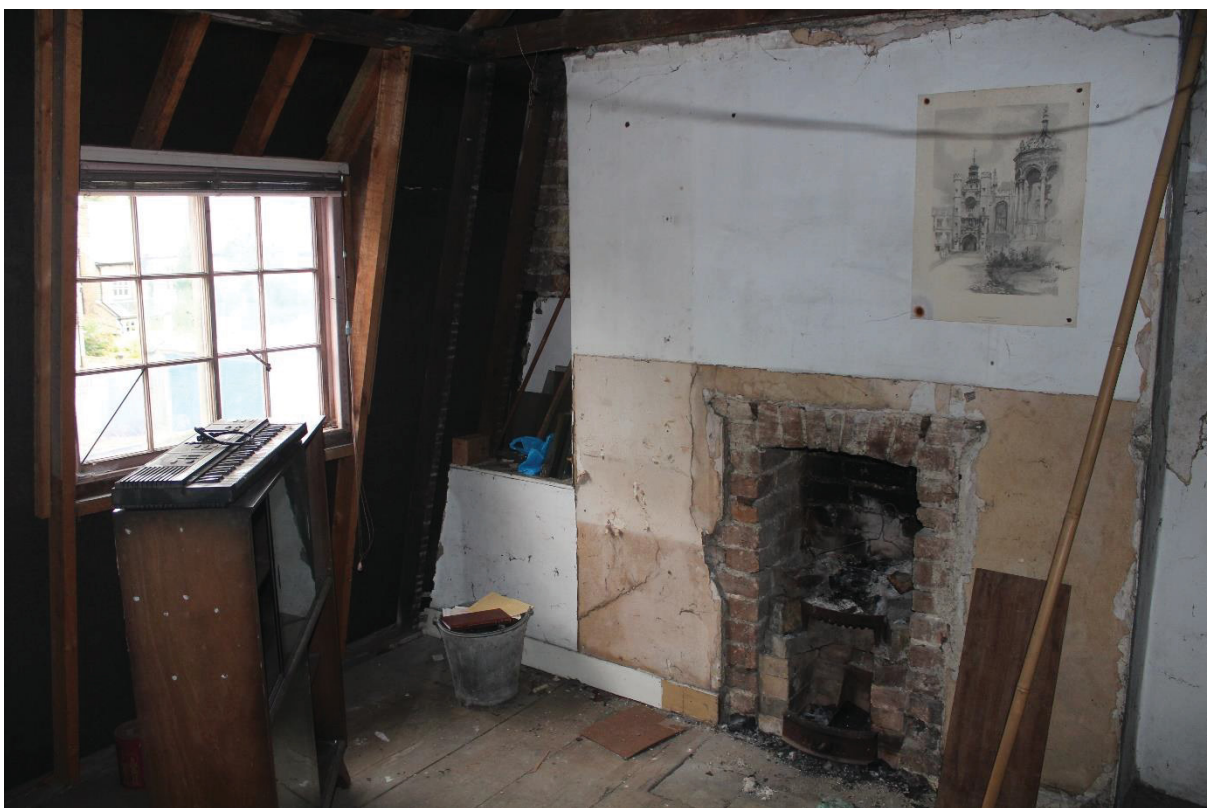
Plate 33 - Interior of east bedroom looking east.

6.16 The eastern first floor room is in similar condition, and again retains very few historically significant features. The internal ceiling/wall material has again been removed, leaving evidence of the lath and plaster on the rafters. The fireplace has lost its original surround and grate, and has had a makeshift grate installed. The C19 four panel door to this room remains in situ, with a C19 lock, but has a mid-C20 plastic doorknob.

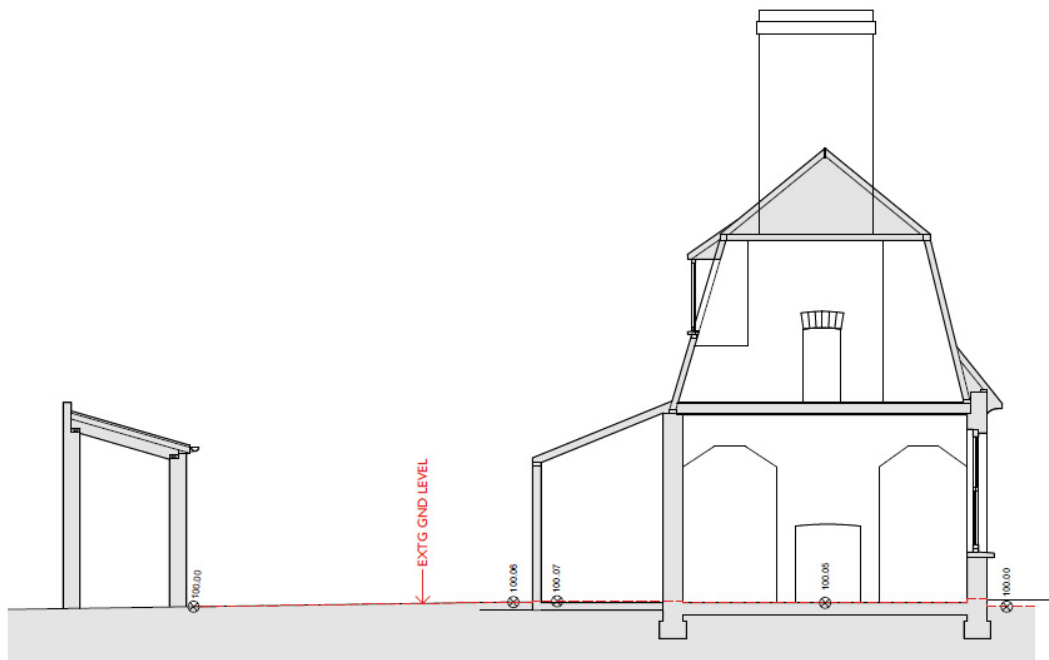
Drawing 6 -Section as existing.

6.14 The roof structure shows evidence of substantial reconstruction and the introduction of newer timbers, probably concurrently with the restoration and re-felting of the mansard roof in the later C20. This includes the reconstruction of all three rear dormer windows.
