HISTORIC BUILDING RECORDING

NO. 9 ORCHARD STREET,
CAMBRIDGE

October 2014

Project Ref: 14-1084

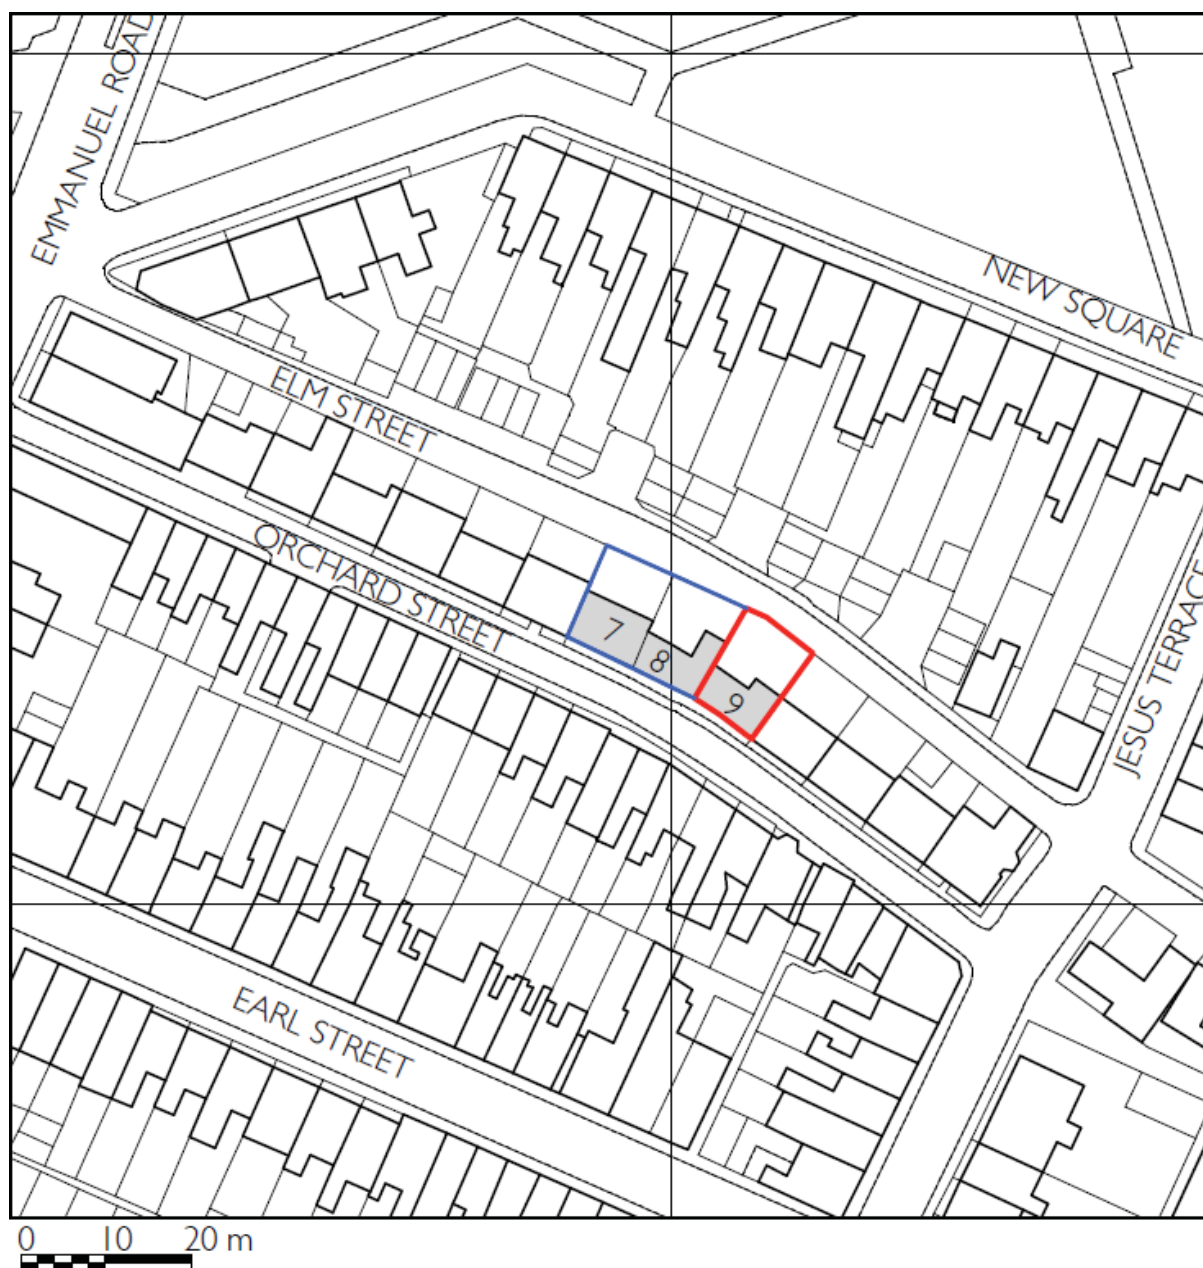
Figure 1 - Site Plan of No. 9 Orchard Street. Courtesy of Haysom Ward and Miller Architects)

2.01 Orchard Street is located on the southeast side of Christ's Pieces, in the centre of the City of Cambridge. To the north is Elm Street, and to the south Earl Street, while Emmanuel Road and Clarendon Street connect to its west and east ends respectively. No.9 Orchard Street lies roughly in the centre of the terrace of cottages which runs along the northern side of Orchard Street, just to the east of where the road bends slightly towards Clarendon Street.

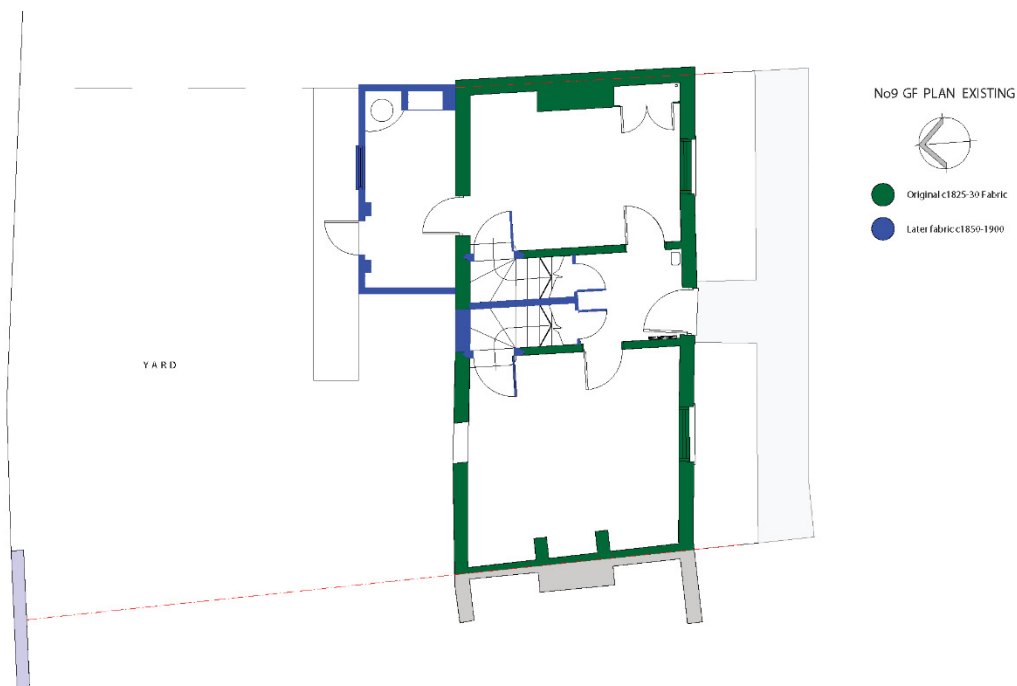
Figure 7 - Ground Floor Phase Plan

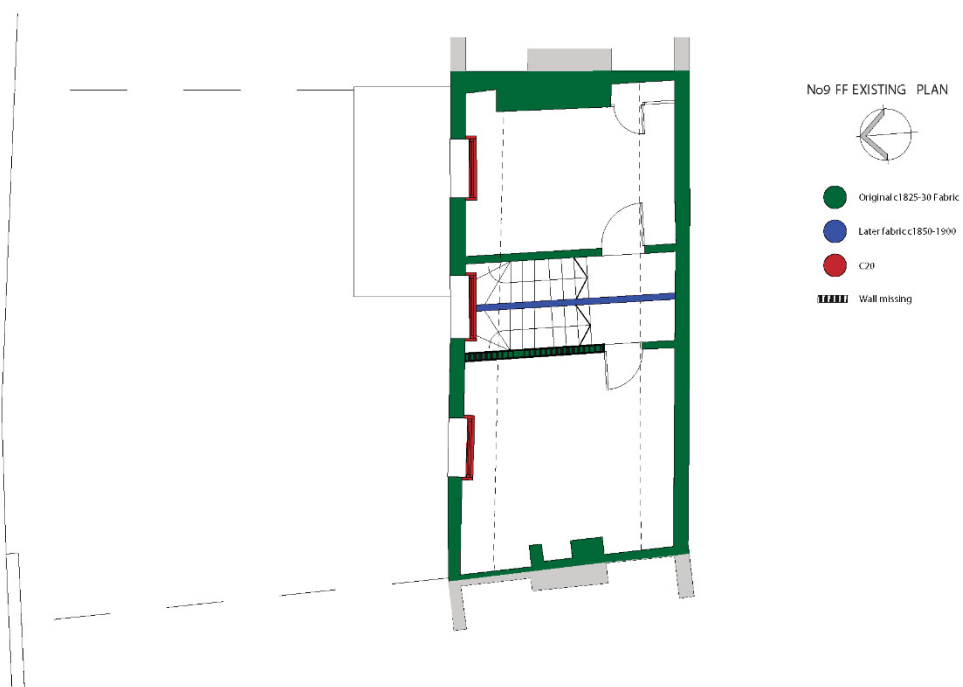
Figure 8 - First Floor Phase Plan

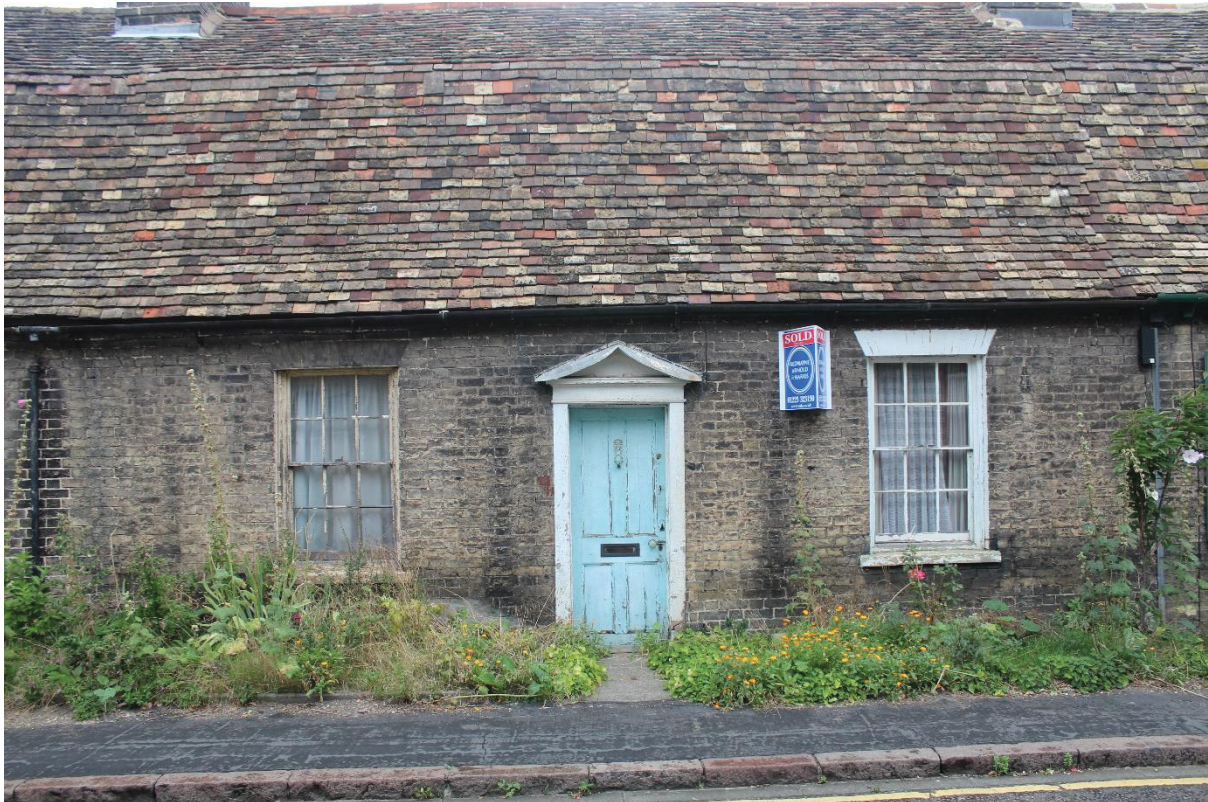
Plate 1- Front elevation

6.01 The principal material of the front elevation of No. 9 Orchard Street is gault clay brick, set in Flemish bond. In common with the rest of the terrace, No 9 retains the unbroken tile-covered mansard roof which forms a significant part of the terrace's appearance. Beneath the eaves is a moulded timber cornice which runs the length of the terrace, protected by the sprocketed eaves, and the guttering where it is still in place.

6.02 The street facing elevation is characterised by a central doorway with Neo-classical pediment hood and entablature, flanked on either side by 6/6 light sash windows, all of which appear to retain their original panes and glazing bars. The door is a wooden four panelled door in poor condition. Whilst four panelled doors grew in popularity in the early C19, and by the middle of the century were almost ubiquitous, it is unclear whether this is the original door. The presence of the letter box, which appears to be an original feature of the door, suggests it post-dates the introduction of the modern postal service in 1840.

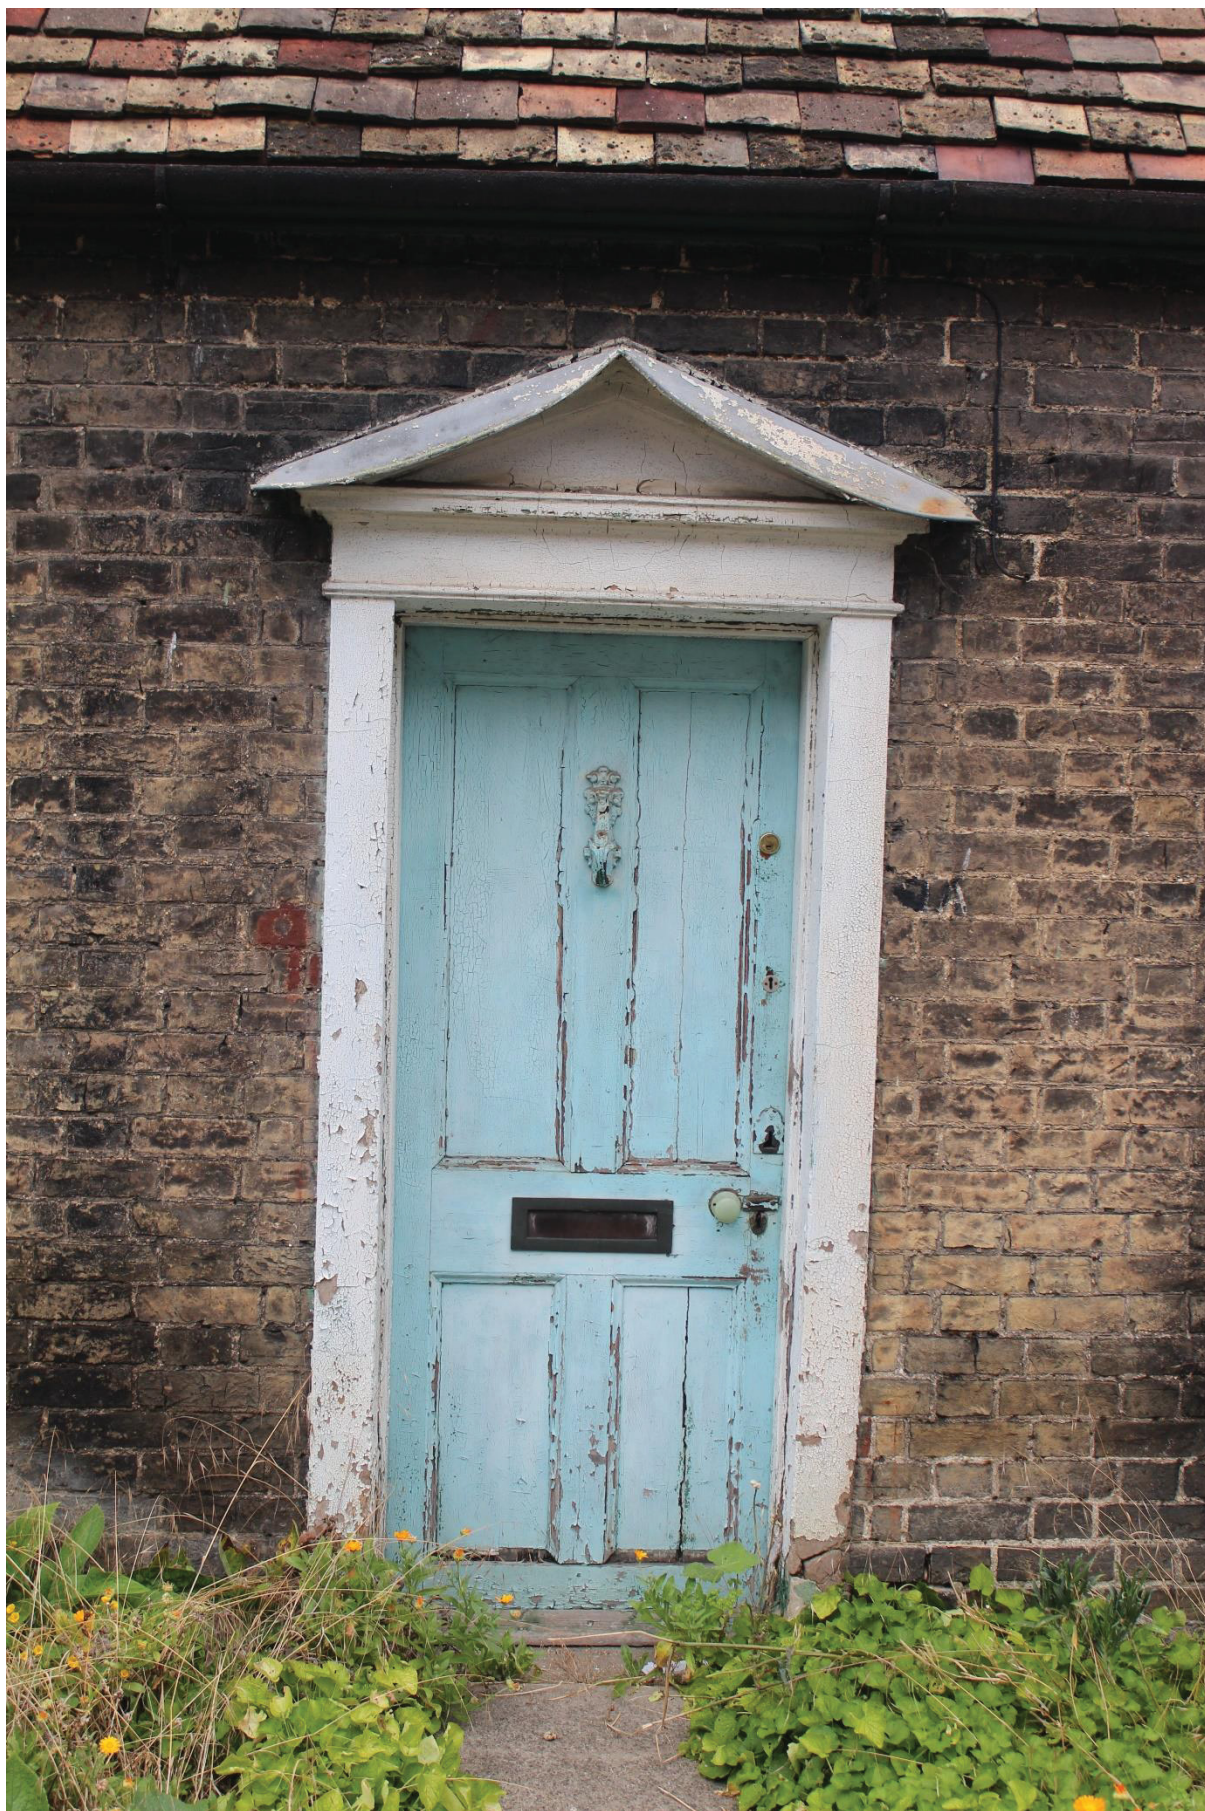
Plate 4 - Detail of front door

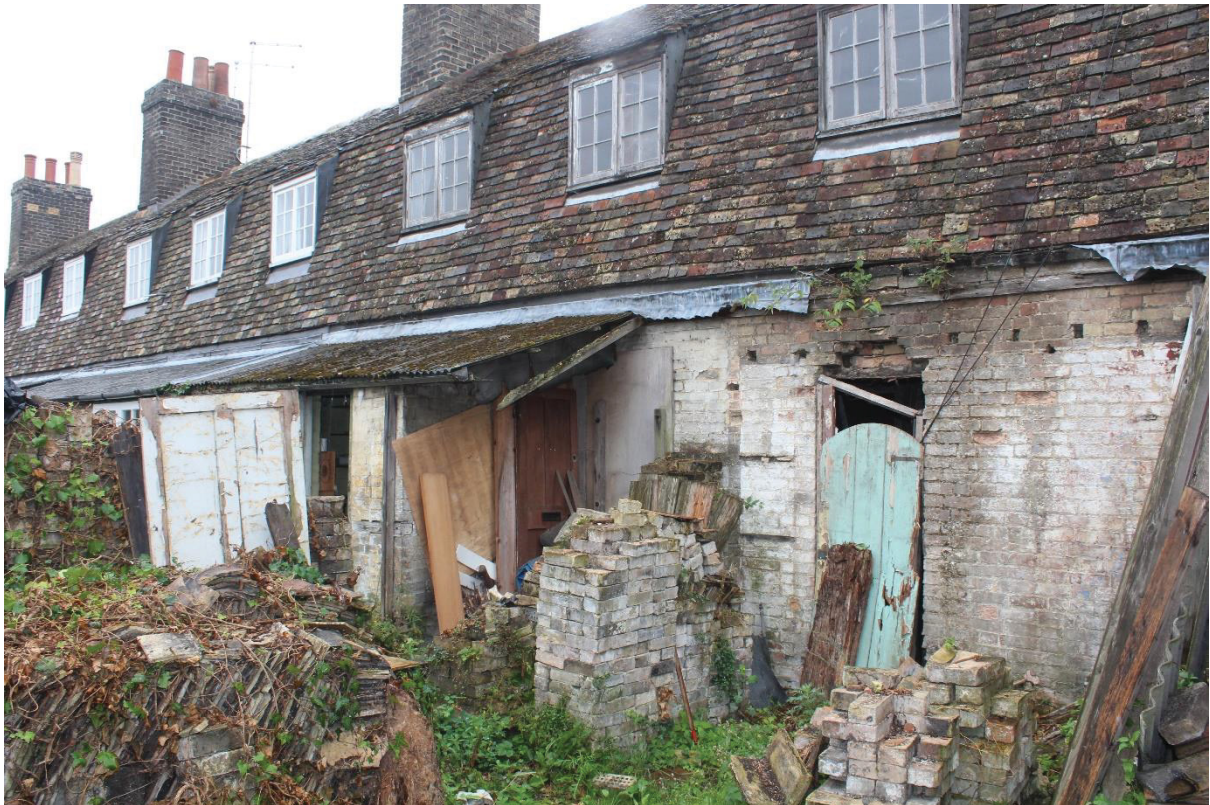
Plate 5- Rear elevation viewed from northwest

6.04 The upper portion of the rear of No. 9 retains its mansard roof and dormers, although the original windows have been replaced with later 6-light timber casements at some point during the C20. The windows are modern replacements.

6.05 On the ground floor, the building has seen extensive modification, and has the remains of several lean-to outbuildings visible in the external brickwork of the cottage. At the eastern end of the building is a brick built lean-to with a corrugated iron roof, timber casement window and rear door. It is likely that this form would have originally extended further westwards, as suggested by the presence of lead flashing and empty sockets, for rafters, in the brickwork of the main cottage. This section has now completely collapsed leaving just the doorway, which is now open to the elements. There is also evidence in the upper west corner of a flue, probably from an external fireplace arrangement similar to that surviving within the eastern side of the building (described below).

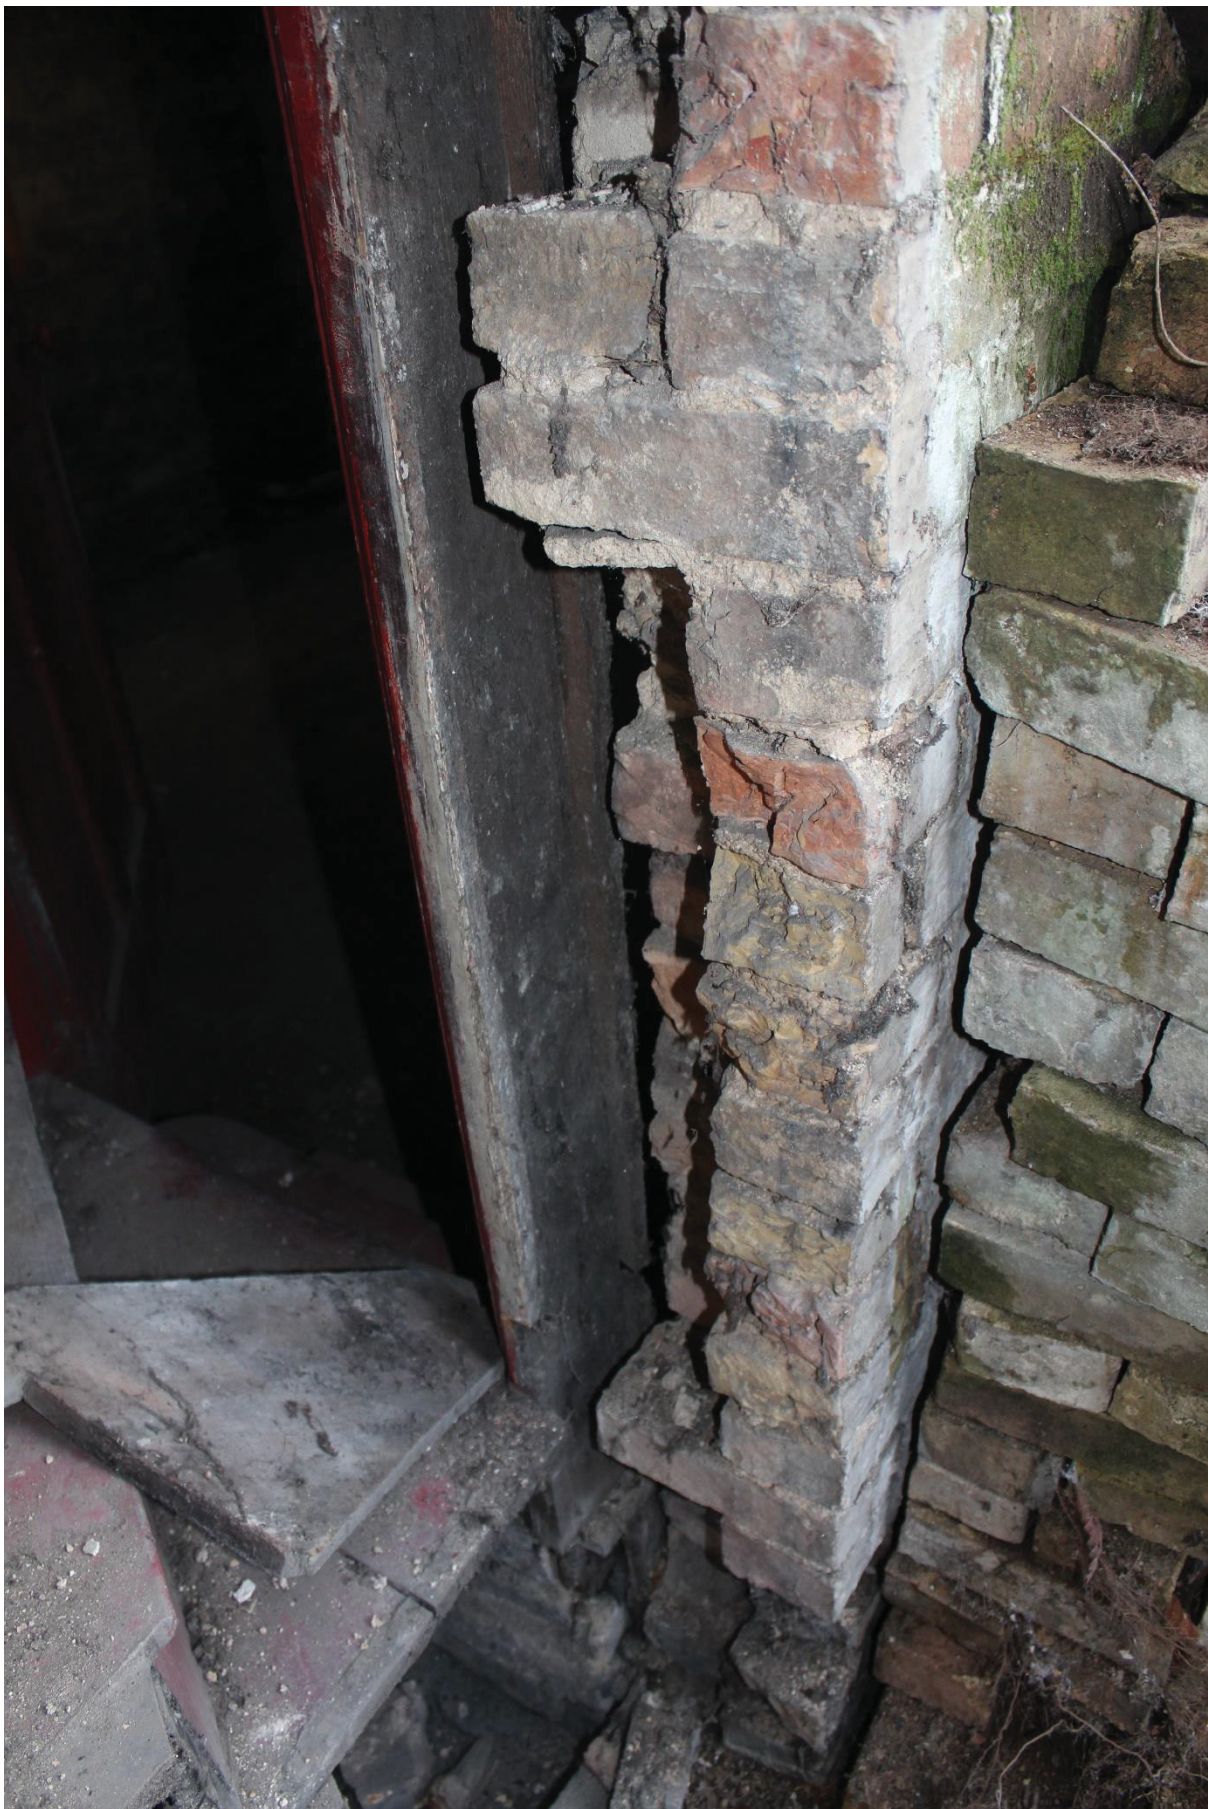
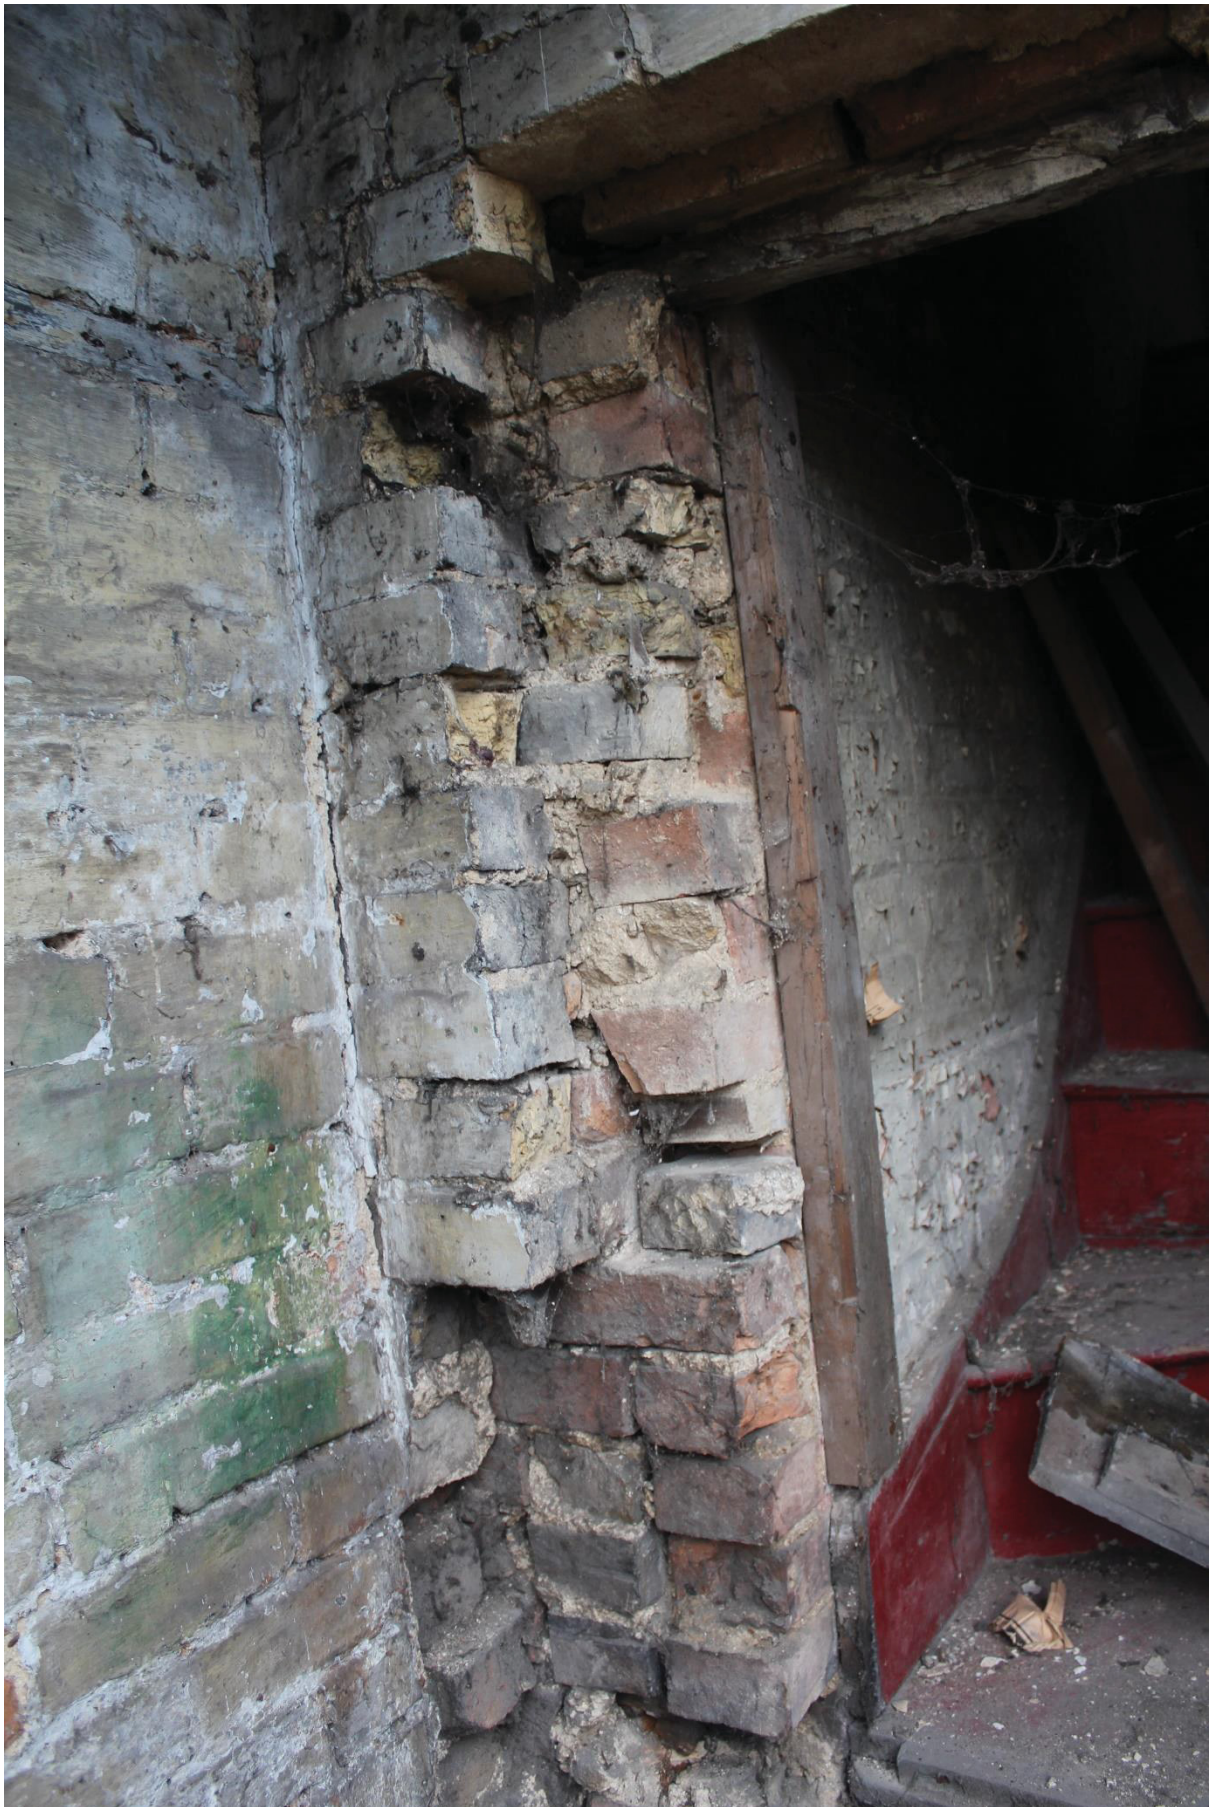
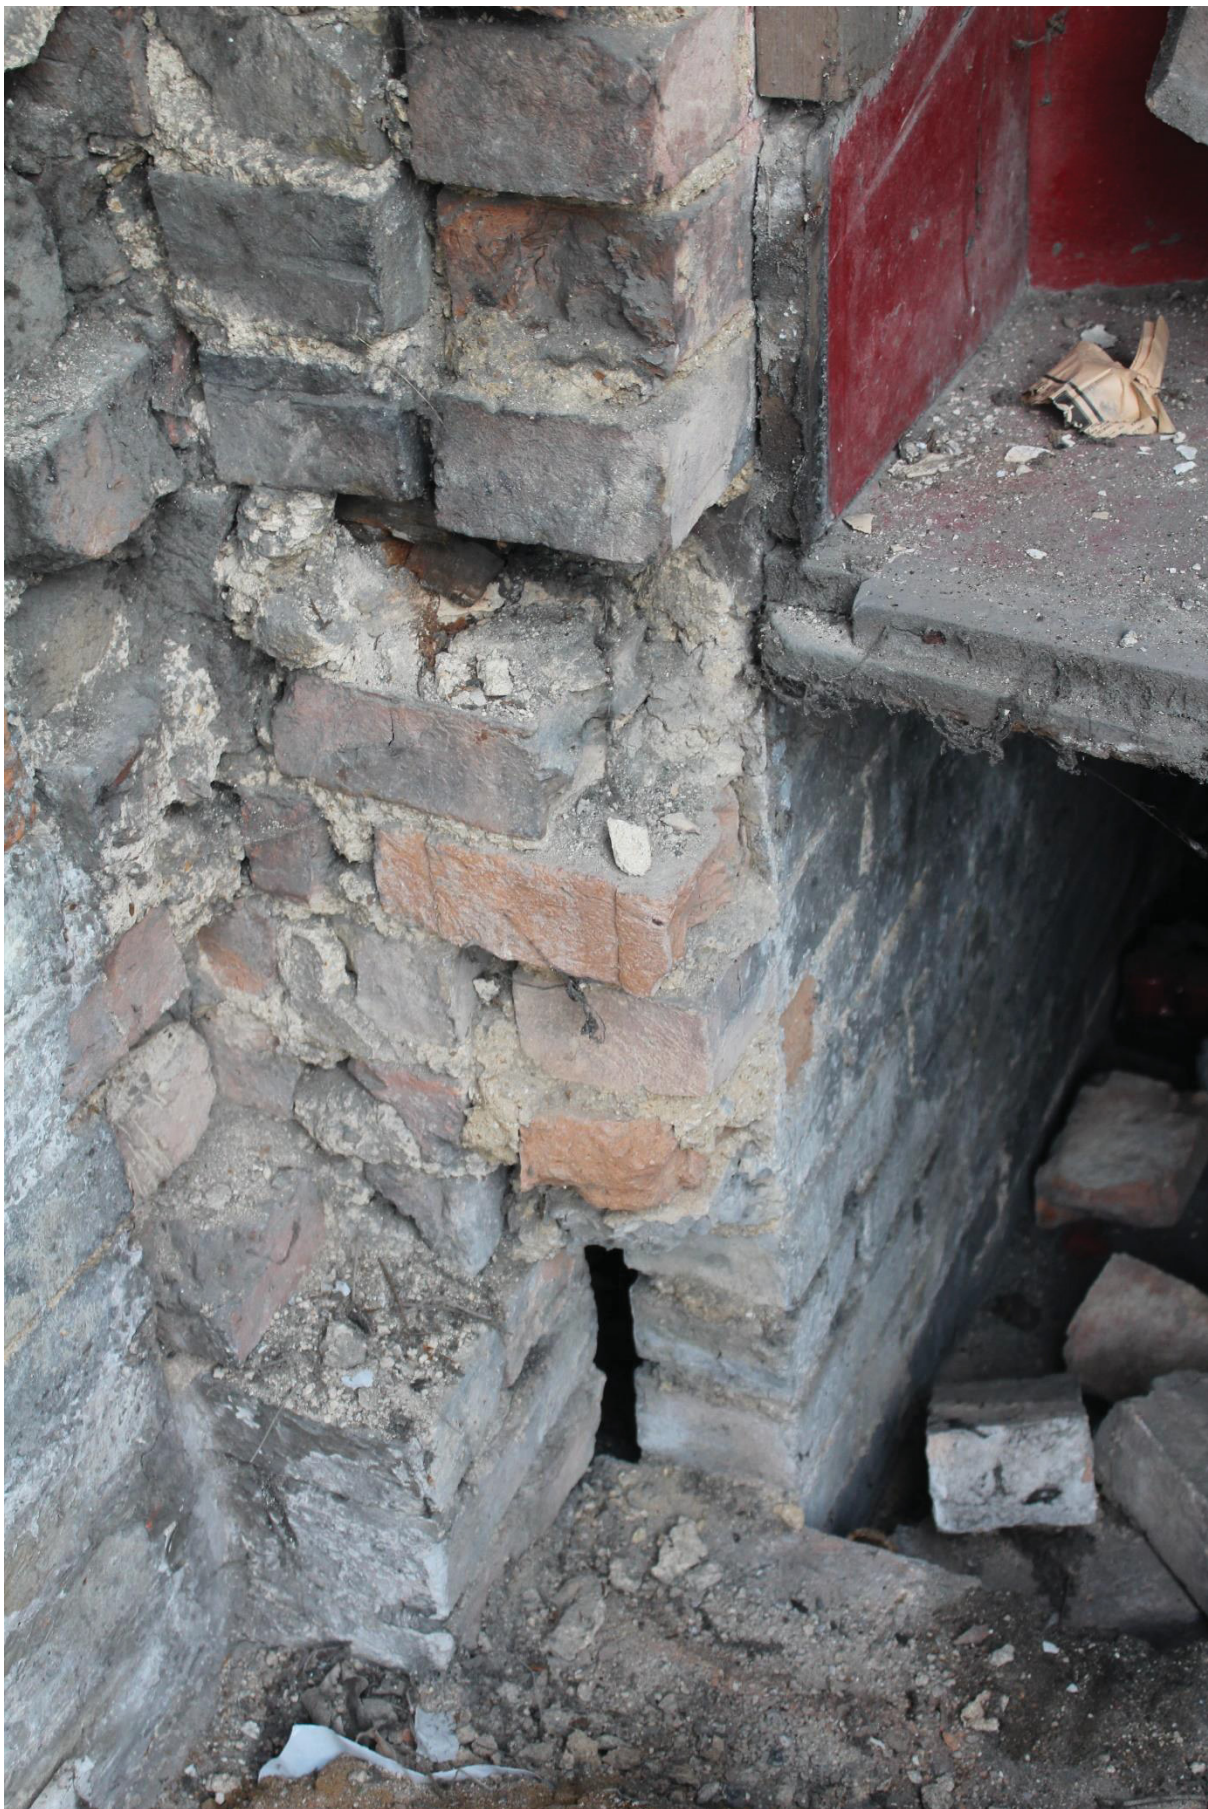
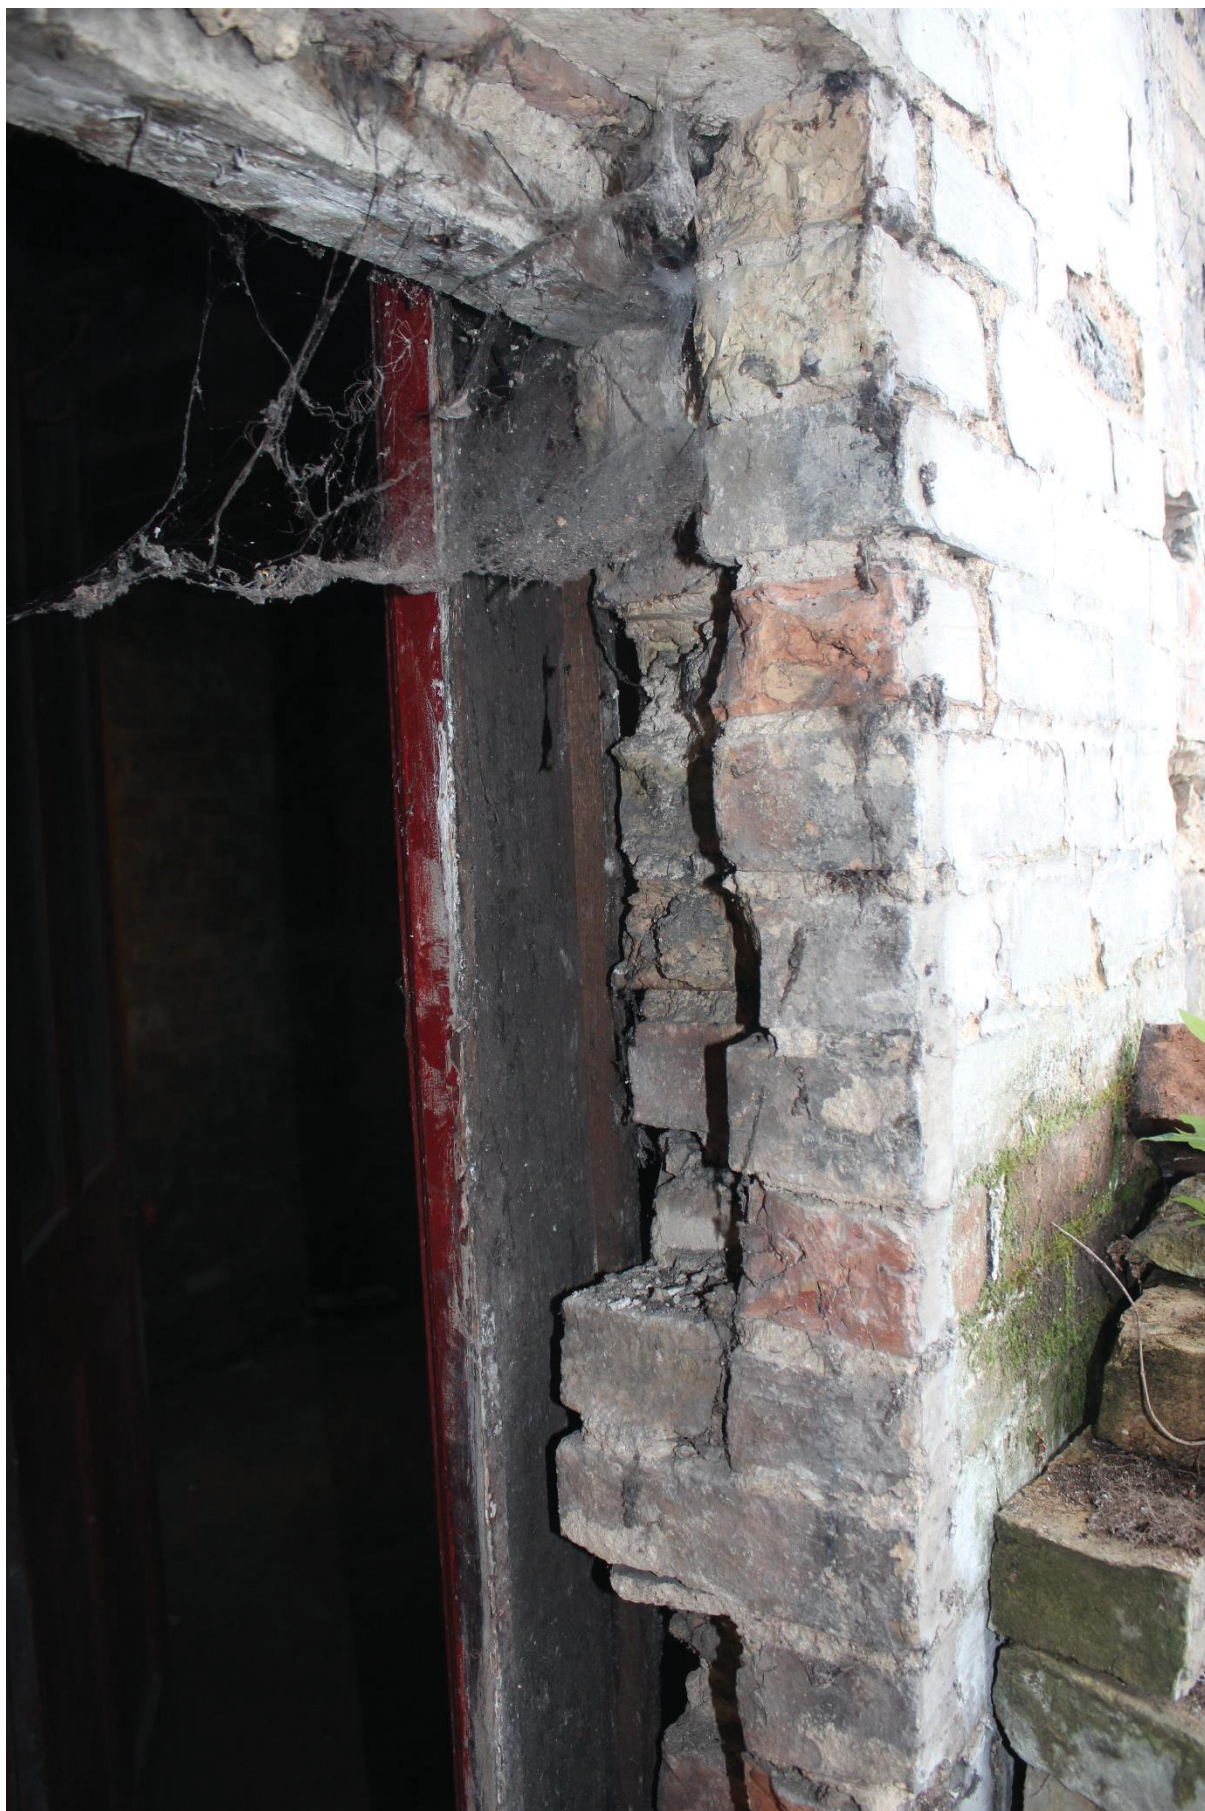
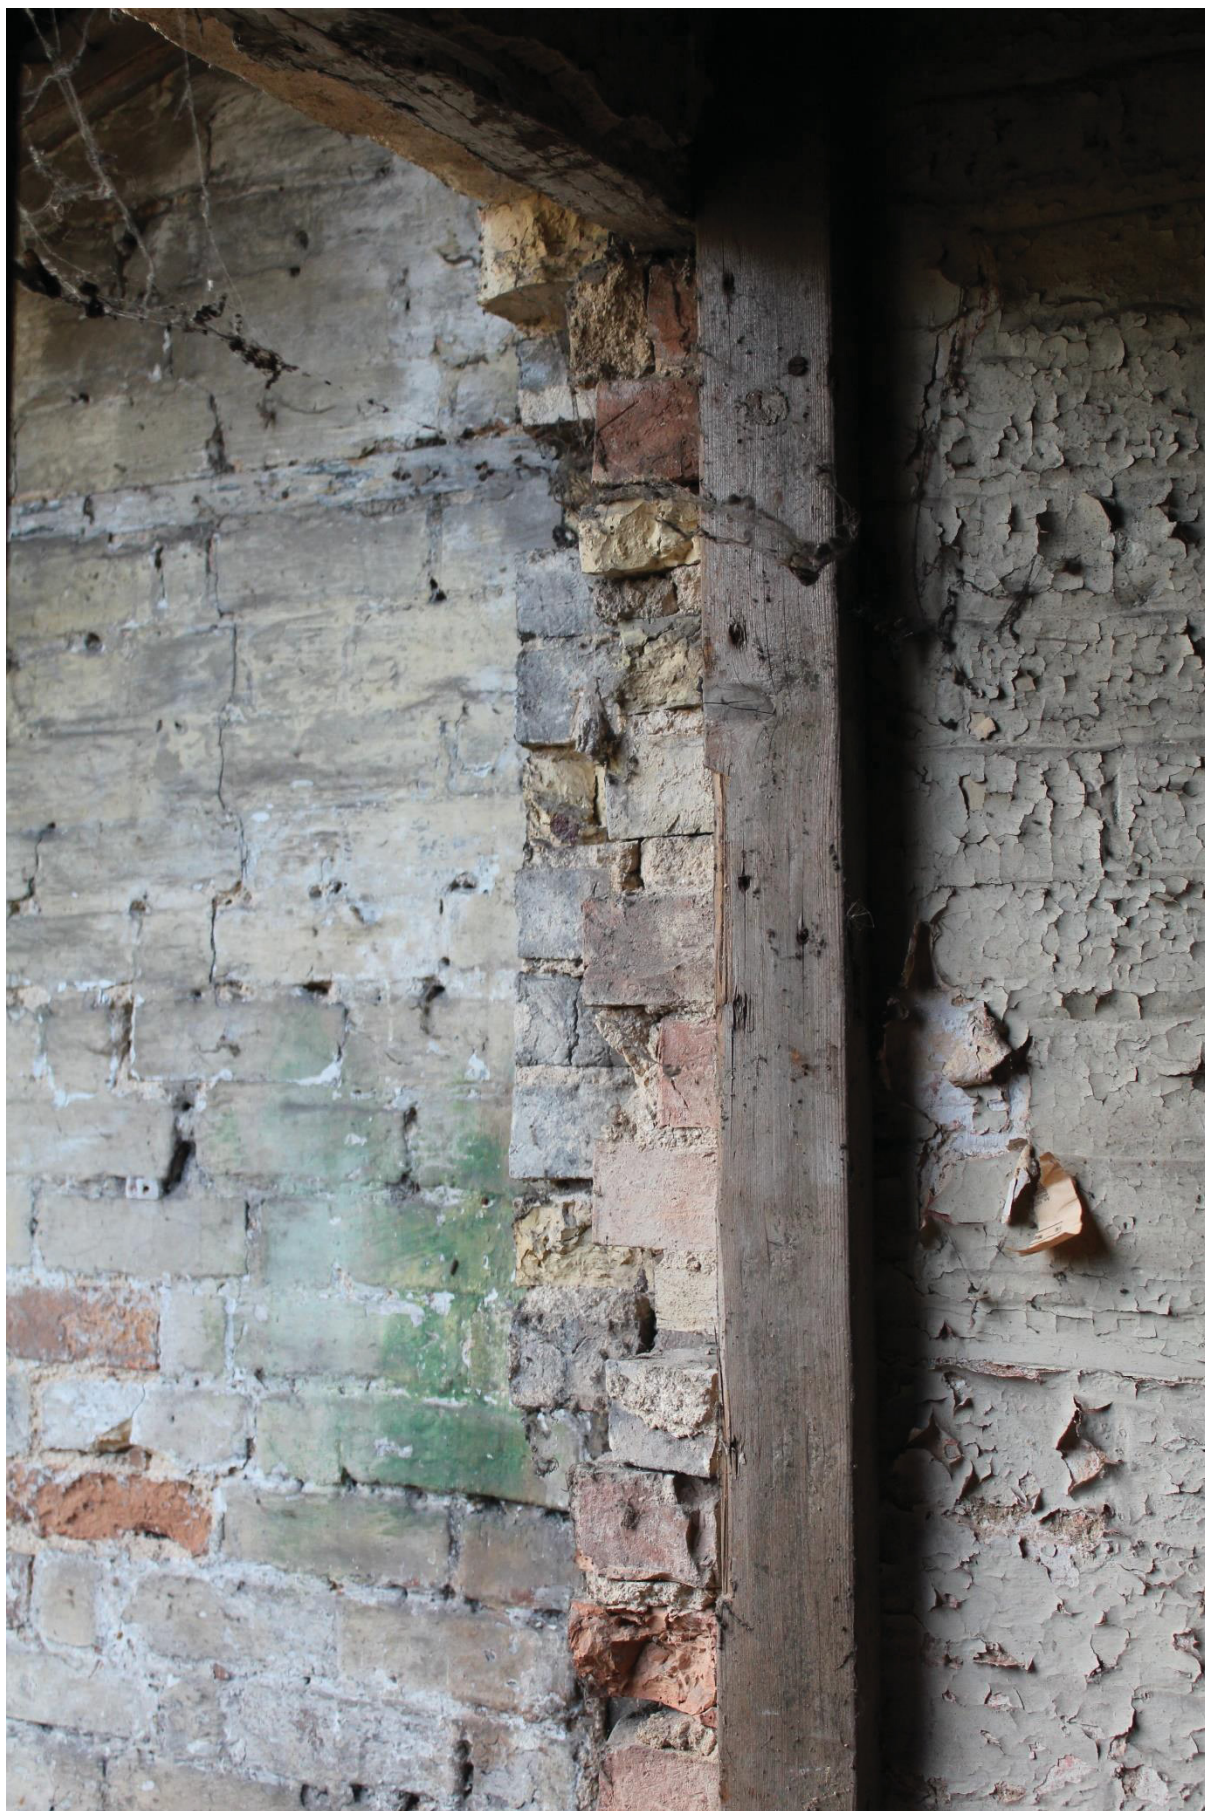
Plate 8 – Detail around original blocked rear entrance to building.

Plate 9 - Detail around original blocked rear entrance to building.

Plate 10 - Detail around original blocked rear entrance to building.

Plate 11 - Detail around original blocked rear entrance to building.

Plate 12 Detail around original blocked rear entrance to building.

6.06 The fabric of the structure suggests that the lean-to was divided into two sections, one for each internal 'half-cottage', and this implies it was constructed at approximately the same time the cottage was divided. This is supported by the 1967 OS Map which shows the configuration prior to the western side's collapse. The 1886 OS Town Plan possibly shows this as well, but it is ambiguous. The original rear doorway to the cottage, centrally located like that in the adjacent cottage at No.8, is visible in the exposed brickwork to the west of the surviving lean-to. This had been blocked to seal in the stairwell of the inserted staircase in the western half of No.9, but has been opened up

subsequently. The exposed brickwork shows the double skin of the original rear wall, and shows the new brickwork used to originally block it and where this was keyed in to the partition wall on the ground floor. The opening also retains the timber lintel of the original doorway within it.

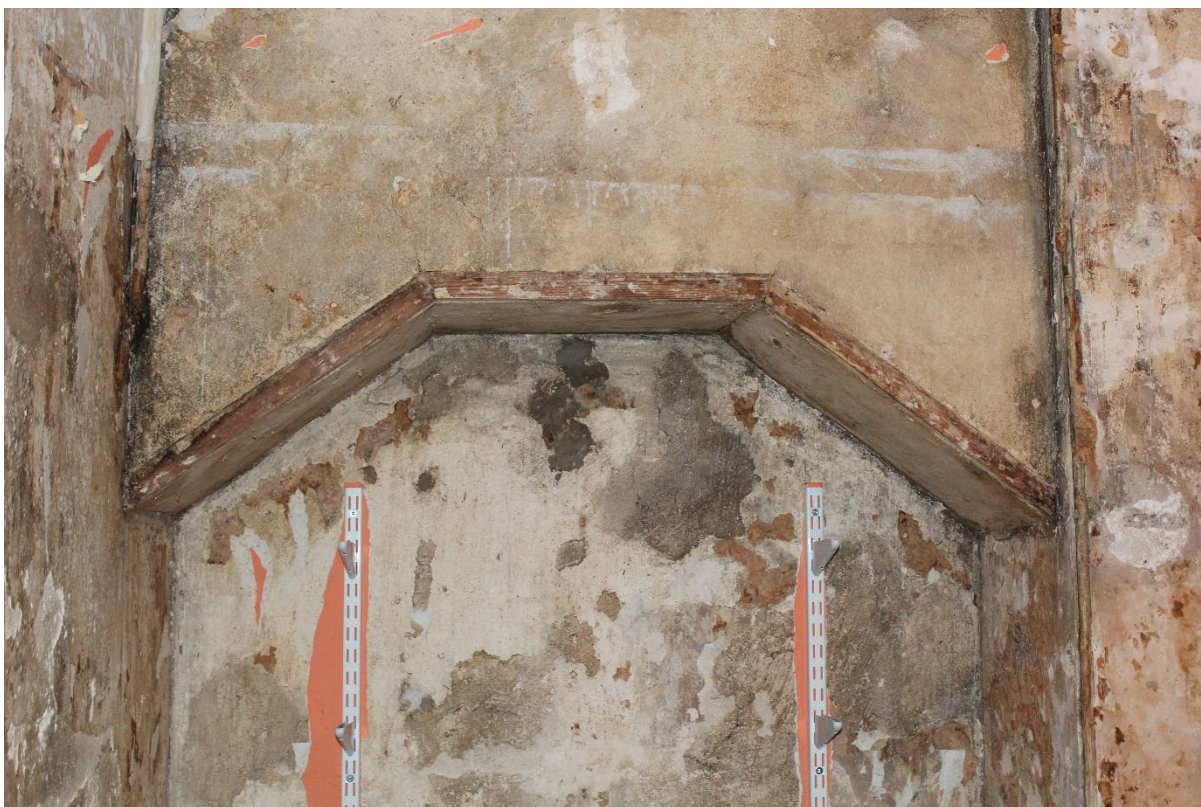
Plate 16 - Detail of semi-octagonal alcove header in east front room.

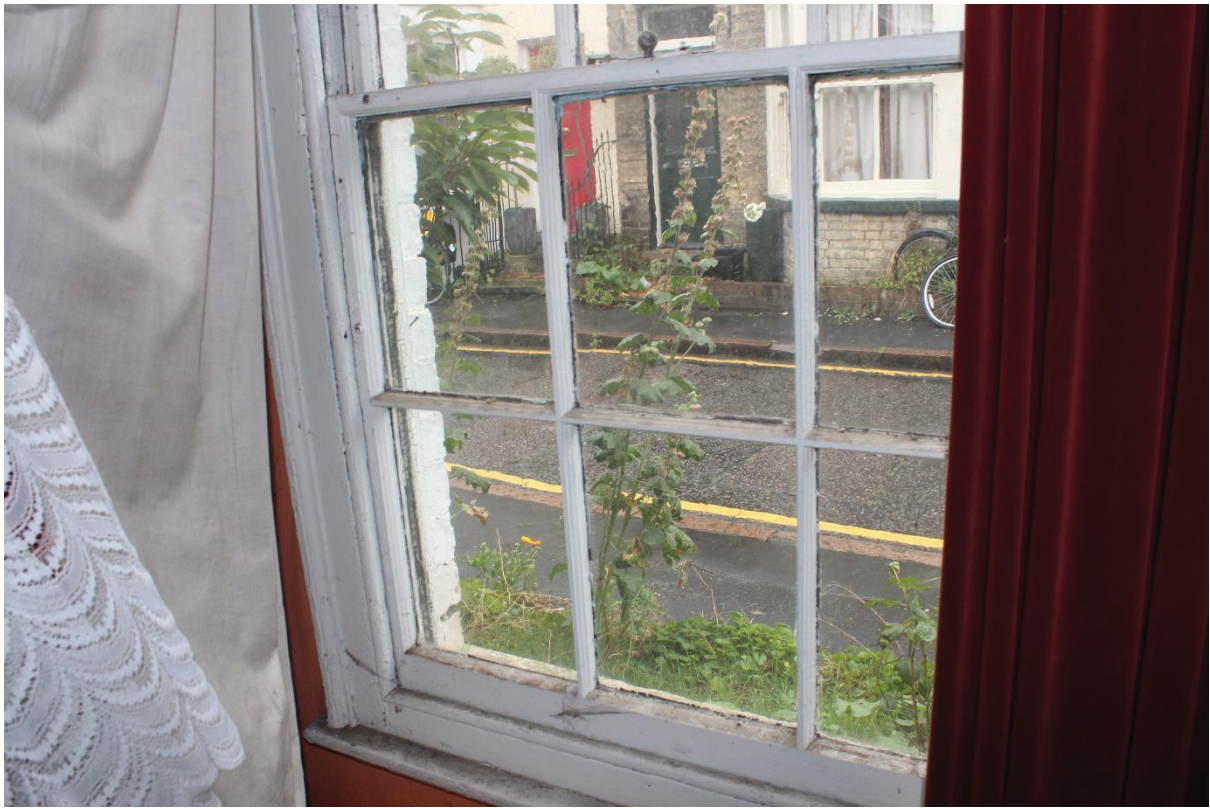
Plate 19 - Detail of front sash window in east room.

6.08 The eastern ground floor living room is in reasonable condition, with various historic features surviving, albeit in poor condition in some places. These include skirting boards, doors, architraves and the front facing sash window. The cast iron fireplace dates from approximately c.1870-80. These may have been inserted around the time the cottage was partitioned. The floor is brick, laid in herringbone pattern. This is in contrast to the floor in the other living room, which would have had wooden floorboards. This may suggest the east side of the house was originally designed to be used as a more functional space, probably for cooking or food preparation – the hard floor supporting the weight of a range or stove.
