HISTORIC BUILDING RECORDING

NO. 9 ORCHARD STREET,
CAMBRIDGE

October 2014

Project Ref: 14-1084

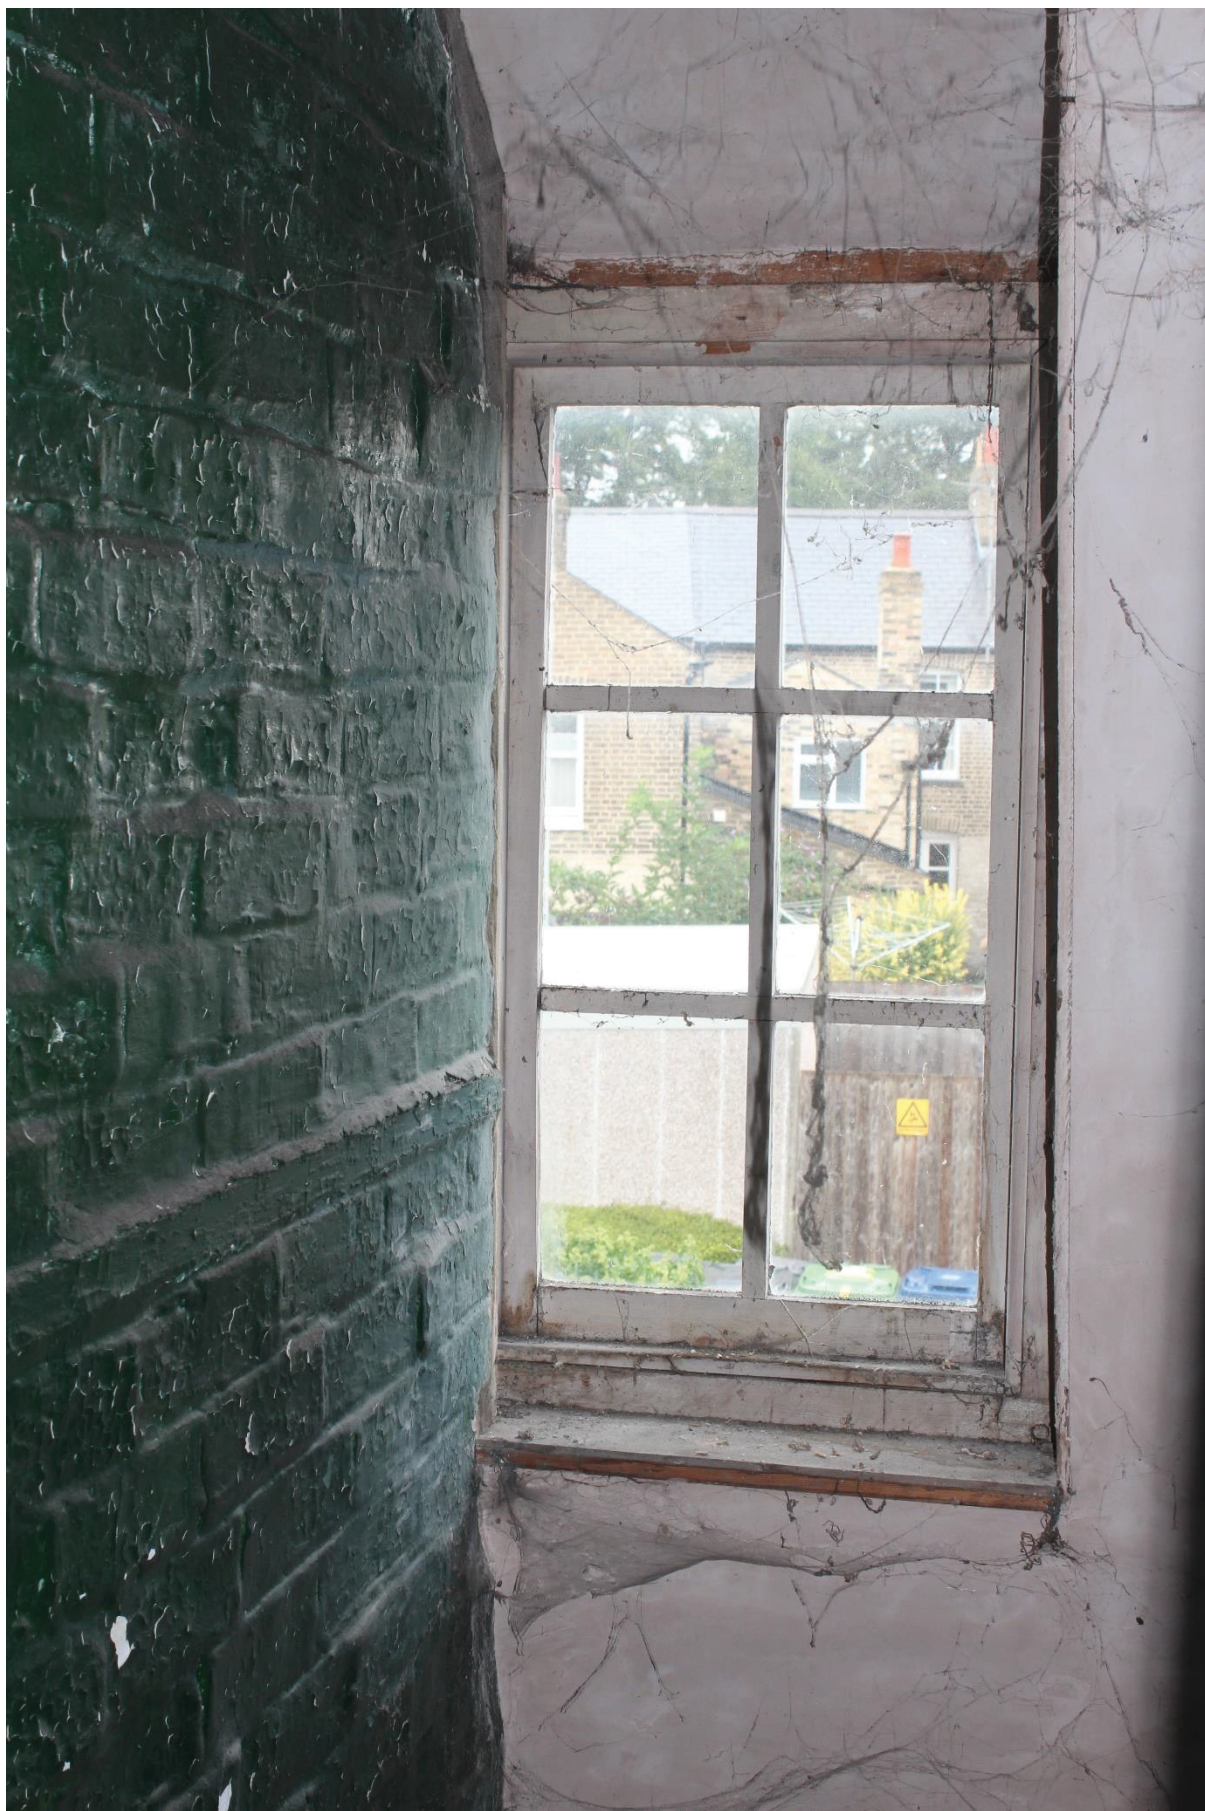
Plate 21 - Looking north from east stairs, through partitioned window.

6.11 The narrow stairs on the eastern side of the house lead up to the first floor, where it is possible to see the brick partition wall bisecting the dormer window, suggesting this dormer has not been completely rebuilt, although the casement window itself is a modern replacement. The head of the stairs leads directly into the bedroom to the left, leaving no real landing space. The room and landing both retain their original floorboards.

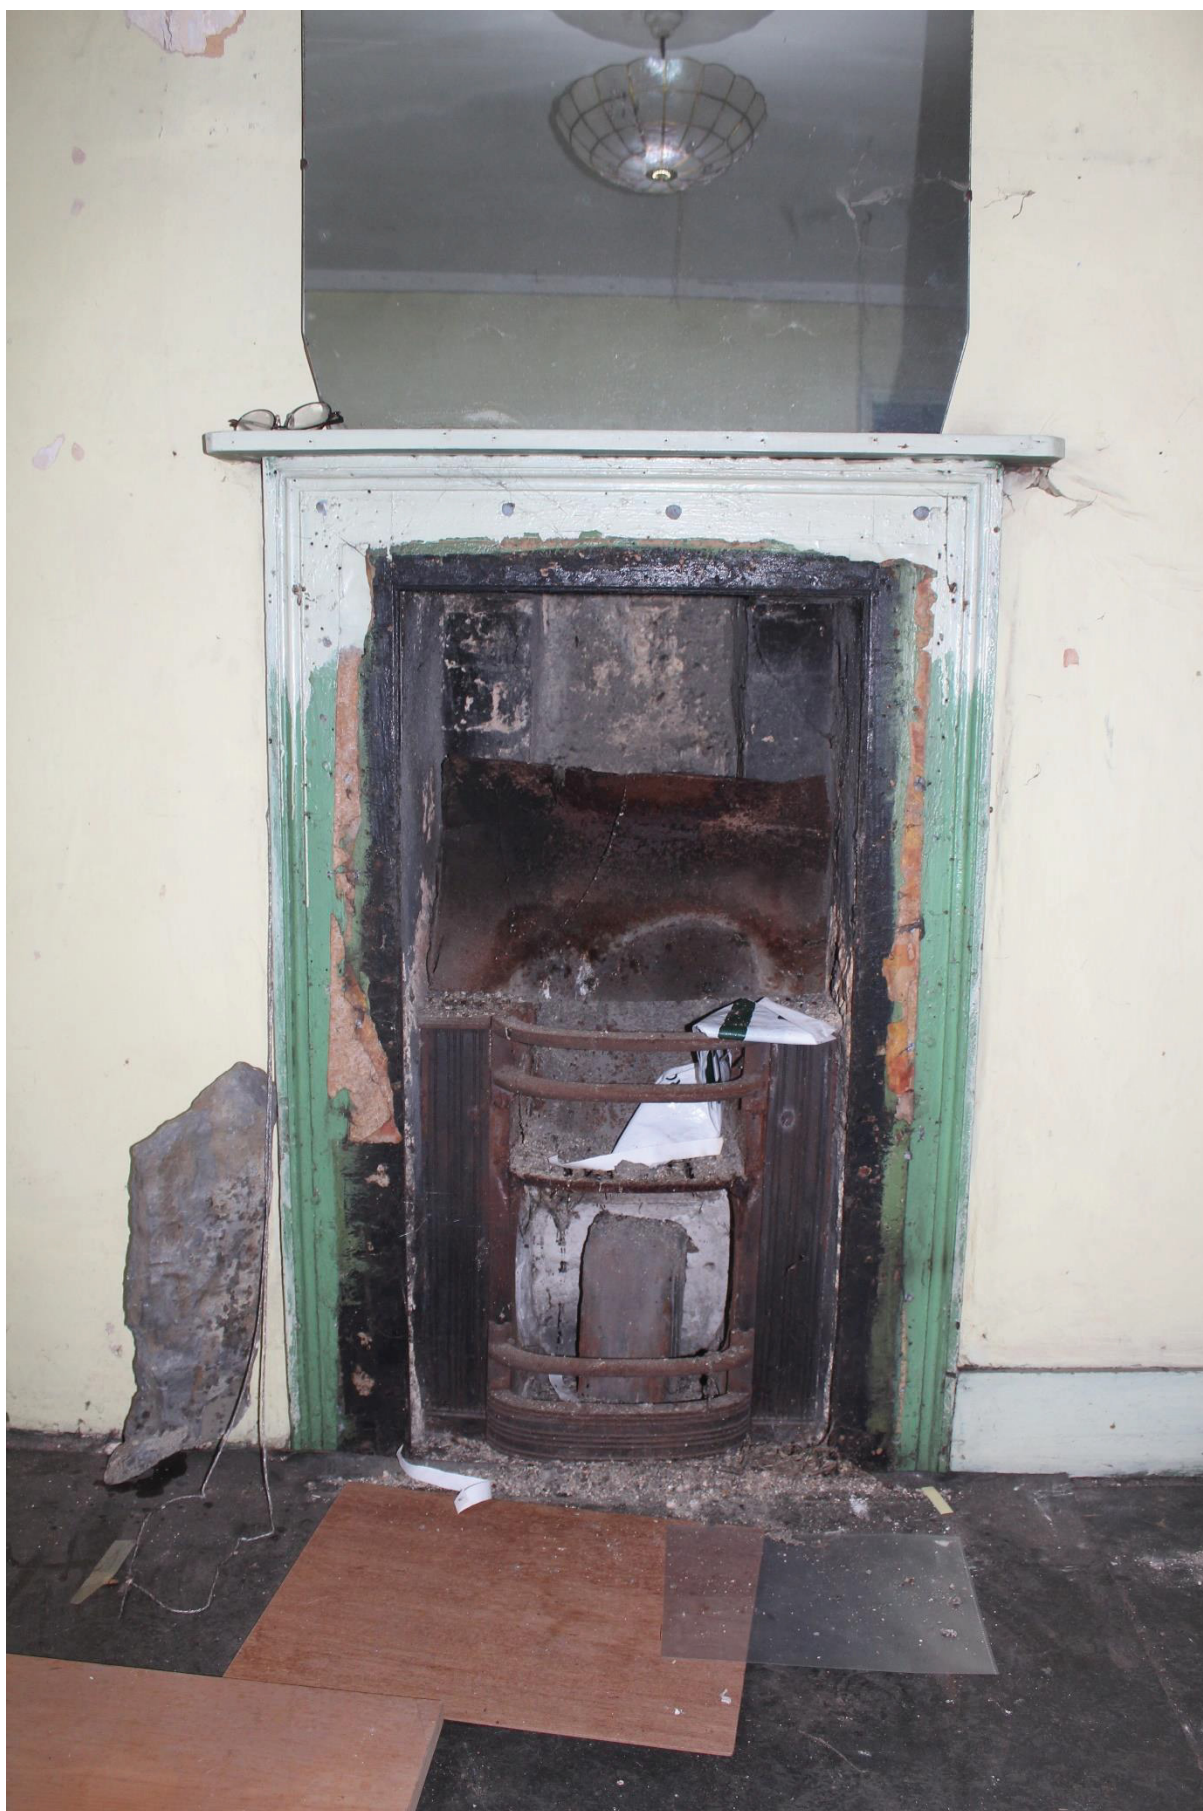
Plate 23 - Detail of fireplace in east first floor room.

6.12 In the bedroom, the fireplace surround is moulded wood, and the fireplace itself is a simple cast iron grate of late C18 or early C19 style. To the right of the fireplace is a small cupboard built into the wall, which also probably dates from the later C19. The wooden casement window is a modern replacement. The remainder of the walls of the bedroom appear to be plastered, and are covered with paper. At their base

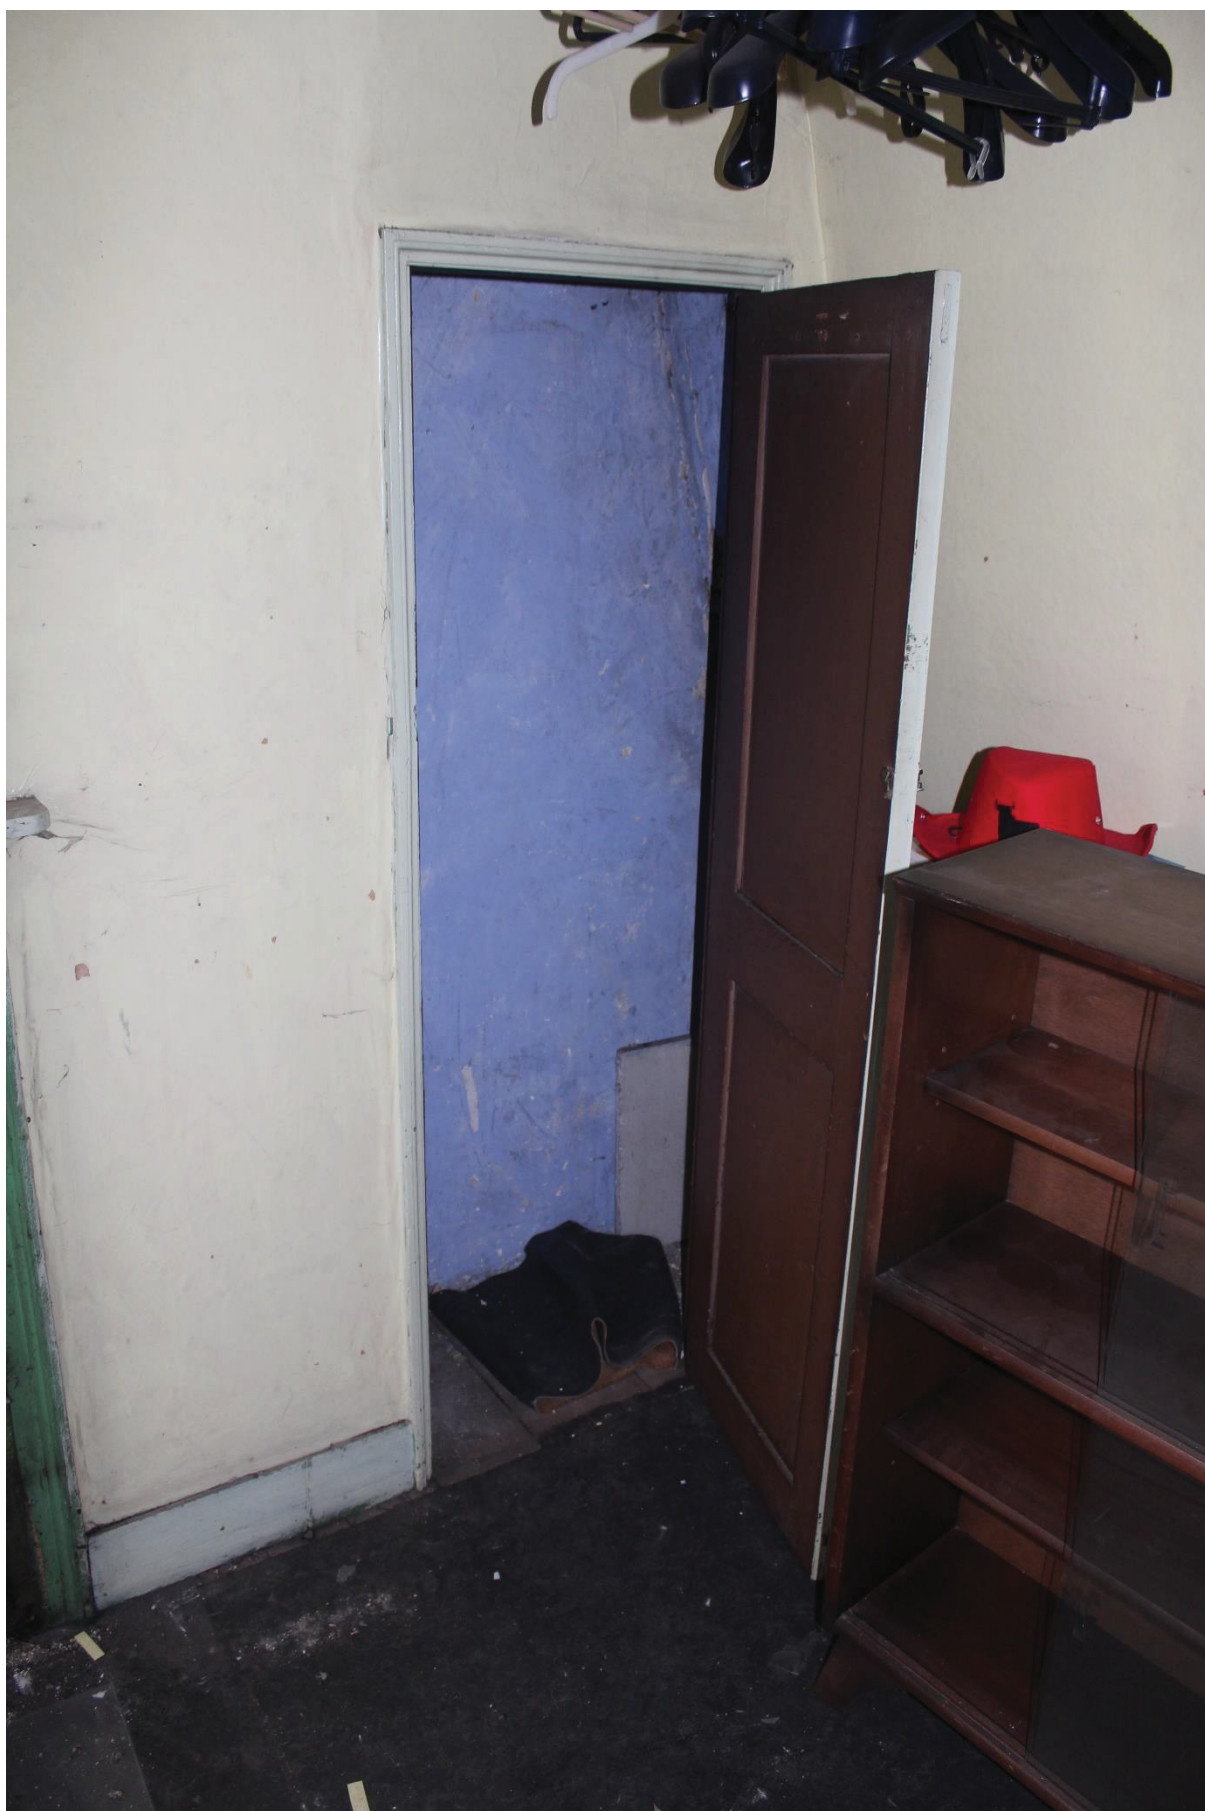
Plate 26 - Cupboard in southeast corner of east first floor room.

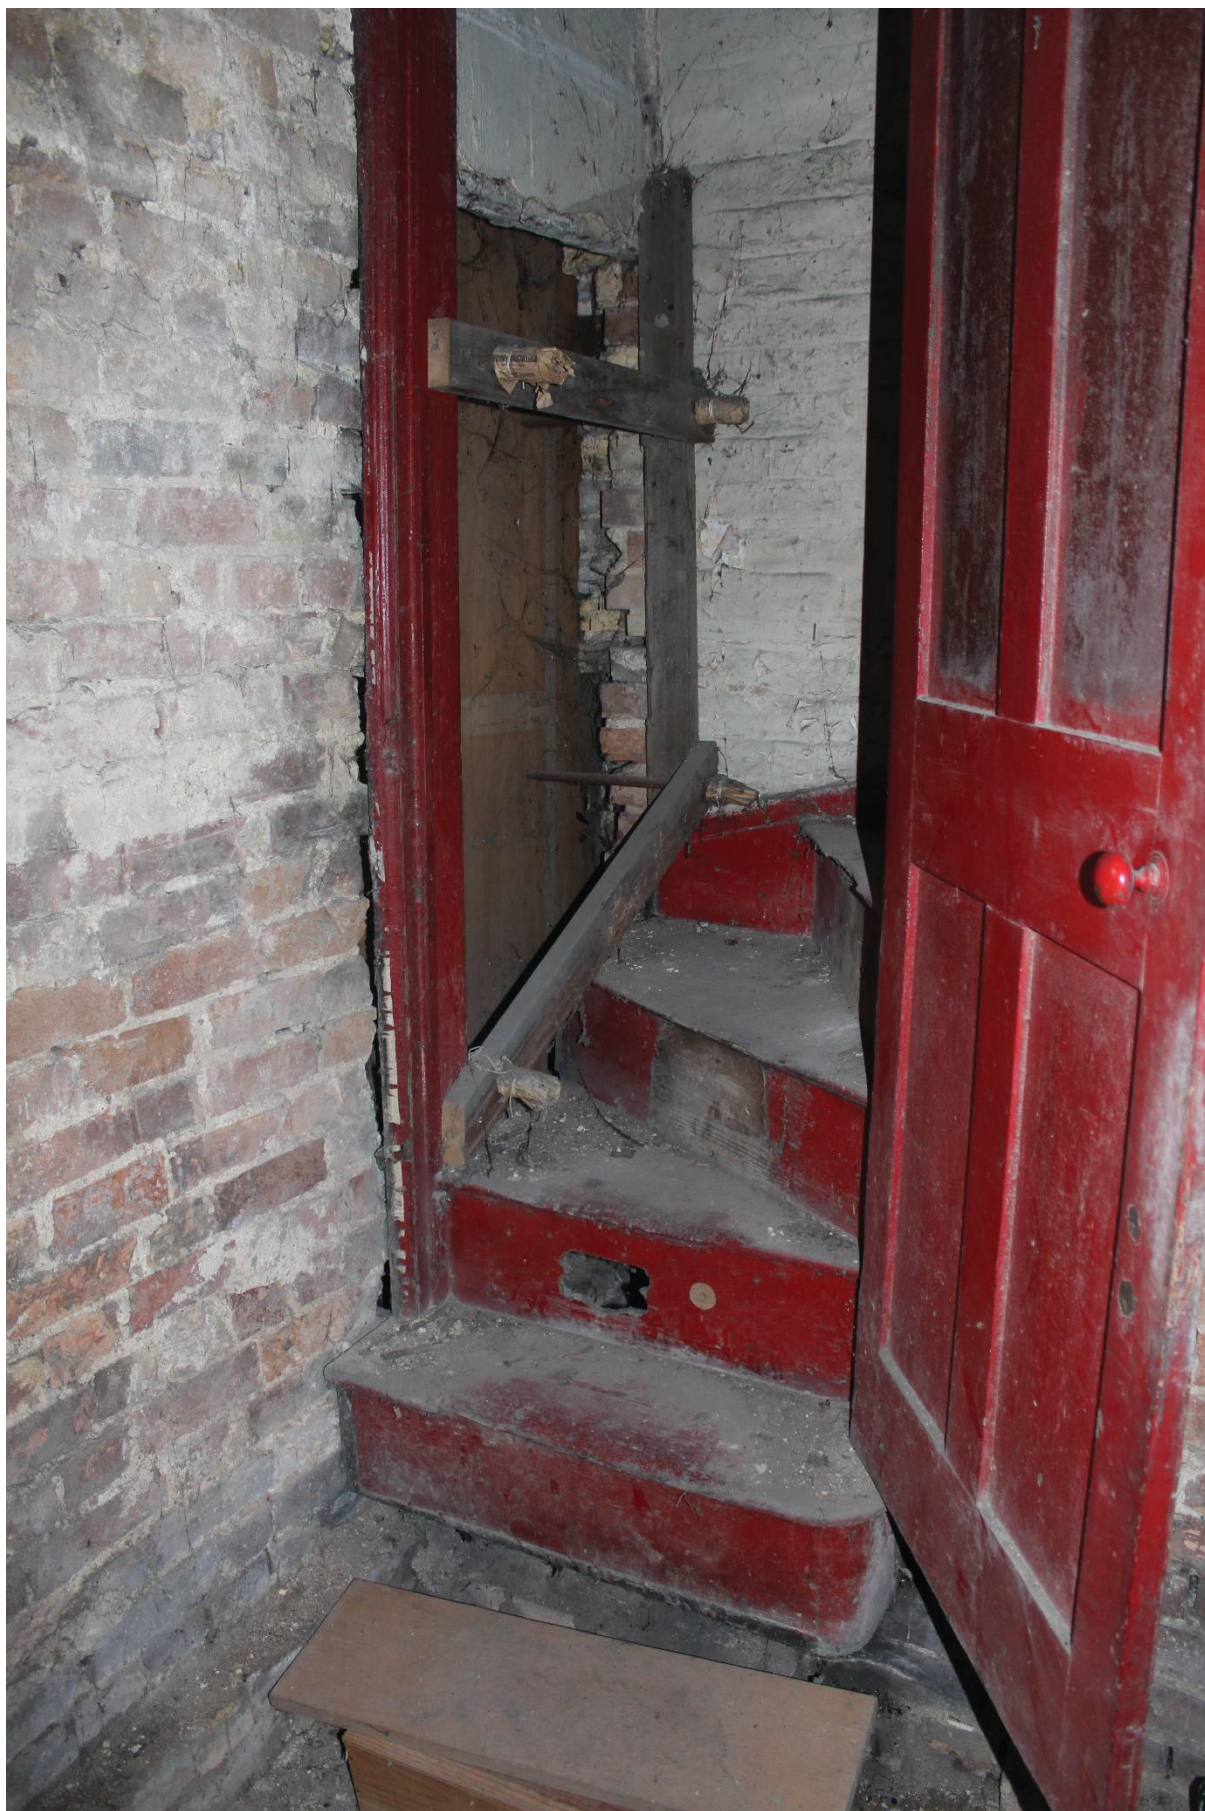
Plate 29 - Doorway and stairs to first floor on west side. Note poorly blocked doorway.

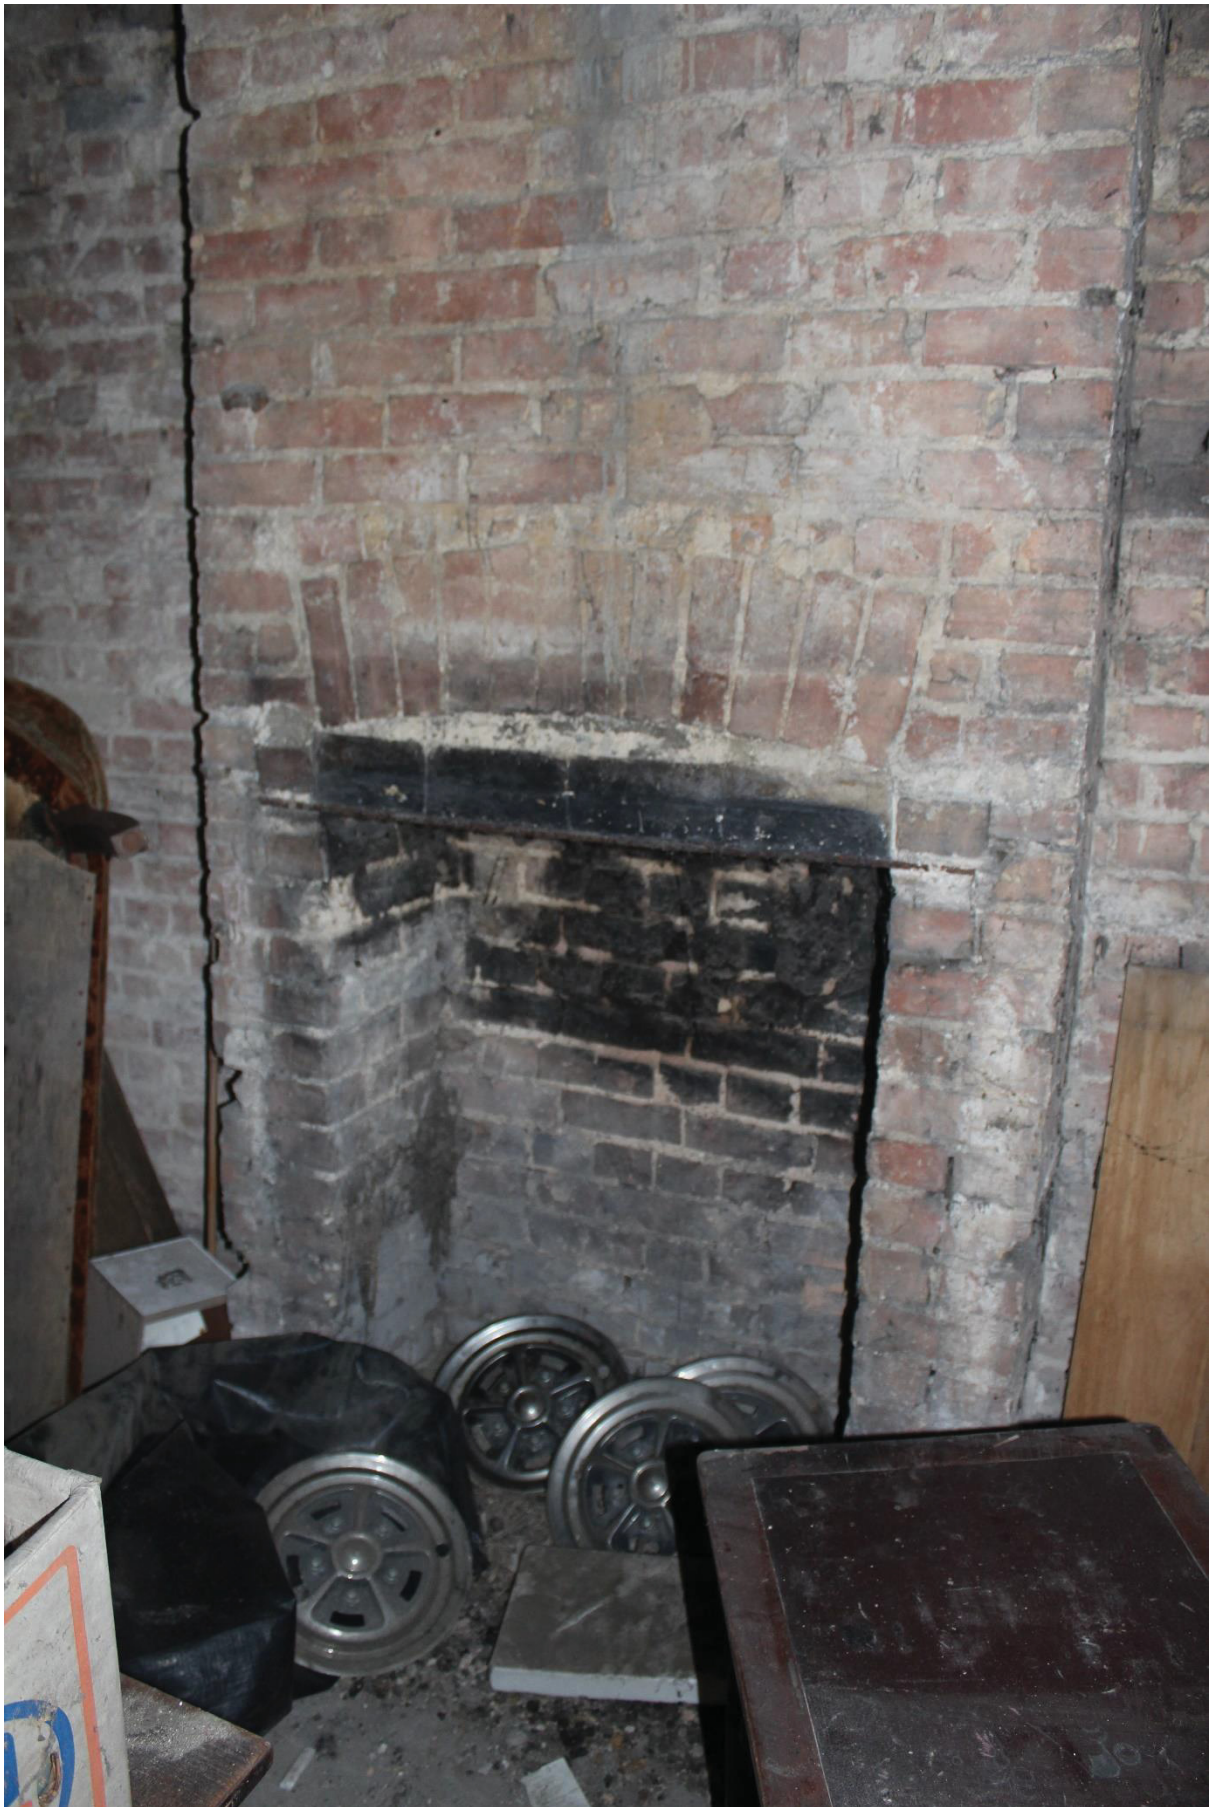
Plate 30 - Detail of fireplace in west ground floor room.

6.09 The western side of No. 9's ground floor is in poor condition. The ground floor has been excavated down from its original level, nearly all fixtures have been removed and the walls of the room stripped back to bare brick. Surviving fixtures on the ground floor are the door from the hall and the sash window to the front. The door and stair to the first floor, dating from the partition of the cottage, remain, as do the stairs, although these are not attached securely. The door is a typical four panel C19 door, and is of a style common from the early-mid C19. There is a C18 type of spring latch on the door, which suggests the whole assemblage, or possibly just the latch, was reused from elsewhere rather than bought new when the partition was being constructed.

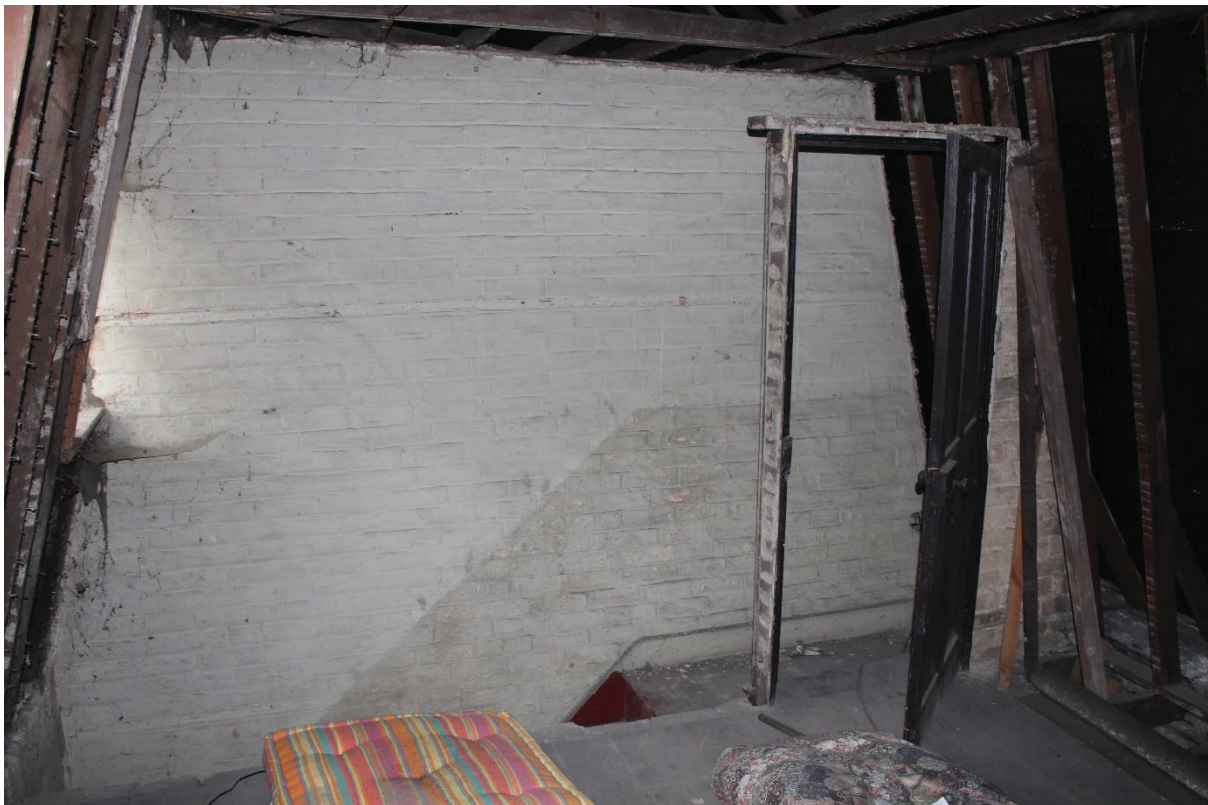
Plate 33 - Looking east in west first floor room. Note lack of wall, and independent door frame.

6.13 On the western side of the house the partition wall between the stairway and the bedroom has been removed leaving just the door and frame. The bedroom walls have been stripped back to the rafters and roofing felt, and the fireplace has been stripped back to bare brick, which is laid irregularly with stretchers and headers, leaving no fixtures remaining. The rafters show the remains of a lath and plaster wall material which would have covered it, parts of which remain adjacent to the partition wall above the original rear opening. This wall material likely remains in the eastern bedroom.

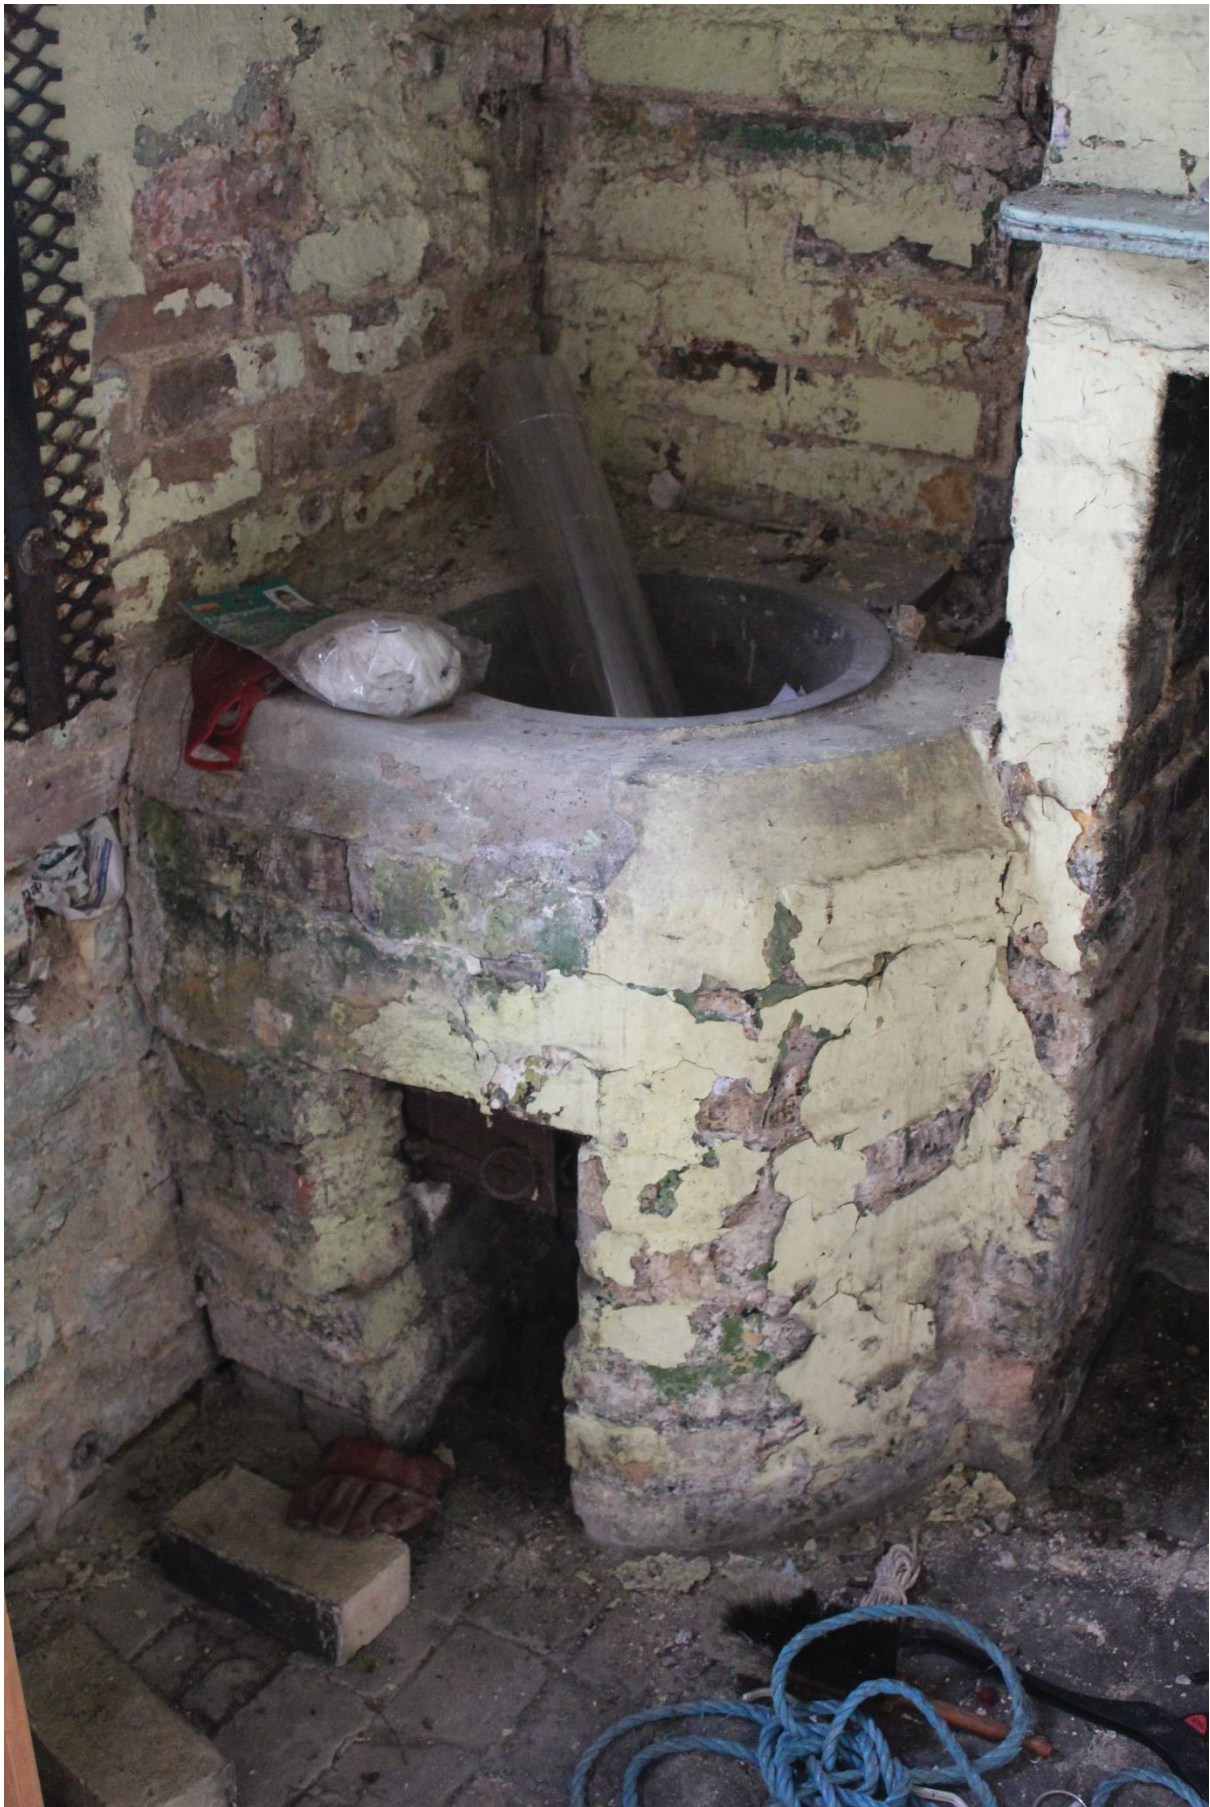
Plate 40 - Detail of water boiler in rear lean-to.

6.10 Access to the surviving section of the rear lean-to extension is gained from the eastern room. This extension, constructed of brick with contains a fireplace and coal fired water heater 'sink', probably used for washing clothes and providing the house with heated water. The flue from this coal fired water heater, and the adjacent fireplace, runs diagonally into the main part of the cottage through the roof space and into the main chimney stack above the ceiling level in the first floor. The brickwork associated with this flue can be seen in the roofspace at each end of No.9, and is obviously a later insertion associated with external fireplaces/heaters of this type. These features almost certainly date from the partition of the cottage. Anecdotal evidence suggests that while the cottages were in Humfrey's ownership there were communal washing facilities which would have rendered this additional water heating capacity unnecessary (Payne 1987, 32). It therefore makes sense that, after being transferred to private ownership, this additional capability was installed.

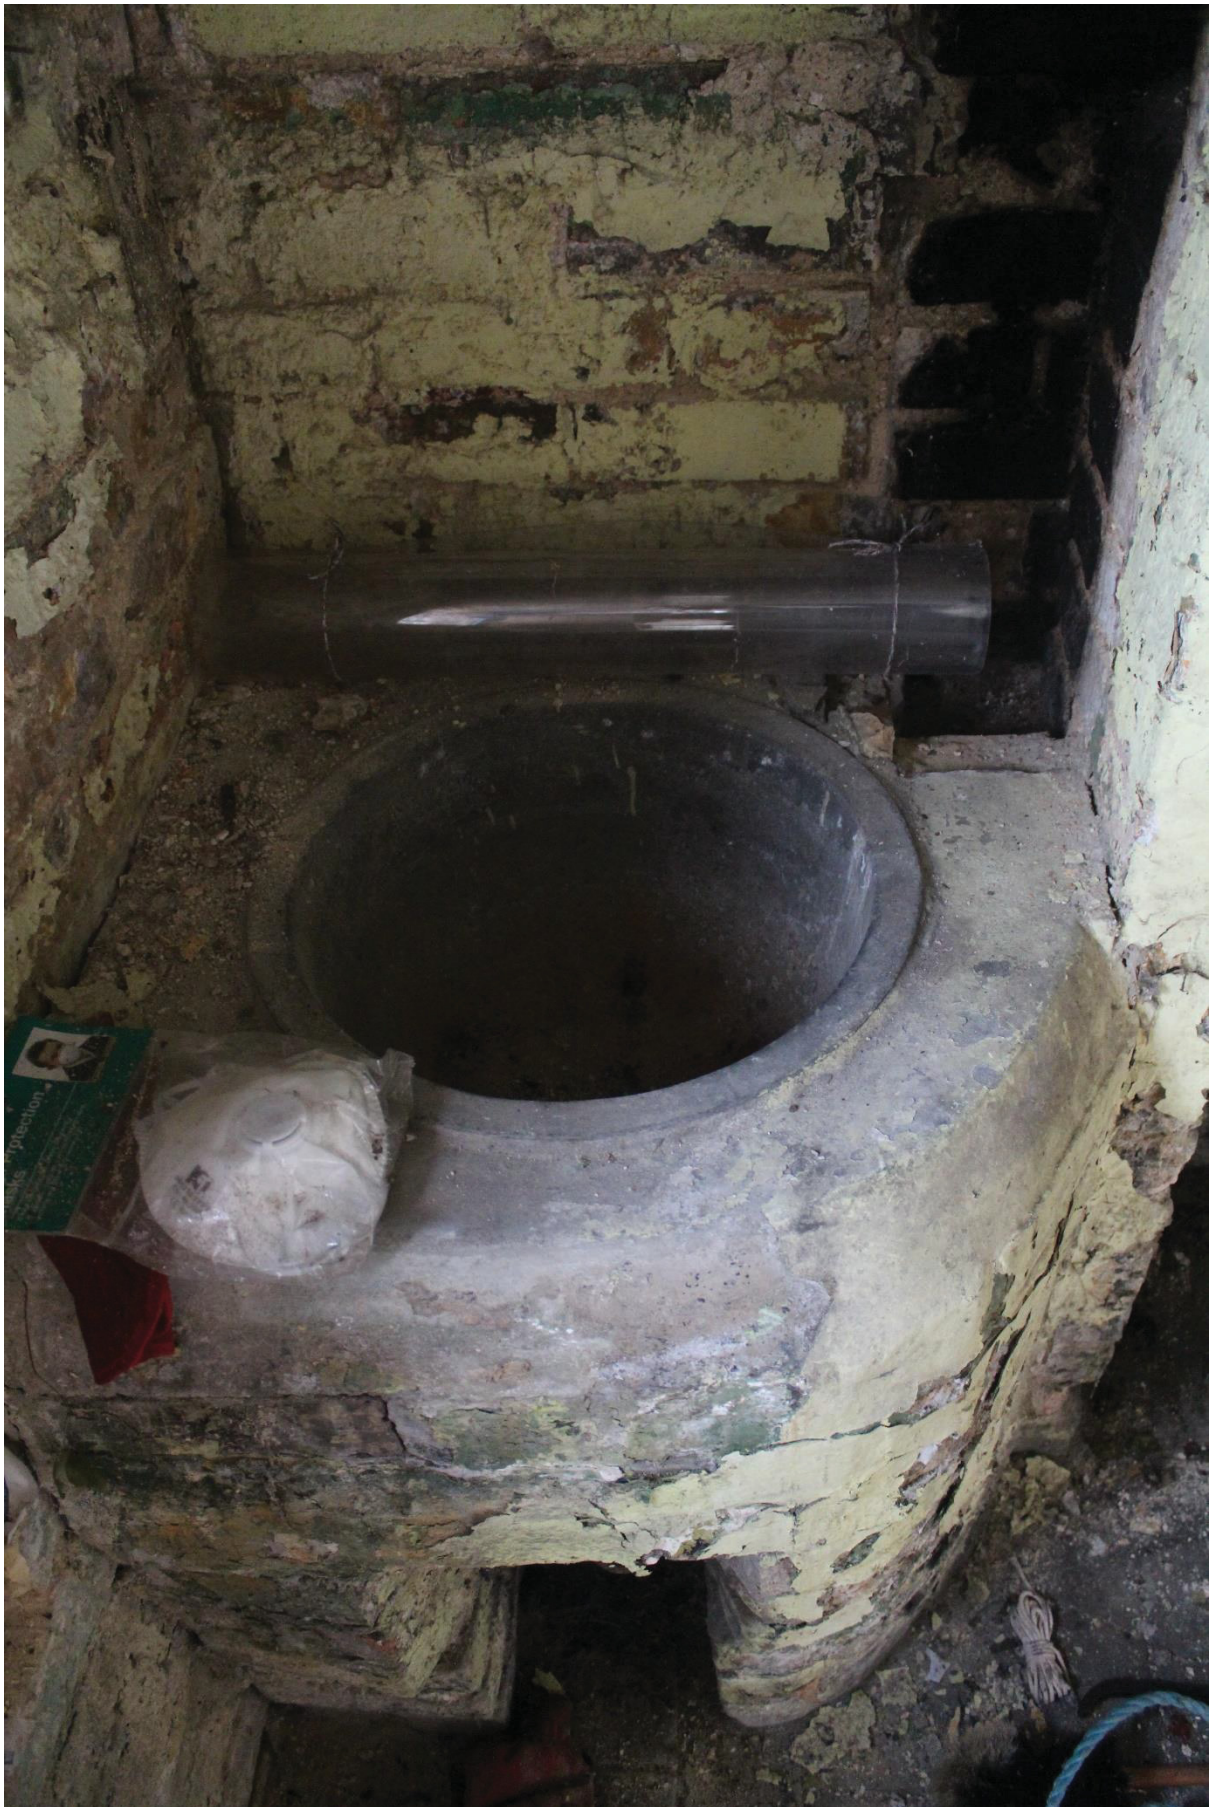
Plate 41 - Detail of hot water boiler in rear lean-to.

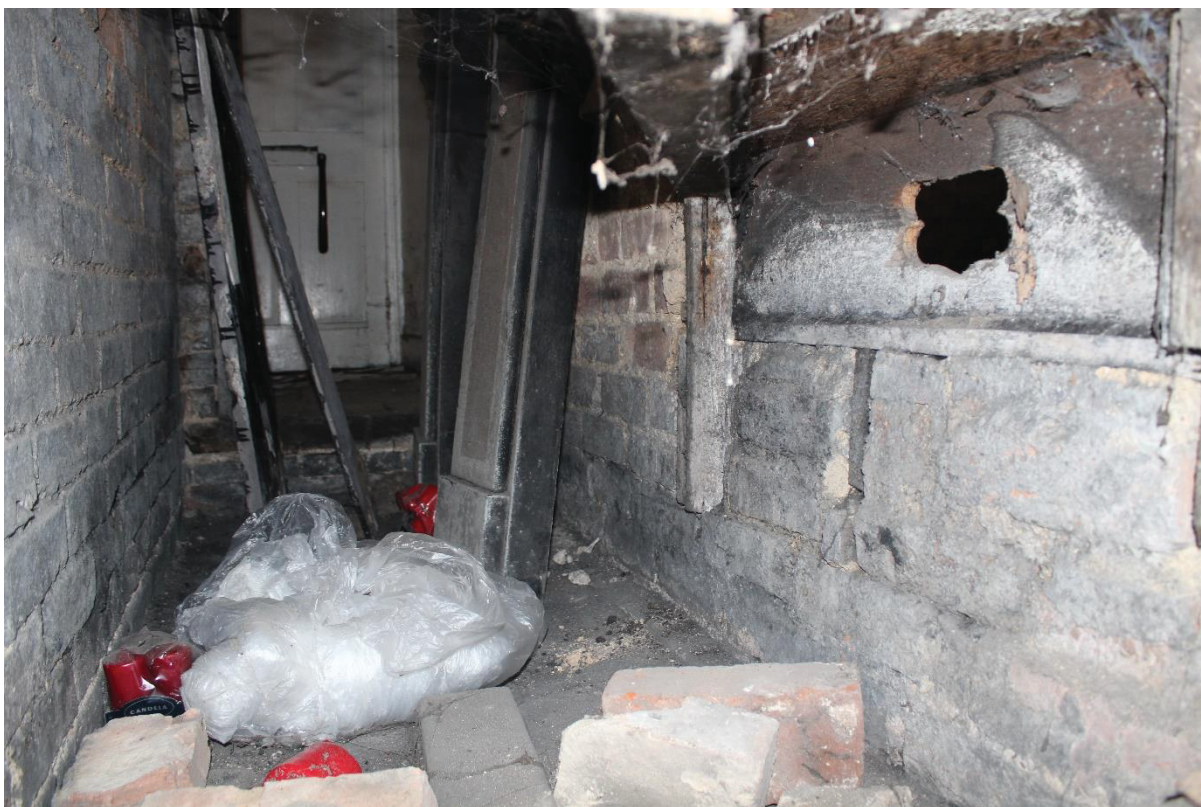
Plate 44 – Looking south under stairwell on west side of house, from rear blocked doorway (temporarily unblocked).
