**92.35 FRIERNHAY 1981  
(Roman military)**

EXCAVATIONS AT FRIERNHAY STREET, EXETER, 1981  
PART 1: ROMAN MILITARY

J.B. Bedford and J.P. Salvatore

Report No. 92.35

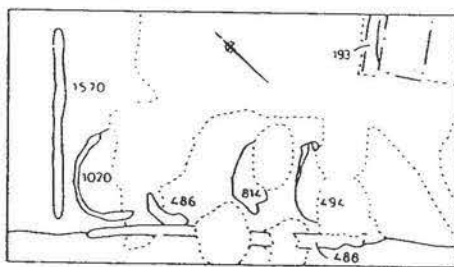
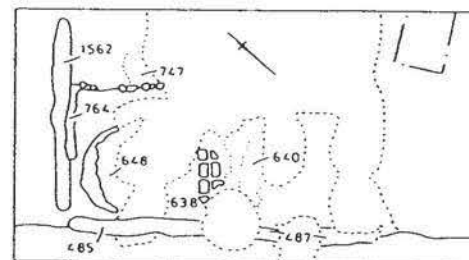
FH81 904/1

Fig. 8 Simplified plan of the oven development in Building 4 shown by reference to context. Scale 1: 200

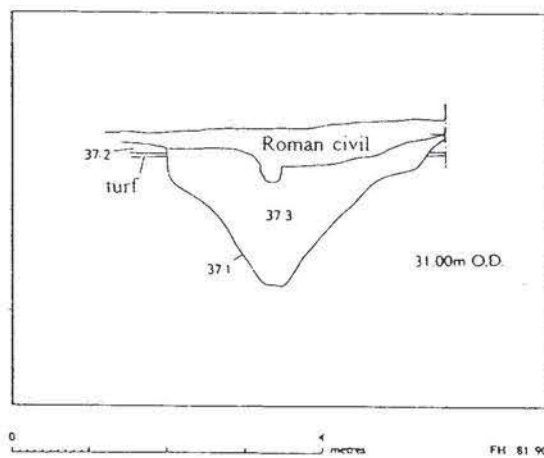
Group 37 (Simplified section)

Fig. 13 Section through the ?annexe ditch. Shown by reference to sub-group. Scale 1:100.

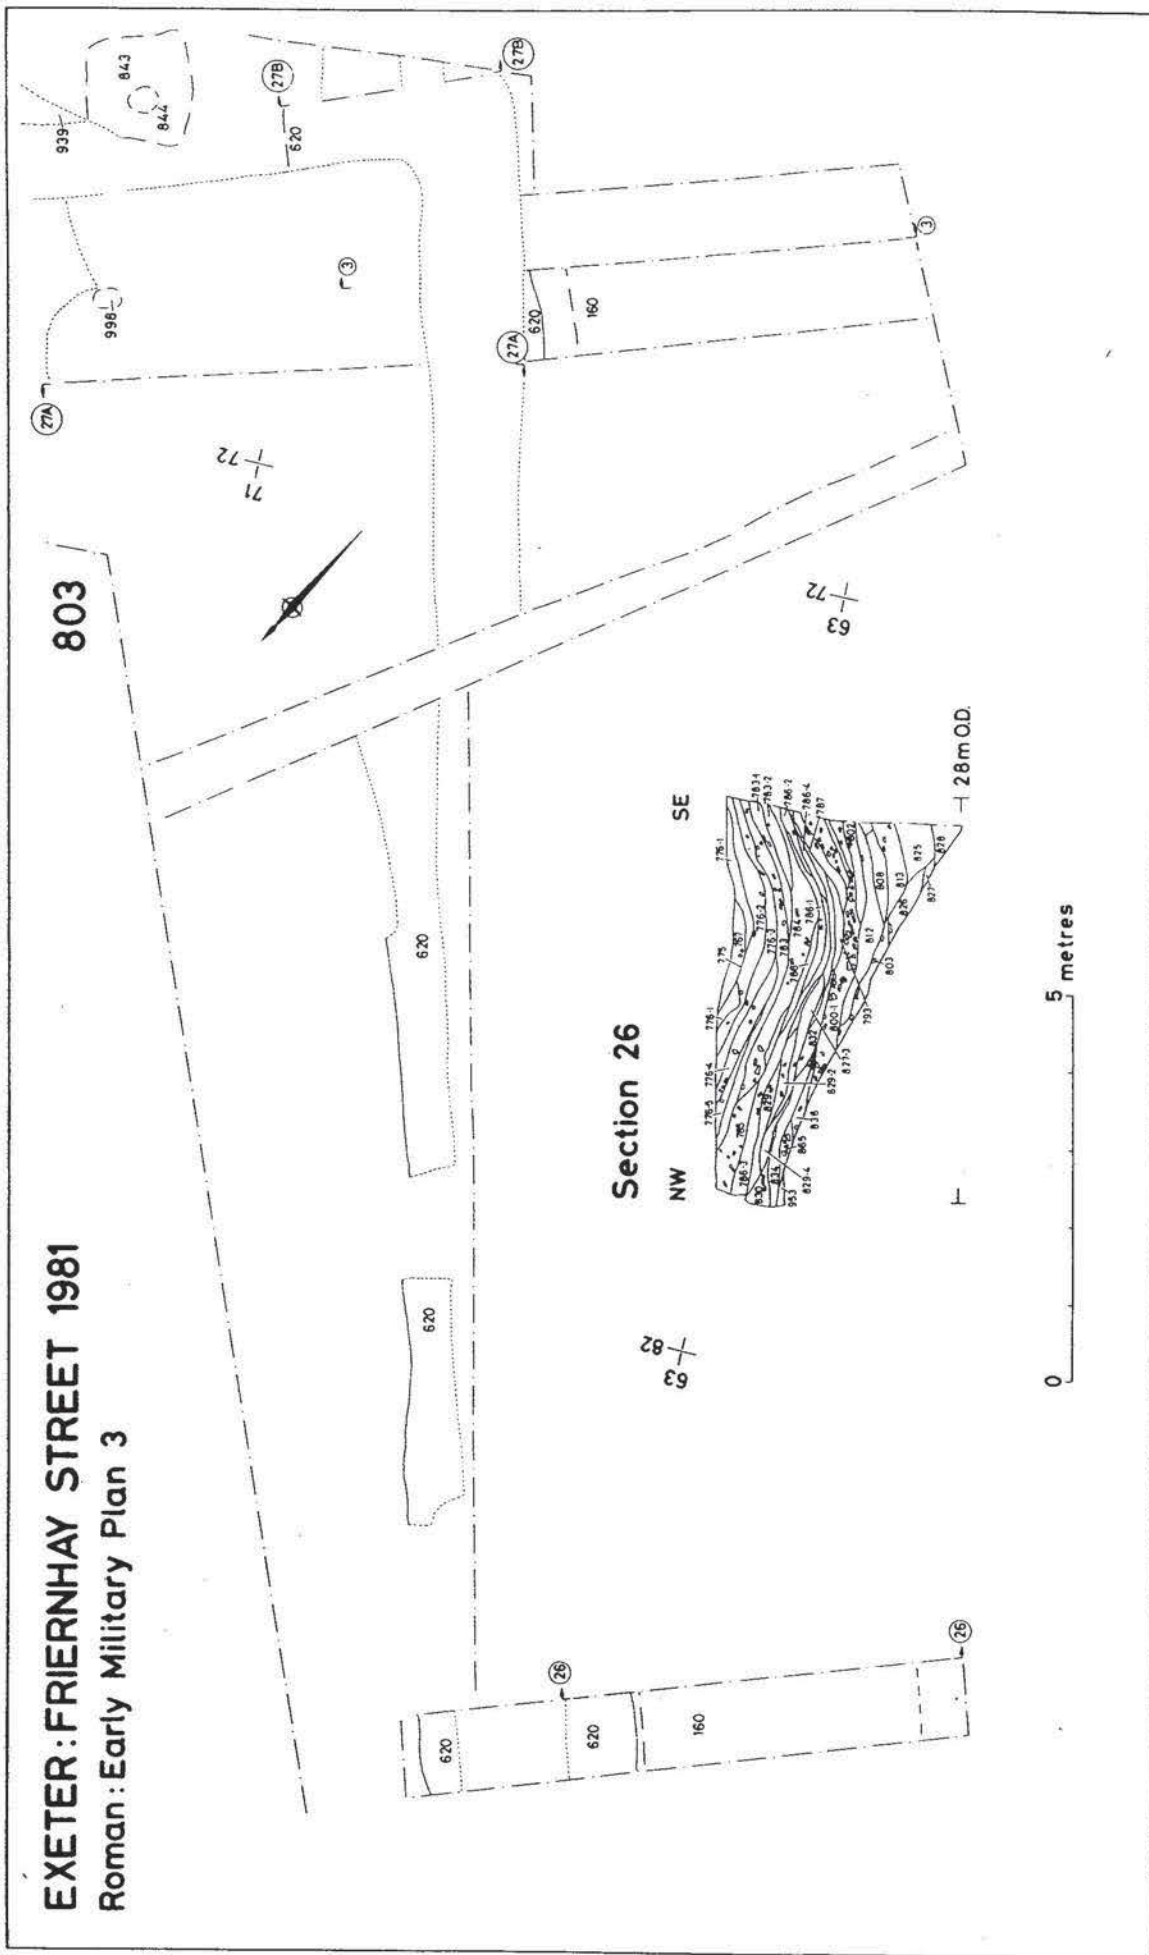
801

Fig. 16 Plan of the early military remains plus section 26 (803) Scale 1:100.

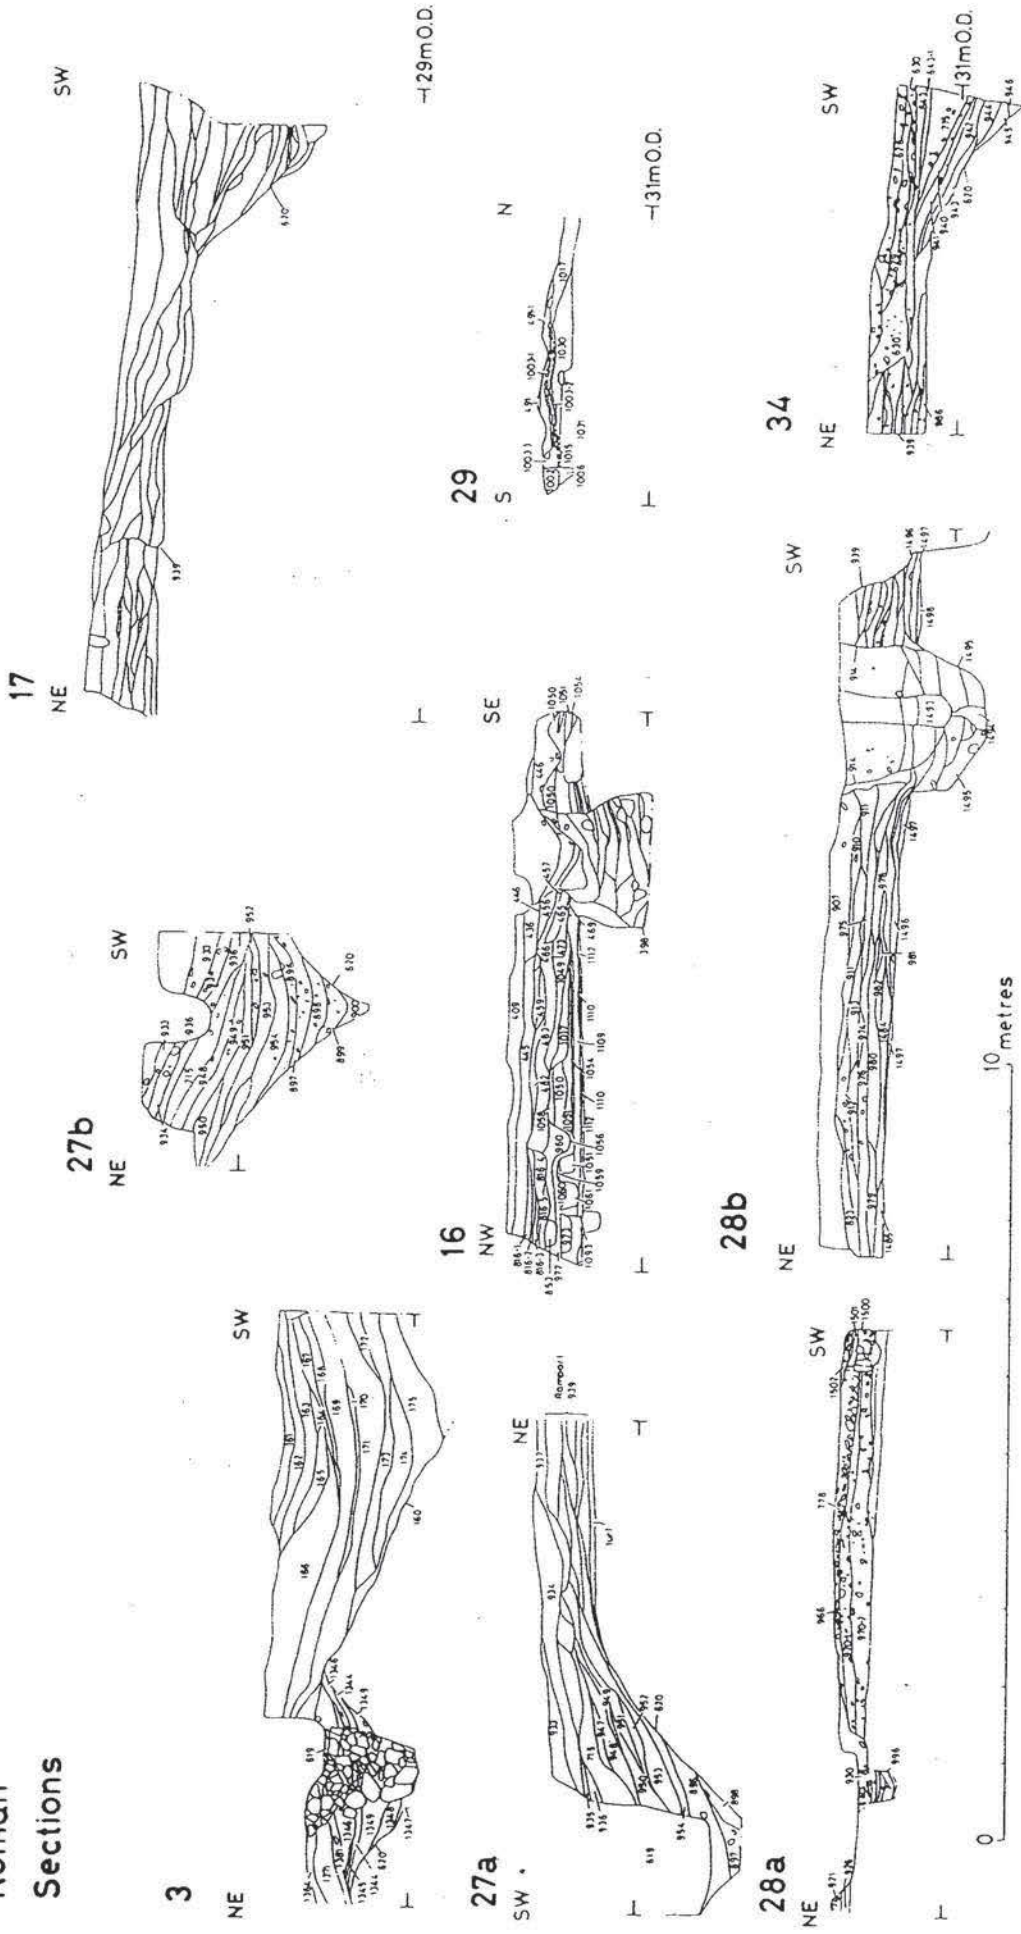
809

Fig. 22 Sections through the Roman military and civil deposits (809) Scale 1:100.

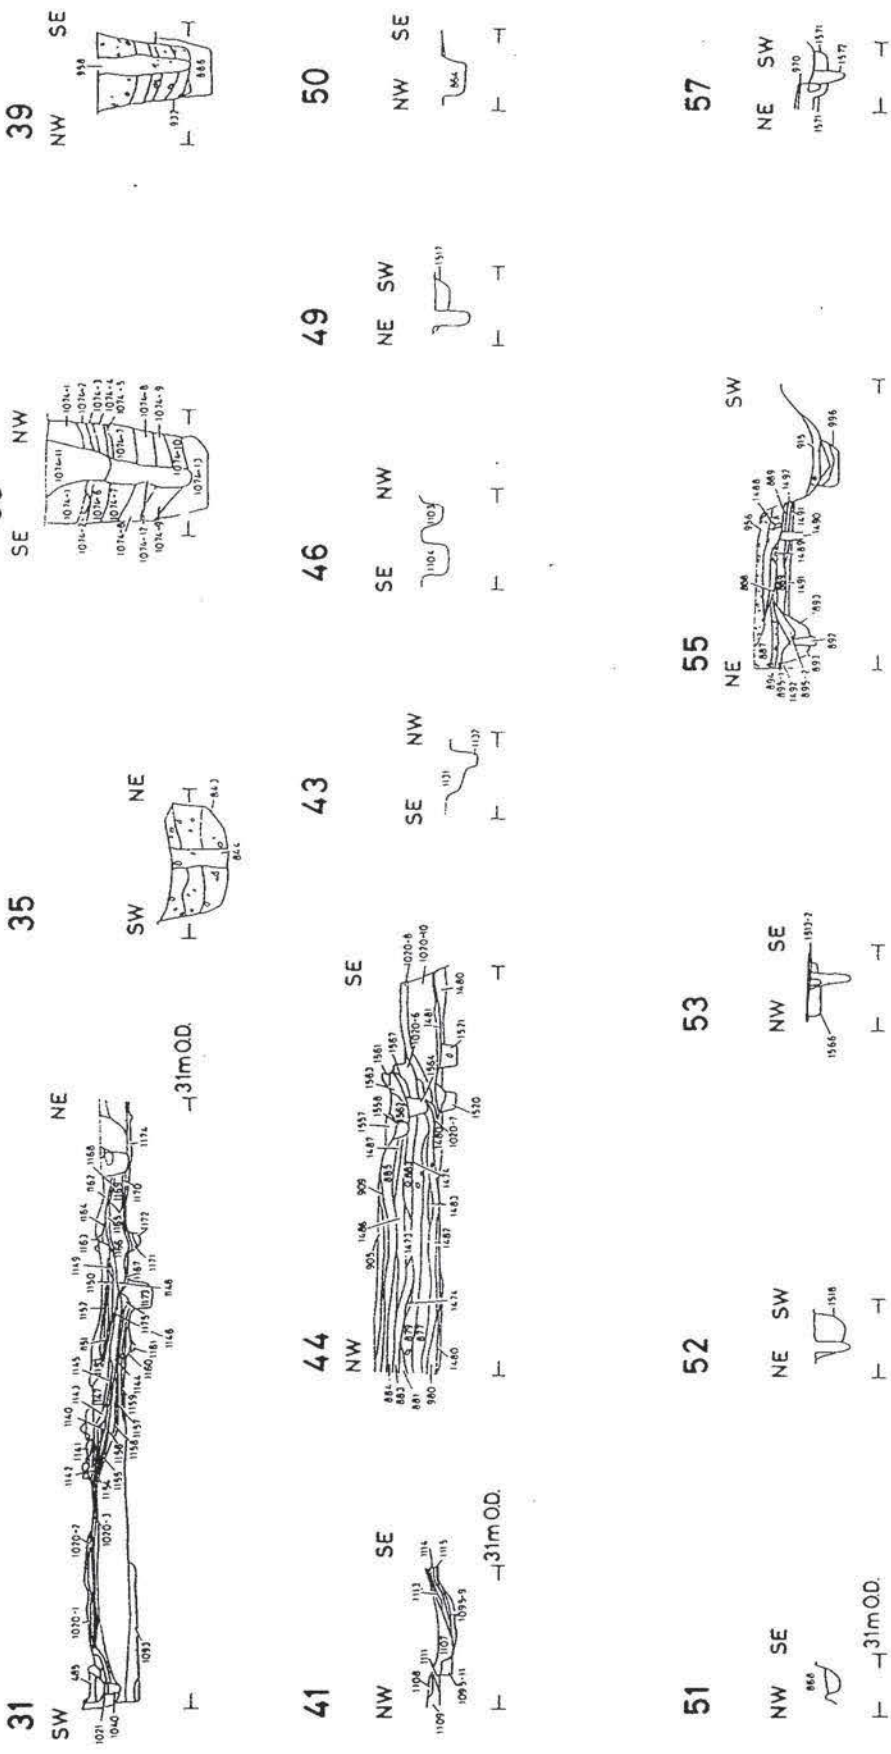
810

Fig. 23 Sections through the Roman military and civil deposits (810) Scale 1:100.

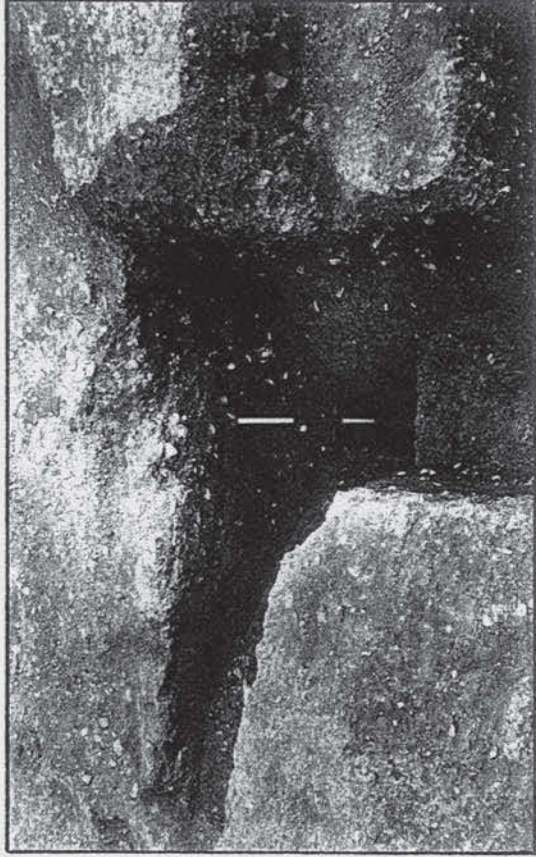
Plate 1 Section through the first fortress ditch, looking south-east. 2m scale.

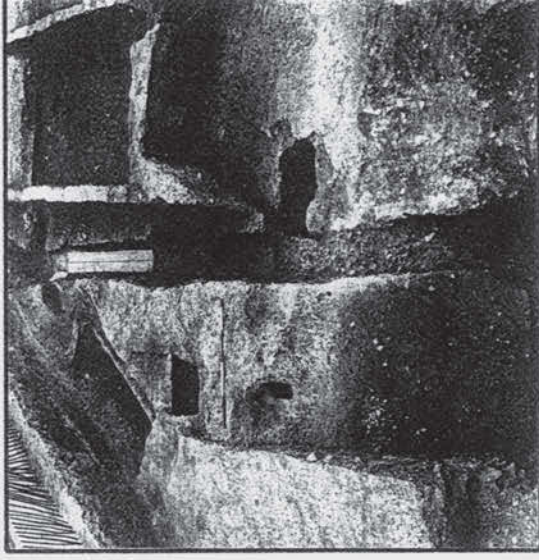
Plate 2 The four post-pits of the interval tower, looking north-east. 2m scale.

Evidence for the presence of two interval towers built within the body of the rampart was found. This sub-group represents the remains of one of them. Prior to the construction of the rampart itself post-pits were dug (1495, 843, 886) to take the upright timber posts. (The post-pit of 1495 and its associated post-pipe is shown in Fig. 10). The fourth post-pit of this tower was not excavated, but the post-pipe (998) was visible in the unexcavated baulk of the rampart.  
Contains contexts: 844, 843, 886, 998, 1494, 1495.

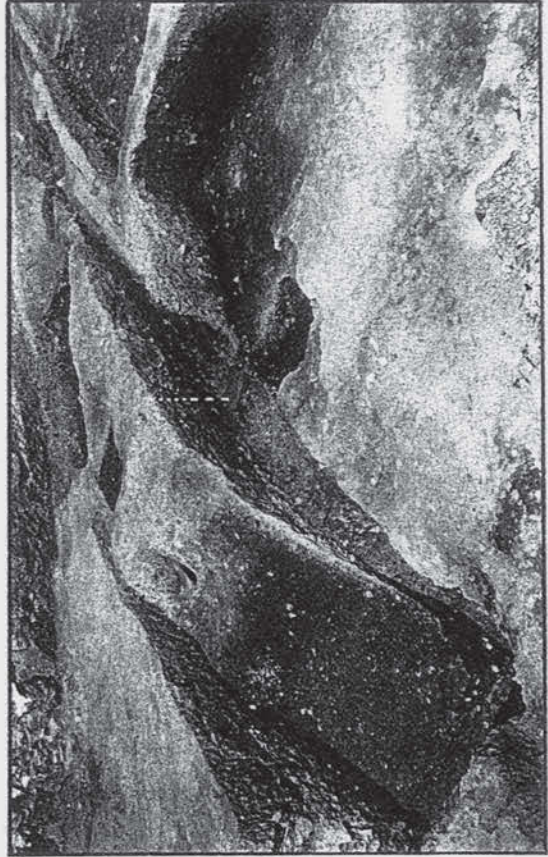
Plate 3 The interval tower with the rampart partially excavated, looking north. 1m scale.

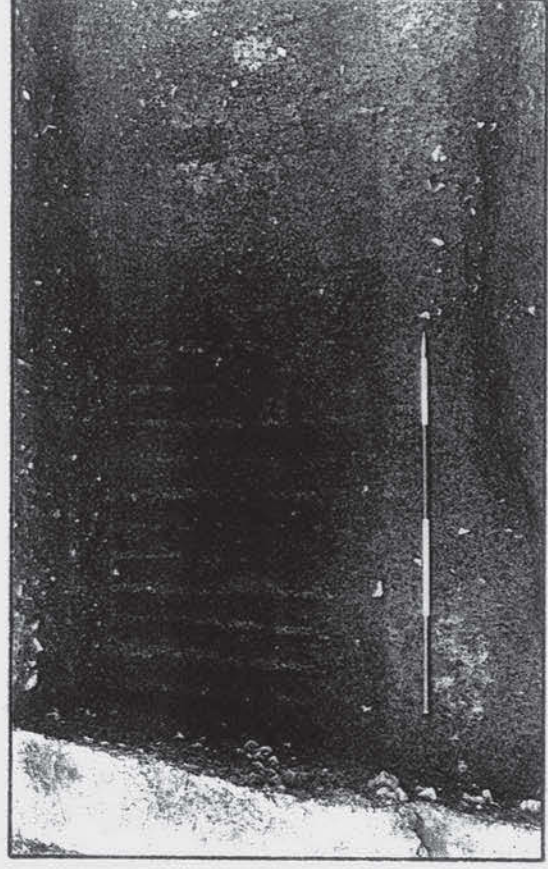
Plate 4 Traces of the log corduroy at the base of the rampart, looking north-east. 2m scale.

This sub-group is for the construction of the rampart. The base of the rampart was composed of a corduroy of logs (987), the impressions of which were left in the form of staining on the pre-existing ground surface (986). This was succeeded by a large bank of clay and other material covering a depth of approximately 1m (939).  
Contains contexts: 939, 986, 987, 1099, 1125, 1480.

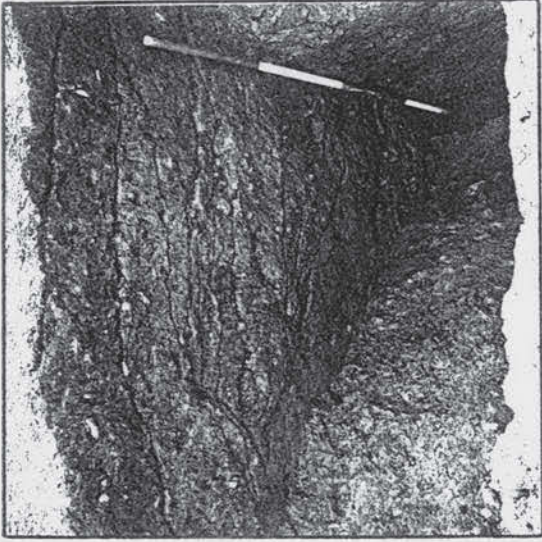
Plate 5 Section through the second fortress ditch, looking south. 2m scale.

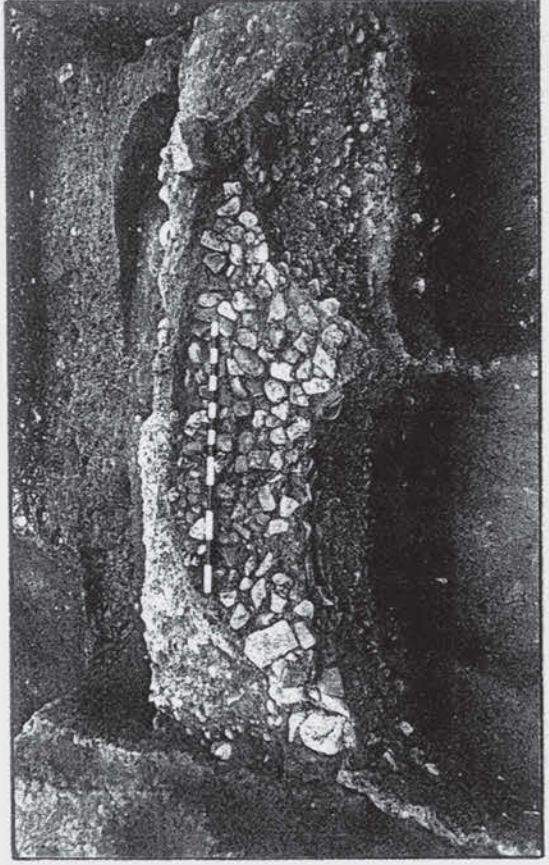
Plate 6 Cobble-base oven in the *intervallum*, looking north-west. 1m scale.

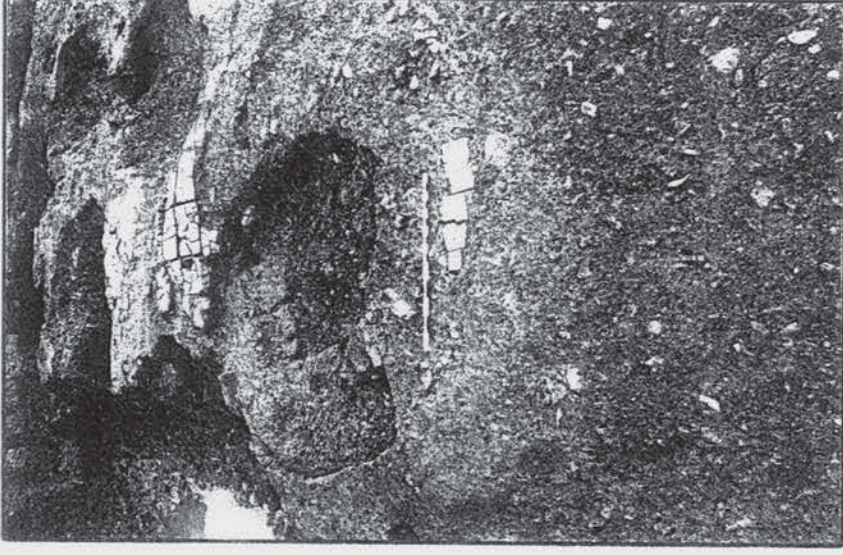
Plate 7 Tile-base oven in the *intervallum*, looking south-east. 1m scale.

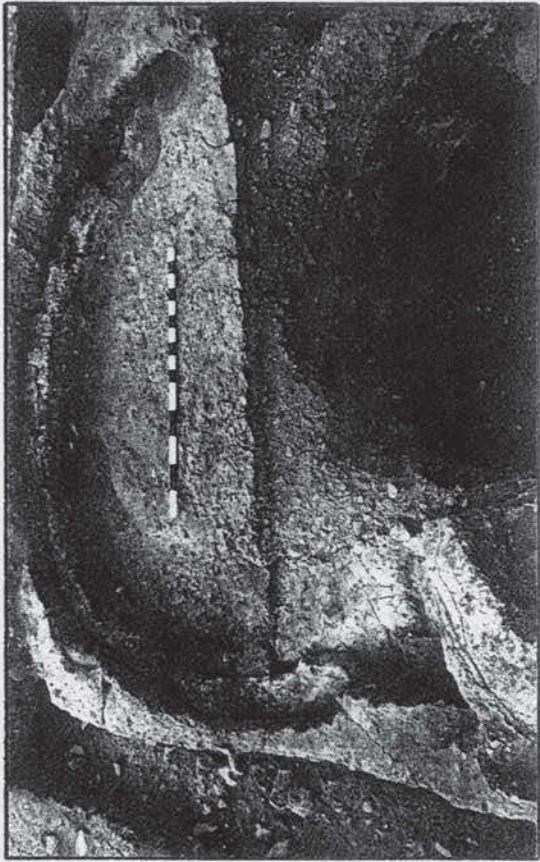
Plate 8 Clay base of an oven in the *intervallum*, looking north-west.  
1m scale.

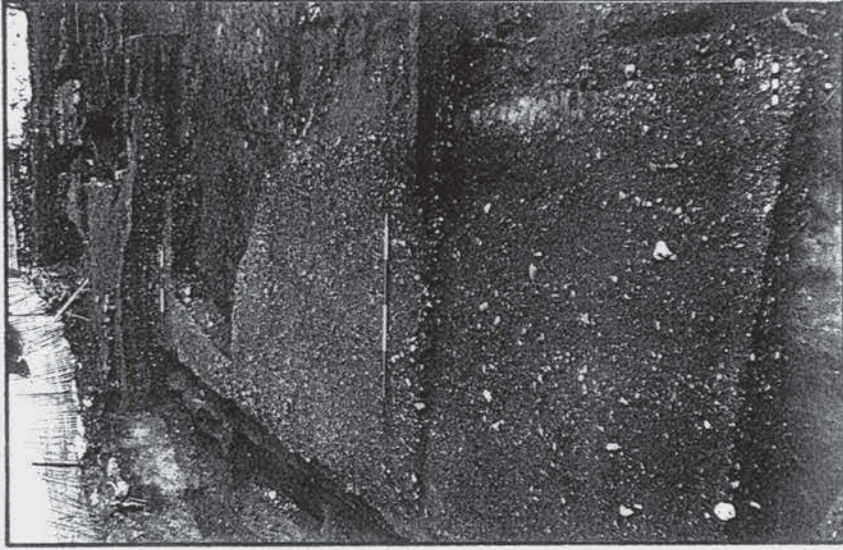
Plate 10 The *via sagularis*, looking south-east. 2m scale.

This represents a resurfacing of the *via sagularis*. The surface was metalled, consisting of small pebbles compacted onto volcanic stone chippings, with the larger pebbles at the edge not as compacted.

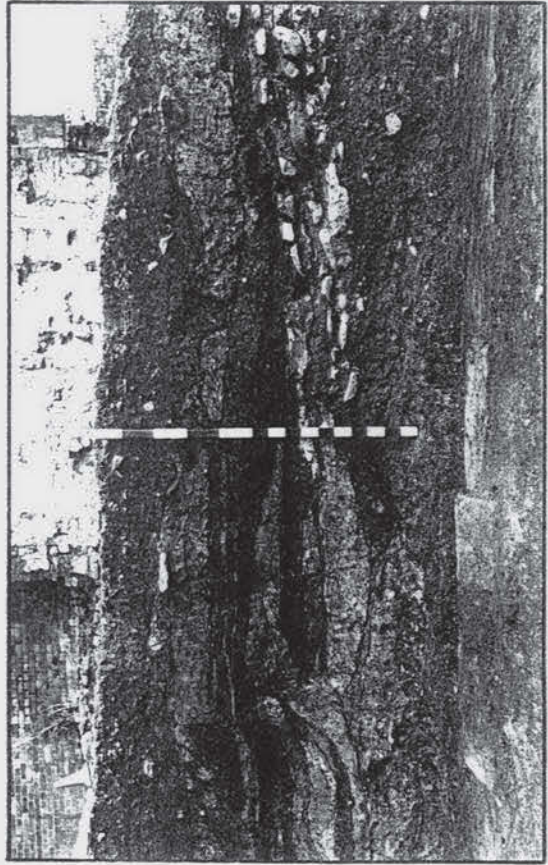
Plate 9 Complex stratigraphy behind the rampart, looking south-east.  
1m scale.
