**An Archaeological Watching Brief at
Speke Hall, Speke,
Merseyside.
NGR SJ 4187 8256
(Site Code 112)**

Produced for The National Trust.

September 2008

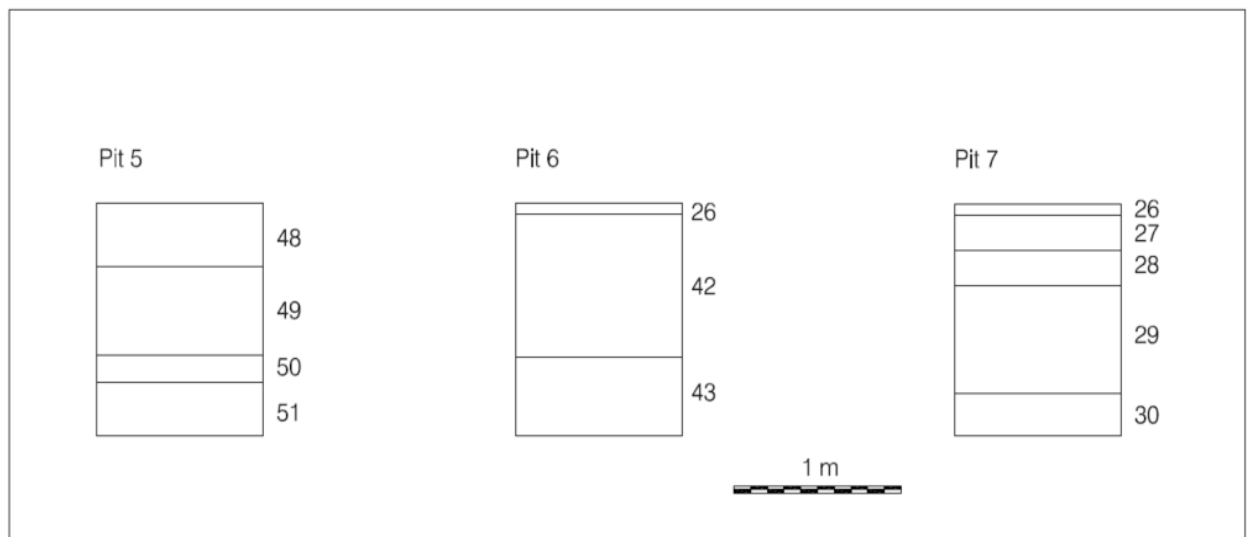
Fig. 9. Schematic profiles of generalised sections across pits 5, 6 and 7 showing the relative positions of contexts.

Pit 6 was located at the north-west corner of the path surrounding the moat. An upper turf layer 26, 0.06 m thick, lay directly over a deep, dark brown humic topsoil layer, context 42, 0.80 m thick with frequent roots from the nearby shrubs. This was followed by a firm, gingerish brown clay layer, context 43, 0.45 m in depth (Figs 8 and 9, Plate 11). No finds were recovered from this area.

The deposits in Pit 5 consisted of an upper layer of very dark brown, humic topsoil with frequent root action, context 48, 0.35m thick (Fig. 9, Plate 17). This overlay soft, light brown sandy subsoil, context 49, 0.50m, in depth over a thinner orange clay

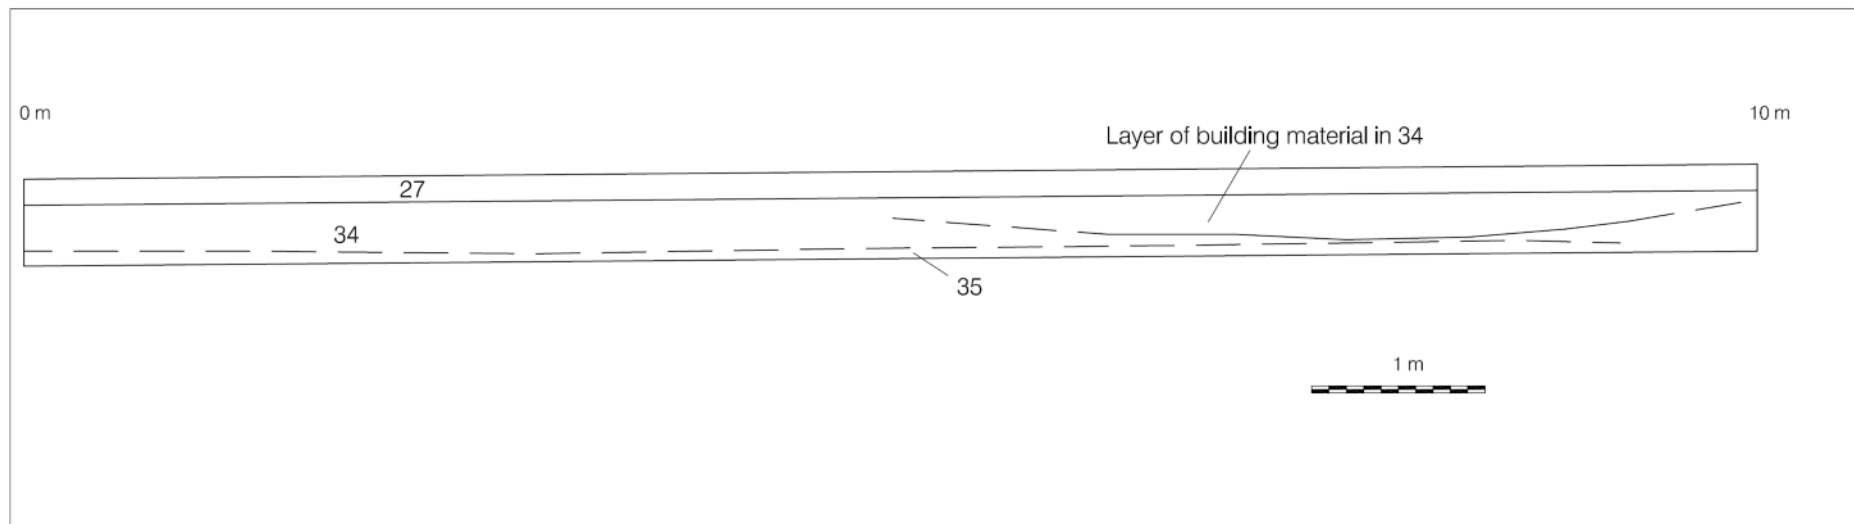
Fig. 10. East facing section, south end of cable trench west of moat.

At c. 5m from the southern end fragments of stone roof tile, one with a peg-hole (SF no.4), were found at around 0.30 m deep in subsoil 34. This increased to very frequent inclusions within the context 34 at the base of the trench (Fig. 10). The only associated material was one fragment of handmade brick and one fragment of Welsh roofing slate which suggests that this material was deposited in the 19th century or later. No other dating evidence was present. At this point the subsoil was observed overlaying very coarse gravels, context 35, at a depth of 0.50 m. The gravels had

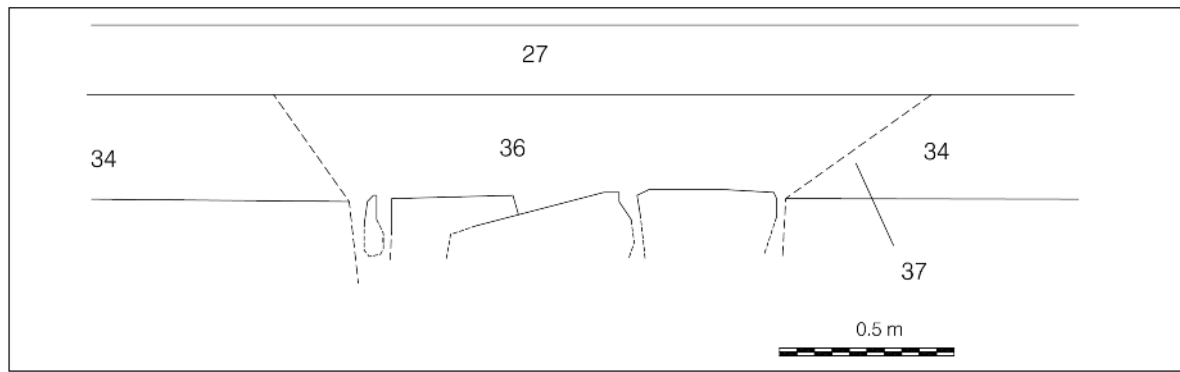
Fig. 11. East facing section of cable trench showing drain 36.

At c. 45 m from the north end of the trench there was a group of coarse, unmortared, red sandstone blocks (Plate 7) set within a very compact reddish brown clay (Fig. 8). The section (Fig. 11) showed slight evidence of a cut, context 37, filled by clay and gravel, c. 1m wide. The blocks were left *in situ* and were probably an 18th or 19th century land drain.

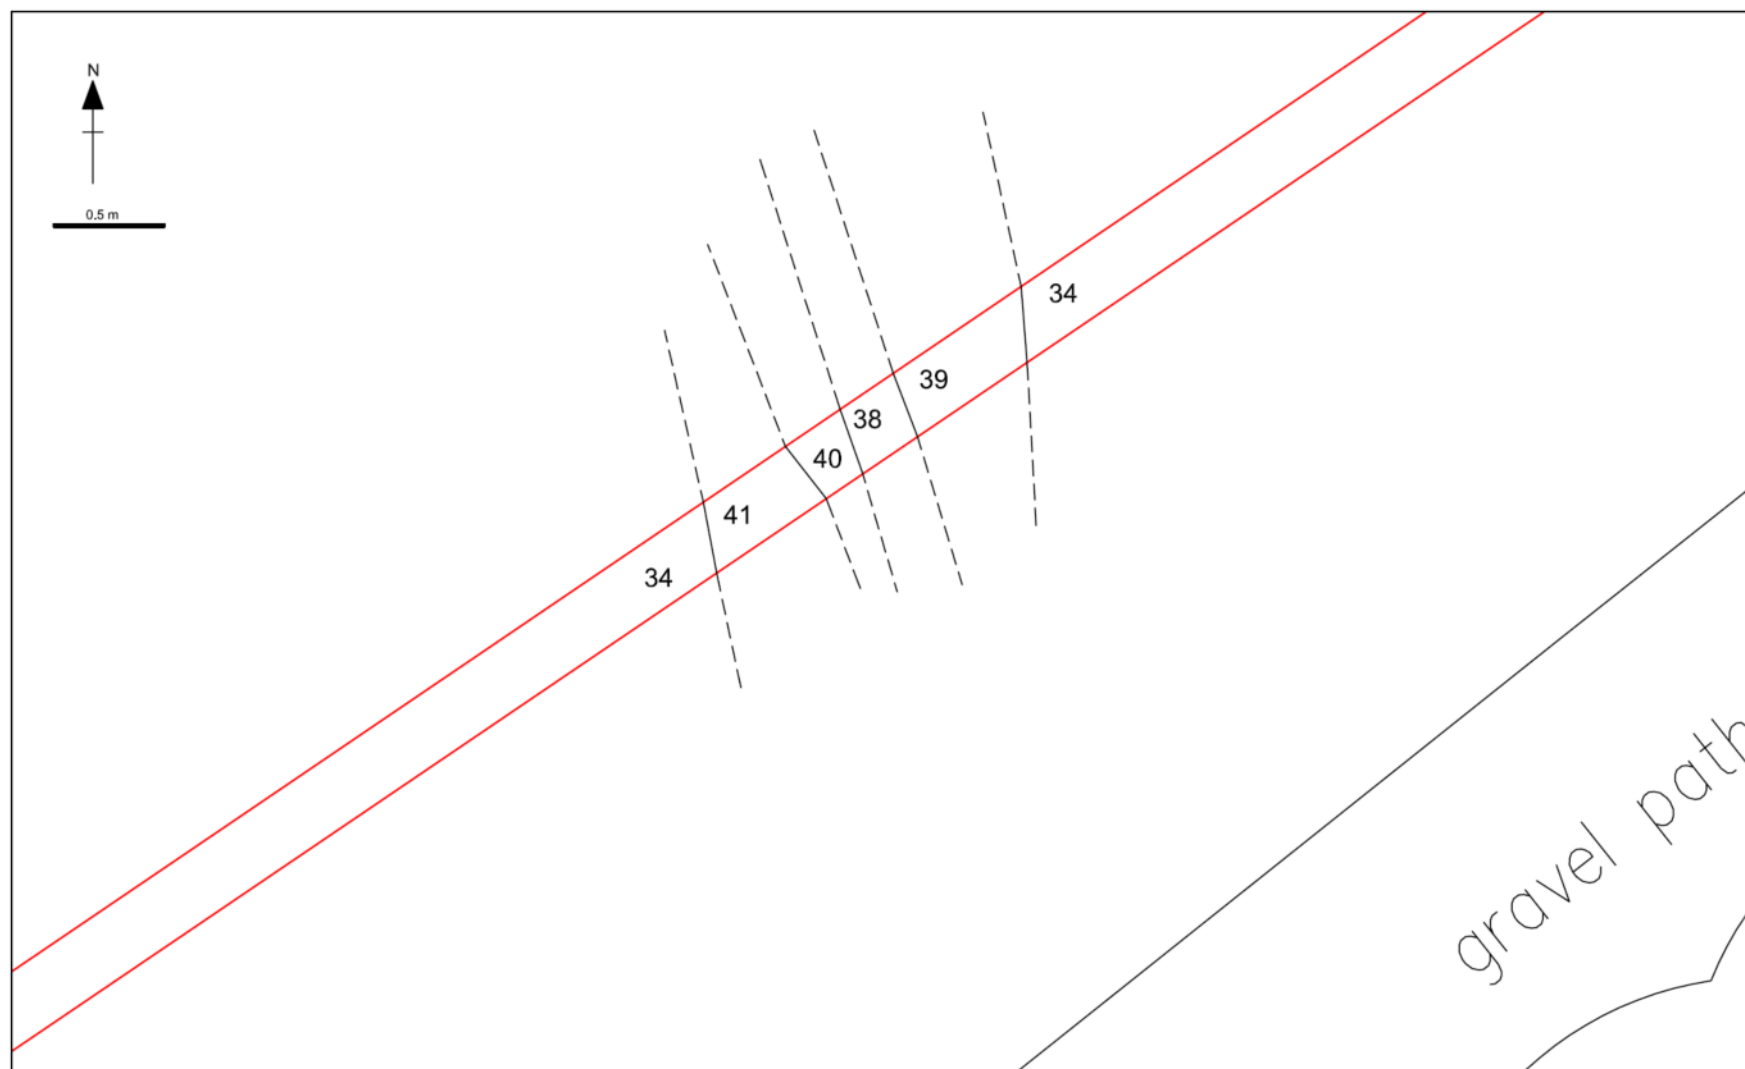
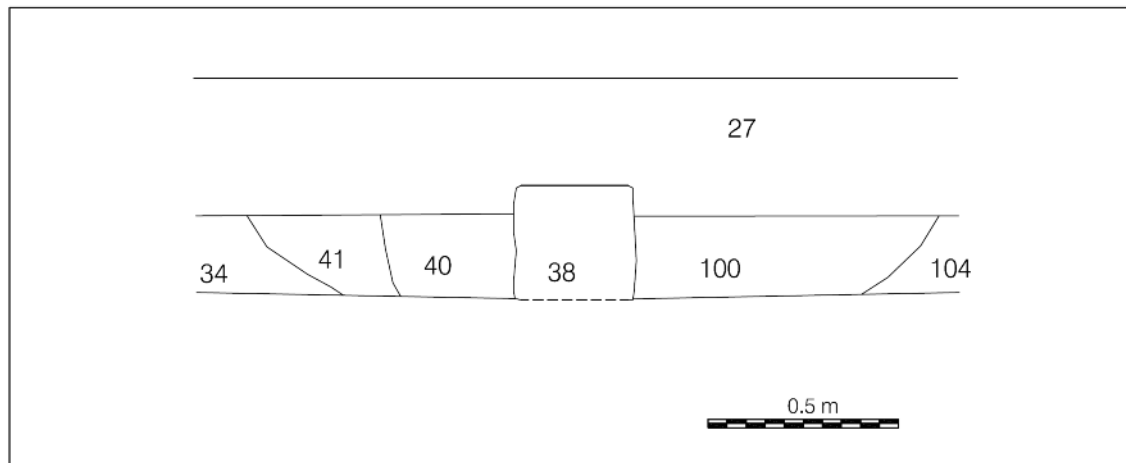
Fig. 12. Plan of wall 38 and associated contexts

At 22 m from the centre of Pit 6 (Figs 8, 12 and 13) was an *in situ* red sandstone block, context 38, apparently part of a wall (Plate 8). This was surrounded by a very soft, dark reddish brown silty sand, context 39, containing frequent gravel inclusions and occasional brick fragments and sherds of Victorian pottery (including SF no.2). The sandstone block had punched tool marks on the north face and was 0.30 m in depth. On widening the trench to remove the block the wall was seen to extend both to the east and west (Plate 9). Upon removal of the block another equally substantial sandstone block was observed underneath, the cut here was also more obvious (Plate 10).

The finds evidence suggests that this wall relates to a Victorian garden feature, though the available map evidence shows no structures at this location (Figs 2-7) and its exact function remains uncertain.

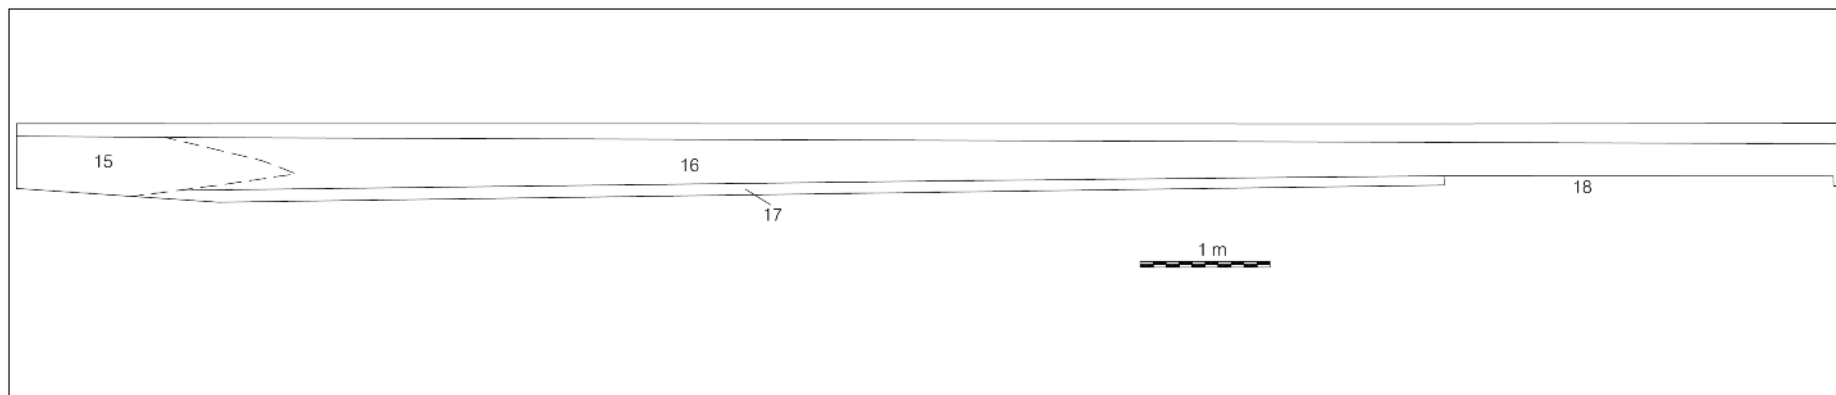
Fig. 19. East facing section, cable trench north of Pit 9.

Immediately to the north-east of Pit 9 the cable trench was excavated through brick and mortar rubble with fragments of red sandstone and Welsh slate within a loose, brown gravelly silt (Context 15, Fig. 19). Approximately 1.50 m north of pit 9 context 15, petered out into a very dark brown humic topsoil, context 16, below the turf containing frequent root action, 0.40 thick (Plate 34). This was followed by a dark brown sandy subsoil context 17, 0.10m thick. At around 10 metres from Pit 9 fragments of concrete slab measuring c. 0.70 by 0.50 by 0.10m, brick rubble and occasional cobble stones, c. 0.15 by 0.07 by 0.05m, were observed within context 17. At around 11 metres a concrete slab, context 18, was encountered 3 metres long at a depth of c. 0.40m (Figs 17 and 19). The slab was left undisturbed and the trench carried on northwards over the surface. At this point the cable trench reached the grassed area outside of the picnic area. A short stretch connected the main cable trench with a duct within the grassed area.

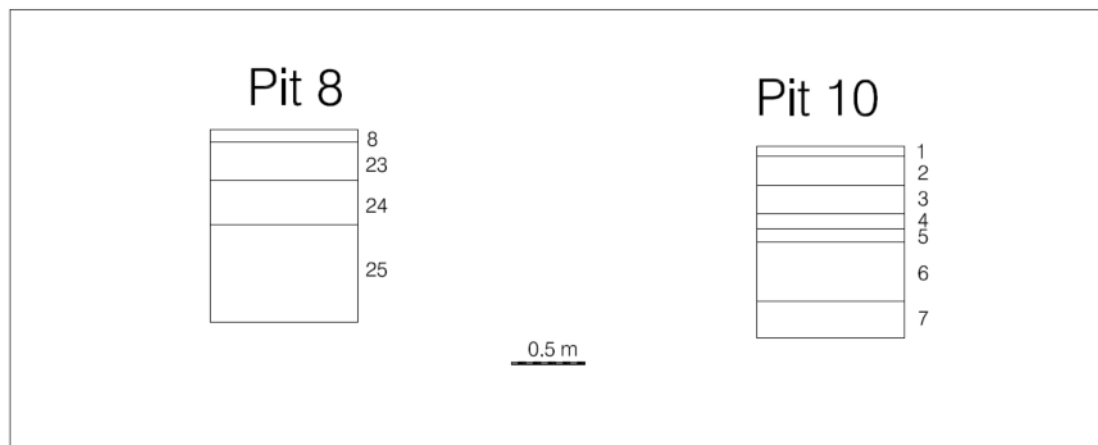
Fig. 20. Profiles across Pits 8 and 10.

deposit, context 23, 0.26m thick, containing frequent red, handmade brick and sandstone fragments (Plate 24, Fig 20). This overlay a soft, dark grey ashy/cinder layer, context 24, 0.30m thick, onto a thick deposit of soft, light brown sand, context 25, 0.64m in depth. No archaeological features or finds, other than building material including whole bricks and fragment, were recovered.

The turf layer, context 1, 0.07 m deep, was excavated onto loose, sandy topsoil context 2, 0.20 m thick, with evidence of extensive root action. This was underlain by a loose, dark grey ashy/cinder layer, context 3, 0.09 m thick, containing frequent fragments of red handmade brick. This overlay a layer of concrete, context 4, 0.10 m thick (Plate 25, Fig. 20). A breaker was used to excavate through the concrete and following compacted layers. A very compacted layer of dark grey/black layer of cinders, context 5, 0.09m thick, followed context 4. This overlaid an unbound, compacted sandy gravel/pebble layer, context 6, almost 0.40m thick over a compacted dark greyish brown soil, context 7, containing a moderate amount of root action, 0.15m thick.

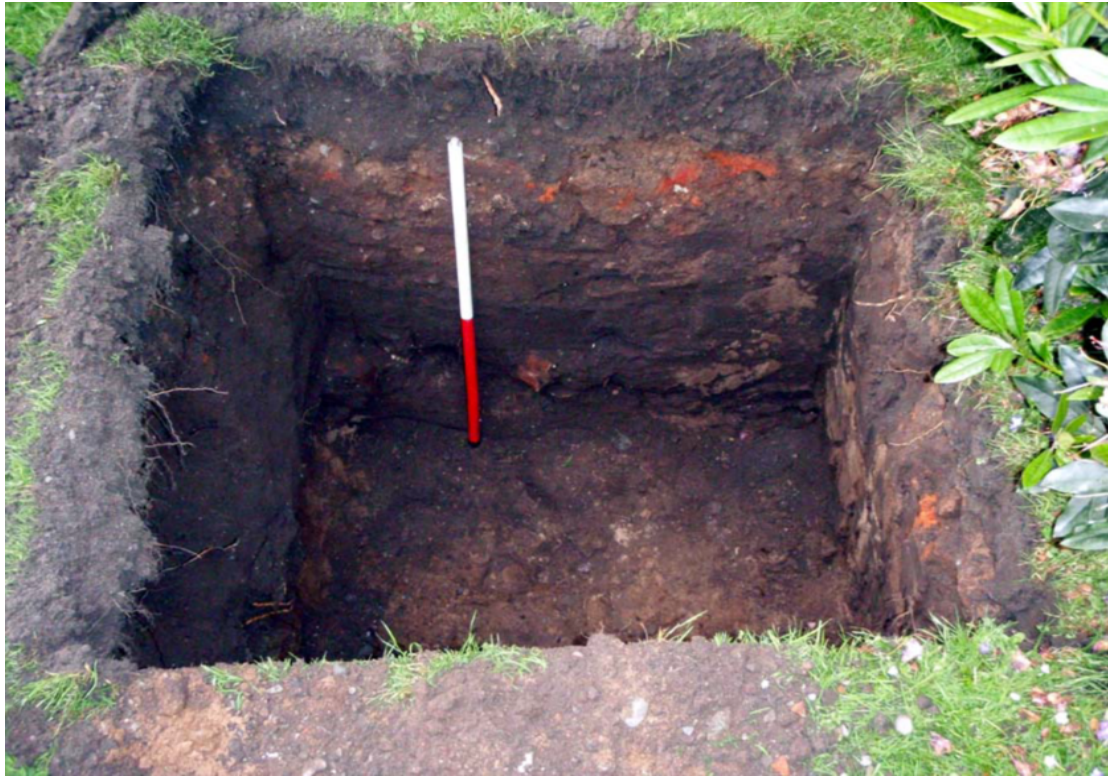
Pit 7 was located on the south lawn, south-west of the moat and 13.50 m from the path adjacent to trees and shrubs (Figs 8 and 9; Plate 1). An upper turf layer, context 26, was 0.06 m thick and overlay a very dark brown humic topsoil layer, context 27, which was 0.20 m thick and contained frequent rounded pebbles. This overlay a loose gingerish brown sand layer, context 28, which was 0.20 m thick and contained fragments of red handmade brick rubble measuring c. 120 by 60 mm. A thicker friable, dark brown sandy loam deposit, context 29, 0.60 m thick, containing occasional brick fragments lay below context 28. The lowest deposit encountered was a soft, light brown sand layer, context 30, 0.24m thick.

Plate 1. North facing profile of Pit 7. From the north.

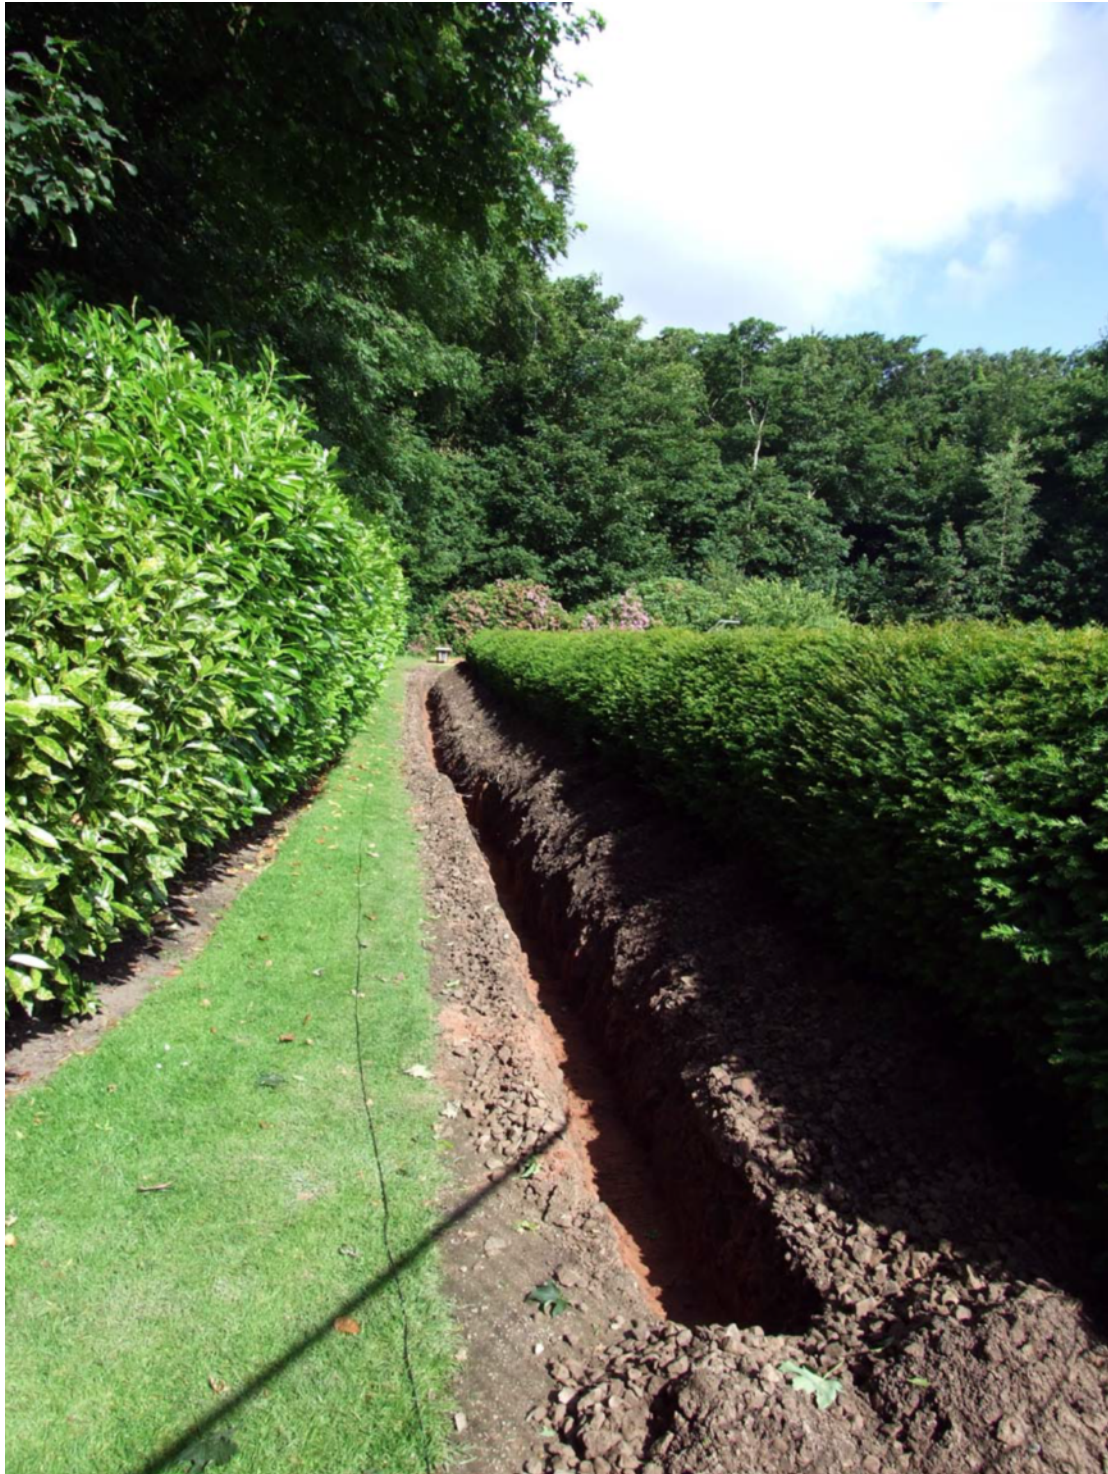
The cable trench continued north-west along the southern path running parallel to the moat through 0.10 m of stone chippings, context 33, onto soft, reddish brown sandy subsoil, context 34 (Plate 3).

Plate 3. View of cable trench running along southern side of moat along E - W path. From the east.

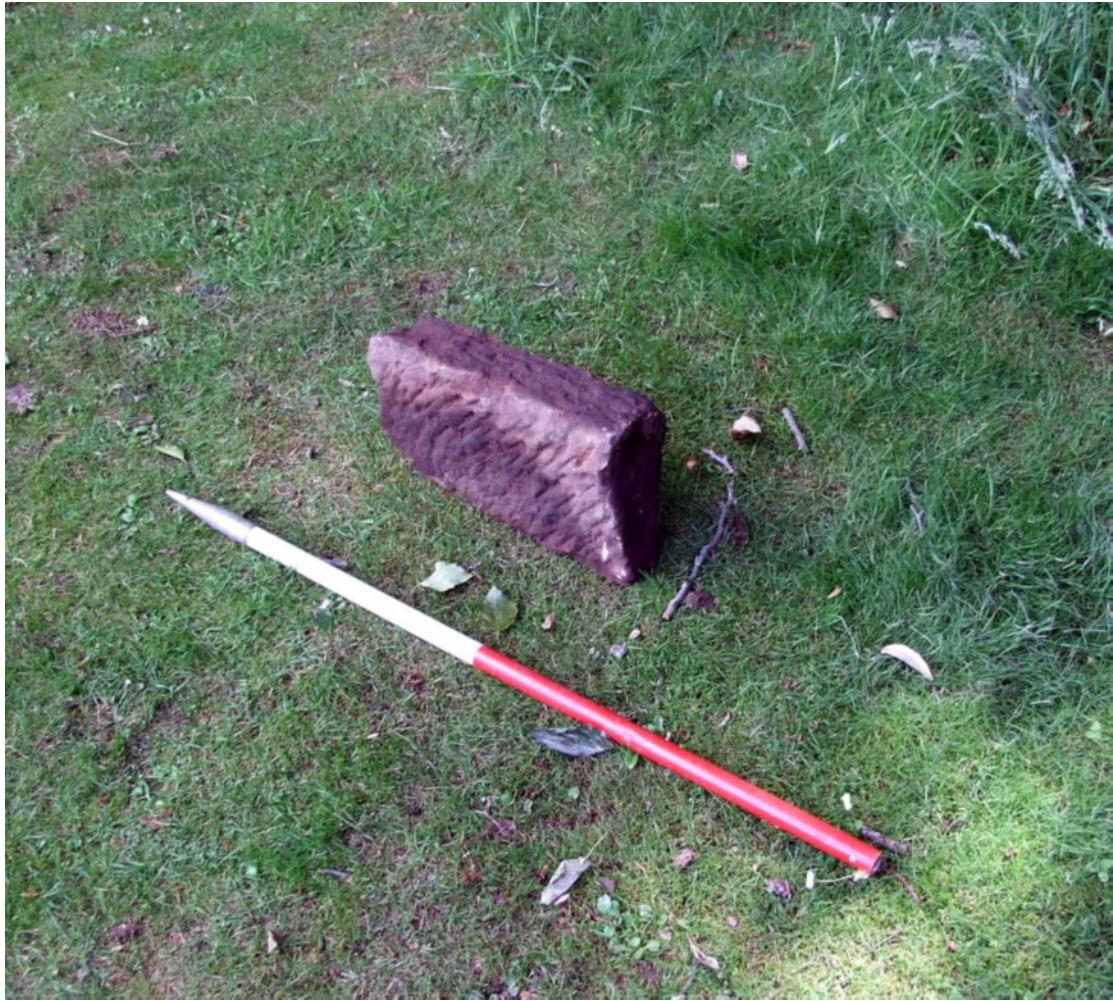
A cut sandstone block (SF no.5), 370 by 220 by 100mm was recovered from the spoil heap at the extreme north-west corner of the moat. The block had punch tool dressing on one broad face and two longer narrow sides (Plate 4). The trench section was checked but there was no evidence of any further blocks, the only deposits present being topsoil (context 27) and sandy subsoil (context 34).

Plate 4. Cut sandstone block (SF no. 5) recovered from spoil heap in extreme SW corner.

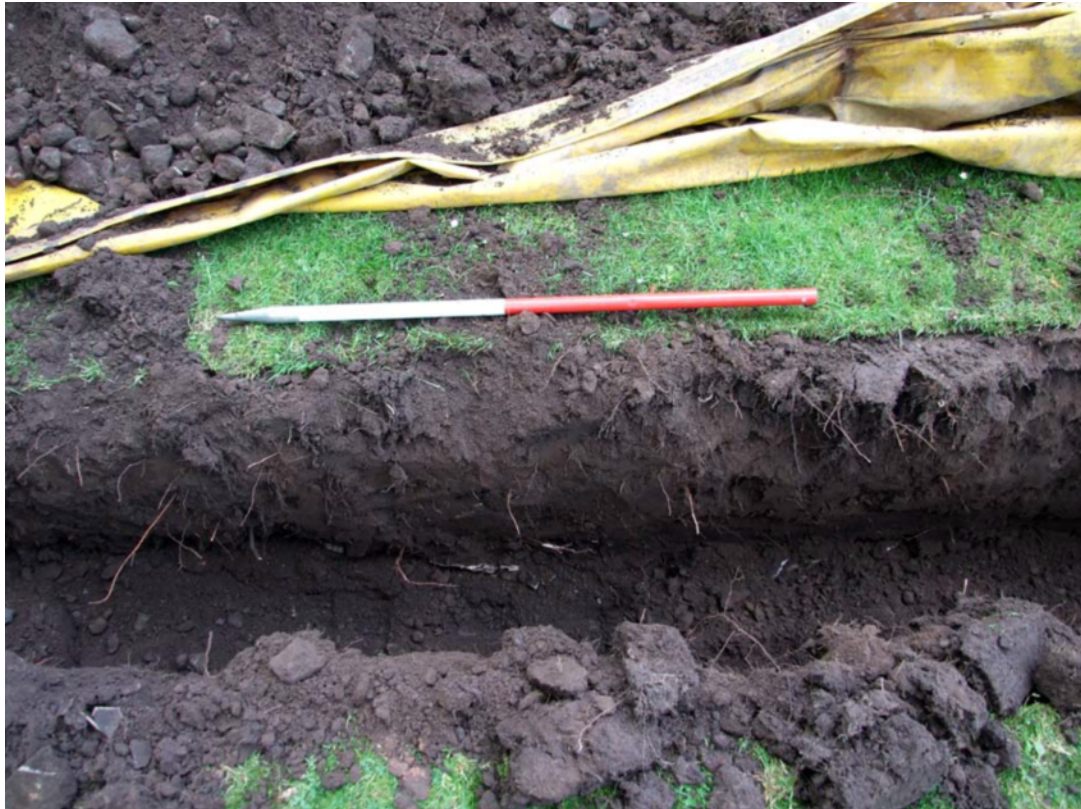
faded out by c. 10 m from the southern end of the trench as had the building material (Plate 6).

Plate 6. Cable trench profile along the grass verge on western side of moat. From the east.

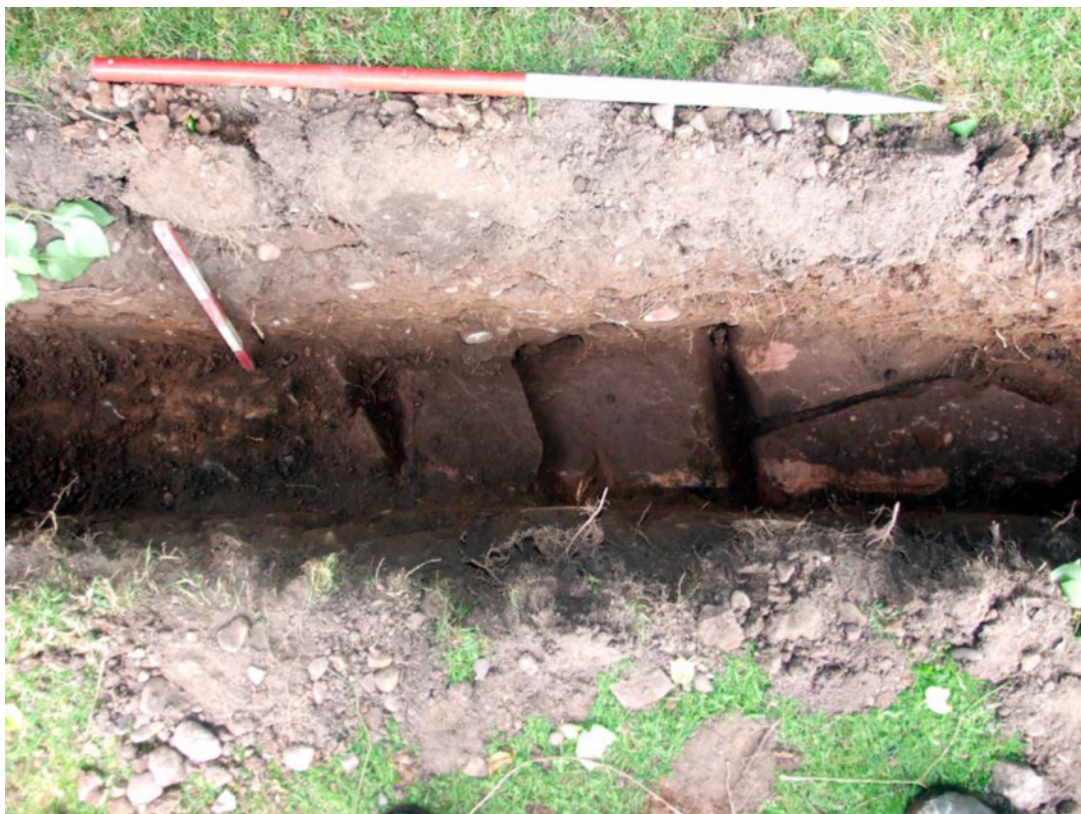
Plate 7. Plan view of sandstone blocks forming part of a possible drain at the base of the cable trench

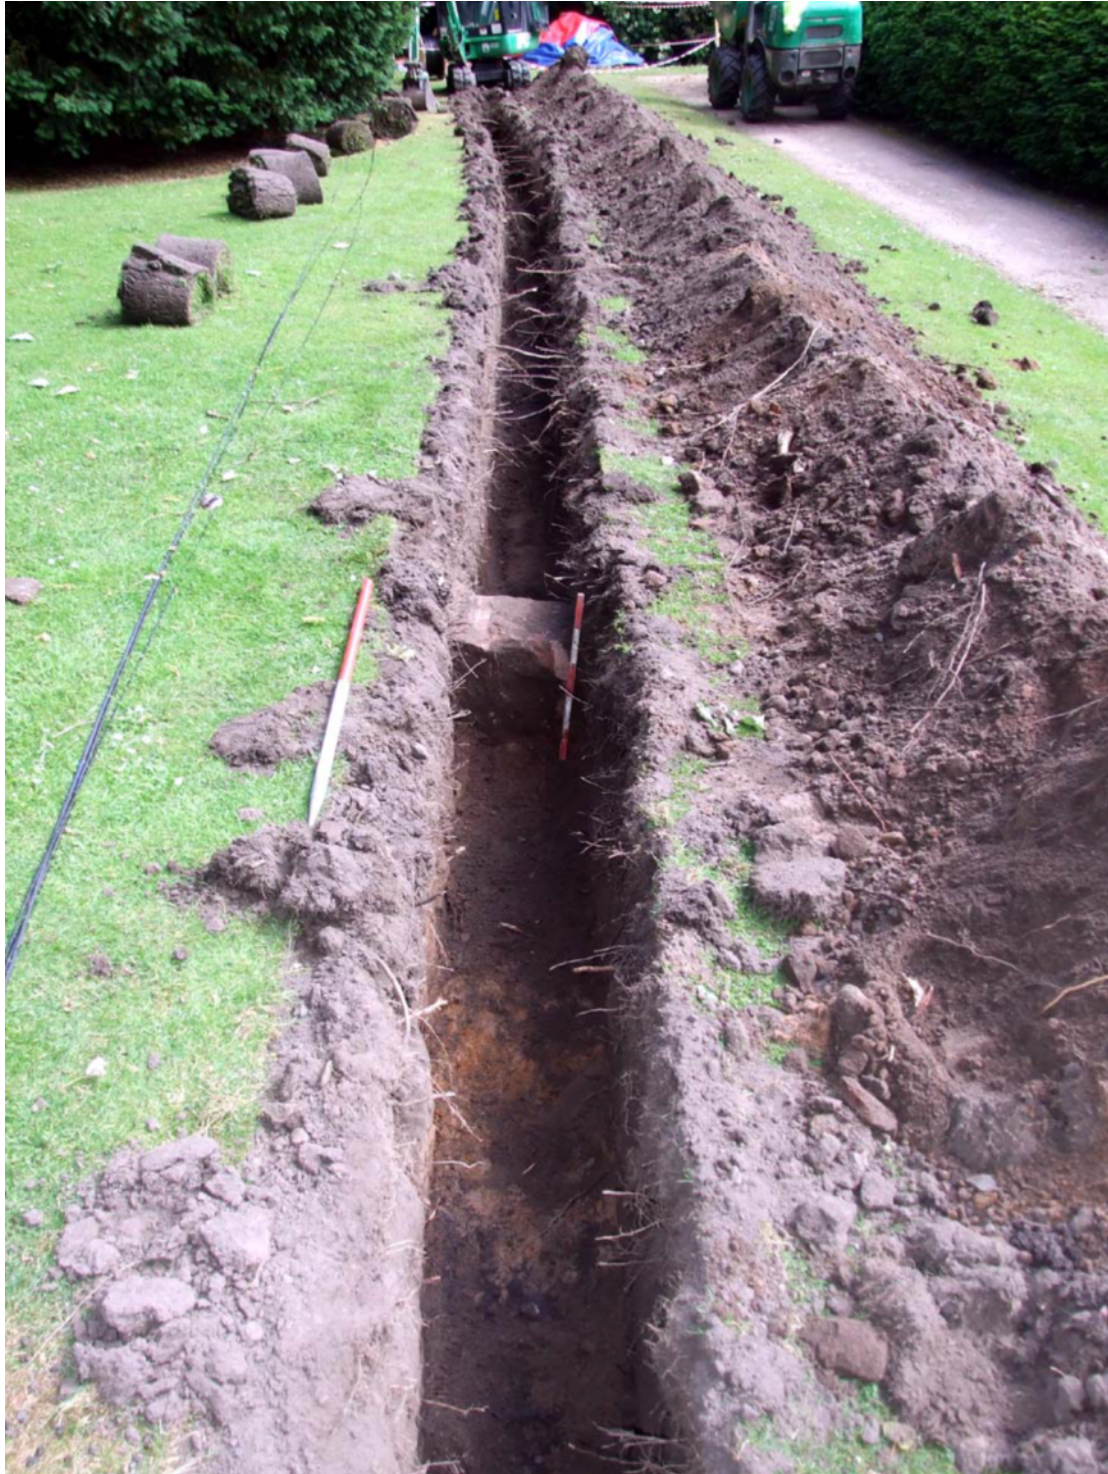
Plate 8. View showing sandstone block forming part of wall 38. From the south.

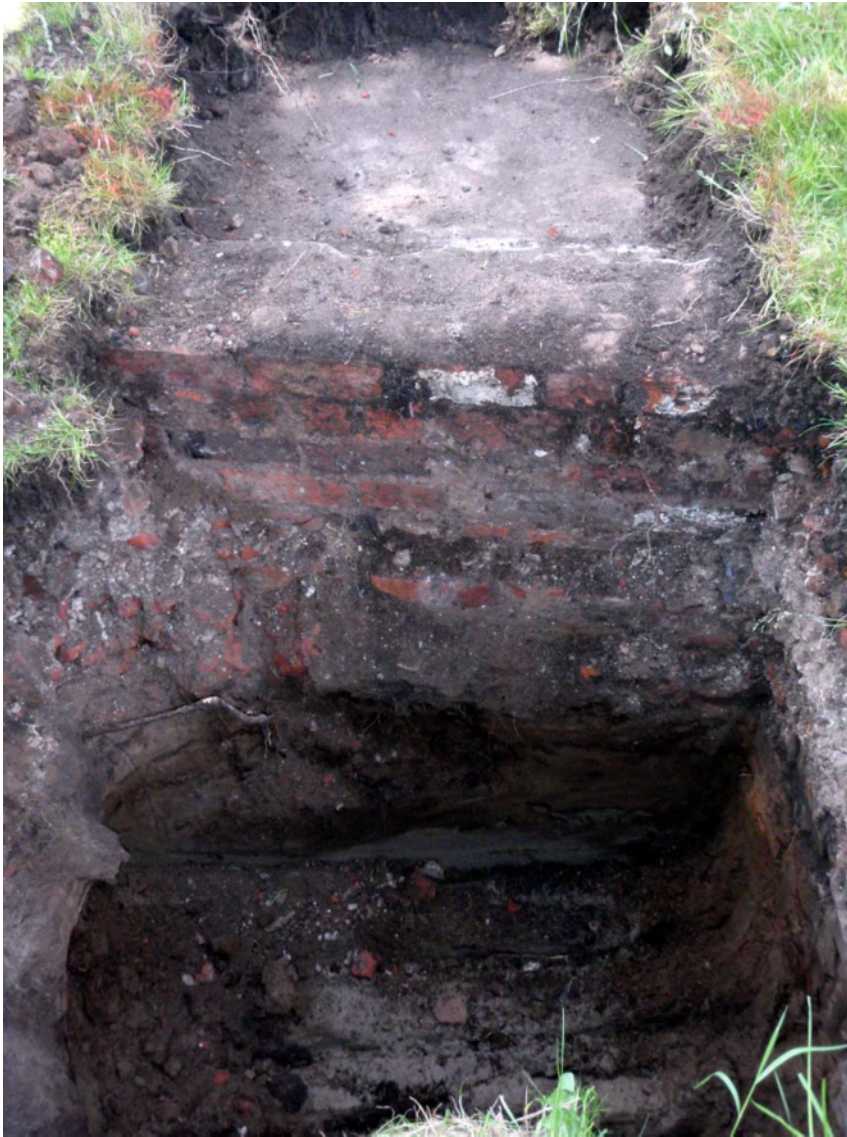
Pit 9 was situated within the picnic area approximately 20 m west of Home Farm. Below the turf, context 8, at a depth of 0.08m, a brick wall, context 9, two courses wide, running northeast – southwest was encountered almost immediately. A concrete slab, context 10, butted against the wall on its western side (Plate 21, Fig. 17). Wall 9 consisted of seven courses, 0.65 m deep, of red hand-made bricks laid in

stretcher bond and using lime mortar. The lowest two courses were stepped out by c. 0.10 m. The brickwork overlaid a thick deposit of soft, brown sand, context 11, measuring 0.60 m thick. It was decided that in order to avoid damaging any of the brickwork that the pit would be re-located to the eastern side of the brickwork (Plates 21 and 22). Here, the pit was opened a further 1.10 (N – S) by 1.40m (E – W). Directly below the turf was a thick layer of disturbed made-ground measuring 0.60 m thick. This consisted of a loose, brown gravelly silt deposit, context 12, containing frequent brick and mortar fragments. This was followed by context 11, a thick layer of soft, brown sand measuring 0.65m in depth (Plate 22).

Plate 21. East facing profile of Pit 9 showing wall 9 in section. From the east.

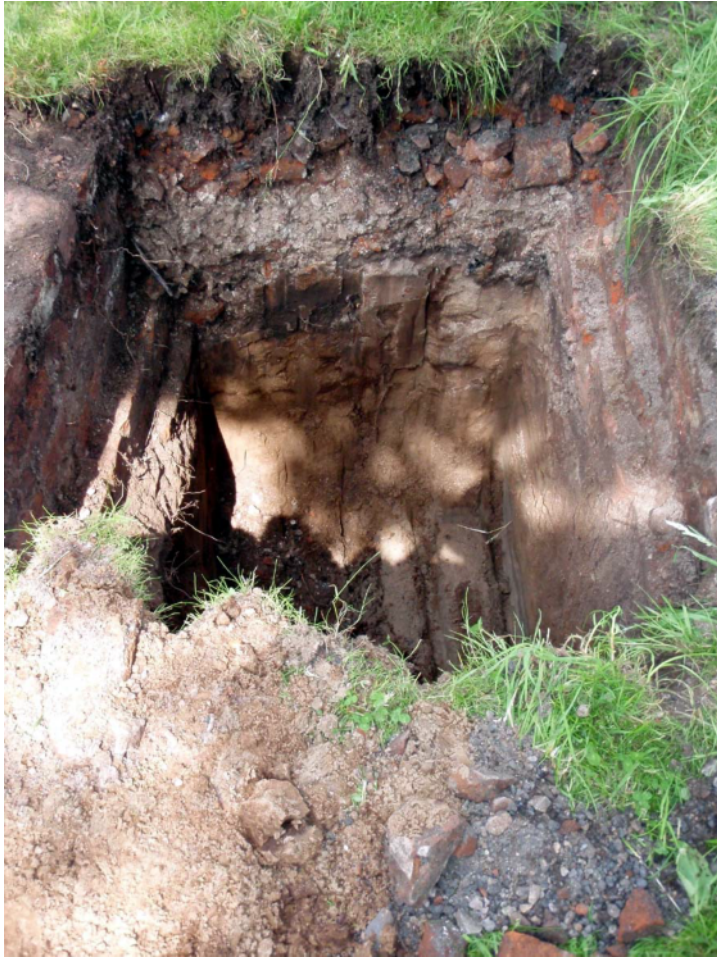
Plate 22. South facing section of Pit 9 showing rubble layer Context 12) between walls 9 and 13. From the south.

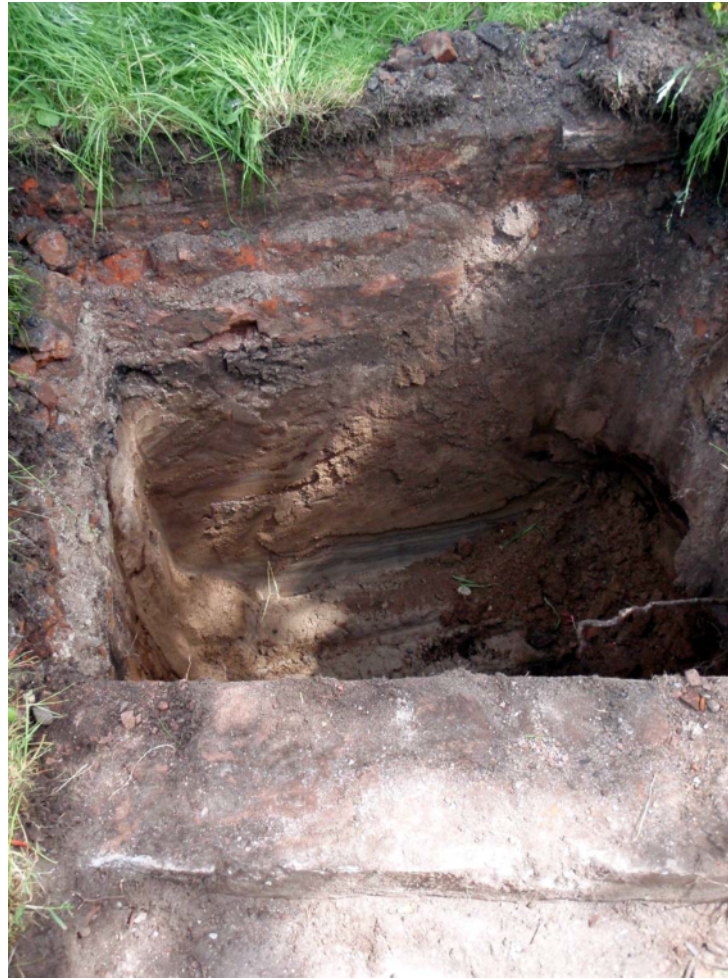
Another brick foundation, context 13, was exposed on the south-eastern side of the pit (Plate 23). Again, the brickwork lay directly below the turf and consisted of three courses of red, hand-made bricks, 0.30 m deep. The bricks lay over a foundation of sandstone blocks, context 14, only three were visible in section, all 0.13m thick. During excavation of the cable trench it became apparent that immediately north of Pit 9 wall 13 turned to the south-east.

It was not clear if these walls were associated with each other, or represented separate structures, though both clearly dated to the late 19th century. However, the closest buildings are a set of small square sheds or similar structures just to the east of Home Farm on the 1893 and 1907 OS sheets (Figs 6 and 7). It is difficult to relate walls 9 and 13 to specific structures, though it seems likely that wall 9 relates to what appears to be a boundary between the sheds and Home Farm which suggests that the concrete surface is part of the farmyard for Home Farm.

Plate 23. West facing section of Pit 9 showing wall 13. From the west.

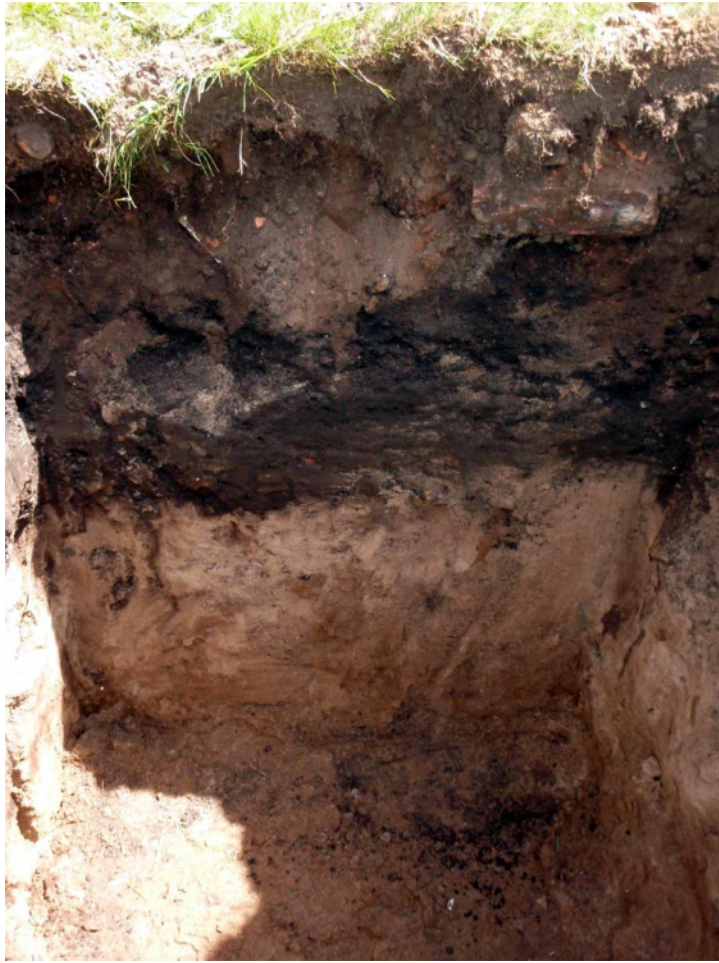
Plate 24. East facing profile of Pit 8. From the east.
