**An Archaeological Watching Brief on Land Adjacent to
Bromborough Court Moat, Pool Lane, Bromborough, Wirral.
NGR SJ 344 840**

Produced for Hantall Developments

January 2008

An Archaeological Watching Brief on Land Adjacent to Bromborough Court Moat, Pool Lane, Bromborough, Wirral. NGR SJ 344 840

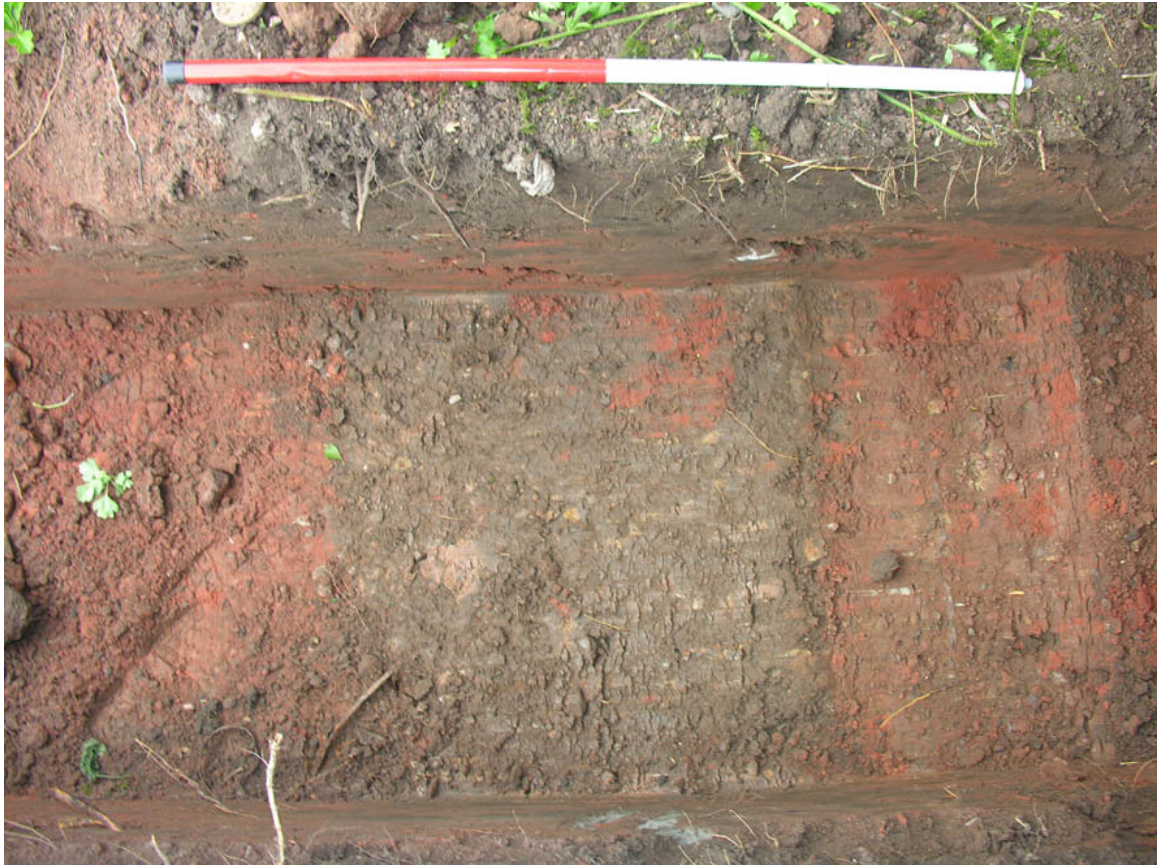
measured c. 2 m east-west and 0.80 m north-south with a total depth of 0.35 m. A red sandy clay was cut for the trench for the drain which was filled by a mid-brown sandy silt loam approximately 1 m wide (Plate 1).

Plate 1. Trench XLIII. Disturbed ground resulting from sewer pipe insertion along moat edge.

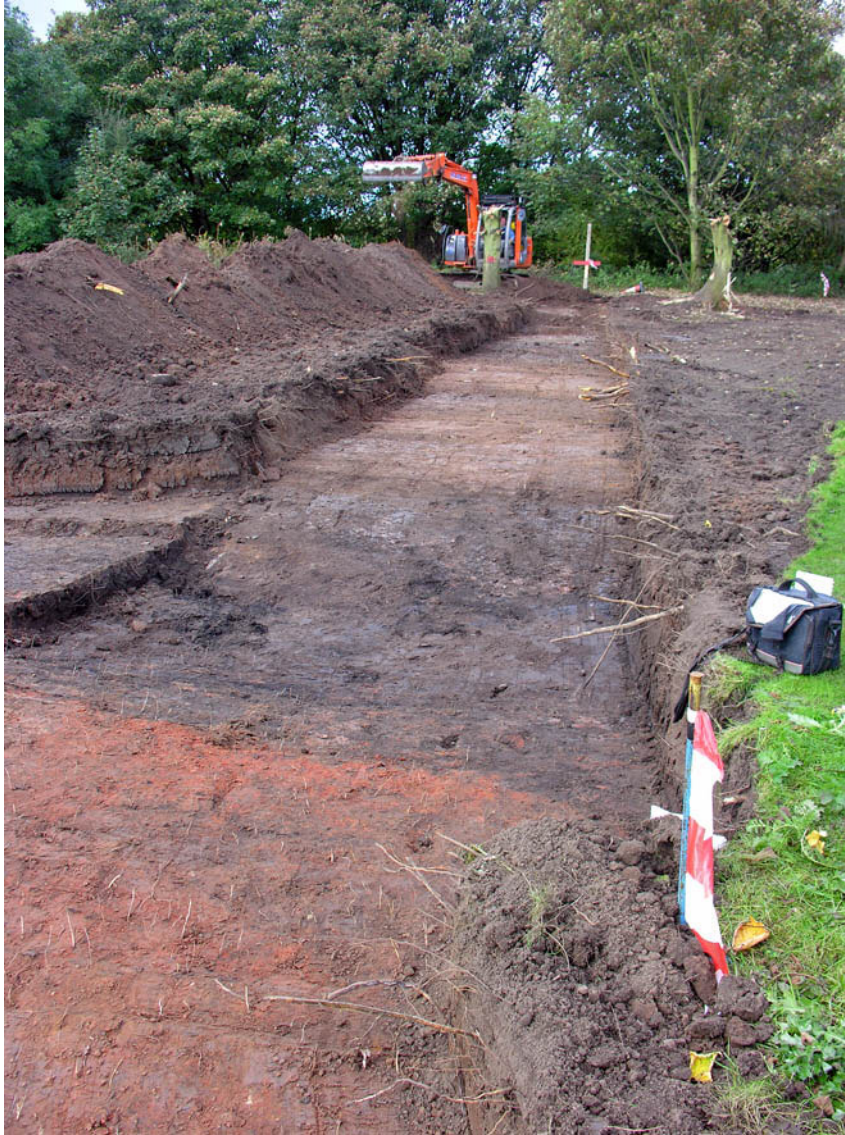
East of this trench a possible ditch (Plate 2) was noted when reducing the overall level of the site in this area. The fill consisted of a black loamy silt and measured approximately 2 m wide north-south and extended c. 9.5 m west from the west bank of the pond to a point where it was truncated by the insertion of the pipelines. A section across this feature observed in the side of Trench LIV suggests that it was of natural origin. A similar feature (context [6], Trench III) was observed during the evaluation in 2004 (Adams, M & Ahmad, C., 2004).

Plate 2. Possible ditch east of Trench LI.

A possible ditch extending west from the western edge of the fishpond was in fact most likely to represent a variation in the upper surface of natural partly truncated by later activity. No boundary is shown on historic mapping of the area and its profile appears very shallow for an anthropogenic feature. The deposits within it probably resulted from natural accumulation of silts and organic matter. It is possible that the material seen in this feature was present as a result of dredging the fishpond, a similar feature was observed to the east during the archaeological evaluation in 2004.

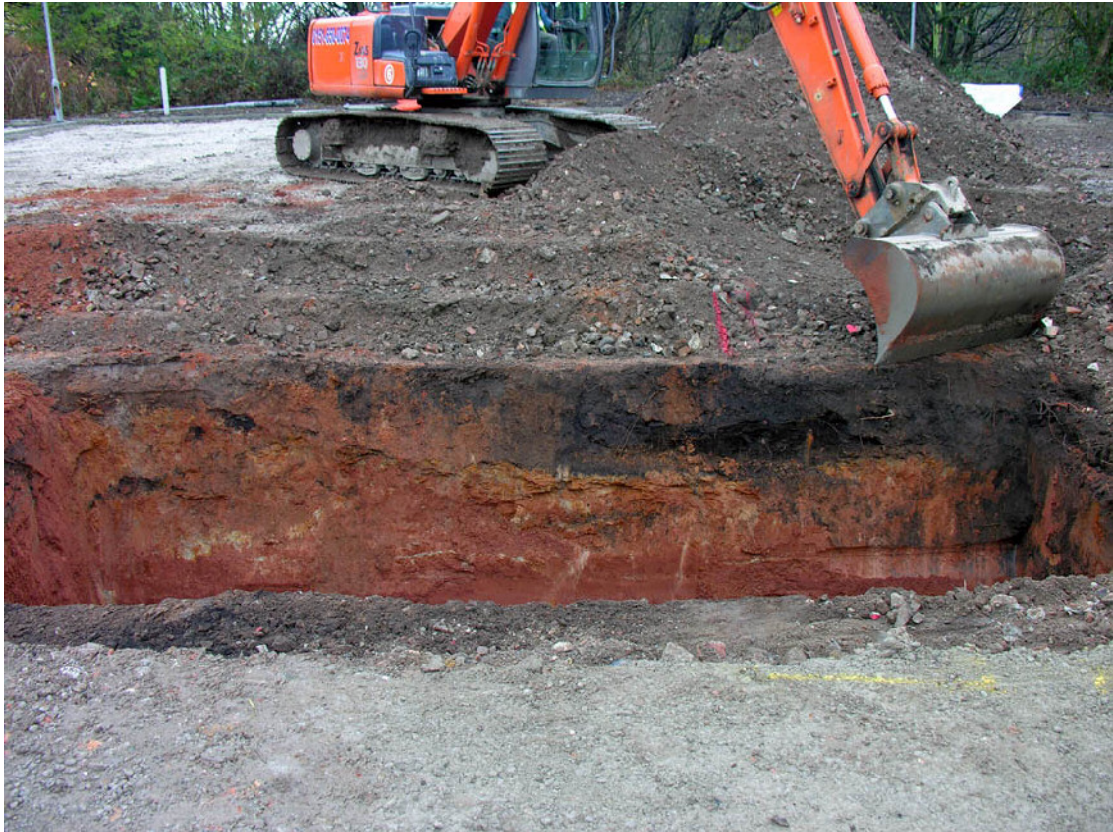
A further large trench measuring 6 m east-west and 3 m north-south was excavated immediately south of Trench LIII for the insertion of a petrol/oil interceptor tank. Again, several shallow pockets of black silty material were observed. The silty material in the south-facing section of the trench was part of the ditch observed east of Trench LI (Plate 3). This filled a shallow, dish shaped 'scoop' into the top of natural, reaching a depth of up to 0.6 m at the eastern end of the trench and petered out to the west. Moderate root action was observed within the silted area which implies that the deposit is of an organic nature. Below the silt was a band of gingery yellow sand c. 0.2 m deep which was overlying highly compacted red clayey sand to a total depth of 2 m.

Plate 3. South-facing section in Trench LIV showing the deposits in section.
