An Archaeological Watching Brief of land for the proposed Pier Head Canal Link, Liverpool. Site Code 91.

Produced for British Waterways.

January 2006

## Report on an Archaeological Watching Brief of the Pier Head Canal Link, Liverpool (Site 91)

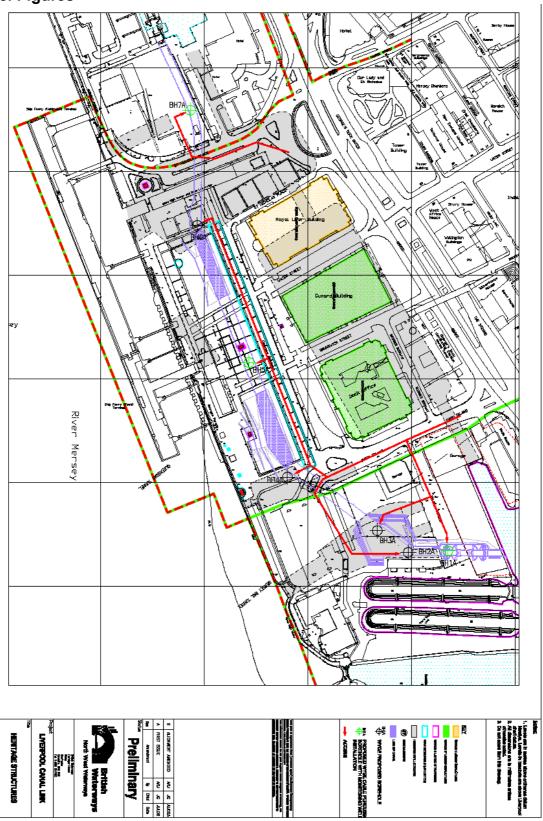
Figure 1. Borehole Locations (Data from client).

This watching brief was undertaken during the manual excavation of inspection pits excavated for seven boreholes (Fig.1) located along the line of the new Liverpool Canal Link which will connect the Leeds Liverpool Canal with the South Docks on Liverpool's waterfront. The study area extended from the Pier Head Ferry Terminal to the GWR Building at Mann Island. The boreholes were drilled to test the ground for contamination in preparation for excavation of the new canal.

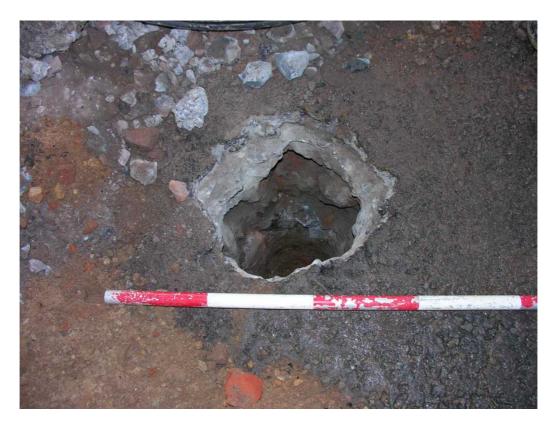
Fig 1. Borehole 7B

Borehole 7B was located approximately 1.5m to the North West of 7A. The same layers were excavated to an identical flat concrete surface to that encountered in Borehole 7A, suggesting that it was not in fact a drain and the concrete was then excavated to a depth a 0.67 m from the base of the tarmac.

The final layer excavated was a heterogeneous mixture of sand, brick and sub-angular and rounded stones (Context 4). Finds included four fragments of 19<sup>th</sup> century china and one piece of black glaze ware pottery (also 19<sup>th</sup> century) were found at the top of this layer (J. Speakman, pers. comm.). The very base of this layer was much sandier and became a very light brown sand. The maximum depth of the borehole before mechanical drilling commenced was 0.96 m.

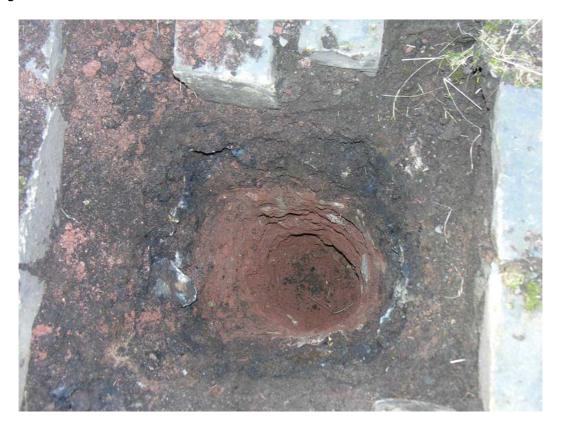
Fig. 2. Borehole 2A

Borehole 2A was located in the car park of the GWR Building at Mann Island (Fig 1.). This was the most Southerly of the boreholes and lies within the former Manchester Dock (in-filled *c*. 1927-30). The borehole was situated at the eastern end of the car park on the Northern side of the GWR Building and measuring 0.40m maximum width and 1m deep. Following removal of tarmac a layer of brick and sandstone rubble was excavated (Context 5). This was made up of approximately 25% brick rubble and the rest was sand and sandstone. This is most probably dock fill from the infilling of Manchester Dock in the 1920's. One brick fragment with a green glaze was found in the rubble fill and a flat piece of iron was recovered but no other significant archaeological deposits were encountered.

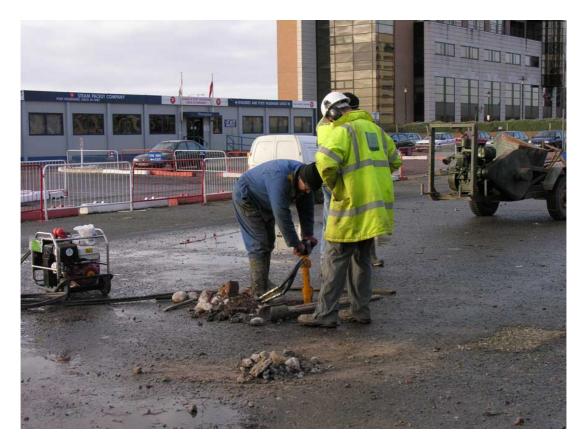
Fig 3. Borehole 7B with 7A in foreground

Borehole 7A was located opposite the Vehicle Ferry Terminal and was the furthest North of the boreholes. Situated in the car park of Princes Dock (Fig. 1), the first attempt (Borehole 7A) was contained the following deposits. Beneath the tarmac surface there was a layer of concrete (Context 1) 0.15m thick which sealed a mixture of concrete and sandstone boulders, again approximately 0.15m thick (Context 2). Excavation was abandoned at a depth of 0.30 m when a flat concrete surface was encountered, possibly a concrete drain cover (Context 3).
