**An Archaeological Excavation at
Court Hey Park, Roby,
Merseyside
SJ 4185 9002**

The Friends of Court Hey Park and Knowsley Borough Council

February 2008

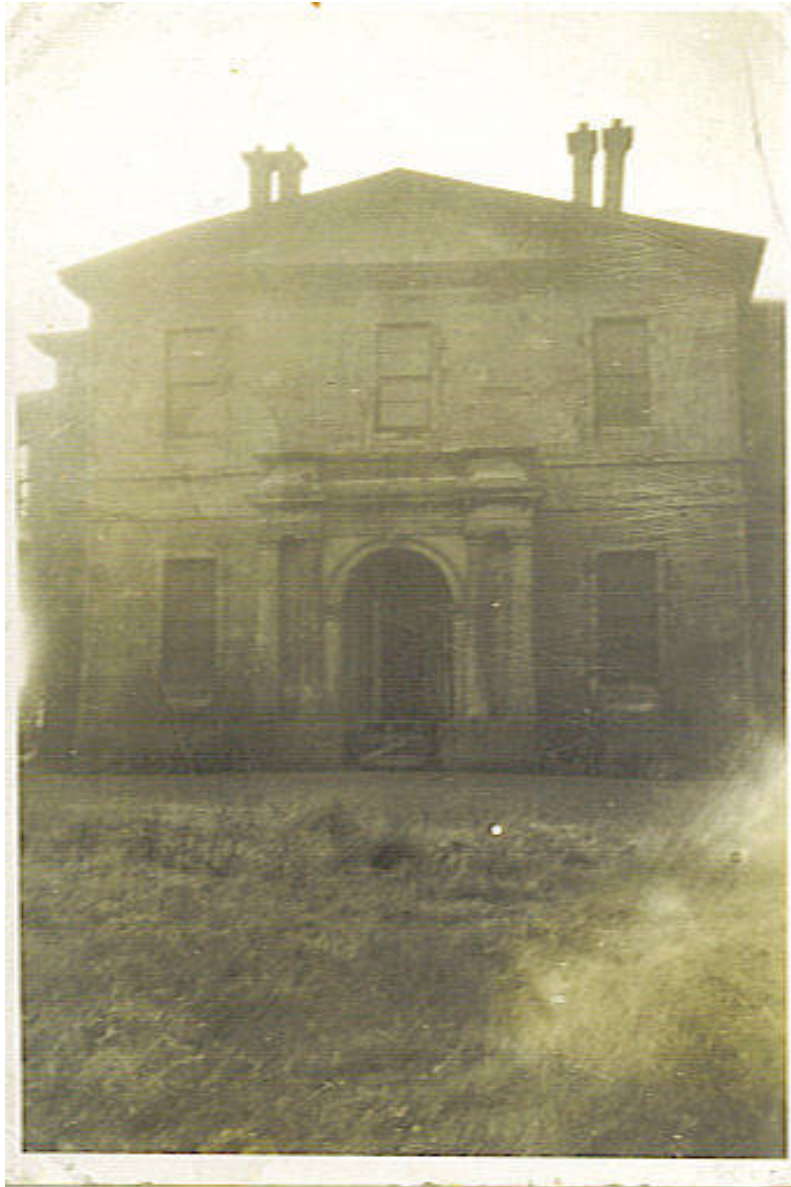
Plate 1. The entrance to Court Hey Hall c. 1940

The excavation aimed to locate and record remains belonging to Court Hey Hall. The Hall was originally constructed for Robert Gladstone (1805-1875), brother of William Ewart Gladstone, and was an imposing L-shaped building constructed in red sandstone (Fig. 2, Plate 1). Little evidence for the Hall existed above ground, though its site is accurately known from cartographic evidence and there was some evidence for its internal layout, including basements.

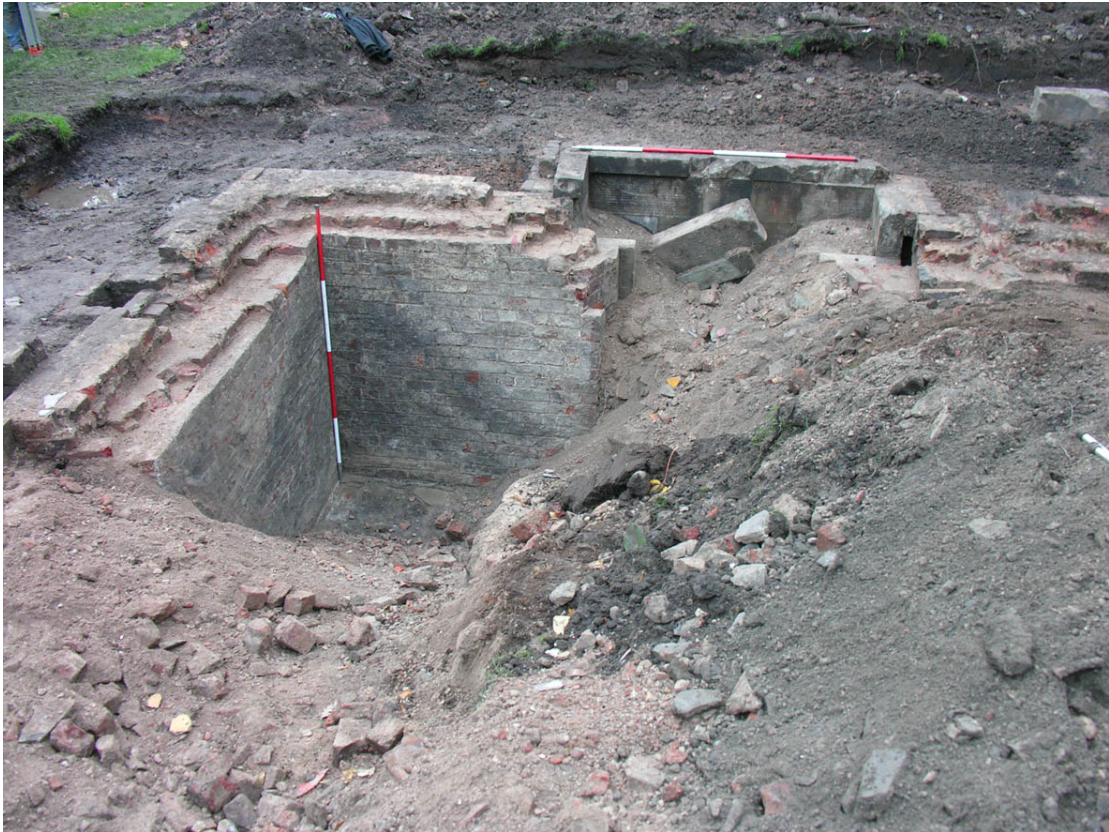
Plate 2. View of the excavated deposits from the north.

Foundations to the hall (Plates 2 & 3, Fig. 4) were sealed by a layer of topsoil (context 6) and a layer of demolition debris comprising fragments of crushed brick rubble and mortar (context 2). A layer of re-deposited orange brown clay (context 4) appeared to be butting up against the external walls (context 1) and capping the surrounding surface areas. Removal of this clay layer, which was 0.10-0.15 m in depth, revealed sections of York stone flags (context 3) butting up against the external walls around the exterior of the building on its south-western side.

The walls (context 1) were constructed of red brick (?wire cut) and sandy lime mortar and were approximately 0.4 m thick. Two bays, one on the west side and one on the south side of the exposed portion of the building were also constructed in red brick on the exterior and were lined with large grey sandstone ashlar masonry on the interior.

A portion of the rubble fill (context 2) in the interior of the building was cleared in the south-west corner to expose the basement floor (context 7). The exterior walls forming the basement rooms were approximately 0.7 m thick, much wider than the other walls and remained in good condition. The basement floor (context 7) was 1.8m below the top of the exposed basement wall and was composed of concrete, compacted brick rubble and cinders. Small fragments of flagstone remained in the very corner of the basement, suggesting that the floor was originally flagged.

A linear area of compacted gravel and mortar (context 5) was observed running north-south, along the western side of the building. This appeared to be only a thin layer, less than 0.05 m in places and was approximately 1.2 m wide. Remnants of flagstone fragments were observed on the surface, suggesting that this was the remains of a footpath running around the outside of the building.

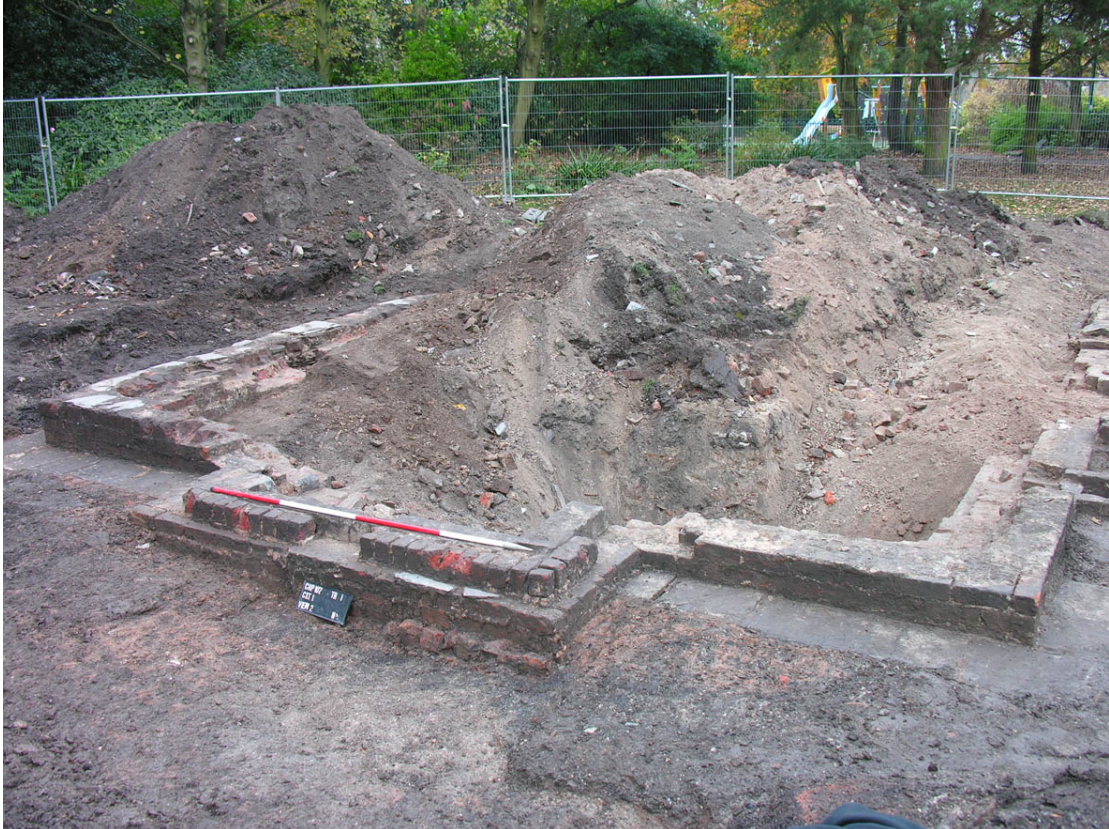
Plate 3. View of the excavated deposits from the south.
