**An Archaeological 'Watching Brief' at
Hightown Sea Defences, Hightown,
Sefton, Merseyside.
Site Code 126**

Prepared for Capita Symonds and Sefton Council

An Archaeological ‘Watching Brief’ at Hightown Sea Defences, Hightown, Sefton, Merseyside. Final Report

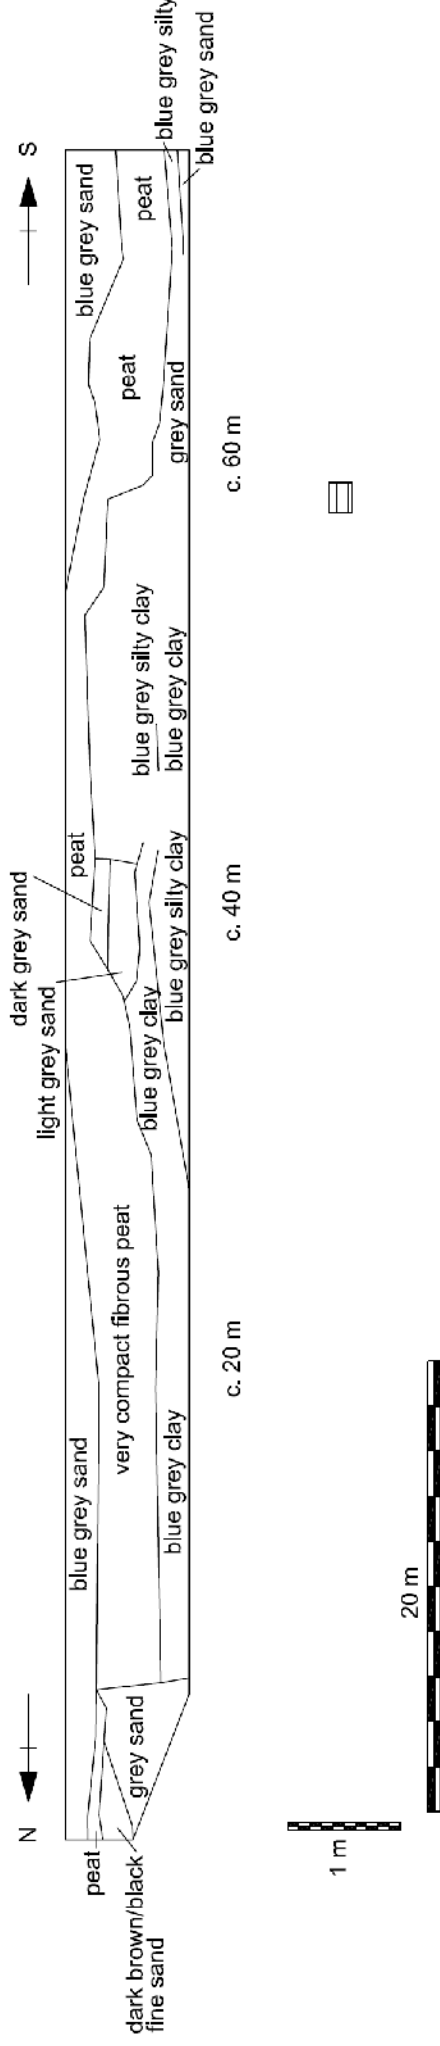
Fig. 3. Sketch of west-facing trench profile during Watching Brief. Note that the vertical scale has been exaggerated x5.

- 8.2 In general the trench profile at the northern end consisted of c. 0.1-0.2 m of modern beach sand containing a moderate amount of brick and rubble over a layer of blue-grey silty sand, c. 0.30 m thick, overlying a 0.50 – 0.55 m thick deposit of peat. The peat sealed a lower deposit of soft blue-grey clay, 0.50 – 0.60 m thick (Plates 1, 2 and 3). When first exposed the peat layers were very compact dark reddish brown fibrous deposits with a high content of decayed organic matter consisting of roots, bark, twigs and fragments of wood. The peat oxidised to black within a minute of exposure making it difficult to observe any significant stratification (Plate 4). Water seepage through the trench sides also made monitoring difficult at times especially around high tides.

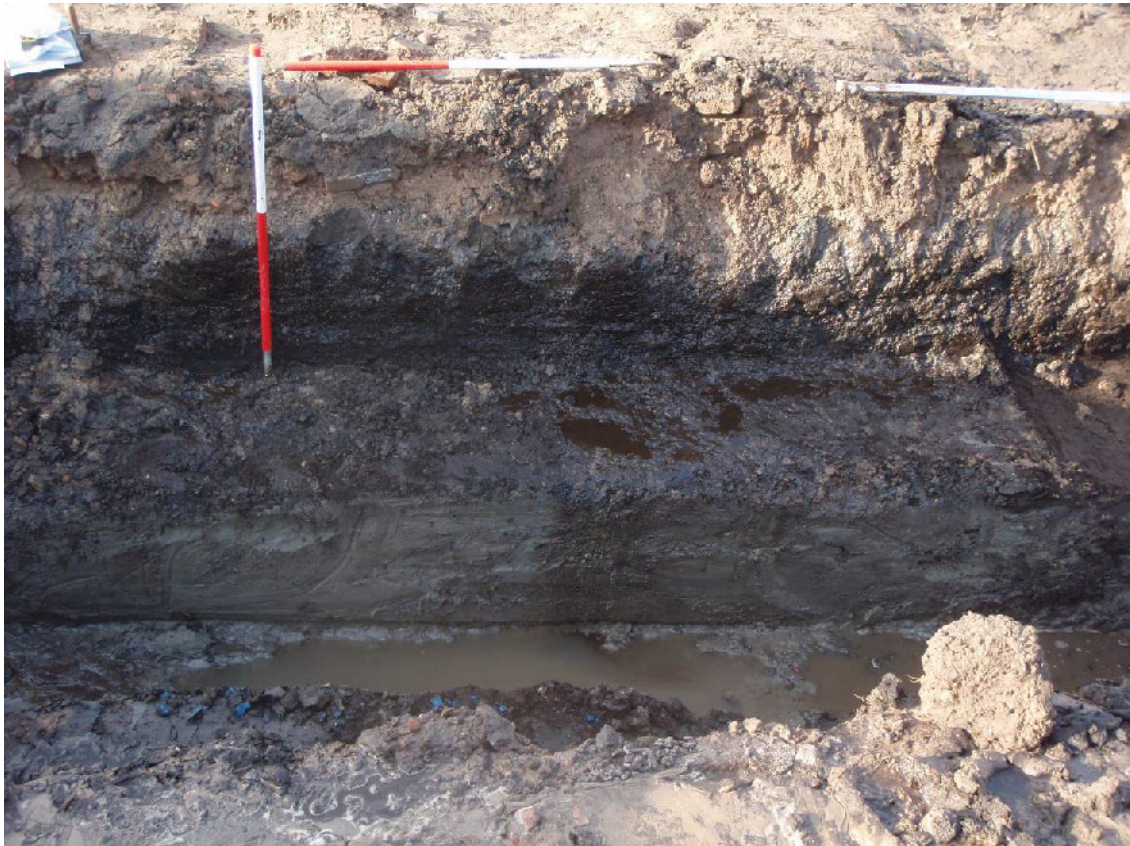
Plate 1. East-facing trench section at far northern end. From the east.

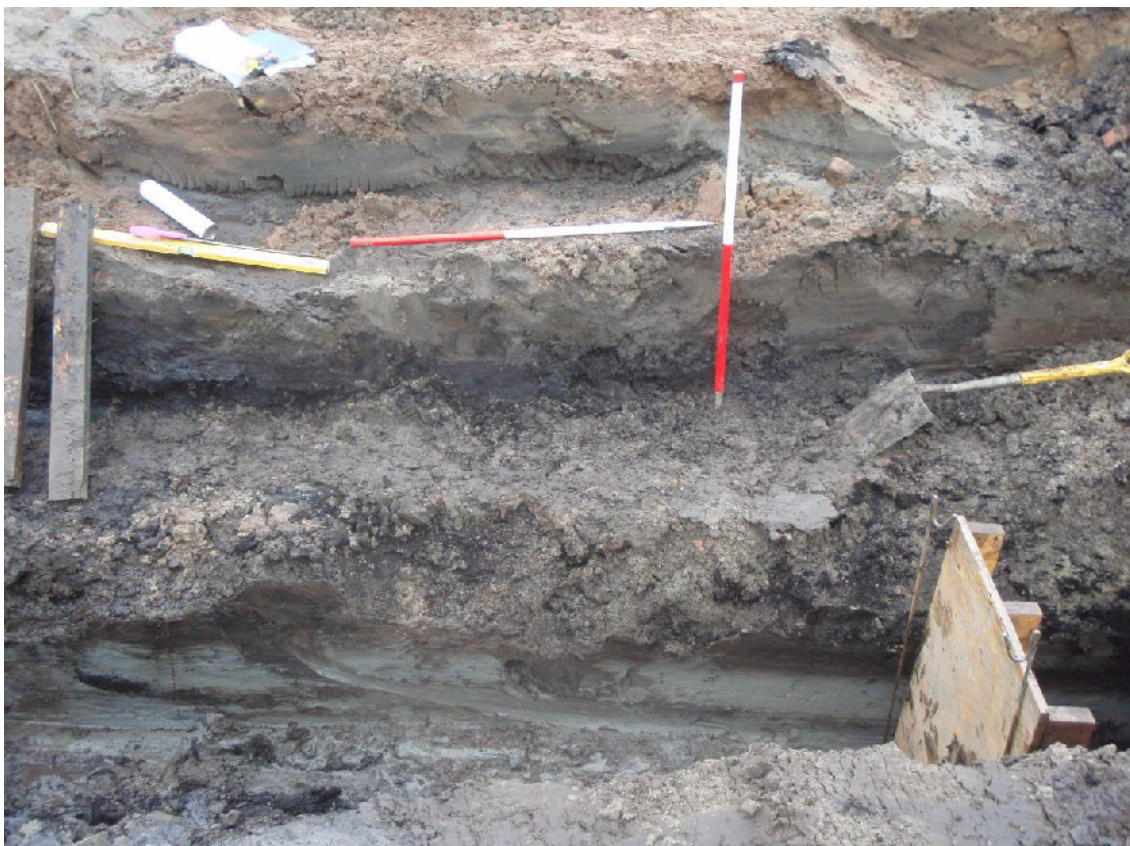
Plate 2. East-facing trench section at northern end. From the east.

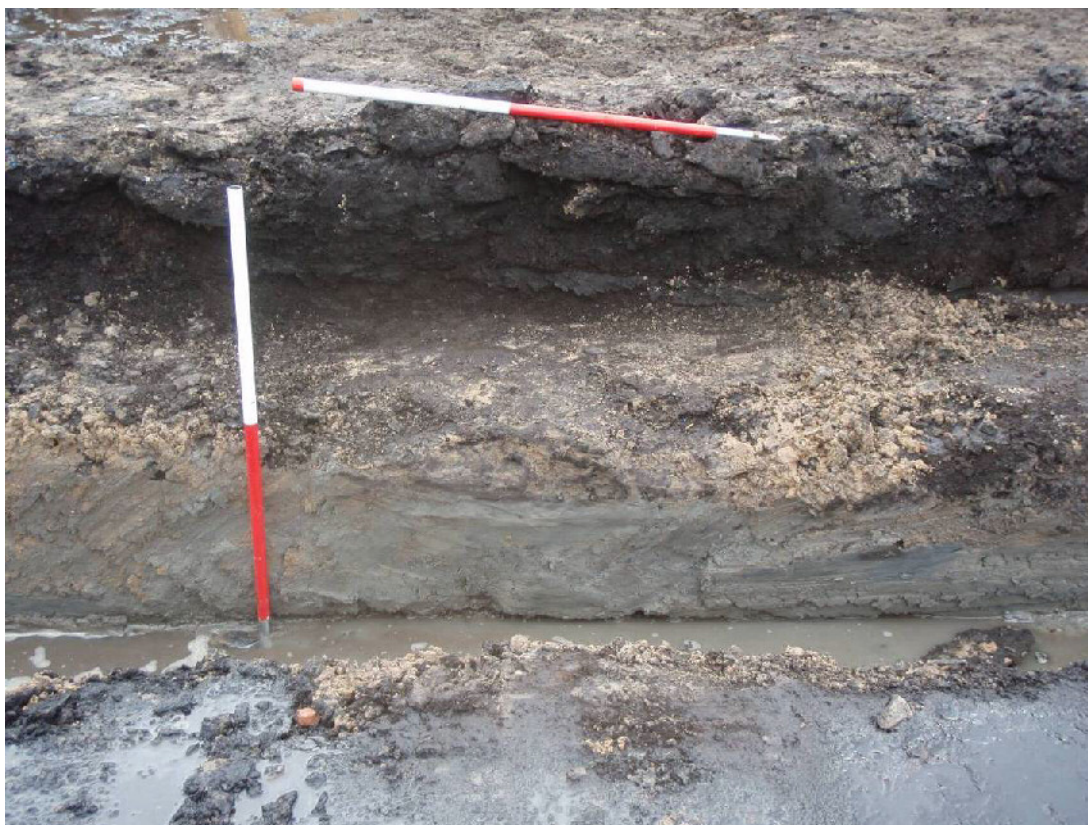
Plate 3. West-facing section at c. 20 m south of northern end. From the west.

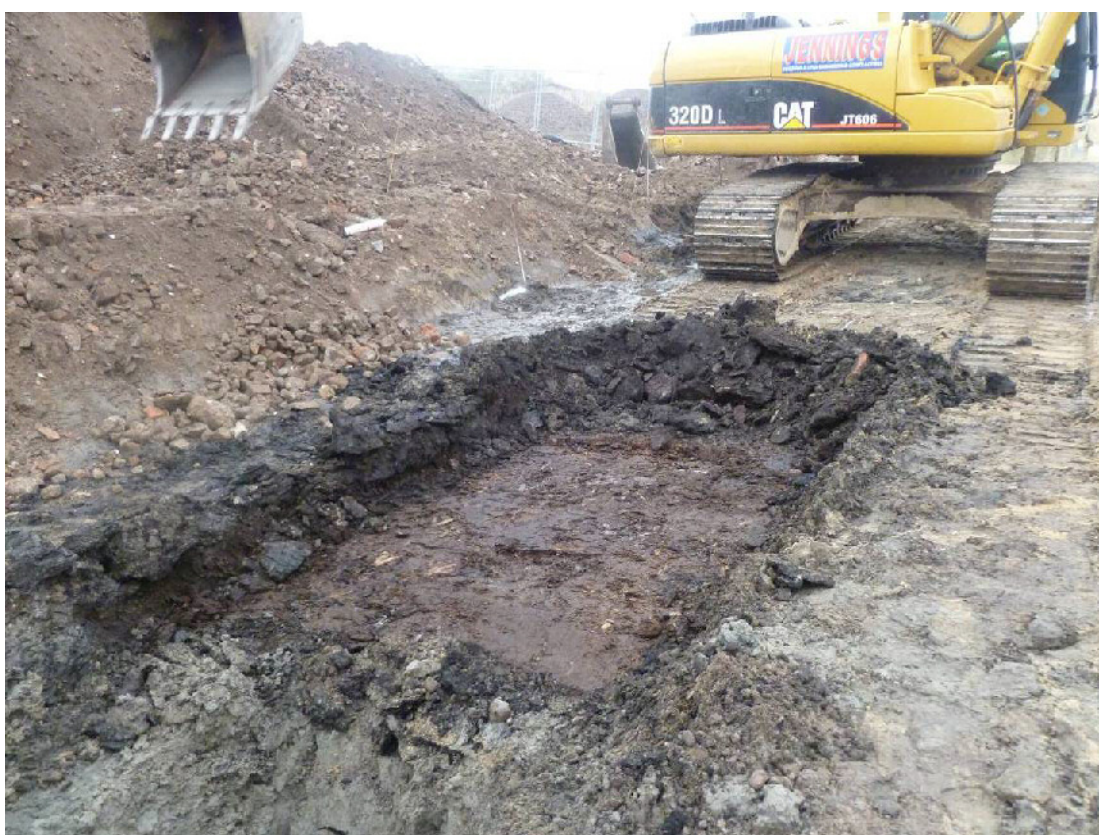
Plate 4. Machine excavating through peat, when initially exposed observed as a very compact dark reddish brown fibrous deposit before rapidly oxidising to black. From the north-west.

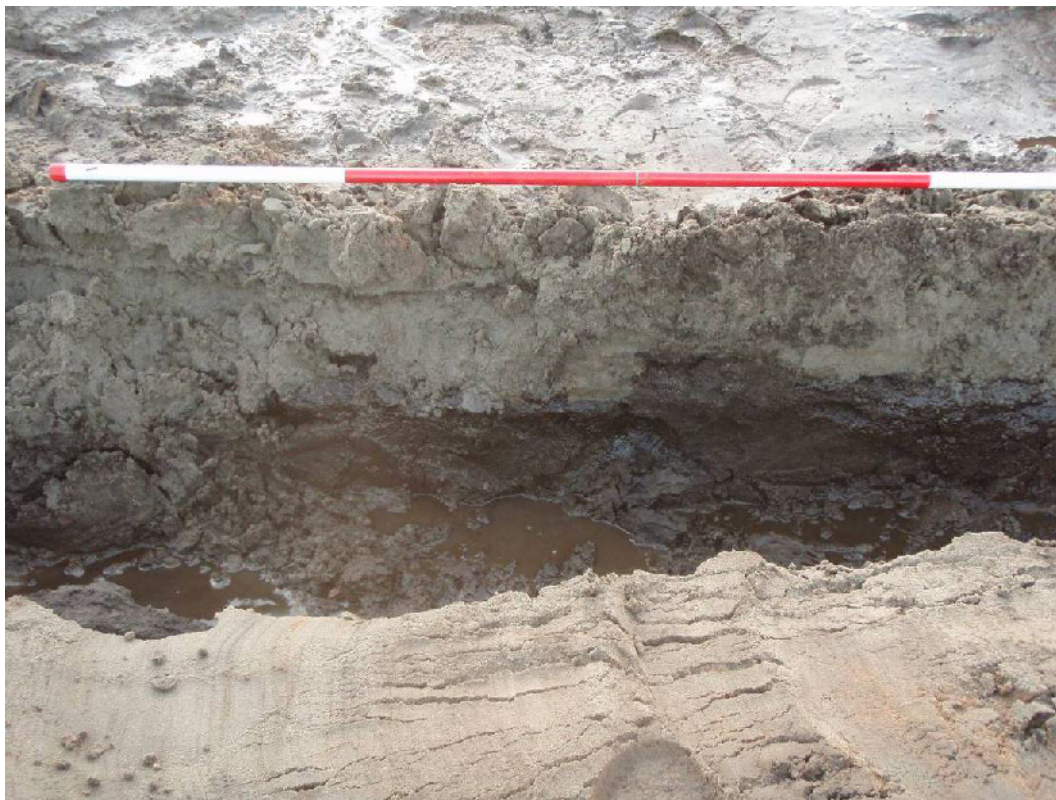
- 8.3 A thin upper peat deposit, c. 0.10 - 0.12 m thick, was observed at the far northern end of the trench overlying a thicker brown/black sand deposit (Plate 5). This section of the trench was not fully excavated due to the rapid ingress of water which made it difficult to establish the full extent of the deposit. At 7.00 m to the south, the thin peat layer was no longer present.

Plate 5. East-facing section through bluish/grey sand and a thin underlying peat layer over brown sand, at c. 4 m from far northern end. From the east.

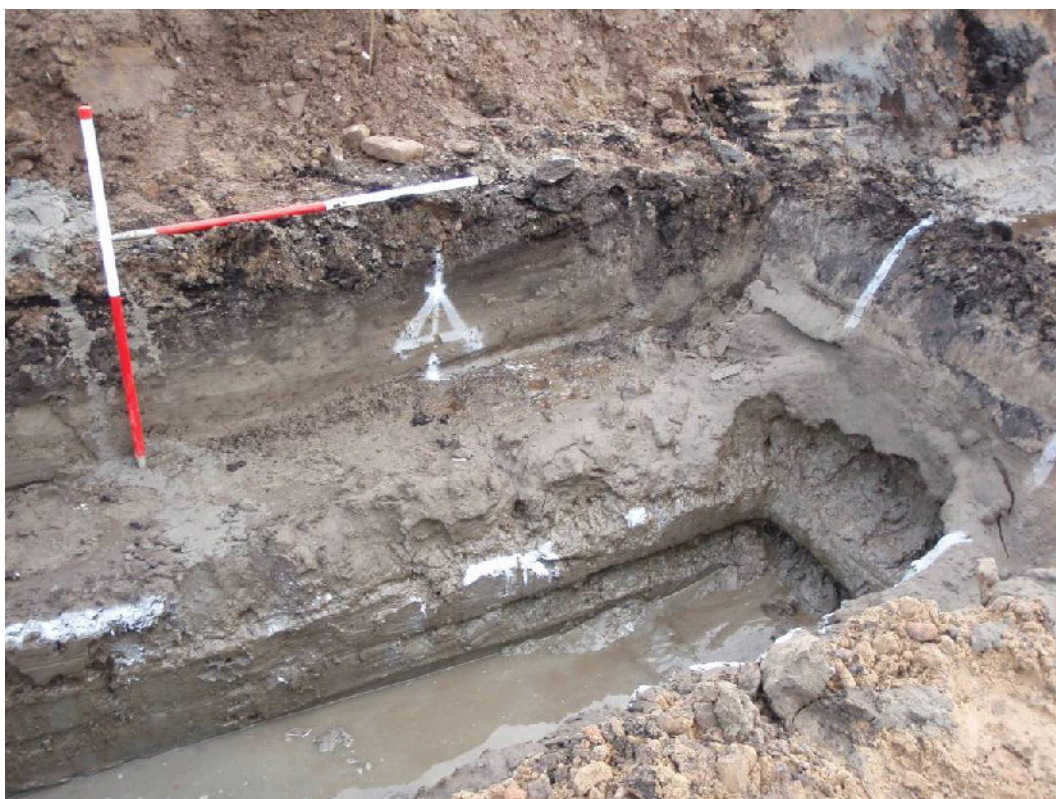
- 8.4 At around 30 – 32 m along the trench the peat layer began to rise towards ground level, thinning out from 0.20 - 0.15 m and overlying dark and light grey sand deposits, c. 0.70 m thick. At around this point the lower blue clay layer also thinned to c. 0.25 m thick sealing an unstable bluish grey silty sand layer, 0.25 m thick (Plate 6). The lower deposits remained consistent through out the remaining sections.

Plate 6. West facing trench profile at c. 36 m showing rising clay and sand layers below thinner layer of peat. Water seepage at base of trench caused by a layer of blue sand below thinning layer of clay. From the west.

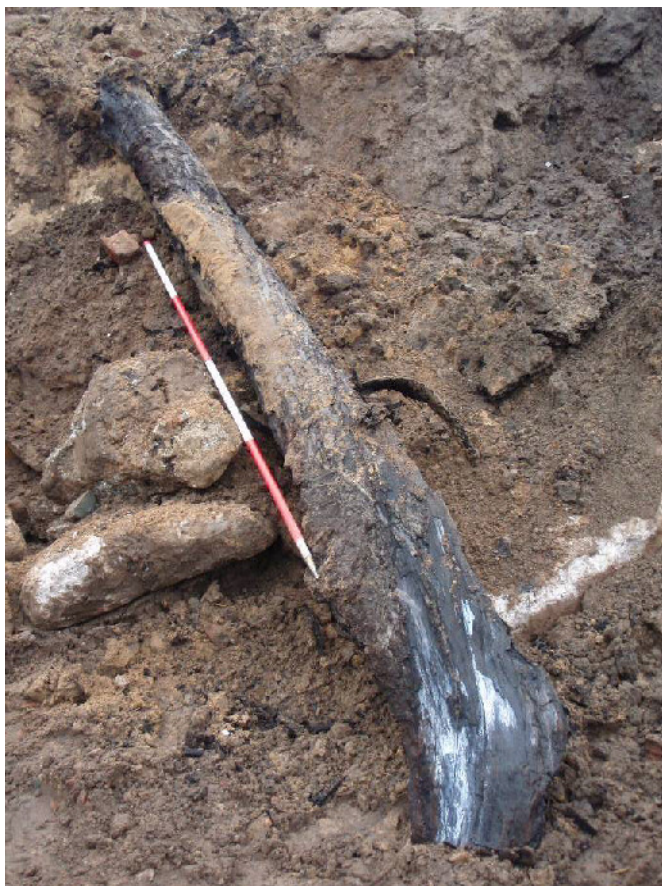
- 8.5 A large tree trunk c. 3.80 m in length was excavated at c. 42 metres from behind the toe beam, around mid-way across the excavated area. It was lying east – west and was c. 0.30 m in diameter at the base (Plate 7).

Plate 7. Tree trunk (c. 3.80 m in length) machine excavated from peat layer at approximately 42 metres south of northern end.

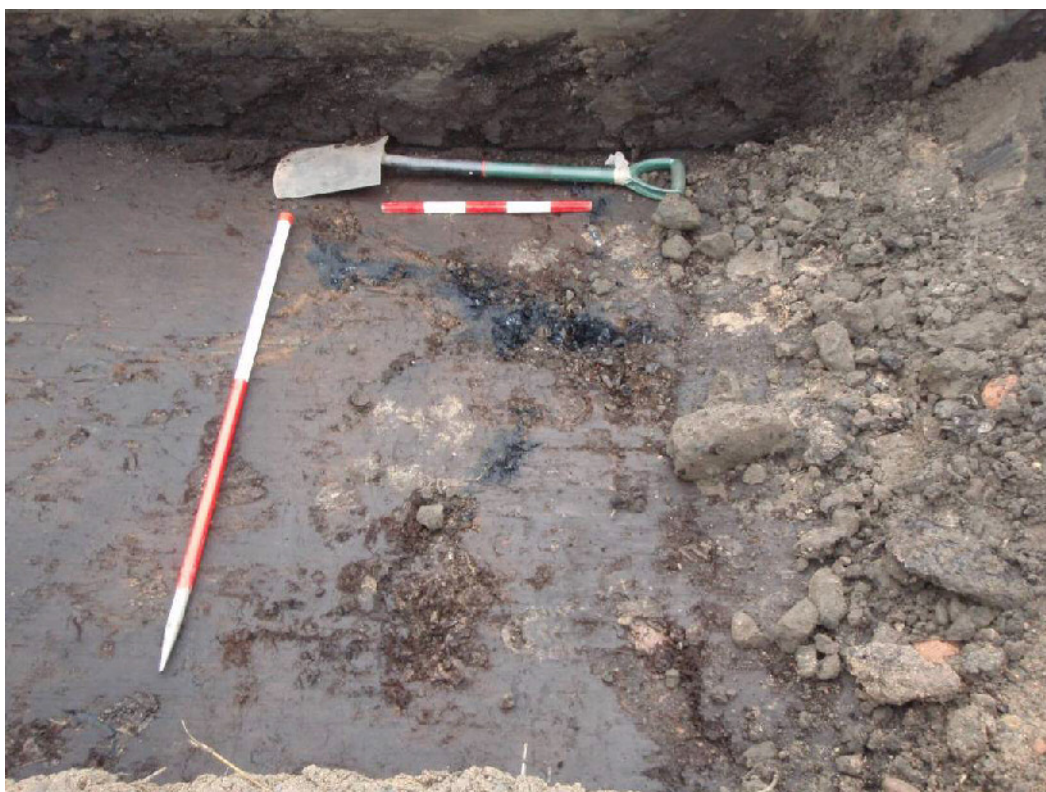
- 8.6 At c. 40 m the peat started to become significantly thinner as the blue/grey clay and sands rose up. A burnt tree stump was noted within the thin peat layer amid a mass of roots (Plate 8). The roots around this area were tentatively identified as Alder and were slightly spongy (Plate 9).

Plate 8. Burnt tree stump noted in peat towards southern end, amid mass of roots. From the west.

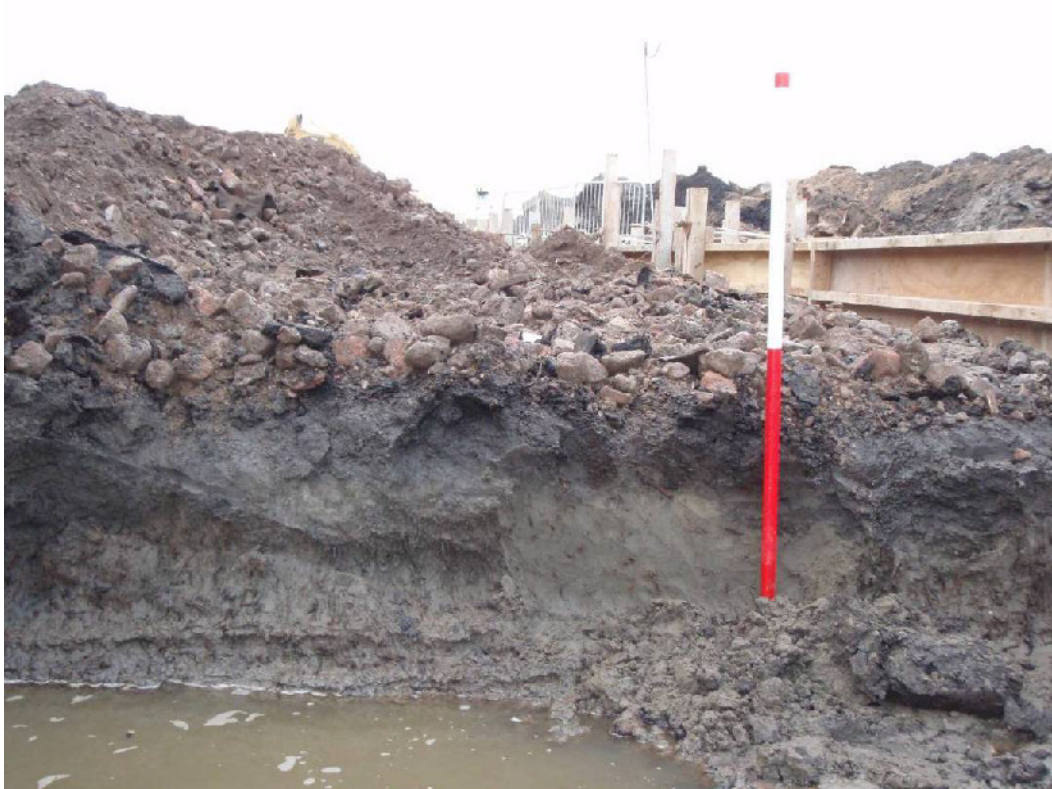
Plate 9. North-facing profile showing deposits behind toe beam including possible alder roots from peat observed within underlying sand layer. From the north.

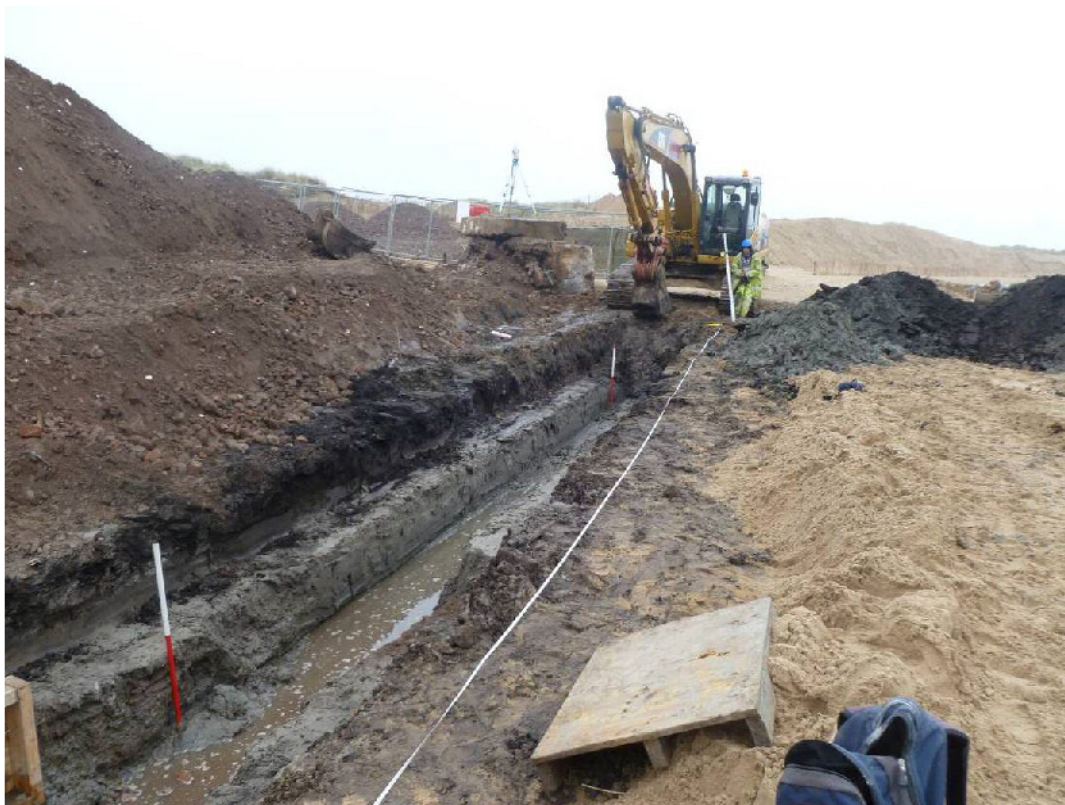
- 8.7 At c. 57 m the depth of the peat began to increase but was varied between 0.20 – 0.60 m in thickness, becoming nearly 1 m thick to the rear of the southern end of the defences (Plates 10 and 11).

Plate 10. Along east-facing trench profile just prior to section across line of ramp to old sea defences. From the north.

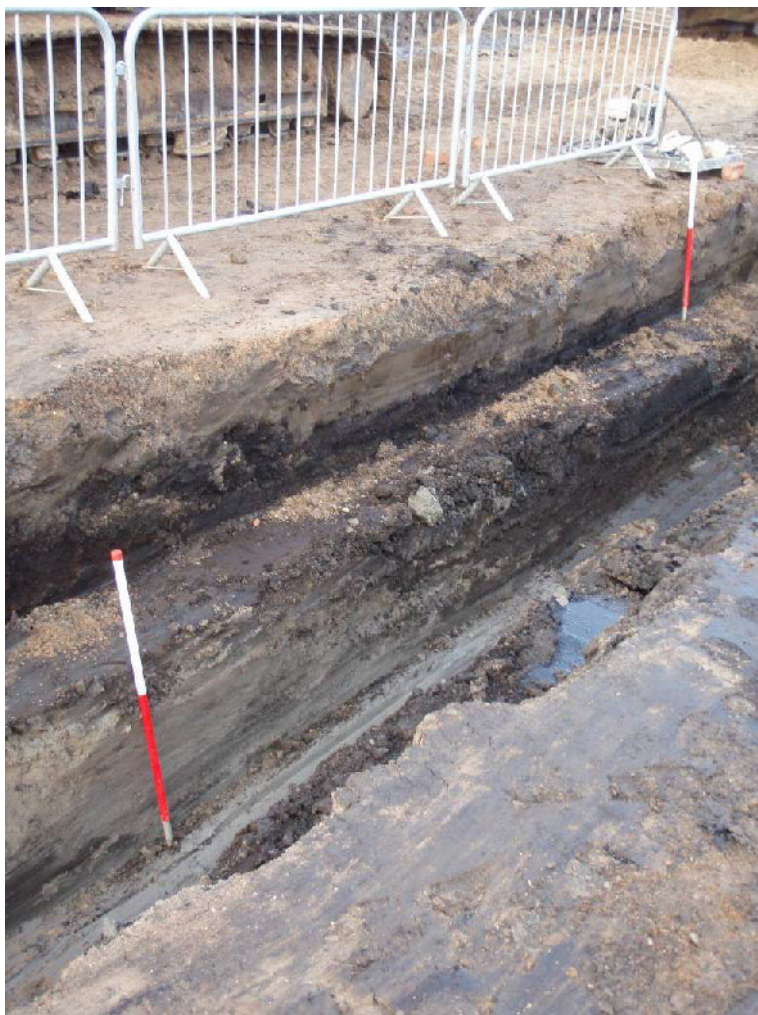
Plate 11. East-facing trench profile at approximately 6 – 7 m into section across line of ramp to old sea defences, showing sharp fall of peat layer mid-way. From the south-east.

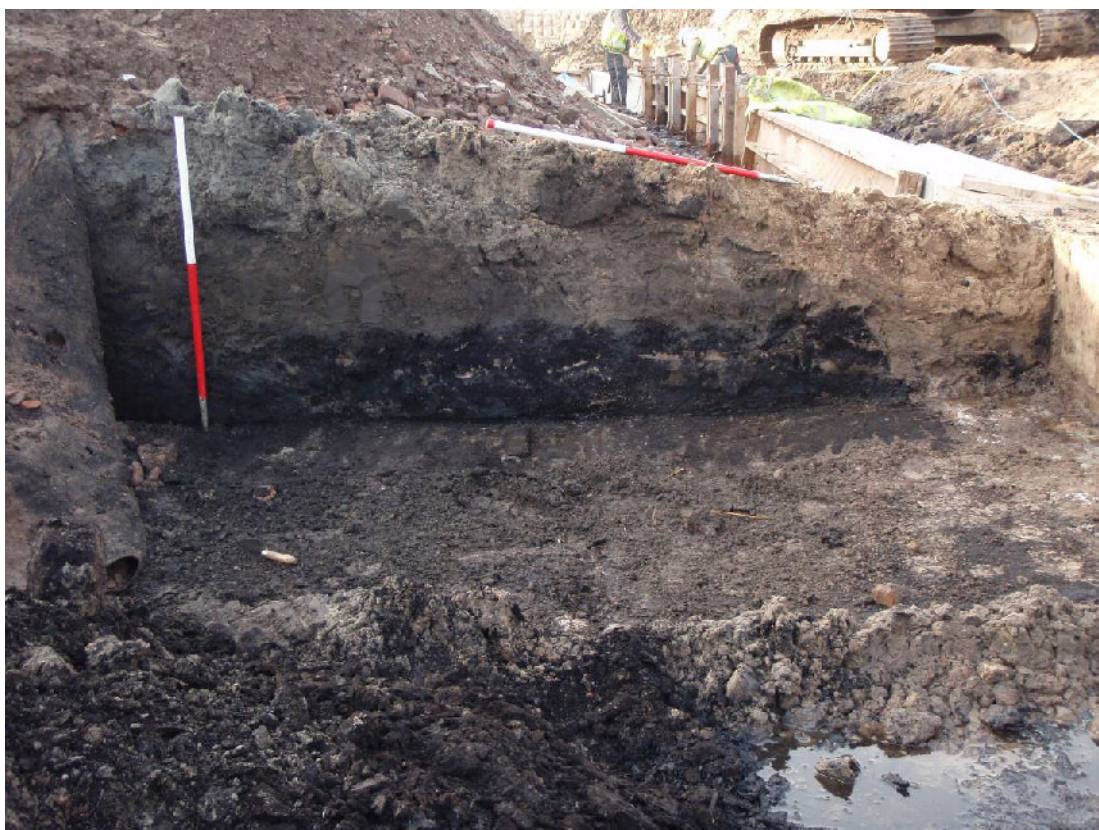
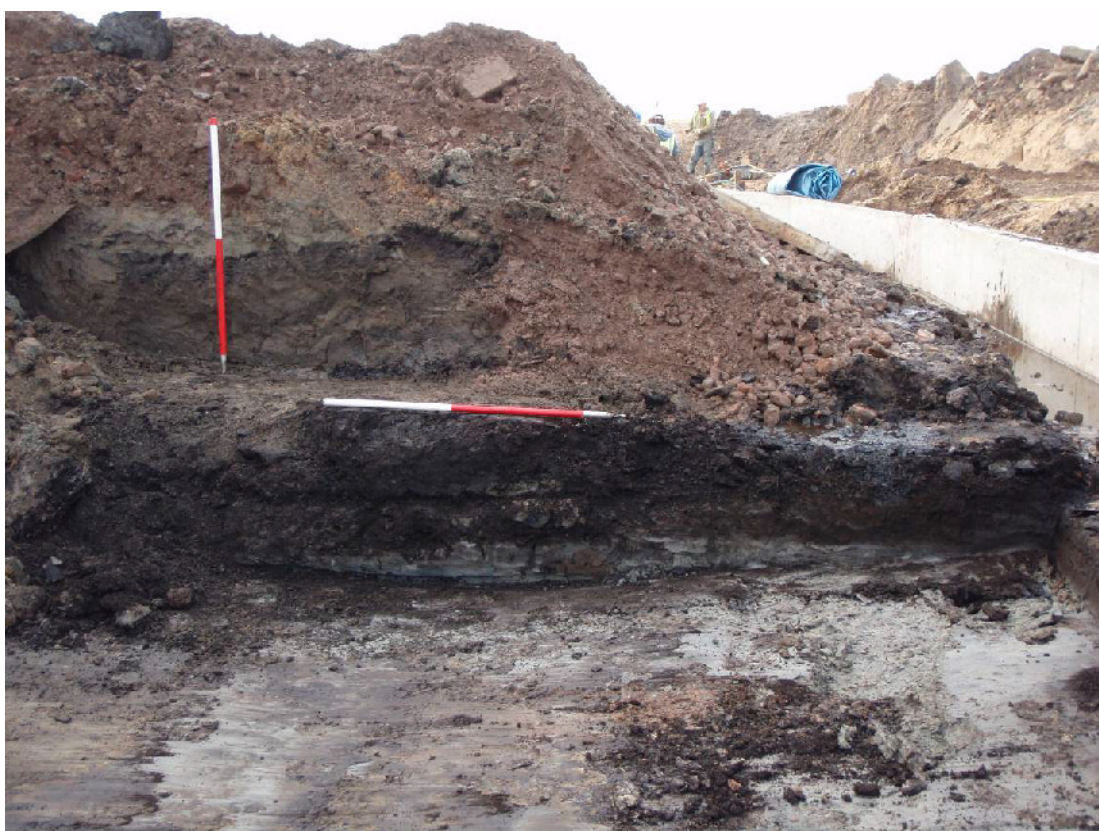
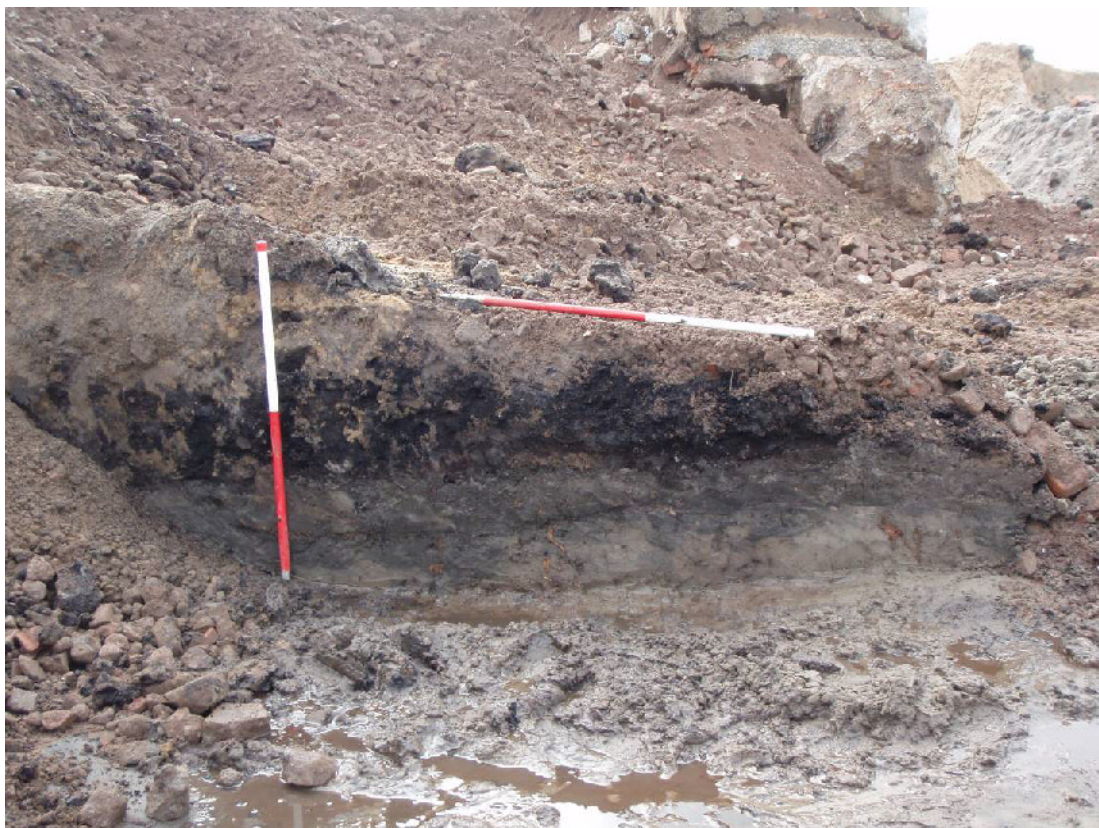
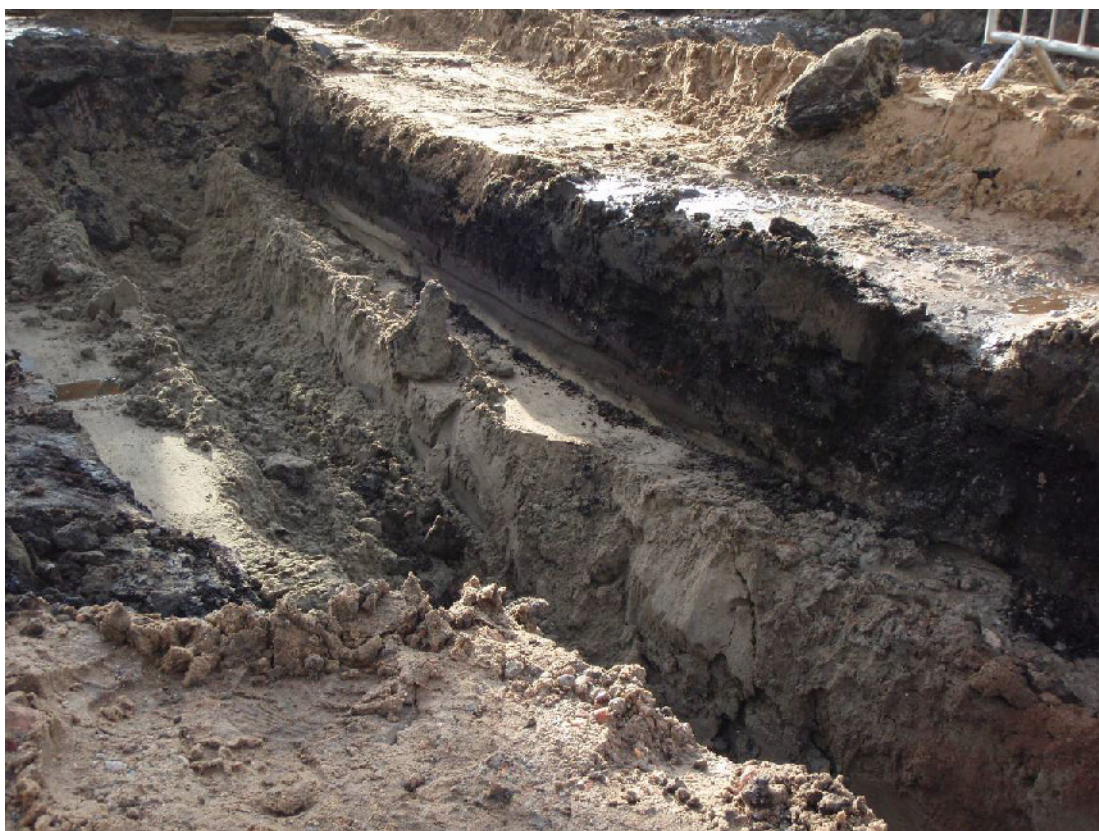
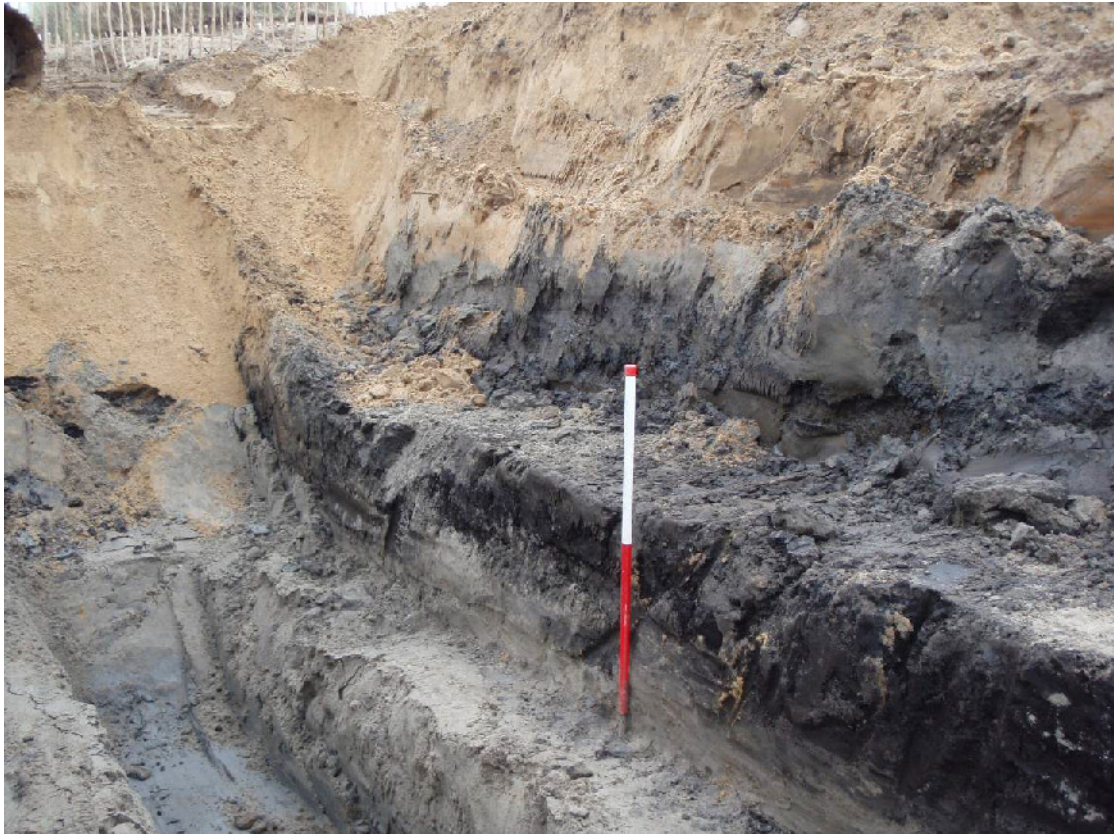
- 8.8 The thickness of the peat varied little along the east-west axis (Plates 12-16), probably reflecting the accumulation of the peat to either side of the sand ridge.

Plate 12. North facing profile through area behind toe beam at c.12 metres south. From the north.

Plate 13. North facing profile through area behind concrete toe beam at c.20 metres south. From the north.

Plate 14. North facing profile through area behind toe beam at c. 36 metres showing underlying sand deposits below peat layer. From the north.

Plate 15. East-facing trench profile at southern end. From the north-east.

Plate 16. North-facing trench profile for eastern return. From the north-west.

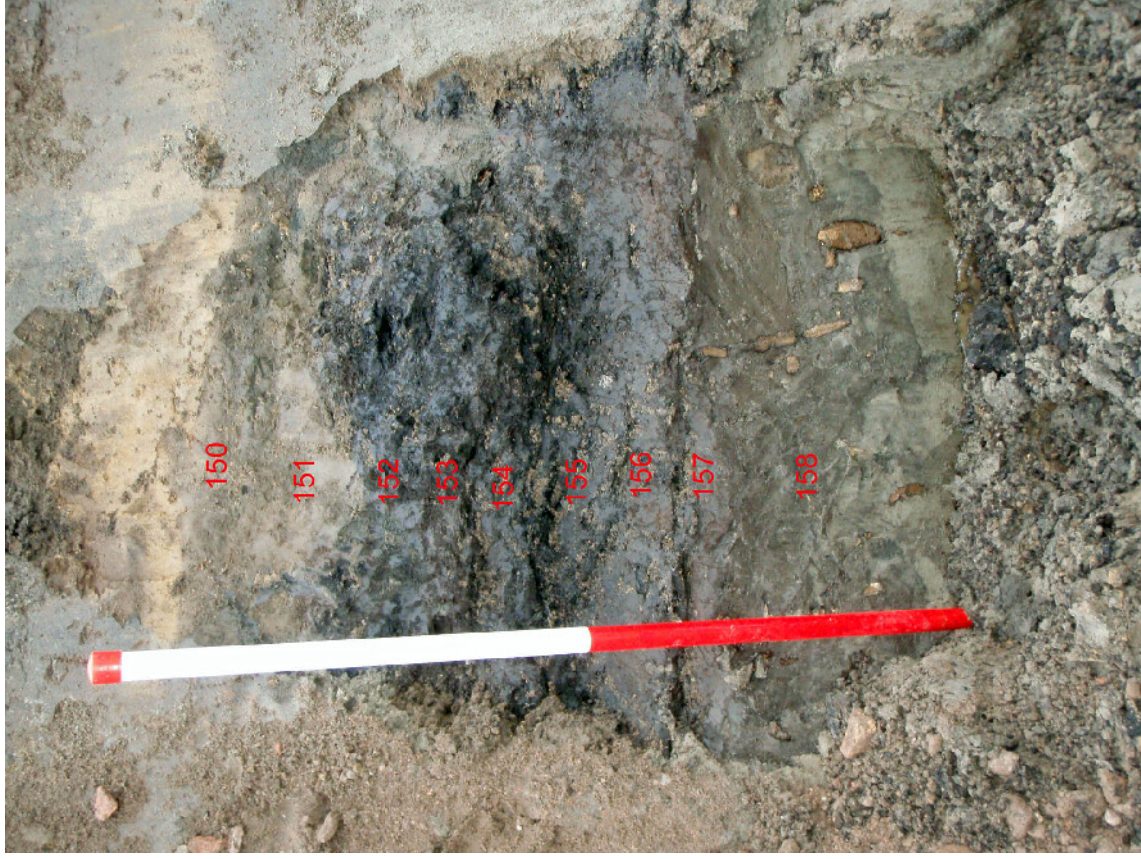
Plate 17. Samples 150-158.

- 7.9 'Grab' samples from the peat layer were taken for pollen analysis at the locations given in Fig. 2 (See also Plates). Due to time and safety constraints it was not always possible to take the samples at regular measured intervals. The approximate locations for samples taken were recorded in the site notebook. The samples were taken using a trowel shrouded in a fresh plastic bag. The depths recorded on bags were measured from the top of the peat deposits. The samples have been delivered to Prof. Ann Worsley, Geography Dept., Edge Hill University College, Ormskirk, Lancashire. The results of any analysis will be reported separately.

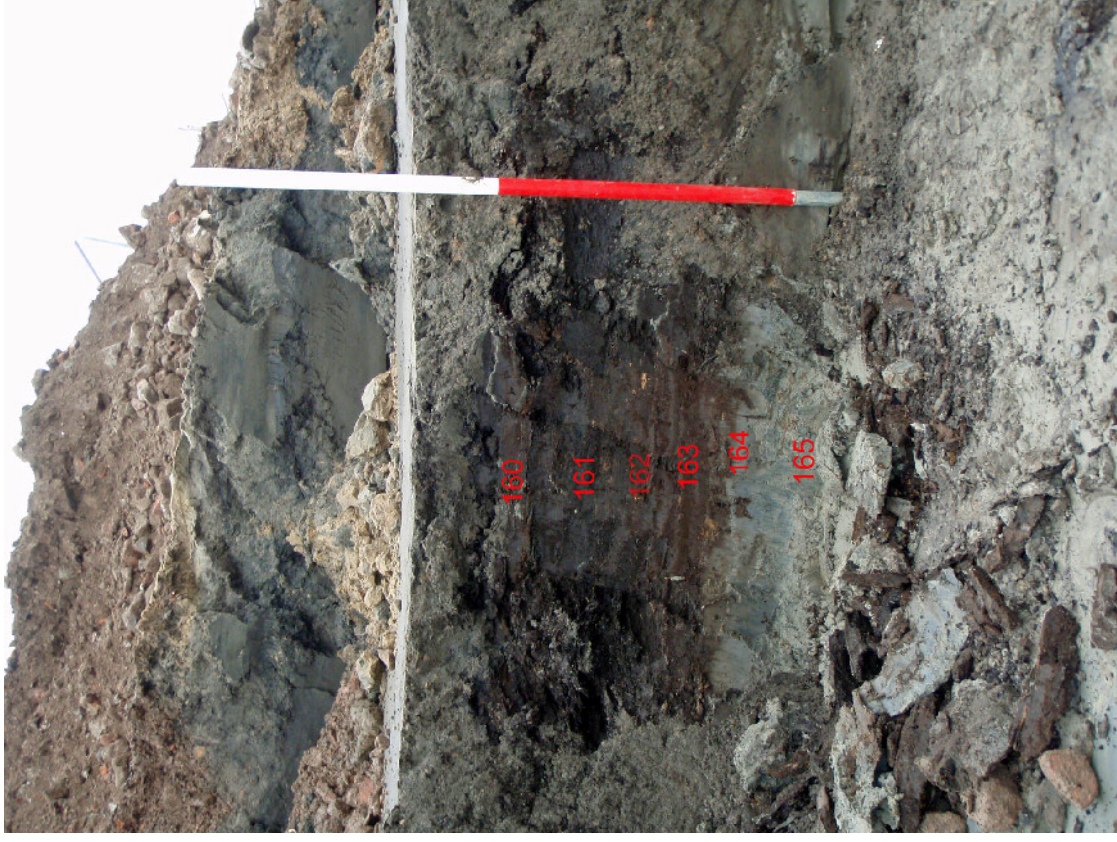
Plate 18. Sample 160 -165.
